# Bat Roost Potential Report

Freidrick Morfill House

Fireman's Cottages

Bounds Green Road

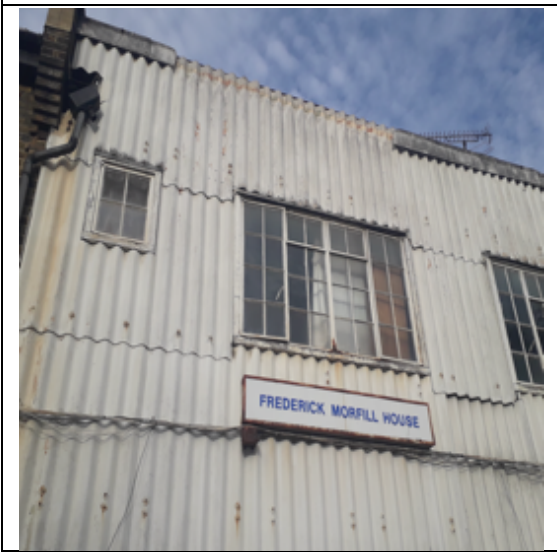
- 4.8 This building was constructed out of a layer of corrugated metal sheeting, set over a steel frame. The roof was flat, which was covered in bitumen to weather proof. There was not any roof void present, that could potentially support roosting bats. There were gaps under the metal sheeting on the external walls, but these were also exposed to the top with limited guttering, creating a channel for any incremental weather (rain) to flow down. This would prevent anything colonising these locations, notably bats as they would be over exposed and not provided with suitable shelter. Any gaps under the sheeting was inspected with both a torch and an endoscope, with no evidence of bat present. There was also thick cobwebbing throughout the external areas of this building, indicating that there was not any ingress into any locations of this building. No evidence of bats was observed during this survey.

| <p><b>Plate 1: Gap under metal Sheeting, checked with endoscope. Open to the top and full of detritus.</b></p> | <p><b>Plate 2: Corrugate sheeting, with gaps at base. No evidence of bats and full of detritus</b></p> |

- 5.1 No evidence of bats was observed within the building and there were no suitable features that could potentially provide roosting locations for bats. Therefore, no further surveys in relation to roosting bats are required.
