# STANHOPE ROAD BRIDGE, HARINGEY

Phase II Generic Quantitative Risk Assessment

OUR REF. NO. 70085596-WSP-GQRA-GW-0001-P01

DATE: JUNE 2023

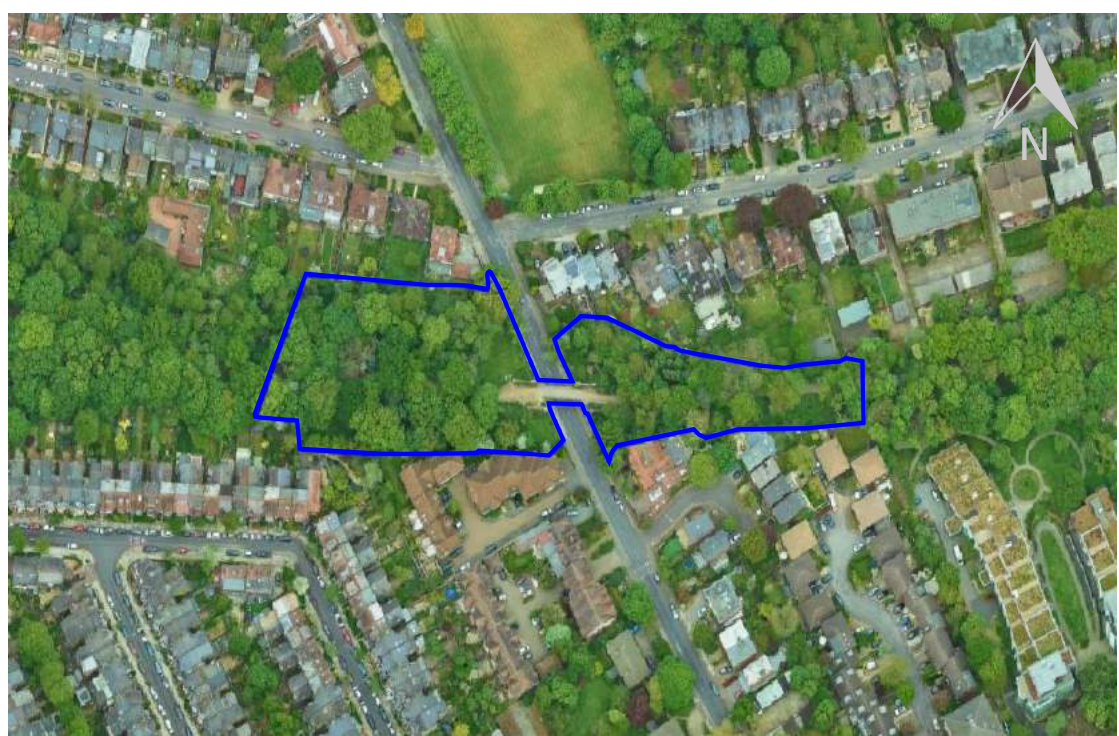
**Plate 1 Recent aerial photograph of the Site**

Figure 1 is a Site location map and Plate 1 is a recent aerial photograph of the Site.

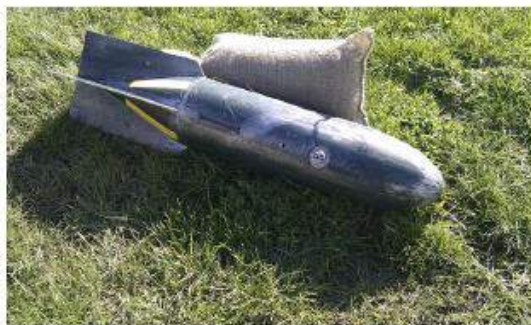
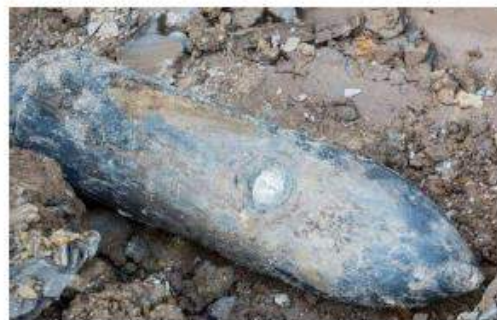
**Description** Thick nose welded to a steel body. Nose may be attached to Kopfring (a triangular section steel ring) or spike. Suspension bolt in eye/body and sheet metal tail attached to body with rivets/screws. Originally painted green-grey with a yellow stripe on the tail. Cast TNT, Amatol or Trialen filling.

**Function** Designed to maximise shock waves through air, water and earth and for general demolition. Used against easily damageable targets, including roads, aircraft hangars, rolling stock and small buildings. Spike bombs/ 'Stabo' (SC 50 with spikes attached to nose) were used against rail lines and country roads, with Kopfring used against naval targets.

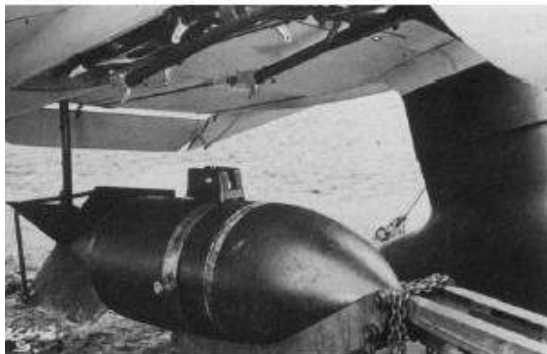
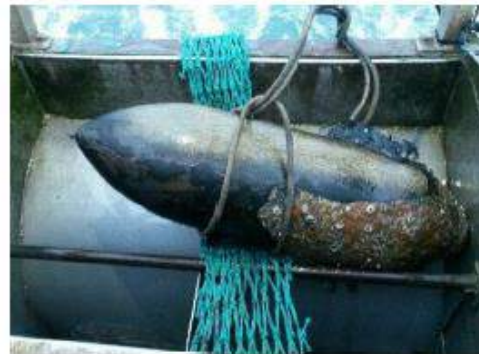
**Description** Thick nose welded to steel body. Nose may be attached to Kopfring (triangular section steel ring) or spike. Sheet metal tail attached to body with rivets/screws. Suspension eye bolt in the nose/body. Originally painted green-grey with a yellow stripe on the tail. TNT; amatol; TNT and aluminium powder, naphthalene, ammonium nitrate and wax/ wood meal filling.

**Function** Designed to maximise shock waves through air, water and earth and general demolition. Used against railway installations, large buildings, ammunition depots and below-ground installations (to 8m). Spike bombs/ 'Stabo' (SC 50 with spikes attached to nose) used against rail lines and country roads.

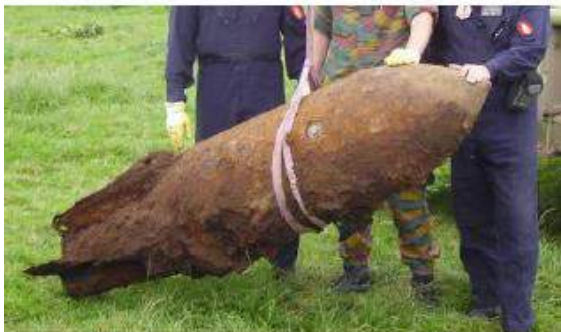
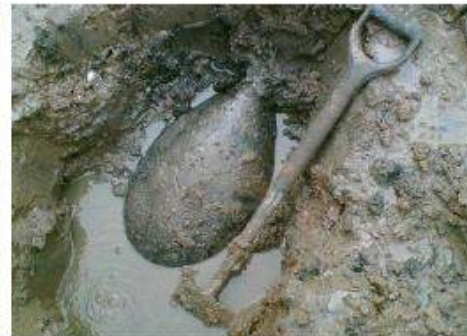
**Description** Thick nose welded to steel body. Nose may be attached to Kopfring (triangular section steel ring). Tail either steel sheet or drum-shaped. Suspension band. Originally painted green-grey/ buff (some later versions sky blue) with yellow stripe on tail. Filled with amatol, TNT or trialen.

**Function** Designed to maximise shock waves through air, water and earth and for general demolition. Used against railway property, large buildings, shipping and below-ground installations.

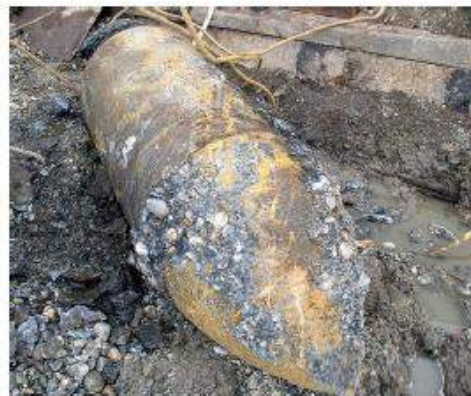
**Description** Thick nose welded to steel body. Nose attached to Kopfring (triangular section steel ring). Drum-shaped tail made of magnesium alloy. Suspension band. Originally painted sky-blue. Filled with amatol, TNT/aluminium/wood meal or trialen.

**Function** Designed to maximise shock waves through air, water and earth and for general demolition.

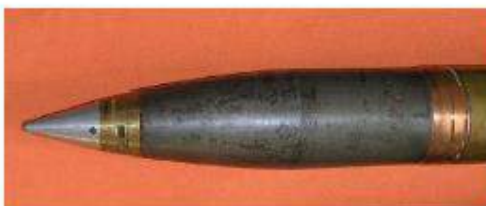
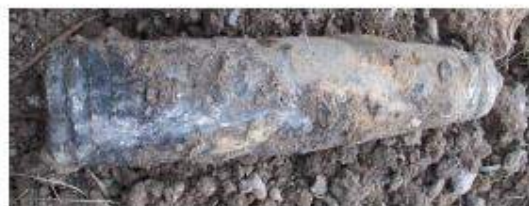
**Description** Brass cartridge case. Square-based shell with tapered nose, filled with Amatol, TNT or RDX/TNT. MK6 had forward centring bands and a wider driving band.

**Function** Used as a defence against enemy aircraft, fired from fixed batteries and mobile mountings. Could fire approximately 20 rounds per minute with a maximum ceiling of 41,000ft and horizontal range of 20,600 yards.

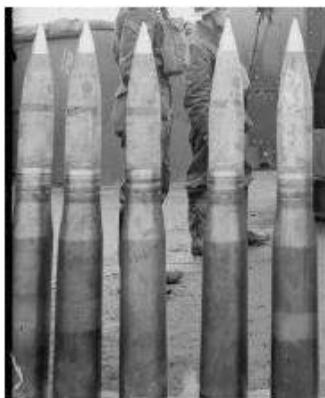
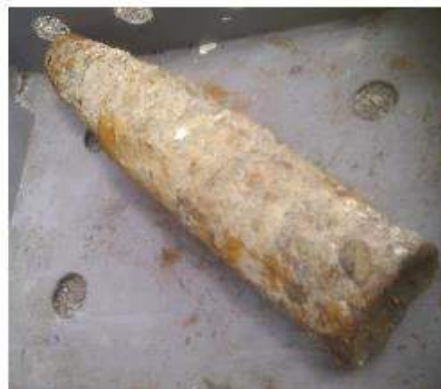
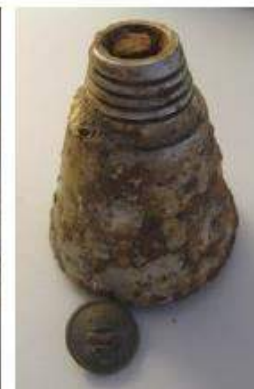
**Description** Square-based, tapered-nosed shell filled with TNT or Amatol. Steel casing, rotating band of either copper or gilding metal located 3.5" in front of the base end with single groove.

**Function** Used as field artillery and adapted for use in anti-aircraft defence from fixed batteries. Rate of fire of 8 rounds per minute, maximum ceiling of 44,000ft and horizontal range of 22,800 yards.

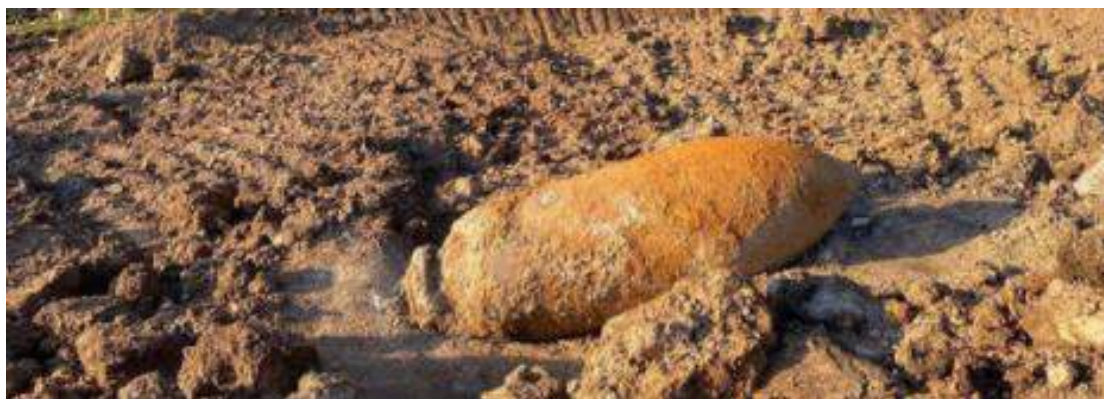
On the 26<sup>th</sup> February 2021, a 1,000kg German “Hermann” UXB was discovered by builders at Exeter University campus (see plate below). It was investigated and detonated in-situ following the evacuation of nearby properties and University halls of residence.
