22 Milton Avenue, London, N6 5QE  
Design & Access Statement

# Site Location and Overall Proposal

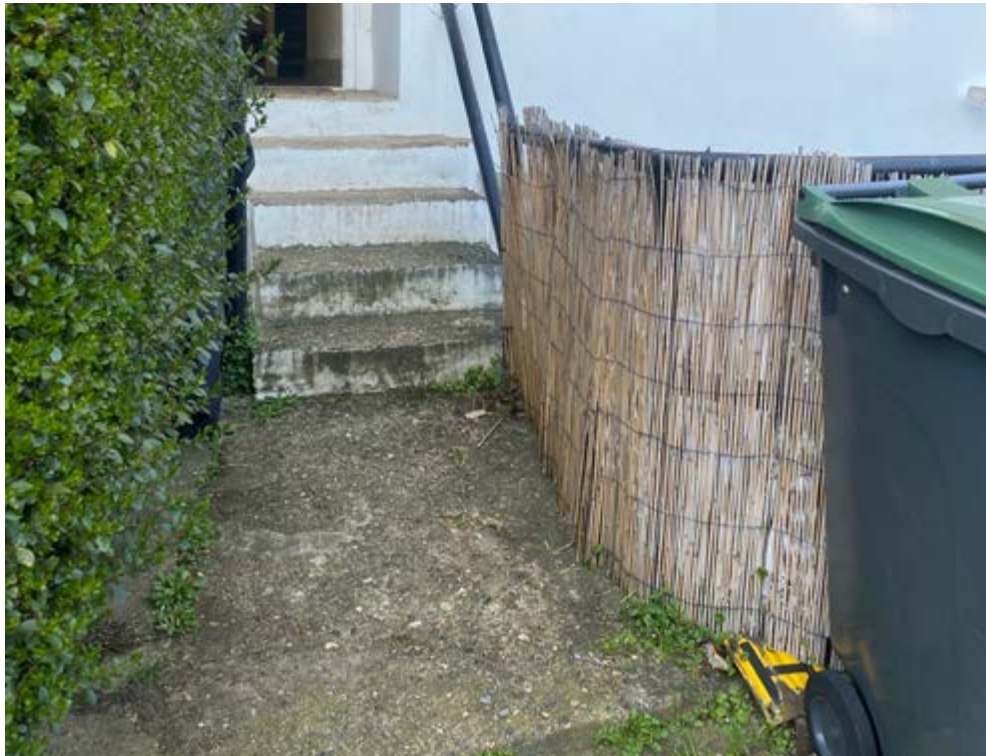
The current access to the building is by Milton Avenue through some relative narrow steps. The existing railing along the frontage of the building is covered with a temporary screening solution to provide a form of security from falling. Additionally, the same railing extents up to the entrance steps which has been identified as dangerous for falling for especially young children.

Existing entrance floor finish and railing along the entrance steps.

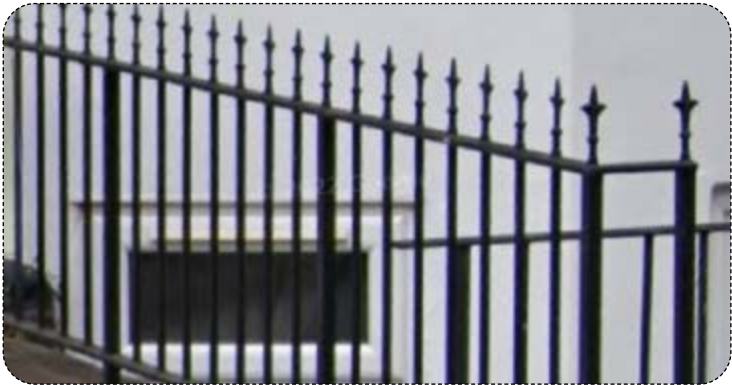
**Railing** - Black Colour

Black Railing to match neighbouring properties.

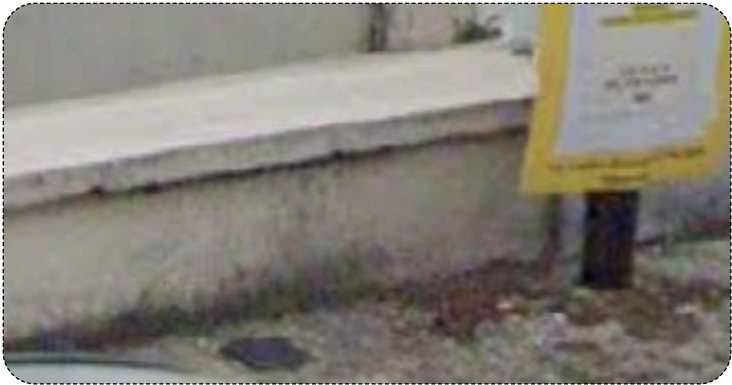
**Wall** - Brick painted white or rendered to match the white lower ground area and neighbouring properties.

Low height wall to stop water accessing the lower ground area. Wall to be painted white to match the surrounding context.

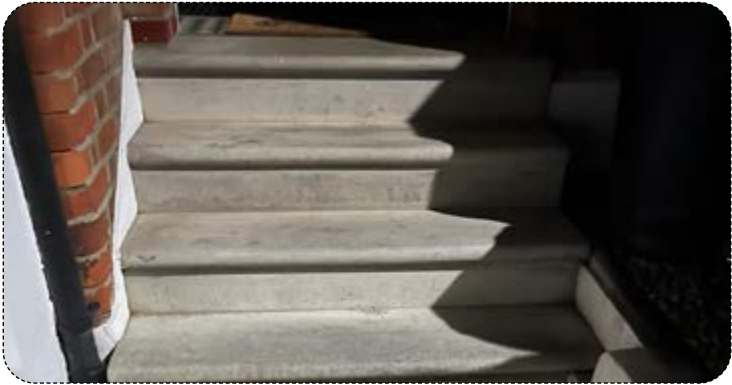
**Floor Finish** - Stone slabs

Stone slabs to improve the current materiality for the entrance pathway and steps.

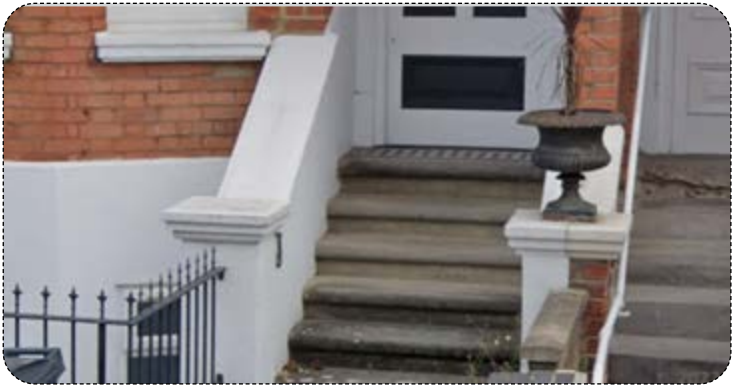
Solid Wall to secure safe access to the main entrance
