**Channing School, The Bank, London, N6 5HF**

## **Significance Assessment**

**WSH Ref: Joo4576**

**March 2024**

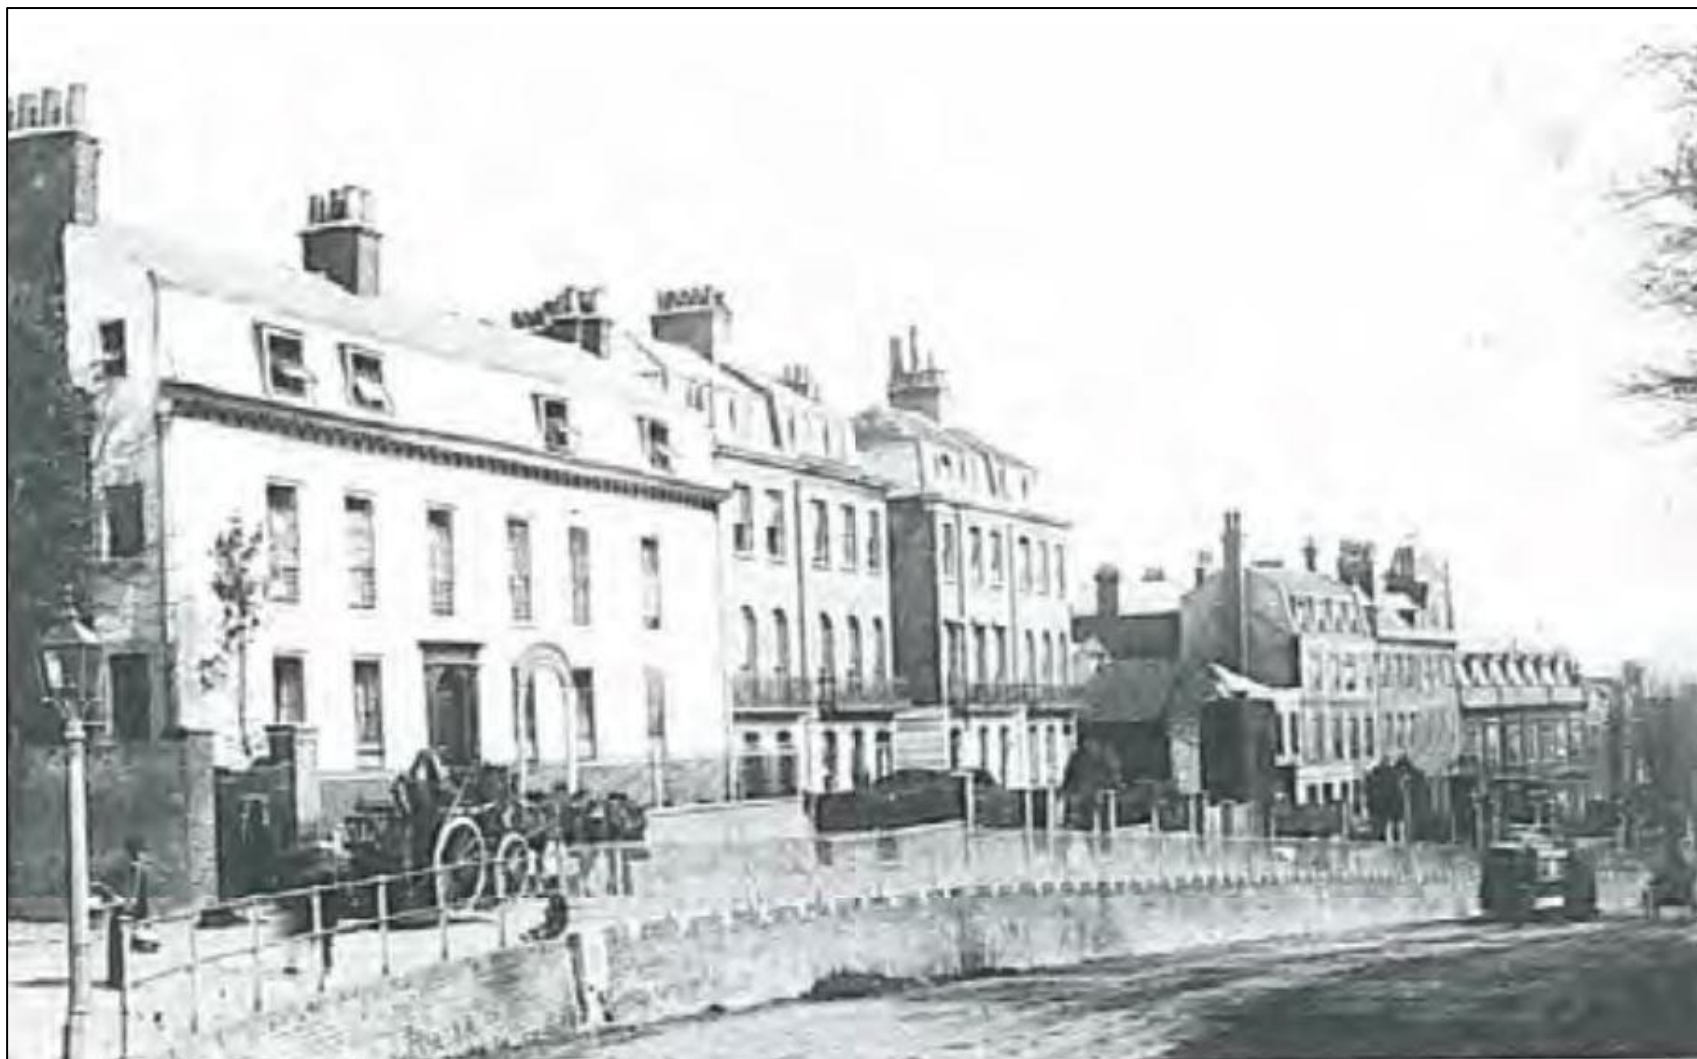
Figure 7: The Bank (reputedly c.1905 - London Borough of Haringey)

- 3.14 On this point, despite being attributed a date of 1905 by the relevant *appraisal* at *p. 41* (see **Figure 7**, above), photographic evidence of Channing House's predecessor (Sutherland House) is likely to be much earlier and from the late nineteenth century (i.e. pre-1885/6 - an interpretation borne out by the aforementioned appraisal over *paragraphs 4.4.33-4.4.34*).

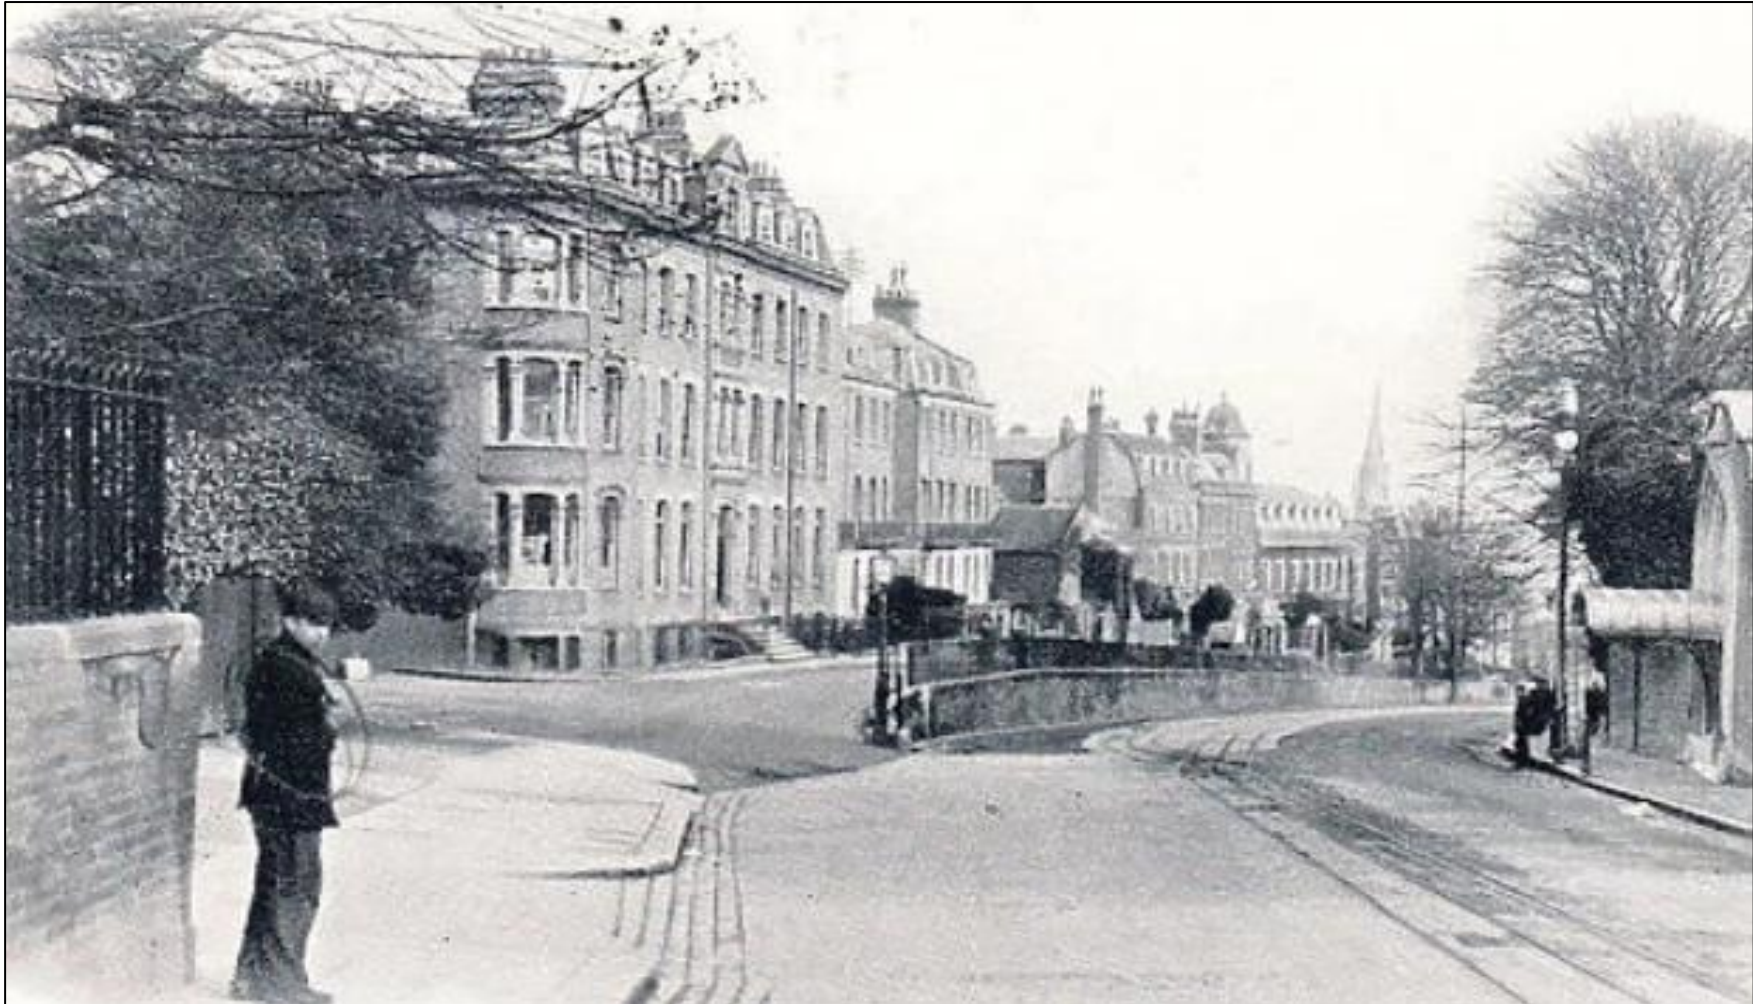
- 3.15 That this is the case is most clearly demonstrated by other photographic evidence of the Sutherland House site. This dates to c.1900 and shows Channing House to have already replaced and occupied the site of its predecessor, Sutherland House, by this time (**Figure 10**). In this photograph, the predecessor to Haigh House can also be seen to project to the right of Slingley at no. 120.

Figure 10: Channing House, c.1900

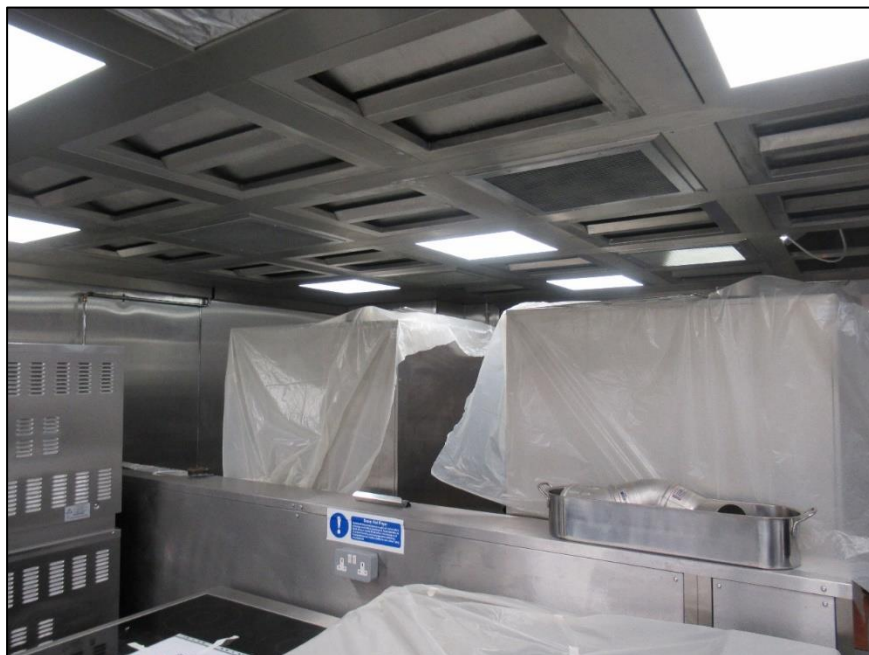
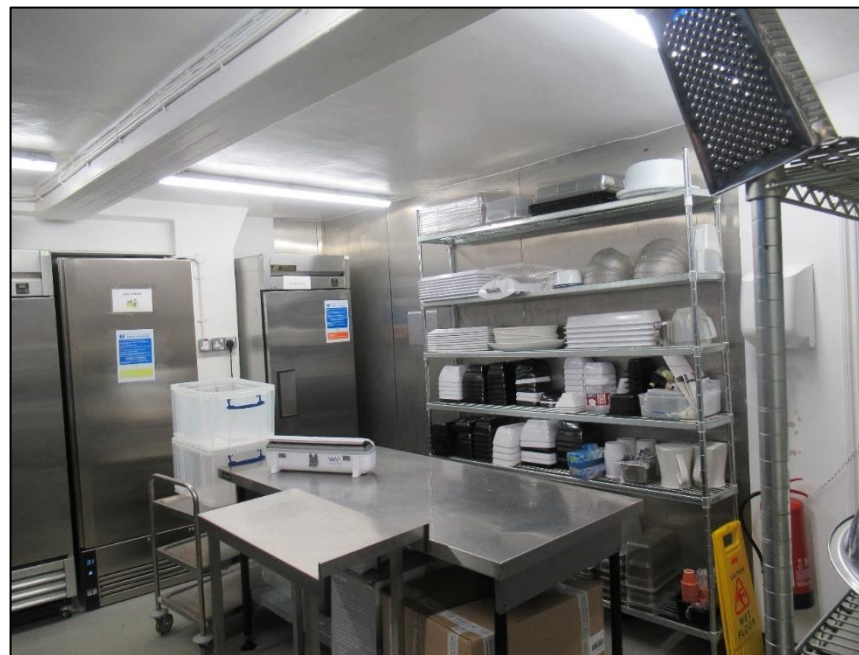
- 4.1 This area has been subject to complete modern redevelopment and/or intervention and therefore does not contribute towards the overarching significance of the interior of the heritage asset. This area comprises the kitchens which service the school, amongst boiler rooms and an office (see **Figures 12 & 13** below).

Figure 12: Basement Level 1 Kitchen (A)

Figure 13: Basement Level 1 Kitchen (B)

- 4.2 Whilst works are proposed for this area, they will only affect modern fabric and will not compromise any historic fabric or detailing. Therefore, proposed works to basement Level 1 will have no adverse impacts upon the significance of the heritage asset.

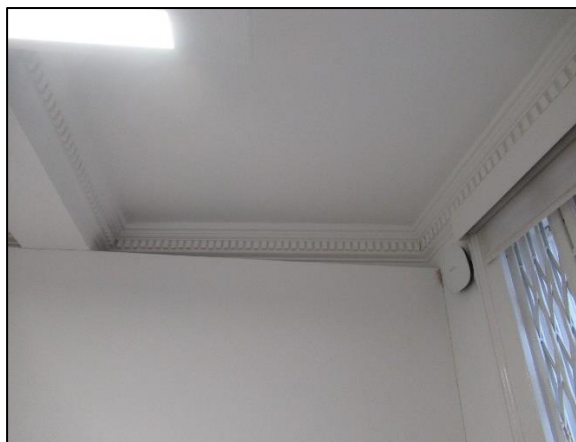
- 4.4 Rooms 1 - 3 have several surviving historic details of significance, although several non-historic partitions have subdivided these rooms which would have originally been one single room. A corridor has been created between Rooms 2 & 3.
- 4.5 Generally the cornice has survived well throughout these rooms, however, non-original internal timber panels have obstructed much of the detailing (**Figure 15**). An ornate structural beam and decorative cornice survives in Room 1 (**Figure 18**).

Figure 15: Room 1 – Obstructed Cornice

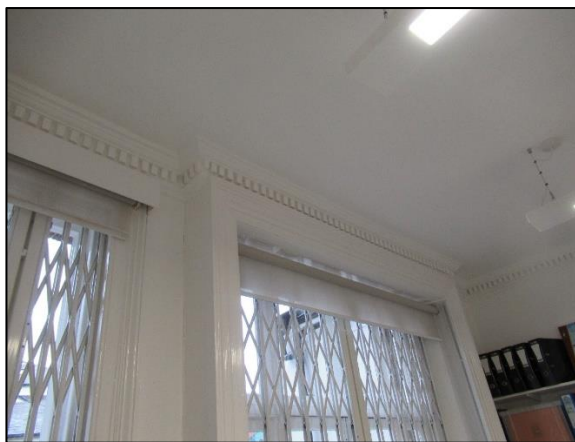
Figure 16: Room 1 - Cornice Above Windows

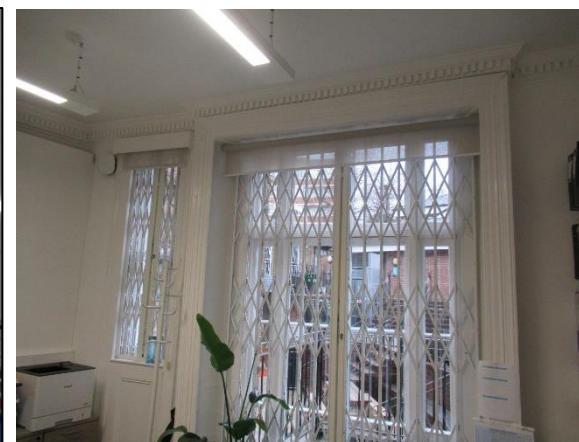
Figure 17: Room 1 – Surviving Cornice and Frame

- 4.6 The windows/doors within Room 1 have had modern shutters installed but the surrounding has survived in good condition (**Figure 17**).
- 4.7 Room 4 comprises a corridor with a staircase and entrance at the rear end with another entrance at the front end. The staircase is in its original location but this has been subject to modern alterations and has no surviving historic detailing.

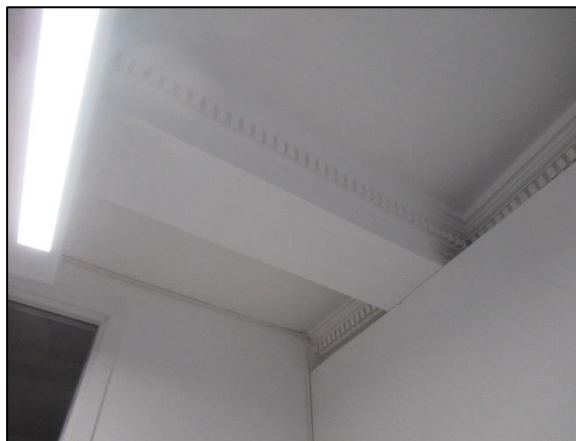
Figure 18: Room 1 – Obstructed Beam &amp; Cornice

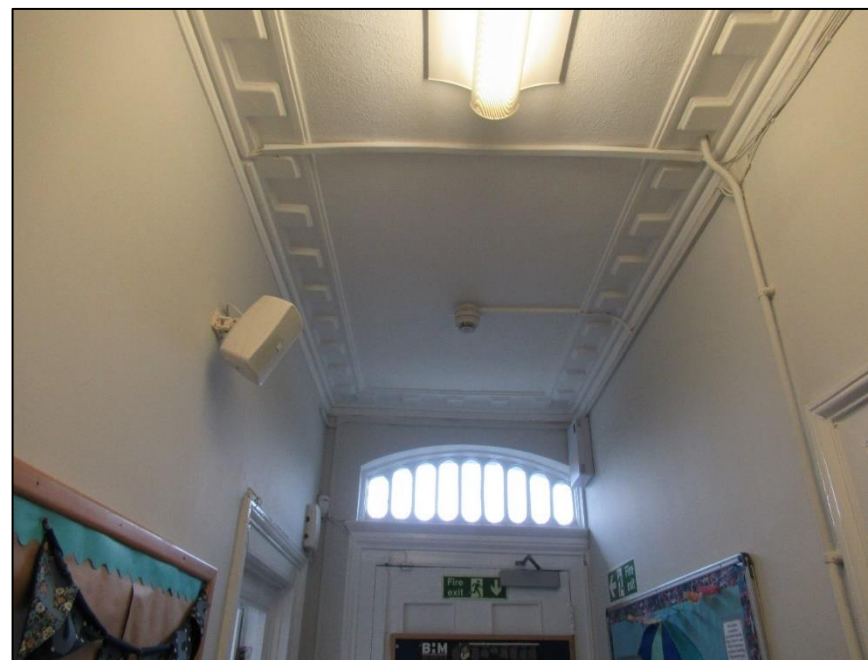
- 4.8 However, the archway leading to the staircase has surviving historic detailing (**Figure 19**). Two decorative column features which flank either side of the arch survive in good condition. Furthermore, the cornice detailing on the ceiling has survived but has missing elements in some places (**Figures 20-22**).

Figure 22: Room 4 – Ceiling Cornice and Fanlight Above Doorway

- 4.9 Both the rear and front entrances have fanlight details above the doorways (**Figure 22**).

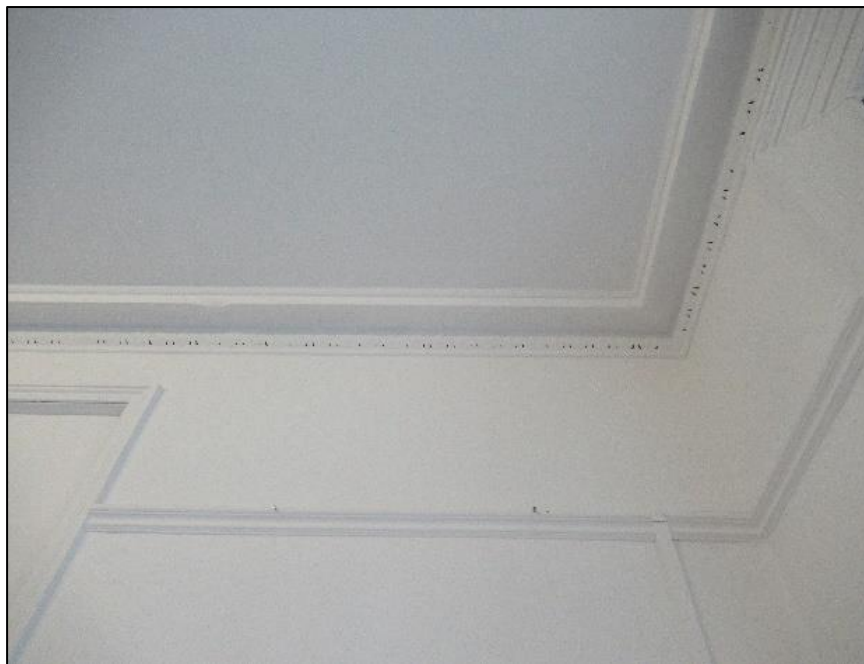
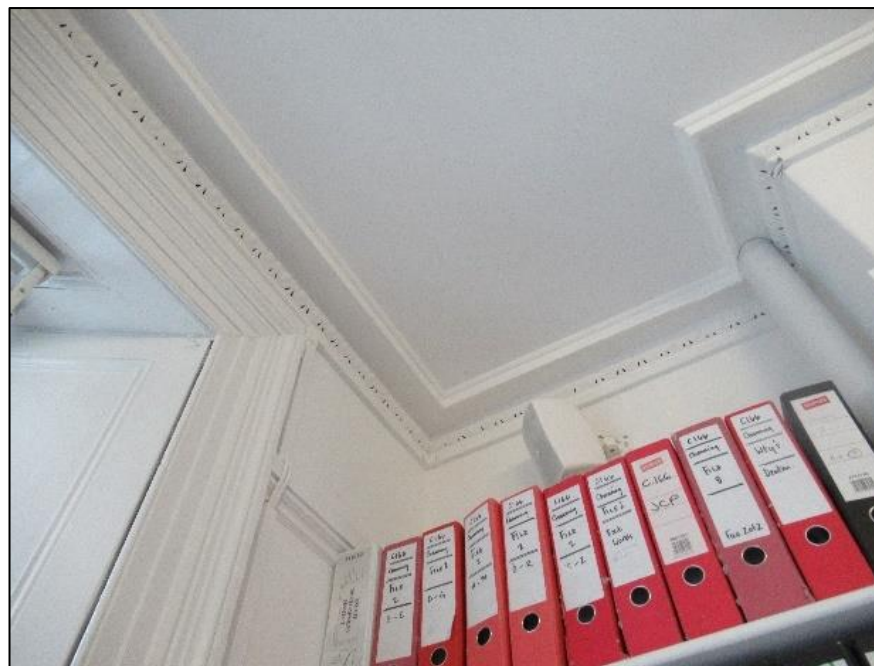
**Figure 23: Painted Over Cornice**

**Figure 24: Painted Over Cornice (B)**

- 4.10 Rooms 5-7 have surviving cornice detailing; however, this has been unsympathetically painted over which has severely compromised its significance (**Figures 23 & 24**). Room 6 has been subdivided by a modern partition to form the corridor of Room 7 which has obstructed the cornice detailing.

- 4.14 None of these surviving historic elements would be adversely affected by proposals, contrarily, they would be better revealed by proposals via the removal of the modern subdivisions which obscure a great deal of the cornice detail throughout this floor.

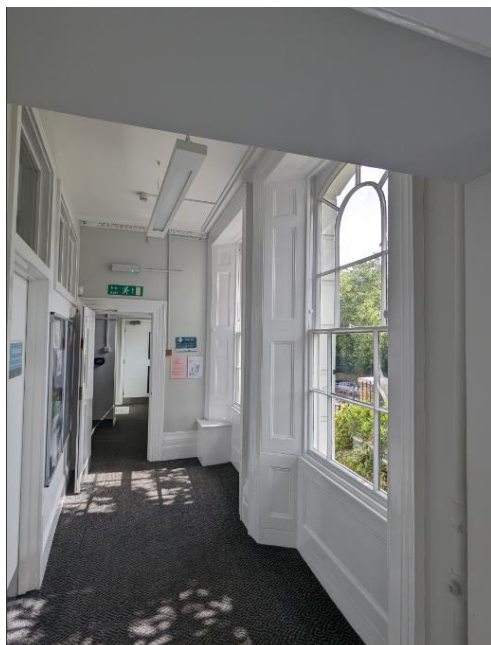
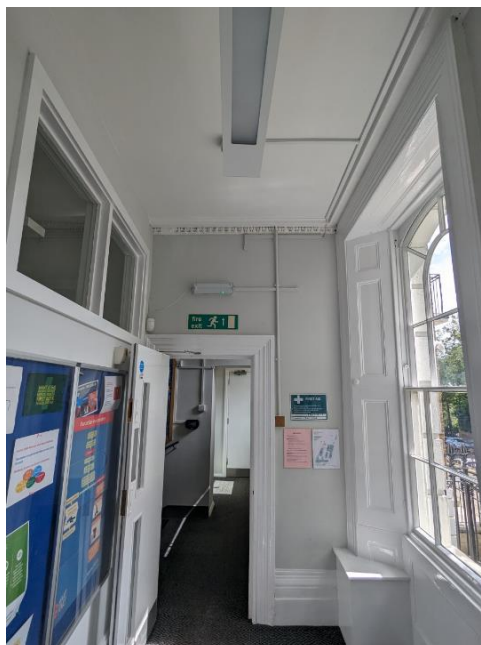
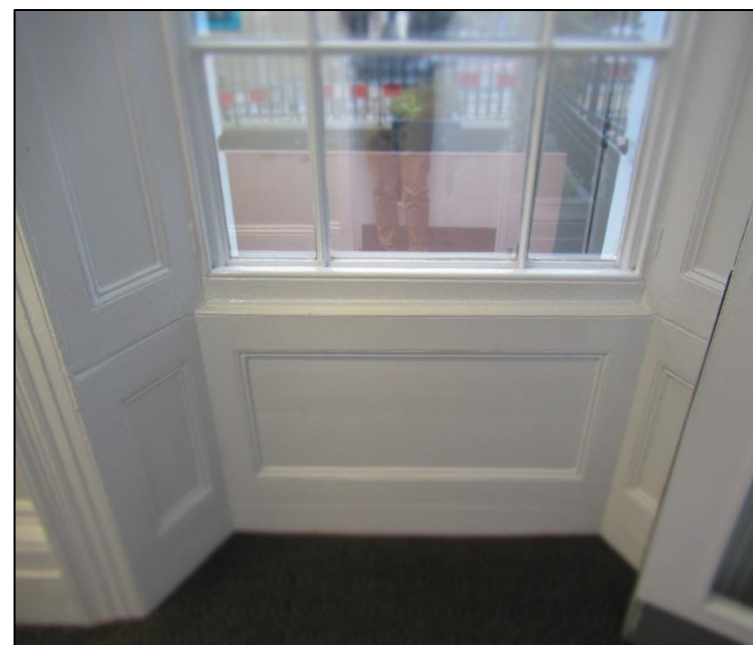
**Figure 27: Window Bays (A)**

**Figure 28: Window Bays (B)**

**Figure 29: Window Bay Detail**

- 4.12 Rooms 7 and 10 comprise a circulation corridor, four window bays are situated along this route on the front elevation of the building. The window bays at the front of the building survive in good condition, however the timber shutters have been fixed into position and only function in an aesthetic sense.

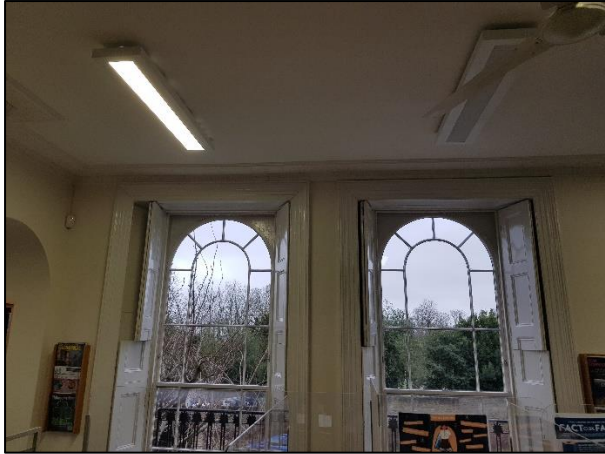
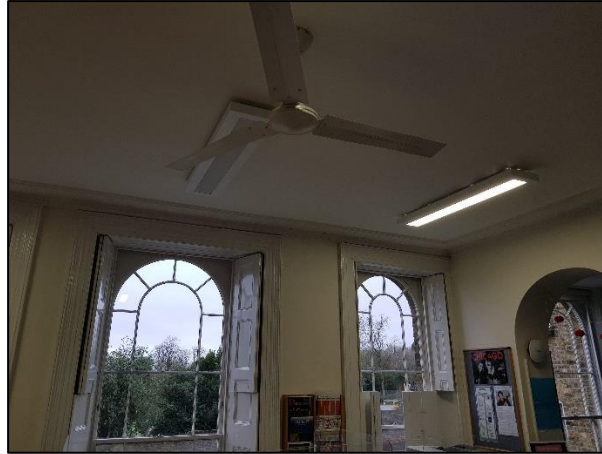
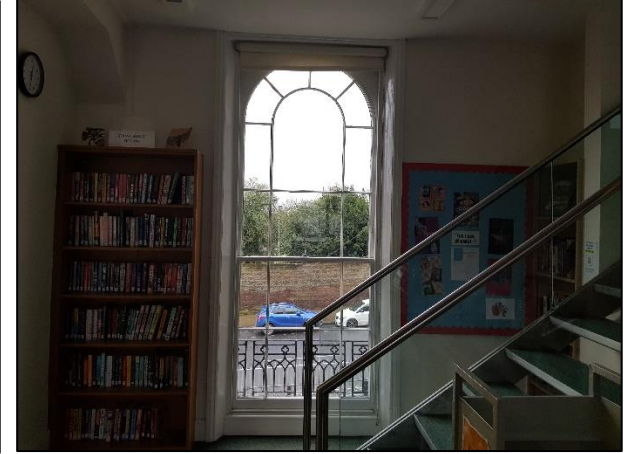
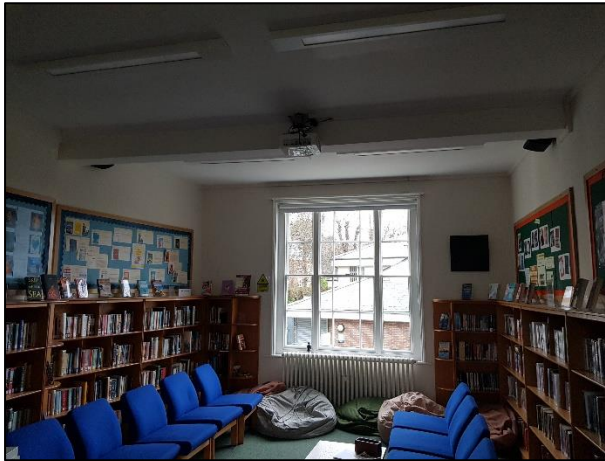
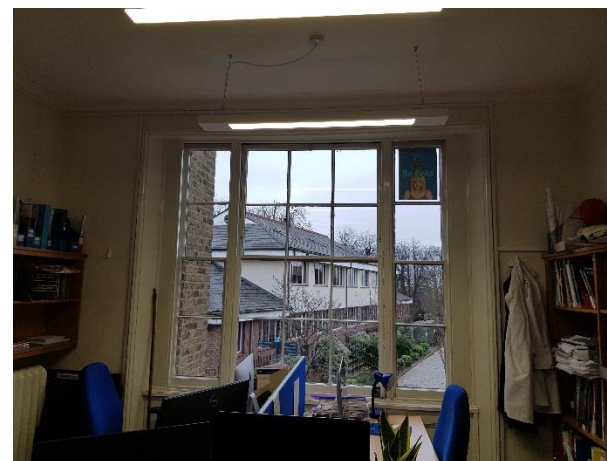
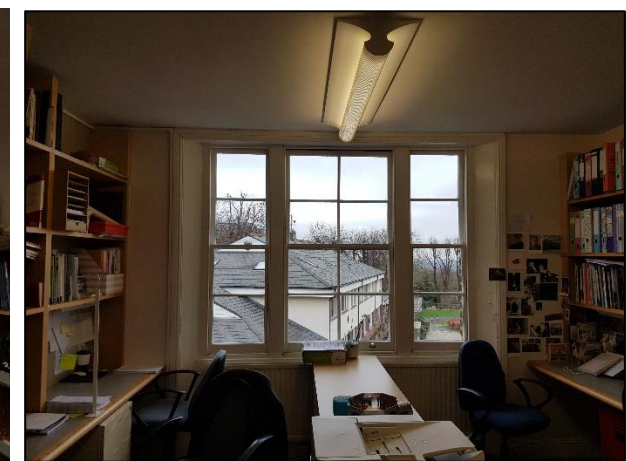
- 4.17 Whilst this area has been subject to major modern alterations and intervention, some historic detailing remains. The ceiling cornice survives in good condition throughout the main library room (**Figures 38-42** below). Furthermore, the windows contribute positively to the interior and the timber window shutters, where these survive, are fully functional contrary to the shutters found on Level 0 (**Figures 32 -37** below).
- 4.18 Importantly, where works are proposed, there are no significant historic features or details of note. Therefore, upon the implementation of proposals a wholly negligible impact is considered to result.

Figure 32: Level 1 Windows (A)

Figure 33: Level 1 Windows (B)

Figure 34: Level 1 Windows (C)

Figure 35: Level 1 Windows (D)

Figure 36: Level 1 Windows (E)

Figure 37: Level 1 Windows (F)

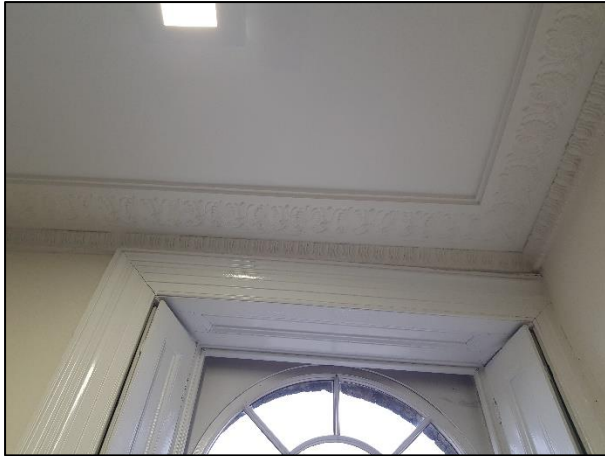
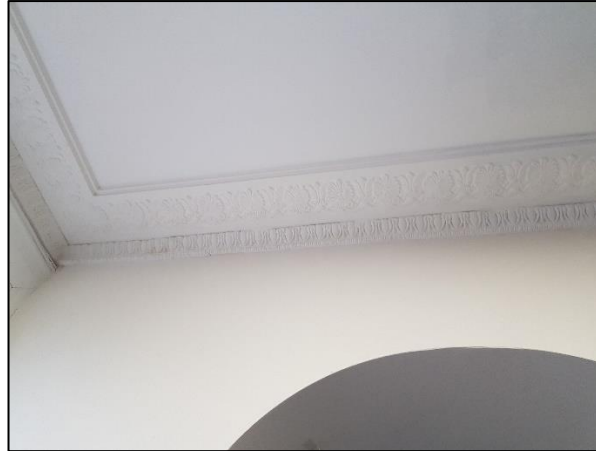
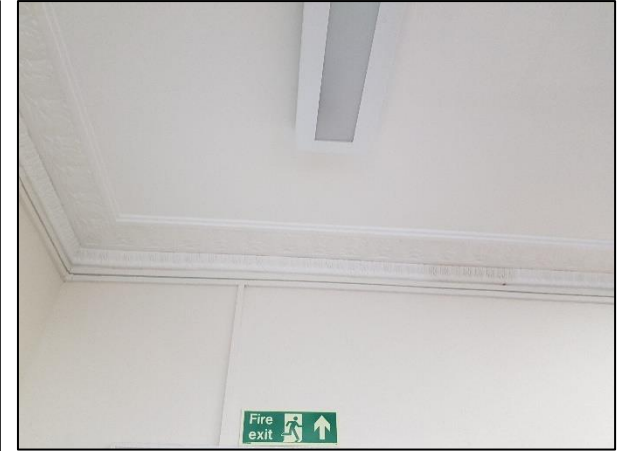
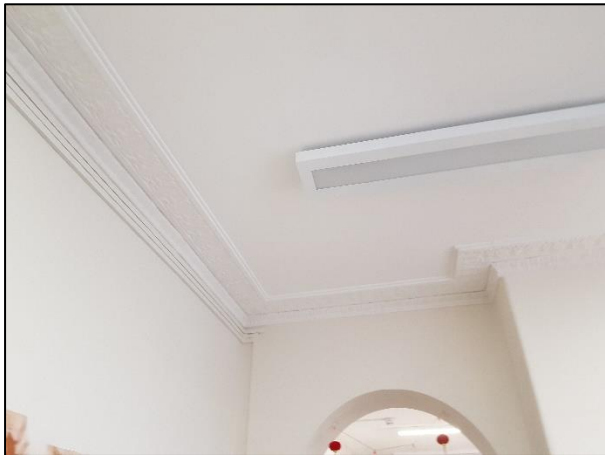
Figure 38: Level 1 Cornice (A)

Figure 39: Level 1 Cornice (B)

Figure 40: Level 1 Cornice (C)

Figure 41: Level 1 Cornice (D)

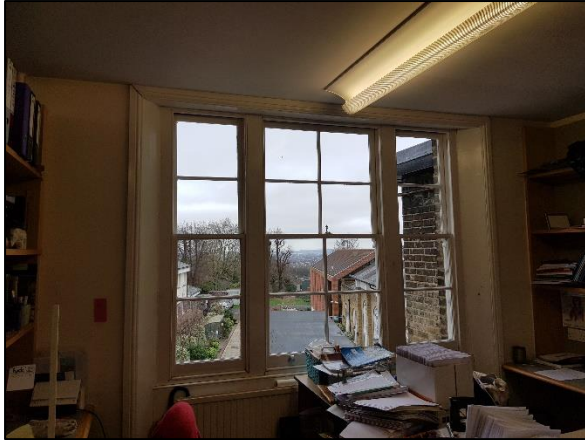
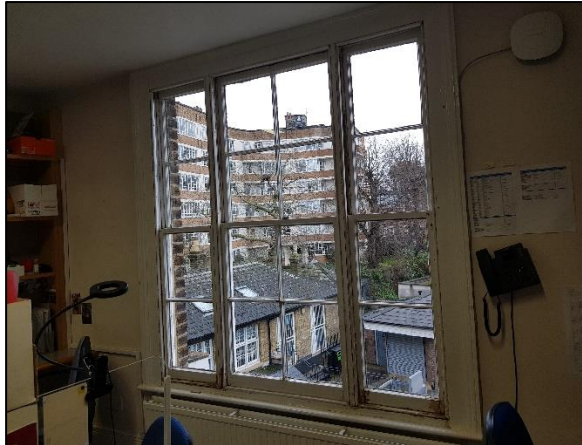
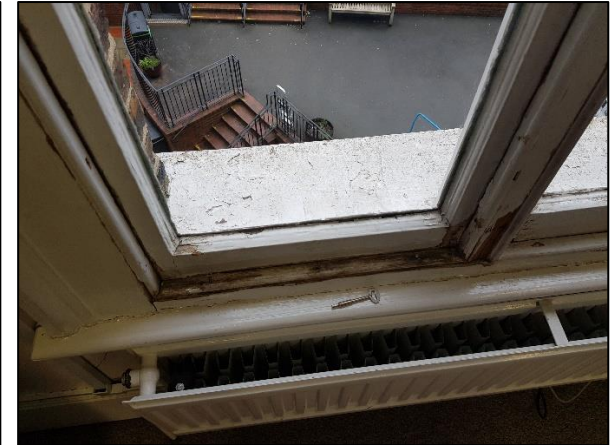
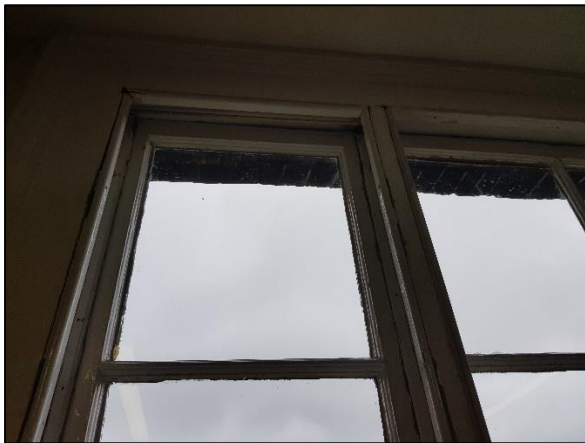
- 4.20 Level 2 of Slingley House comprises the main Staff Rooms, kitchen, balcony and office. However, due to modern intervention and alteration, there are no surviving interior details of note (**Figures 48 & 49** below). Furthermore, the windows appear to be in poor condition, further detracting from the significance of the interior at this level (**Figures 44-47** below). Overall, due to substantial loss and erosion of the baseline scenario, this floor only makes a slight contribution towards the significance of the asset.

Figure 44: Level 2 Window (A)

Figure 45: Level 2 Window (B)

Figure 46: Level 2 Window (C)

Figure 47: Level 2 Window (D)

- 5.6 At Levels 2 & 3, only minor interior details of note survive, namely the windows, albeit in varying levels of condition. Once again, where works are proposed, there are no significance features or details of note. Therefore, a negligible impact is considered to result.

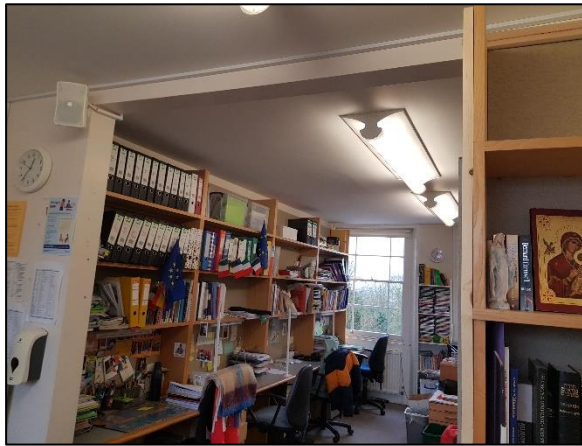
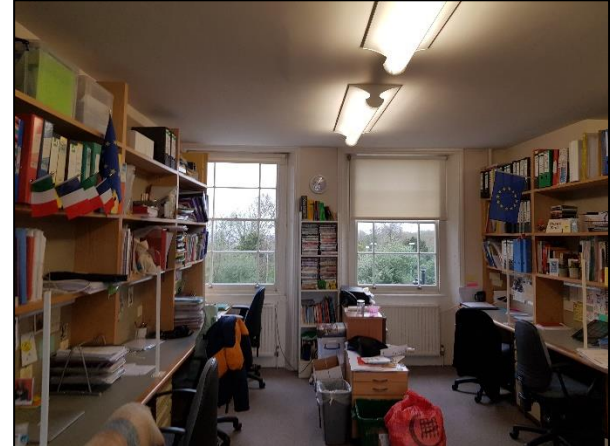
Figure 48: Level 2 Interior (A)

Figure 49: Level 2 Interior (B)

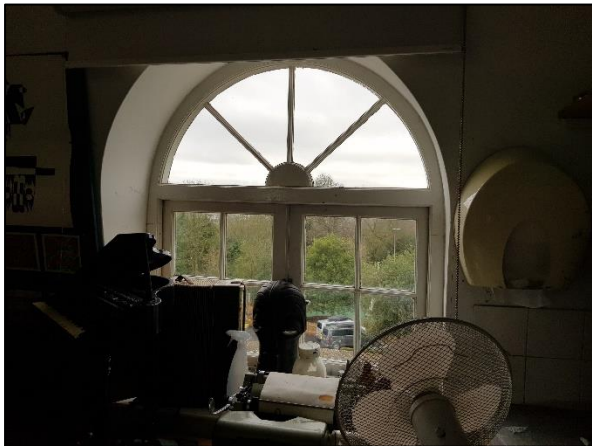
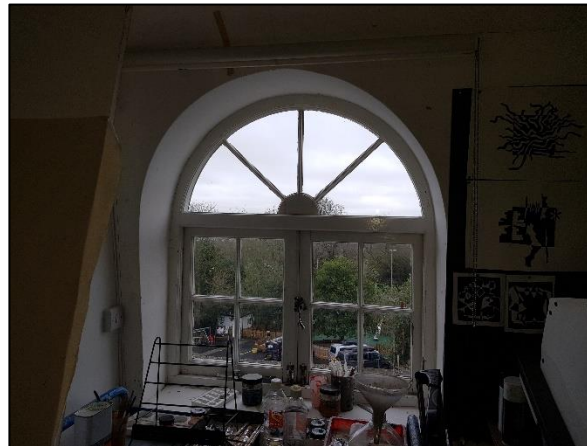
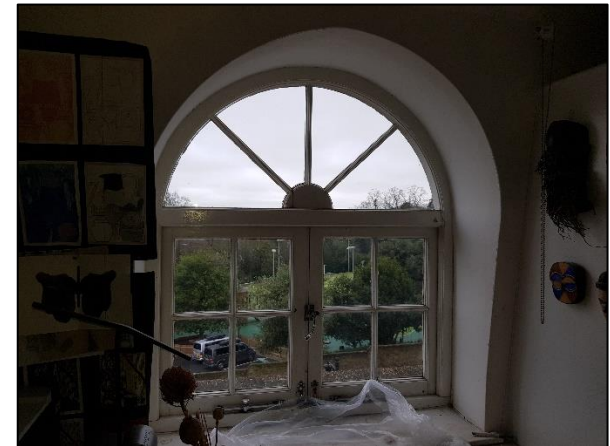
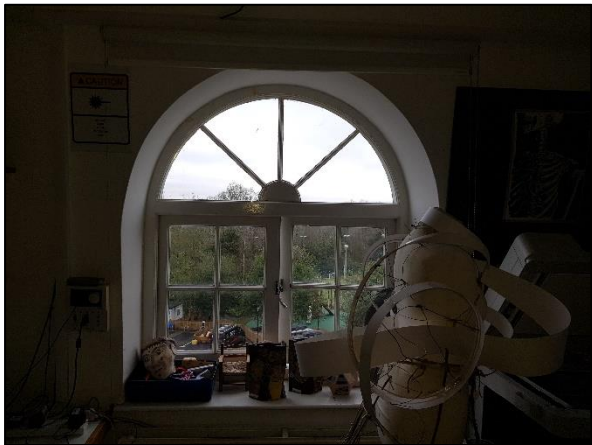
- 4.22 Level 3 of Slingley House comprises a dark room, art store and large art classroom. However, due to modern intervention and alteration, there are no surviving historic interior details of note (**Figures 58 & 59**). The windows on this level are in good condition and are the only contributor towards the significance of the interior (**Figures 52-55**). Overall, due to substantial loss and erosion of the baseline scenario, this floor only makes a slight contribution towards the significance of the asset.

Figure 52: Level 3 Window (A)

Figure 53: Level 3 Window (B)

Figure 54: Level 3 Window (C)

Figure 55: Level 3 Window (C)

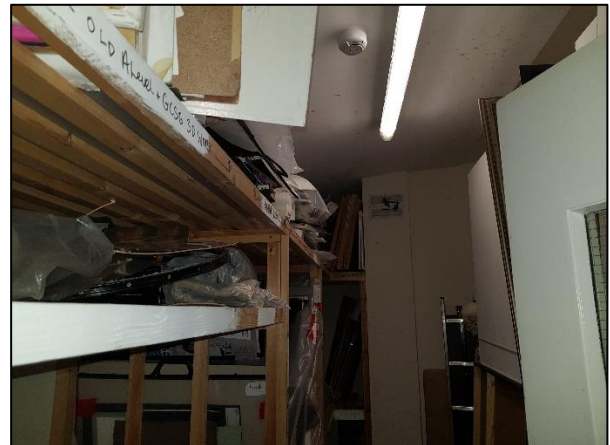
Figure 57: Level 3 Art Store

- 4.23 Proposals for Level 2 comprise the installation of a lift as per the other floors and a reconfiguration of the internal subdivision of the Art Store room to improve circulation. It must be noted that alterations to the subdivisions are to non-original fabric. Therefore, upon the implementation of proposals, there will be no adverse impacts upon any elements of historic significance of the interior of Slingley House.

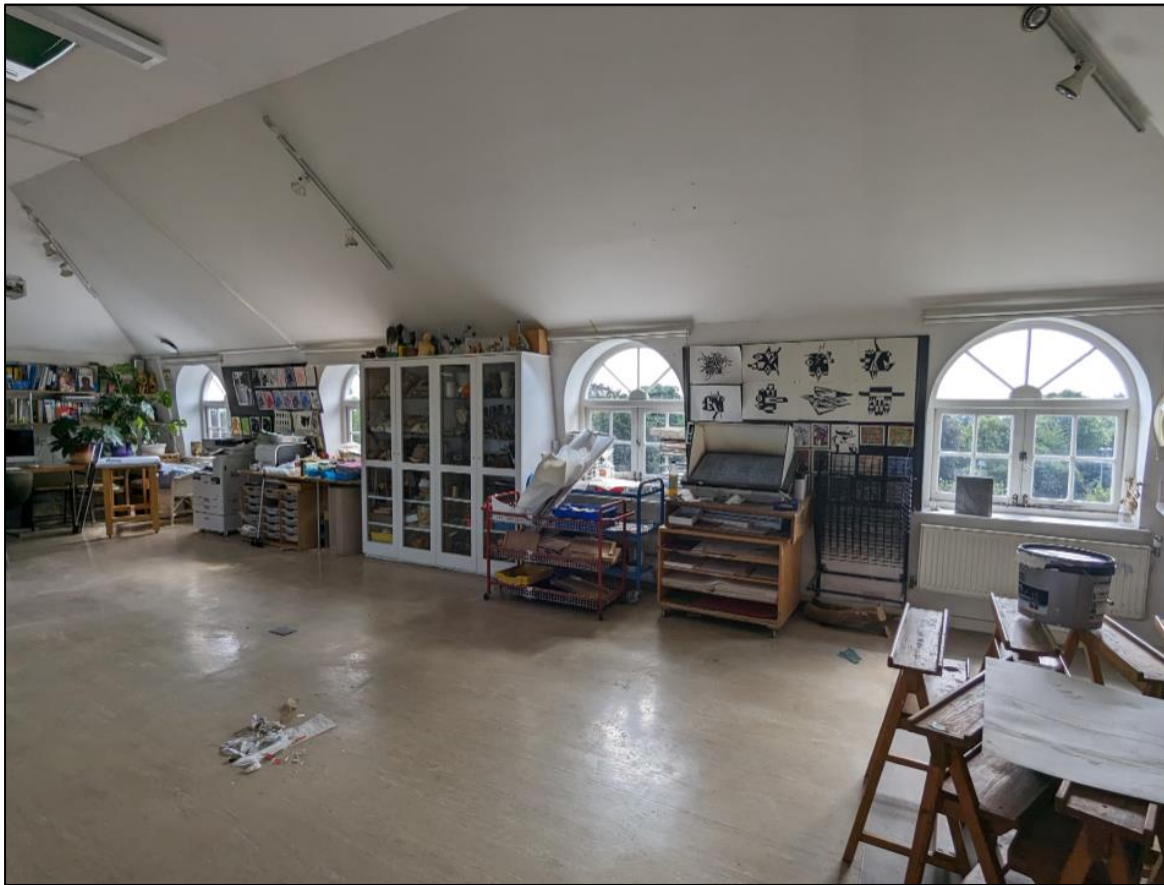
Figure 58: Level 3 Art Room (A)

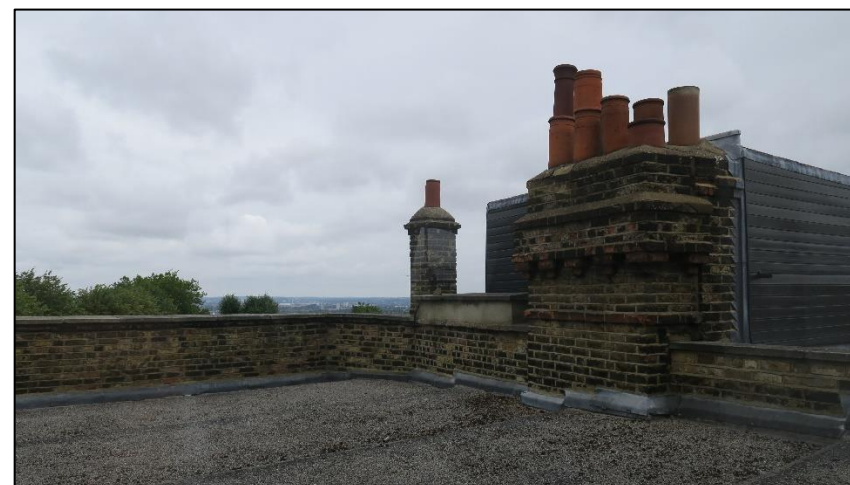
- 4.24 As noted, proposals include the installation of a new lift to provide access to all levels of the main school building due to the School's need to provide equal access for all students (**Figure 60**). The lift will be situated between the party walls of Channing House and Slingley House. In order to install the lift, access will be required through roof level. Therefore, an existing brick chimney stack will be removed in order to facilitate the installation of the lift (**Figure 61**).

**Figure 61: Existing Chimney to be Removed**

- 4.25 Whilst proposals necessitate the removal of historic fabric, Channing House is listed only by virtue of its physical attachment to *Slingley and Westview* and comprises a far less significant late 19<sup>th</sup> century phase of development. The chimney is not therefore listed in its own right and is a non-functioning and now purely aesthetic feature of the building which comprises a low level of significance.

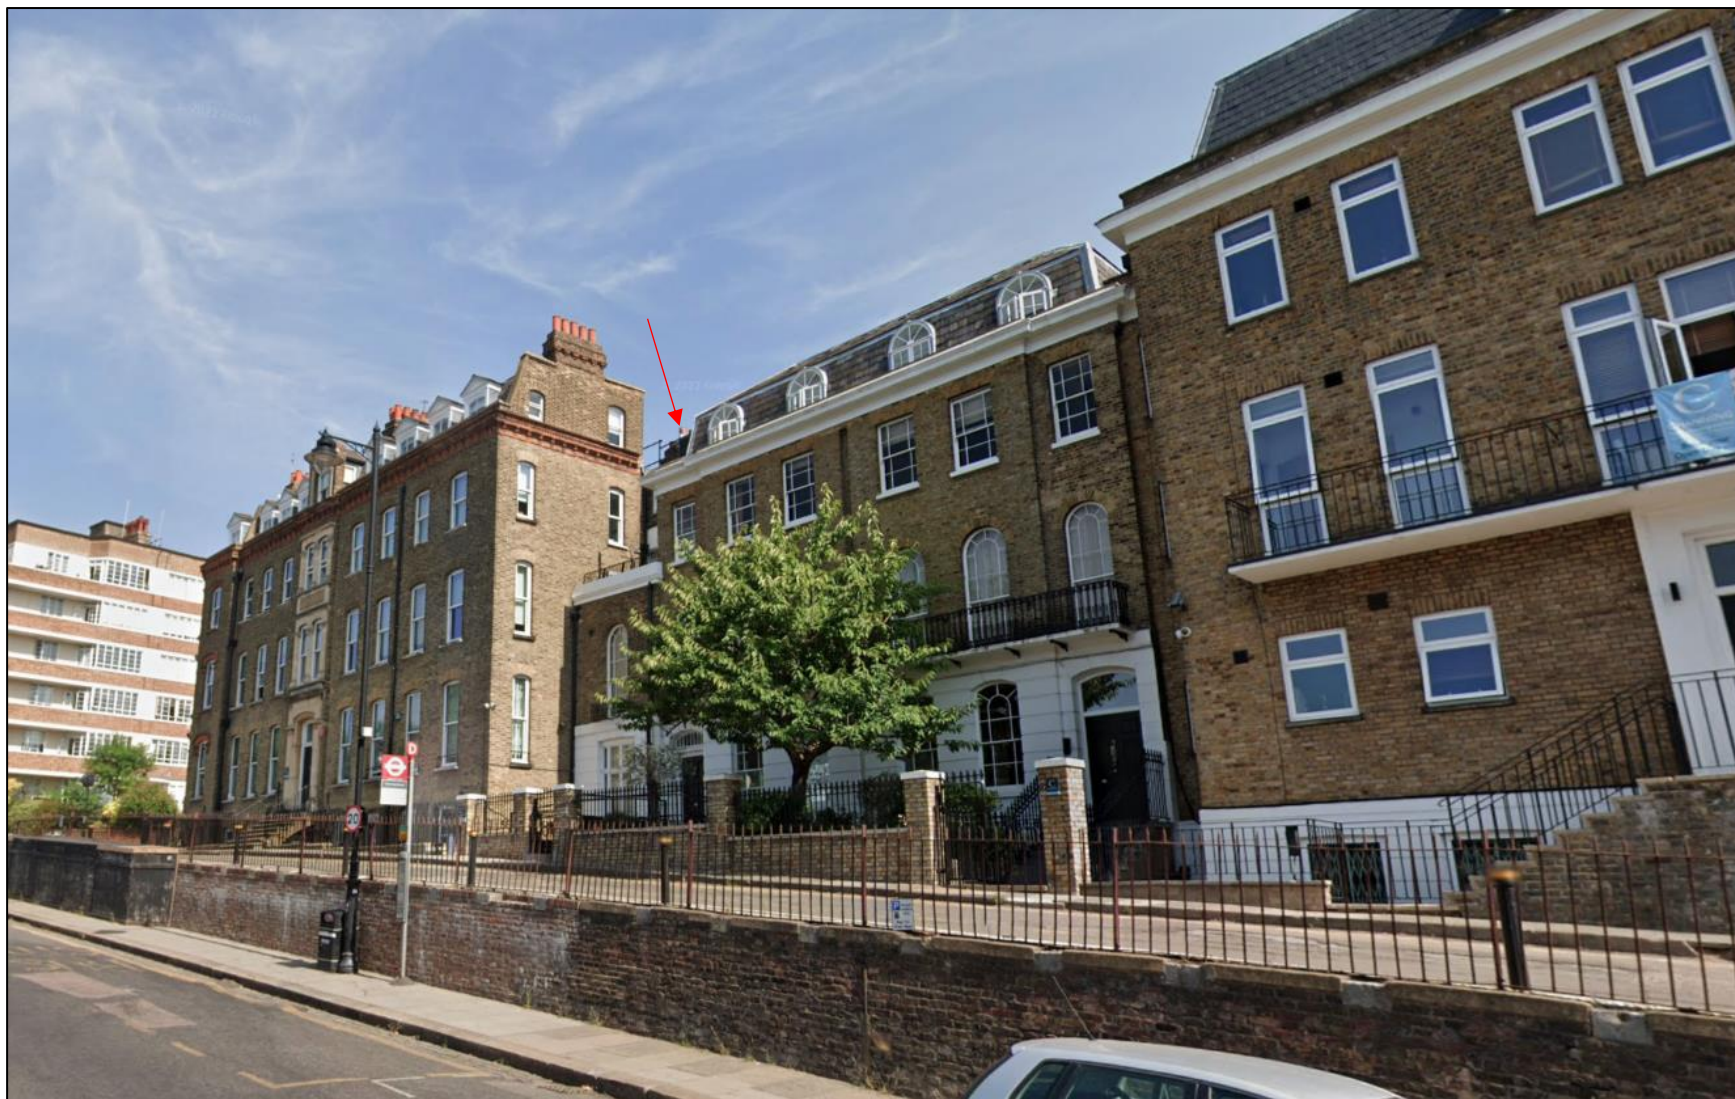
- 4.26 Only glimpsed views of the chimney stack are possible when viewed from the front elevation/street level as the chimney is mostly obscured behind a modern structure (see **Figure 62** below). Therefore, the contribution that this feature makes to the character and appearance of the conservation area is negligible. Furthermore, the public interest generated upon the implementation of proposals – the provision of equal access for all students – is considered enough to outweigh the very minor degree of harm to the character and appearance of the conservation area.

Figure 62: The Channing School (Arrow Pointing to Chimney)
