## Appendix C: Phase I Desk Study Report

# Channing School – Main Building Development

Phase I Desk Study

February 2024

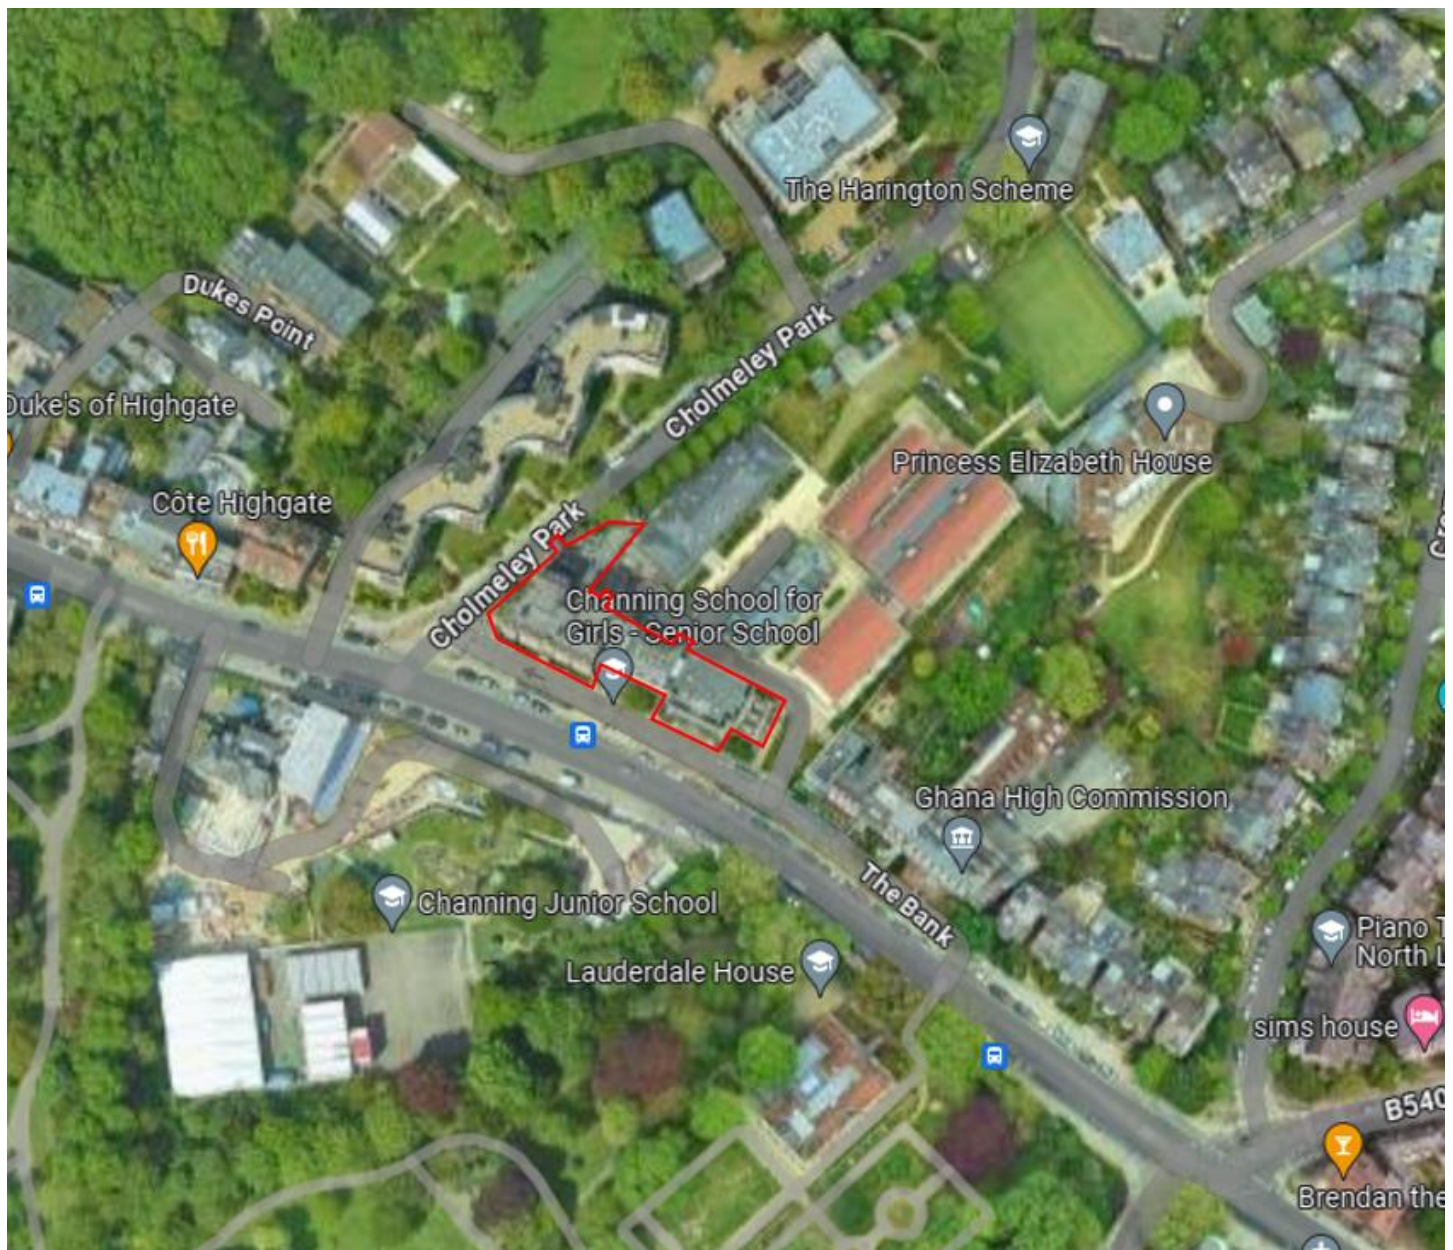
**Figure 2.1** Location of the proposed development (red line reflects the site boundary used for this assessment)

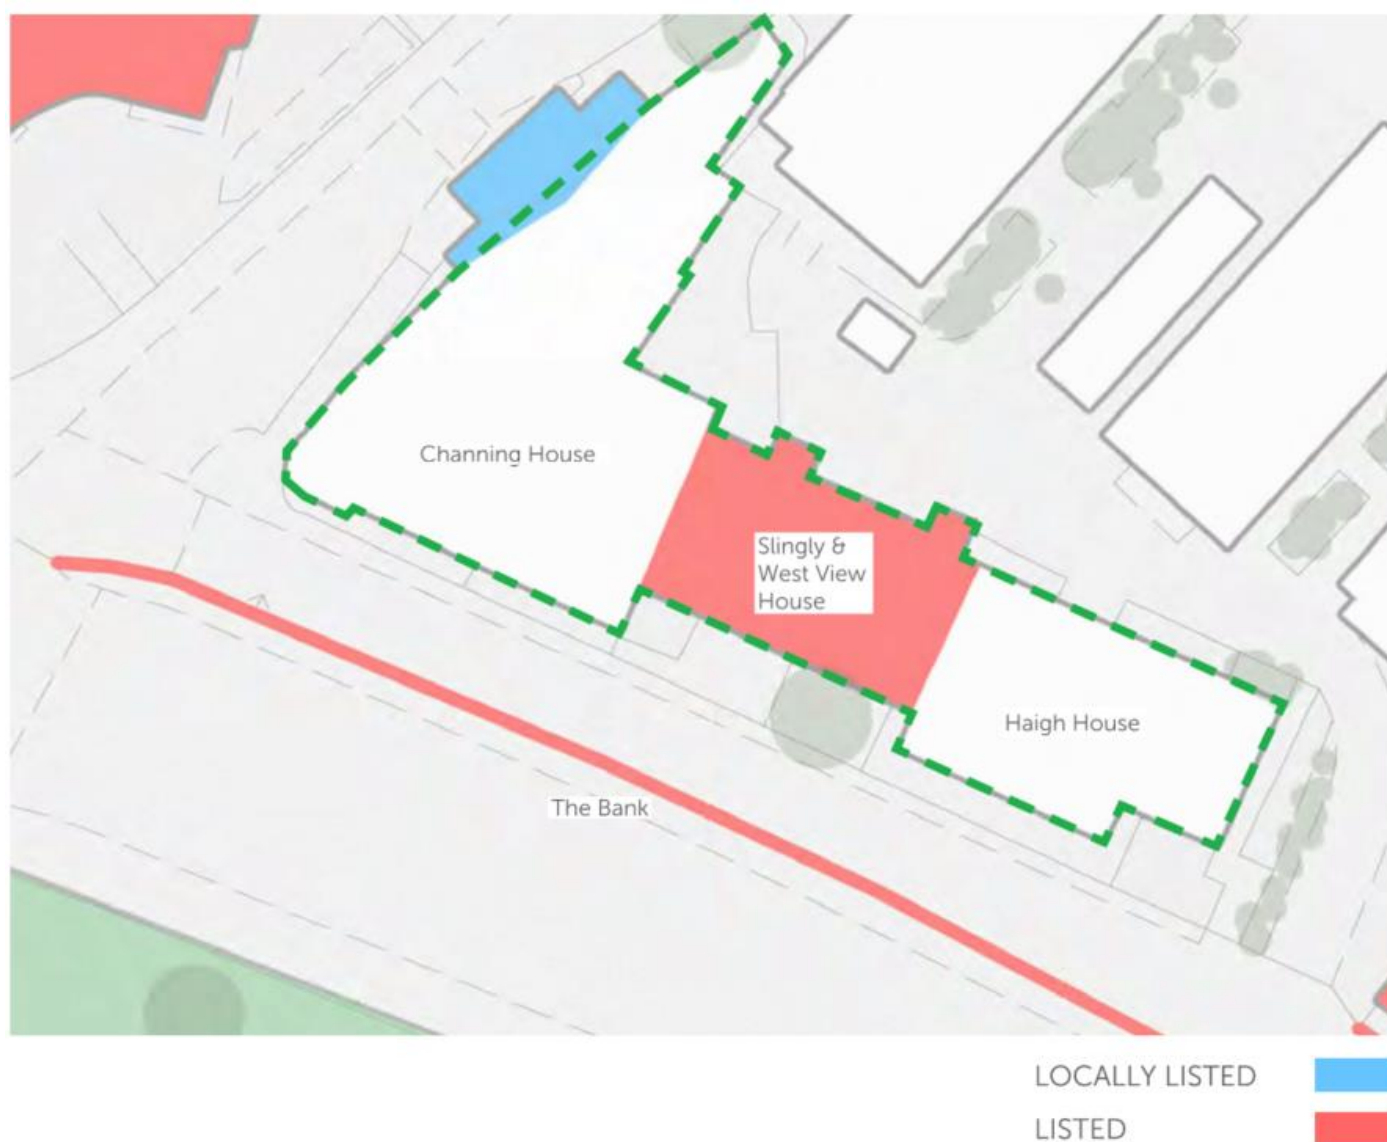
Figure 2.2 Division of the distinct parts of the Channing School Main Building

The site can be divided into three distinct parts: Channing House, Slingly & West View House, and Haigh House all of which have a brick façade. These divisions are illustrated in Figure 2.2. All buildings are used for school facilities such as classrooms, offices, and staff rooms. The site was in a very good condition with no visible structural damages.

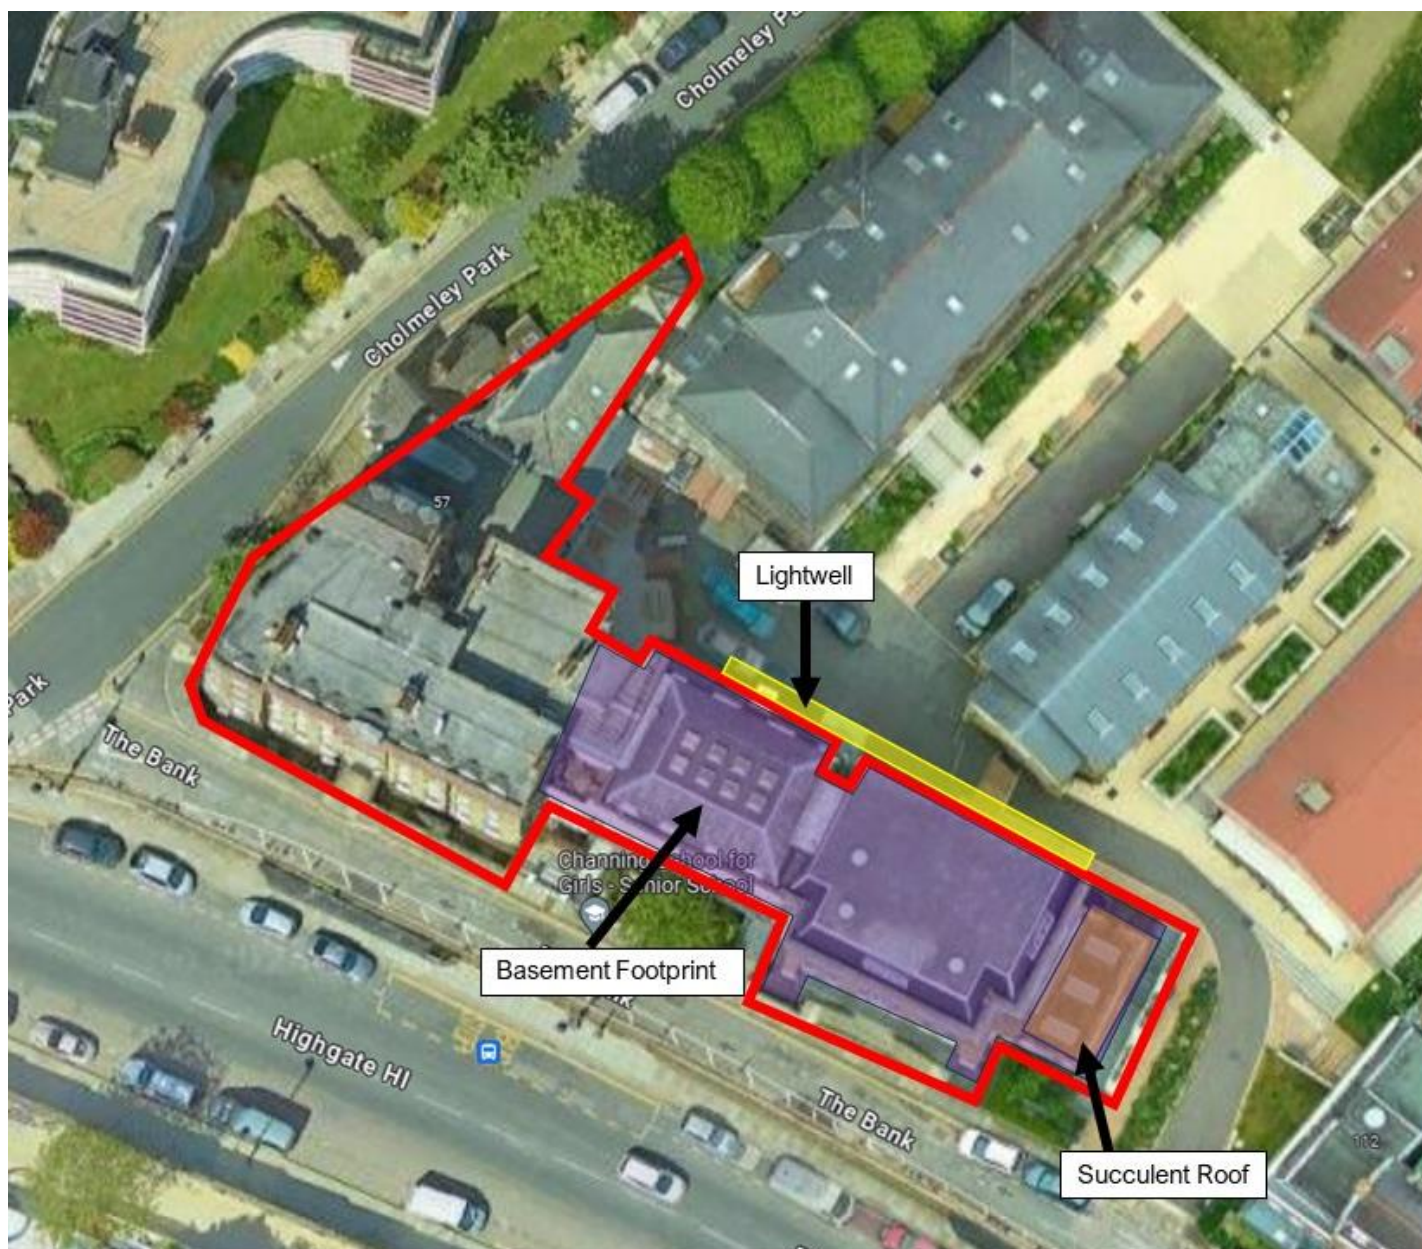
**Figure 2.3** Site features plan

A basement is present beneath Slingly & West View House and Haigh House which accommodates the school's dining hall. The dining hall appeared to be in a very well kept condition with no evidence of industrial infrastructure. A succulent roof was observed above the dining hall located in the easternmost section of Haigh House and a lightwell along the northern parts of Slingly & Westview and Haigh Houses.

A site features plan is included as Figure 2.3.

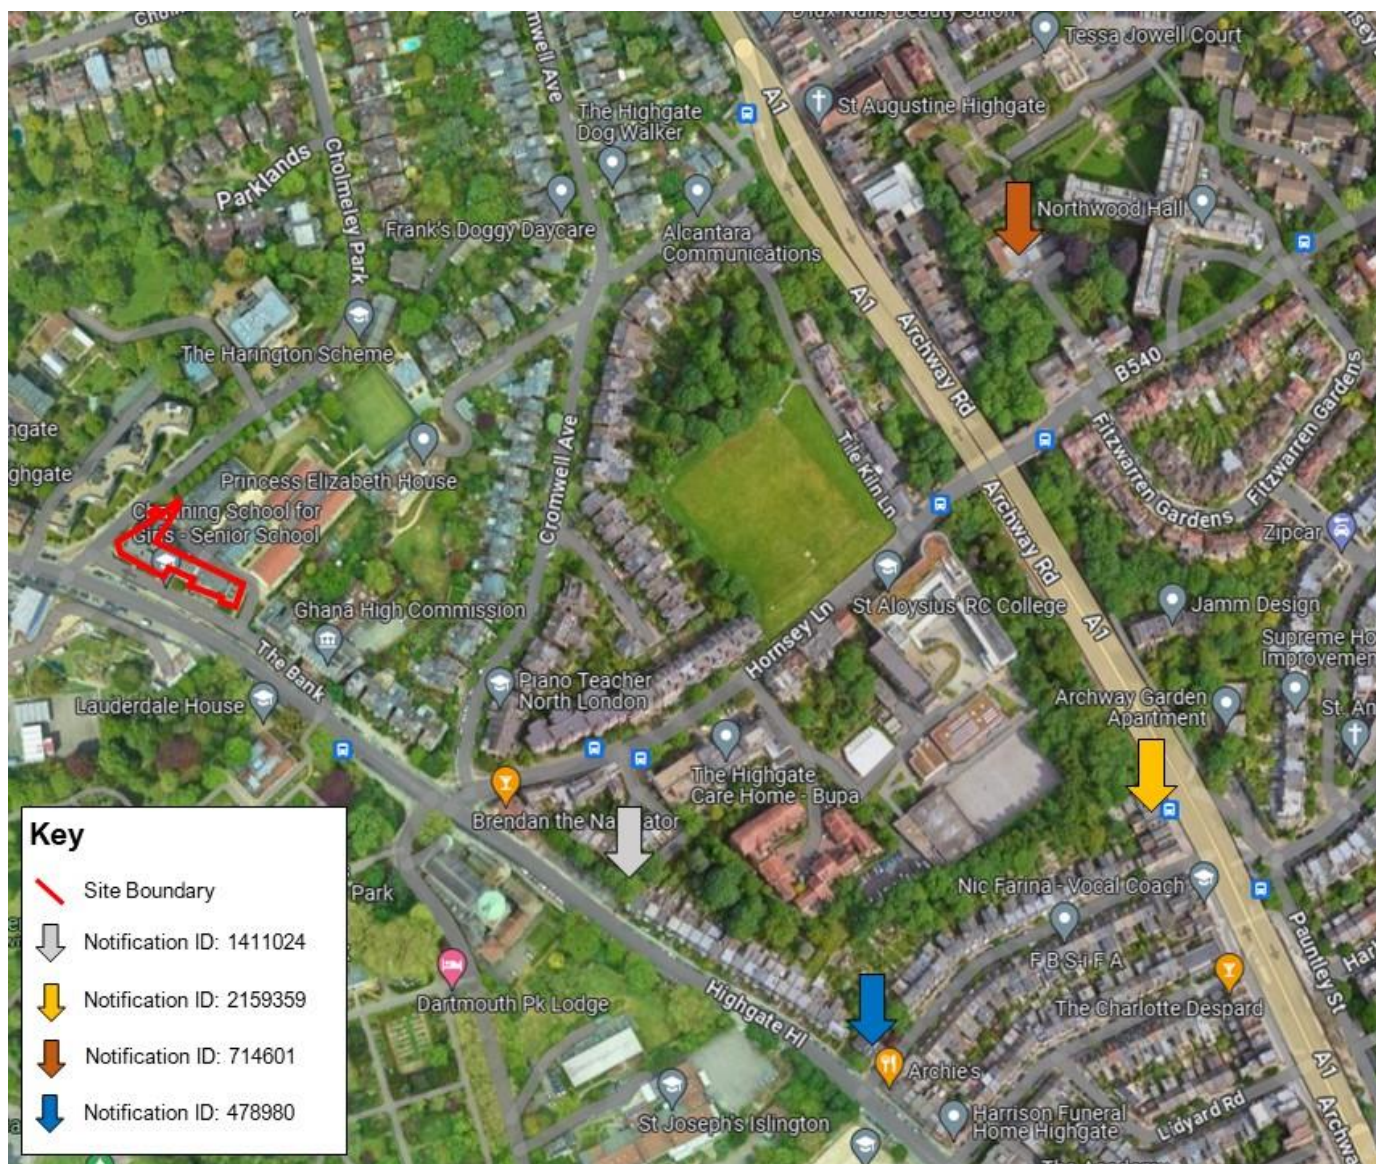
**Figure 2.5 Spatial Distribution of the EA identified Pollution Incidents**

Two of the pollution incidents (Notification ID: 1411024 and Notification ID: 2159359) were classified as having *Category 4 (No Impact)* to ground and / or water therefore, they have not been considered potential sources due to lack of significant impact to ground and groundwater. The remaining pollution incidents (Notification ID: 714601 and Notification ID: 478980) have been discounted as potential sources of contamination due to distance from the site and their locations downgradient of the anticipated groundwater flow.

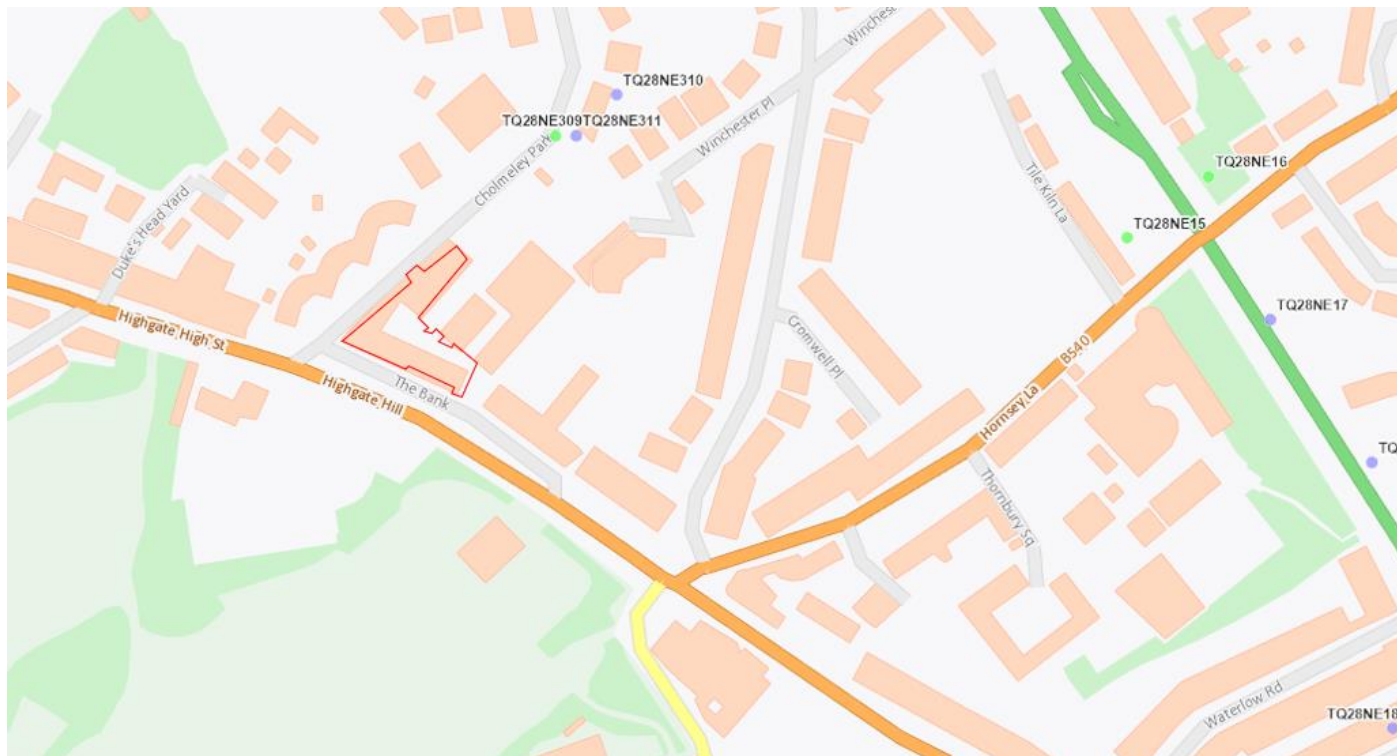
**Figure 3.2** Locations of BGS boreholes in close proximity to the site boundary

The British Geological Survey (BGS) Geology of Britain web map services provide access to the geographic locations and logs of historical borehole investigations and well installations. Historical boreholes surrounding the site are shown in Figure 3.2. The following historical records have been reviewed as part of this assessment; TQ28NE309, TQ28NE310, TQ28NE311, TQ28NE446 and TQ28NE447. The logs included as part of the GEA SI & BIA Report, issued January 2012 (ref. J11240), have also been reviewed. Table 3.1 summarises the preliminary ground model adopted in this desk study, based on the information reviewed.

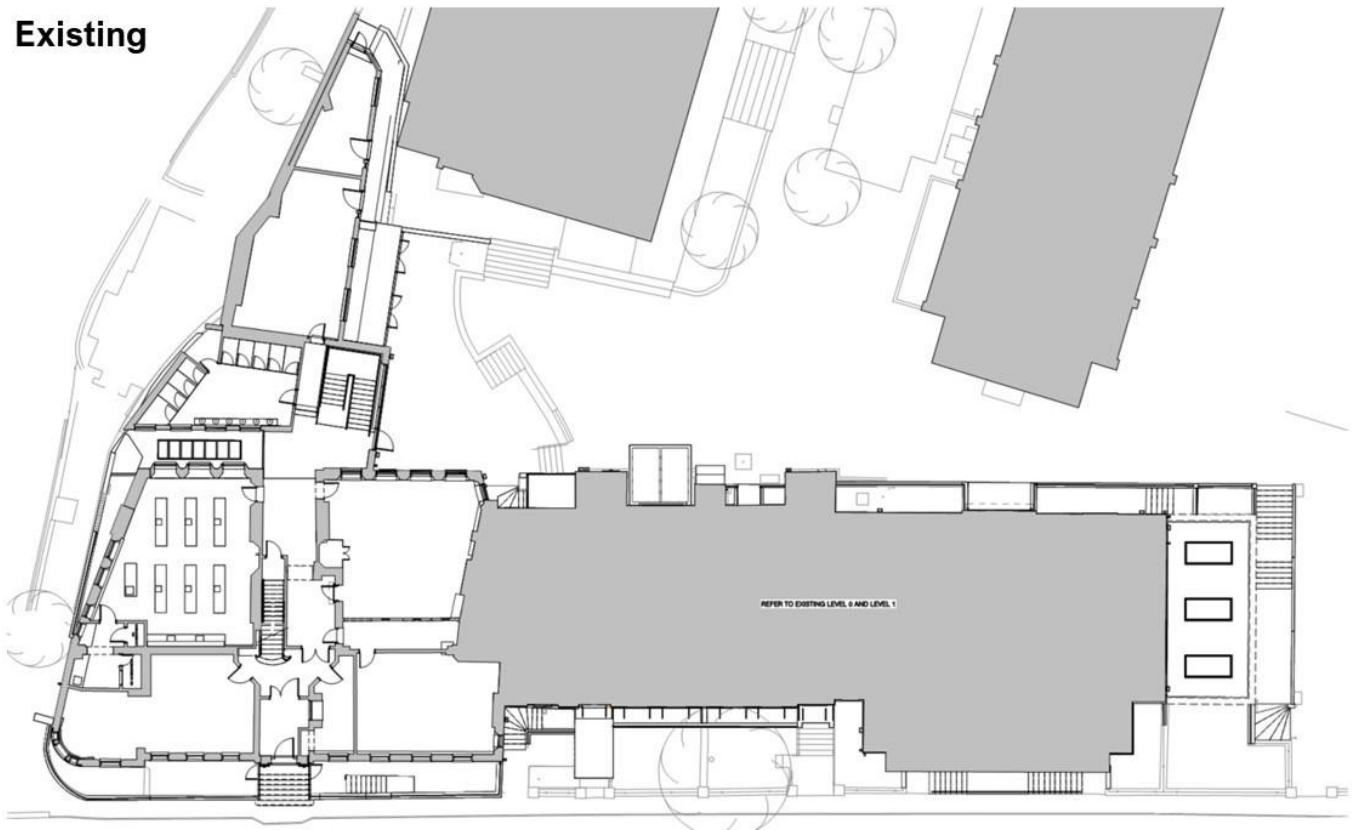
Figure 6.4 Existing and proposed development plans of the first floor (Level 0.5)

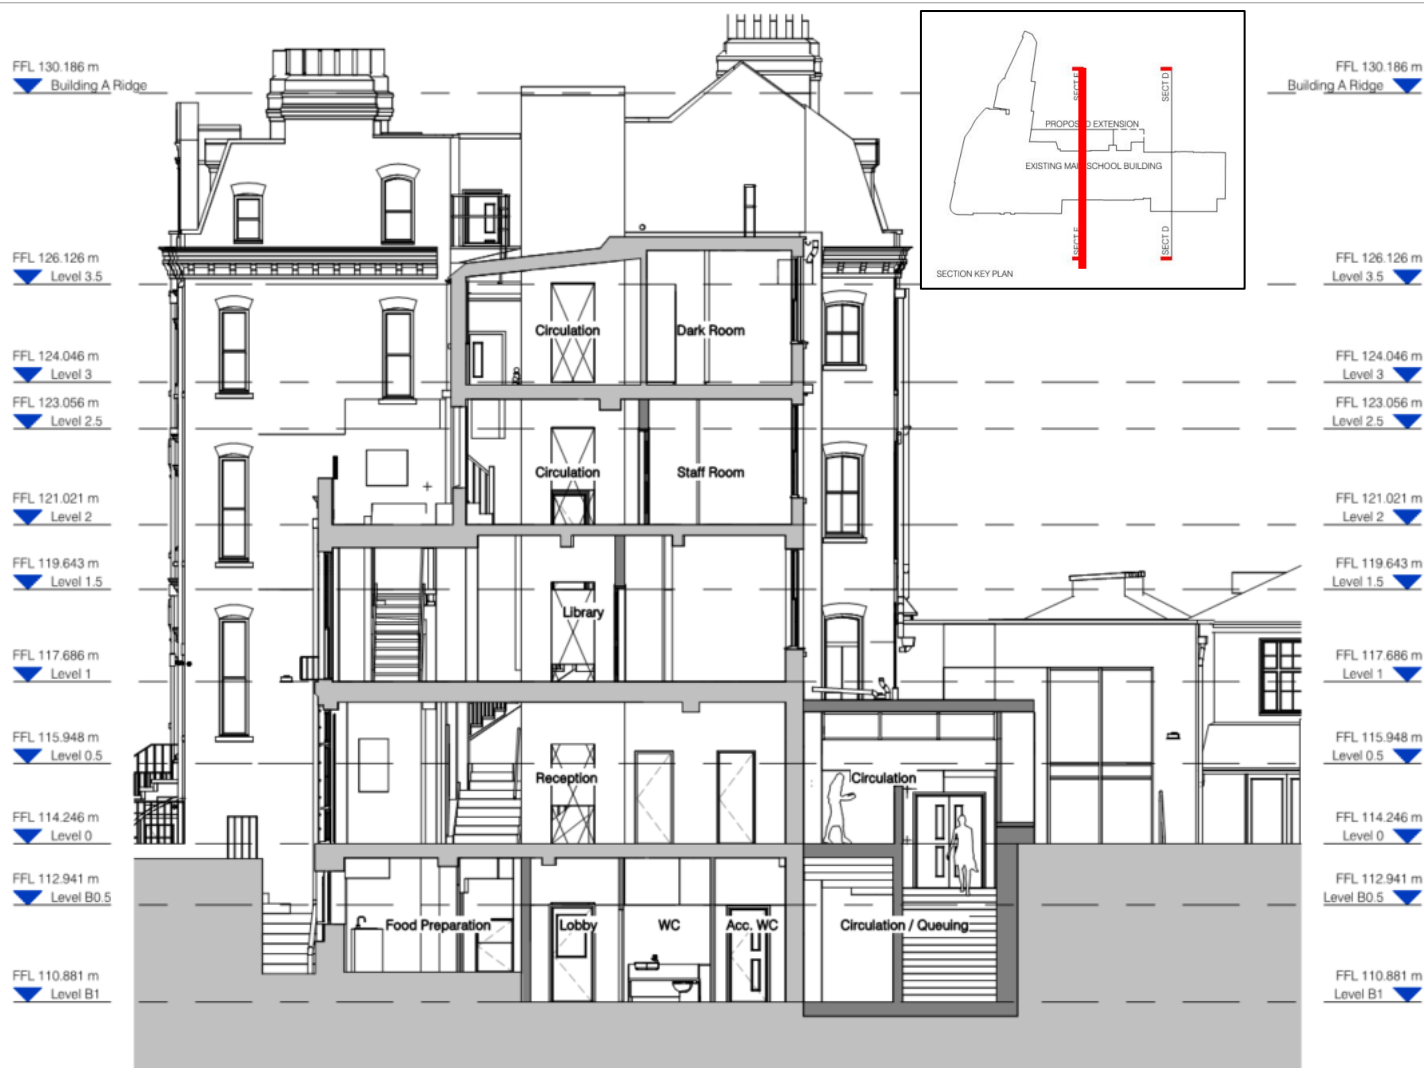
**Figure 6.5** Section E of the proposed development at Slingly and Westview House (as indicated by a red line on the section key plan on the top right).
