## DETAILS OF CRACK MONITORING

| GHG Reference | S2332465 |
| Risk Address | 14 Bloomfield Road,<br>London,<br>,<br>United Kingdom,<br>N6 4ET |

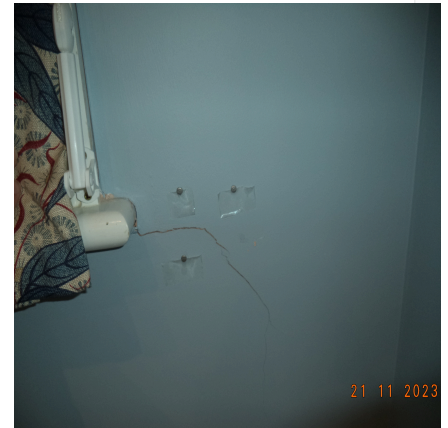
## LOCATION DETAILS

| Location | Internal dining room |
| Crack Width | 5.00 |
| Alignment | Horizontal |

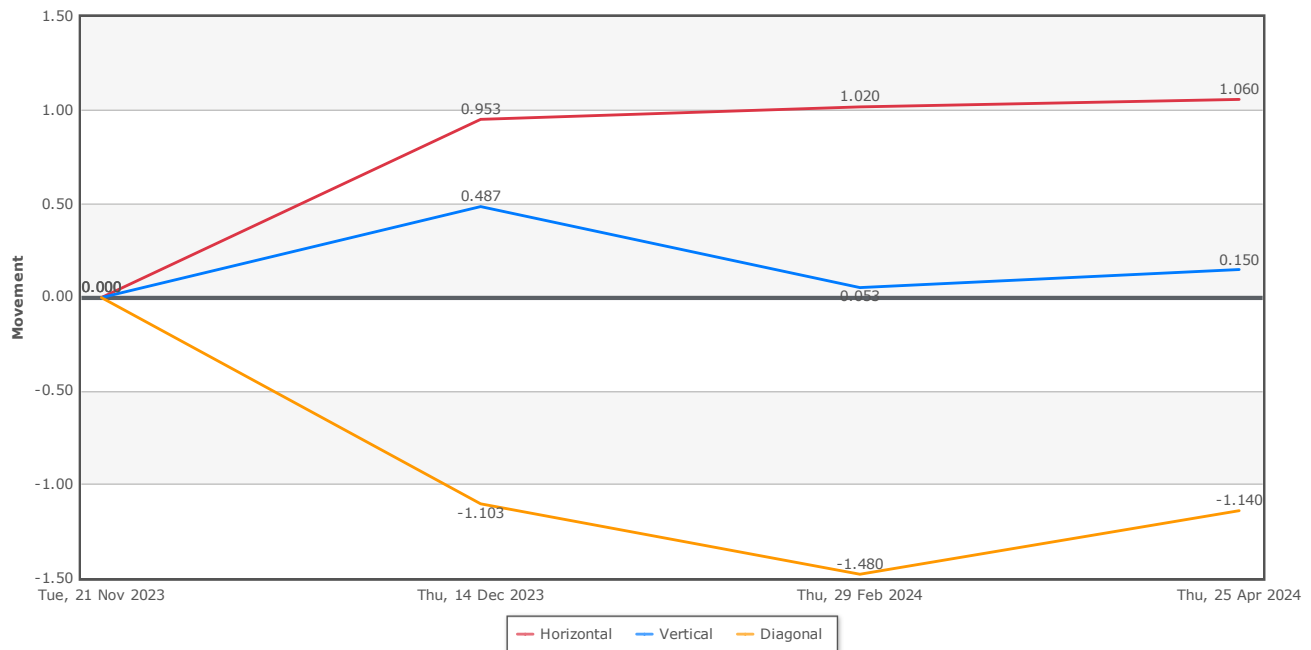
## GRAPH OF CRACK MOVEMENT

| 21/11/2023 | Notes | Segment | Alignment | Value | +/-Initial | +/-Previous |
|---|---|---|---|---|---|---|
| | Dining room | A-B | Horizontal | 62.867 | 0.000 | 0.000 |
| | | B-C | Vertical | 63.667 | 0.000 | 0.000 |
| | | A-C | Diagonal | 89.200 | 0.000 | 0.000 |
| | SML | A-B | Horizontal | 63.820 | 0.953 | 0.953 |
| | | B-C | Vertical | 64.153 | 0.487 | 0.487 |
| | | A-C | Diagonal | 88.097 | -1.103 | -1.103 |
| | | A-B | Horizontal | 63.887 | 1.020 | 0.067 |
| | | B-C | Vertical | 63.720 | 0.053 | -0.433 |
| | | A-C | Diagonal | 87.720 | -1.480 | -0.377 |

| SML | | A-B | Horizontal | 63.927 | 1.060 | 0.040 |
| | | B-C | Vertical | 63.817 | 0.150 | 0.097 |
| | | A-C | Diagonal | 88.060 | -1.140 | 0.340 |
