**VERIFICATION REPORT**  
**of a site at**  
**33 DAGMAR ROAD, FINSBURY PARK**  
**for**  
**SFP GROUP**

**Project No 2831**  
**Report ref: 2831-P4E-1**  
**Issued: 3 April 2025**  
**Revision:**

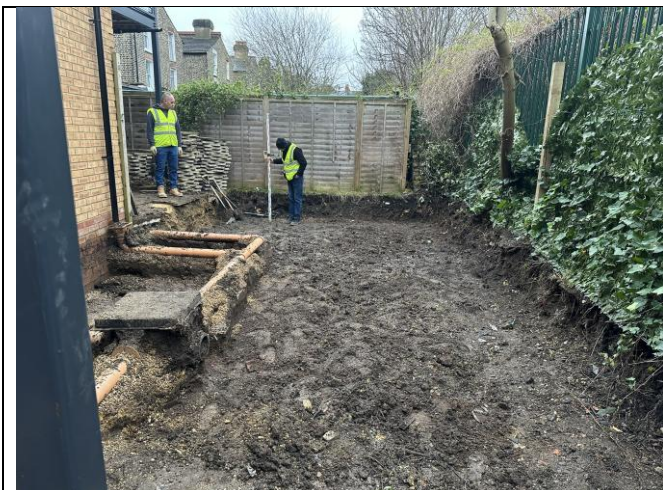
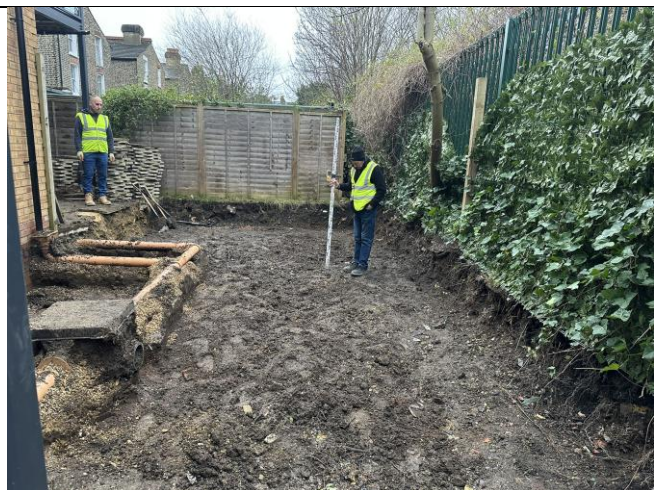
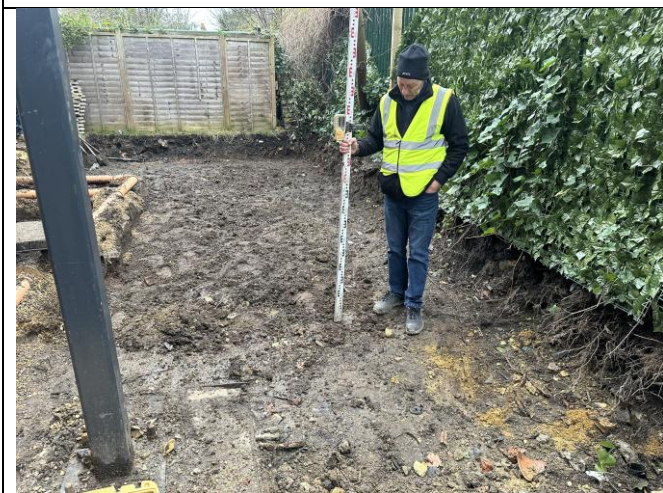
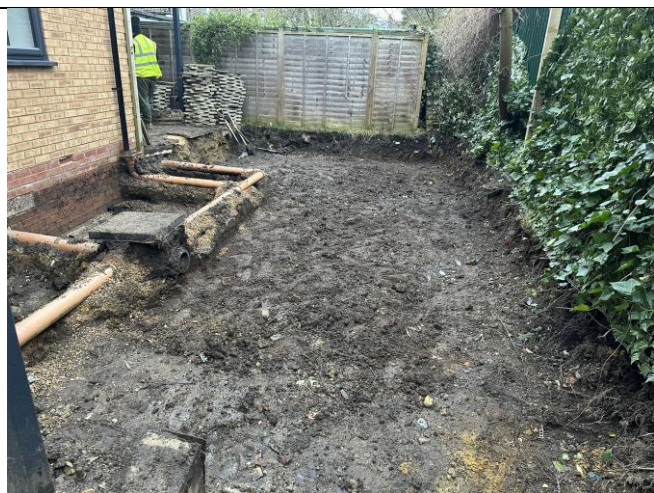
## **Appendix G – Photographs of Remediation**

The made ground within the soft landscaped areas has been removed by 600mm and replaced with clean imported sub soil and topsoil. Three samples were taken per source of imported soil following placement, and all results were below the relevant soil screening values, and no asbestos was identified.

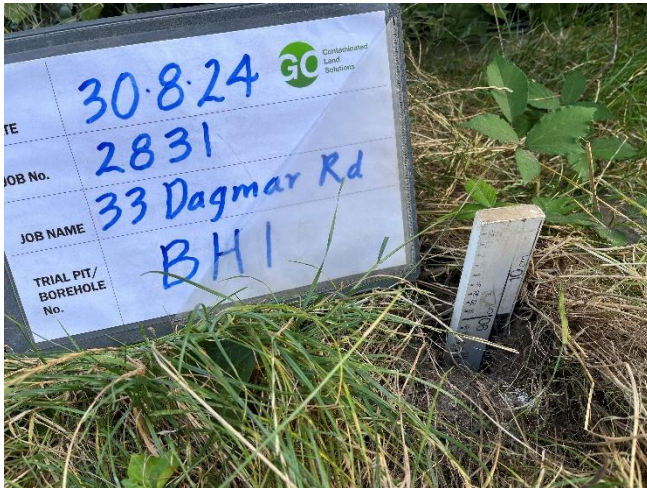
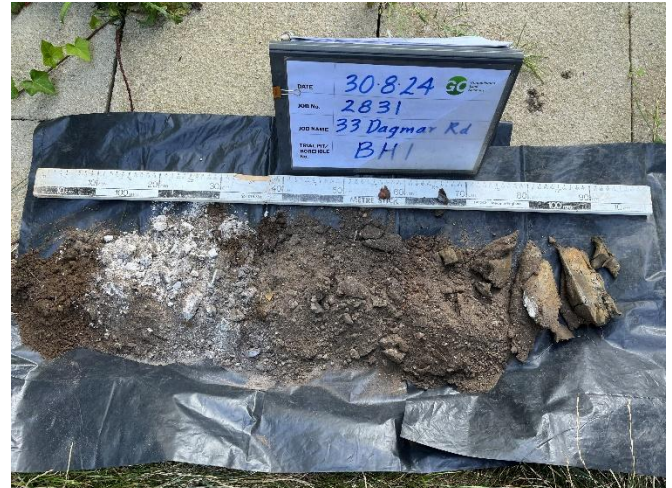
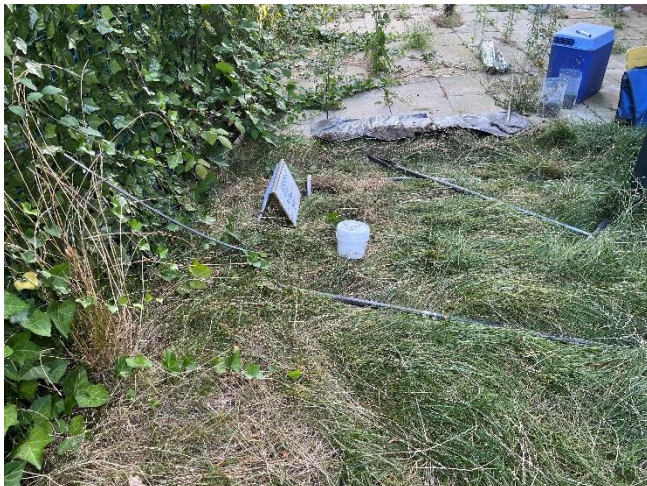
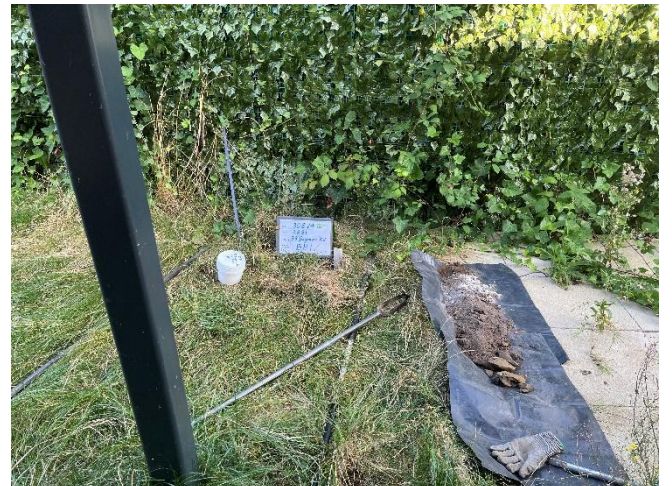
### BH1

It was identified that no attempt had been made to import any clean soils to the site with the ground conditions generally comprising made ground with brick fragments. Refer to borehole logs within appendix F.

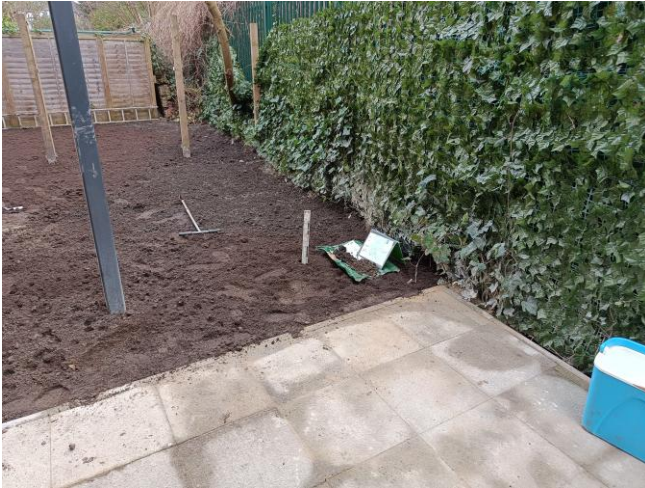
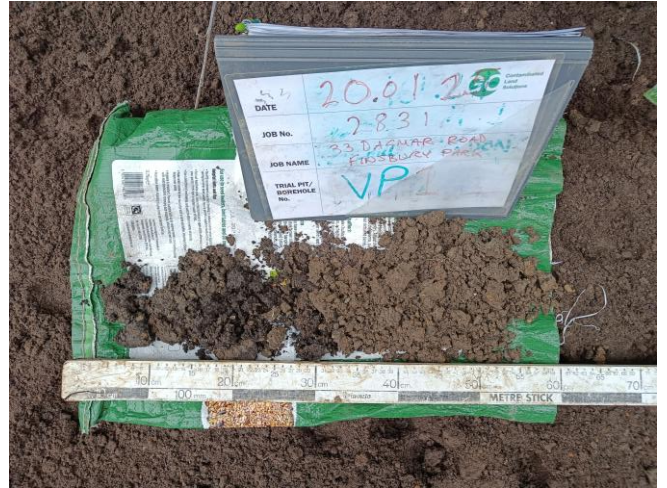
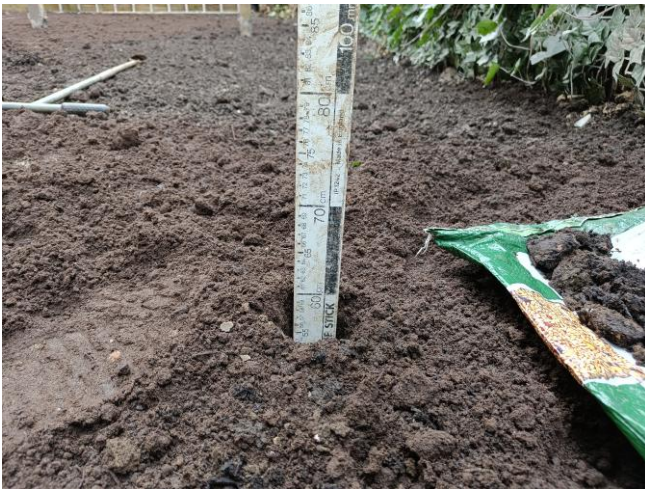
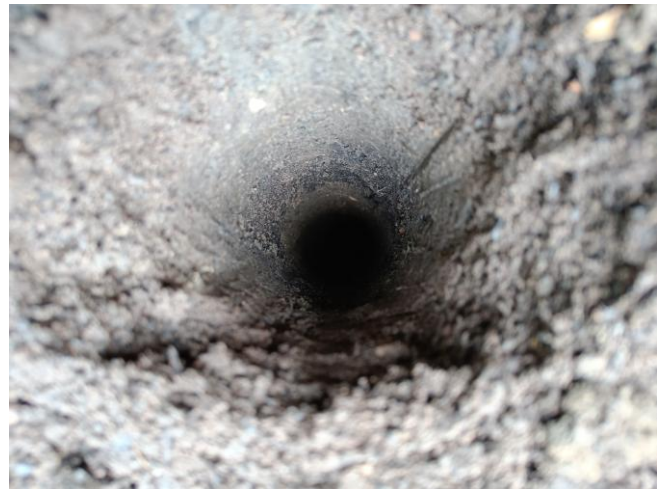
### VP1

A very marginal exceedance for dibenzo(a,h)anthracene (DBAH) was noted at VP1 within the subsoil sample.

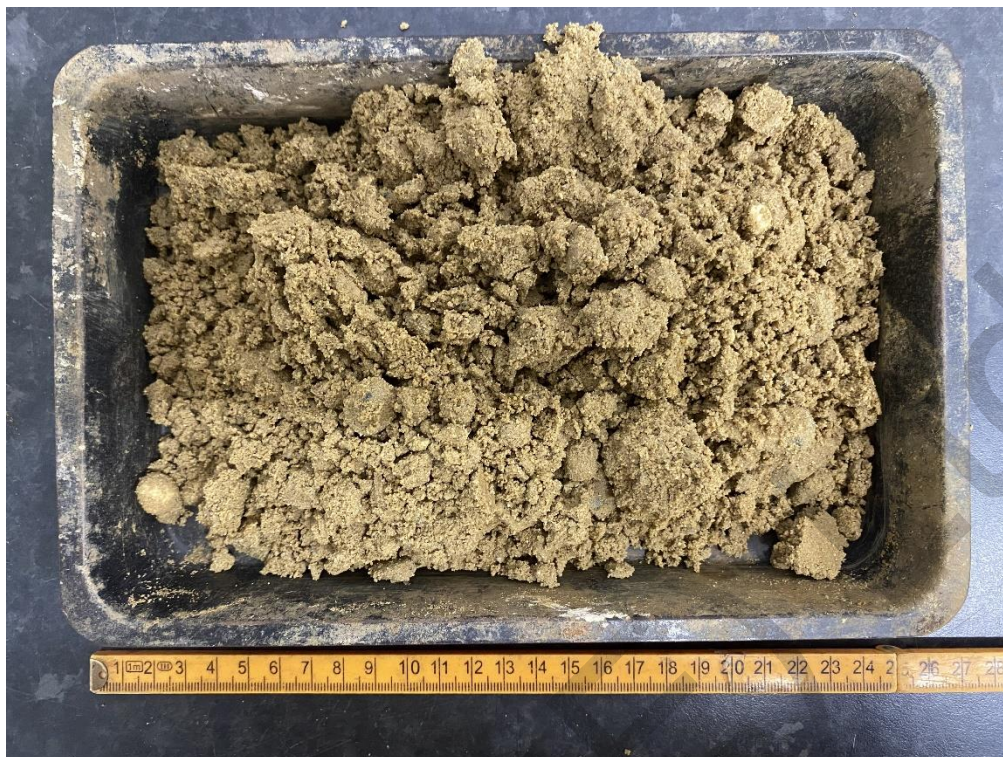
*Plate 1: Sample MSBS1 – London & Essex*

The sample was described as a light yellowish brown (Munsell Colour 10YR 6/4), moist, friable, non-calcareous LOAMY SAND with a weakly developed, fine to medium granular structure\*. The sample was slightly stony, comprising stones up to 50mm in size. No unusual odours, deleterious materials, roots or rhizomes of pernicious weeds were observed.

The sample fell into the *loamy sand* texture class, which is usually considered suitable for subsoil materials in general landscape applications provided the soil's physical condition is satisfactory and compaction avoided.

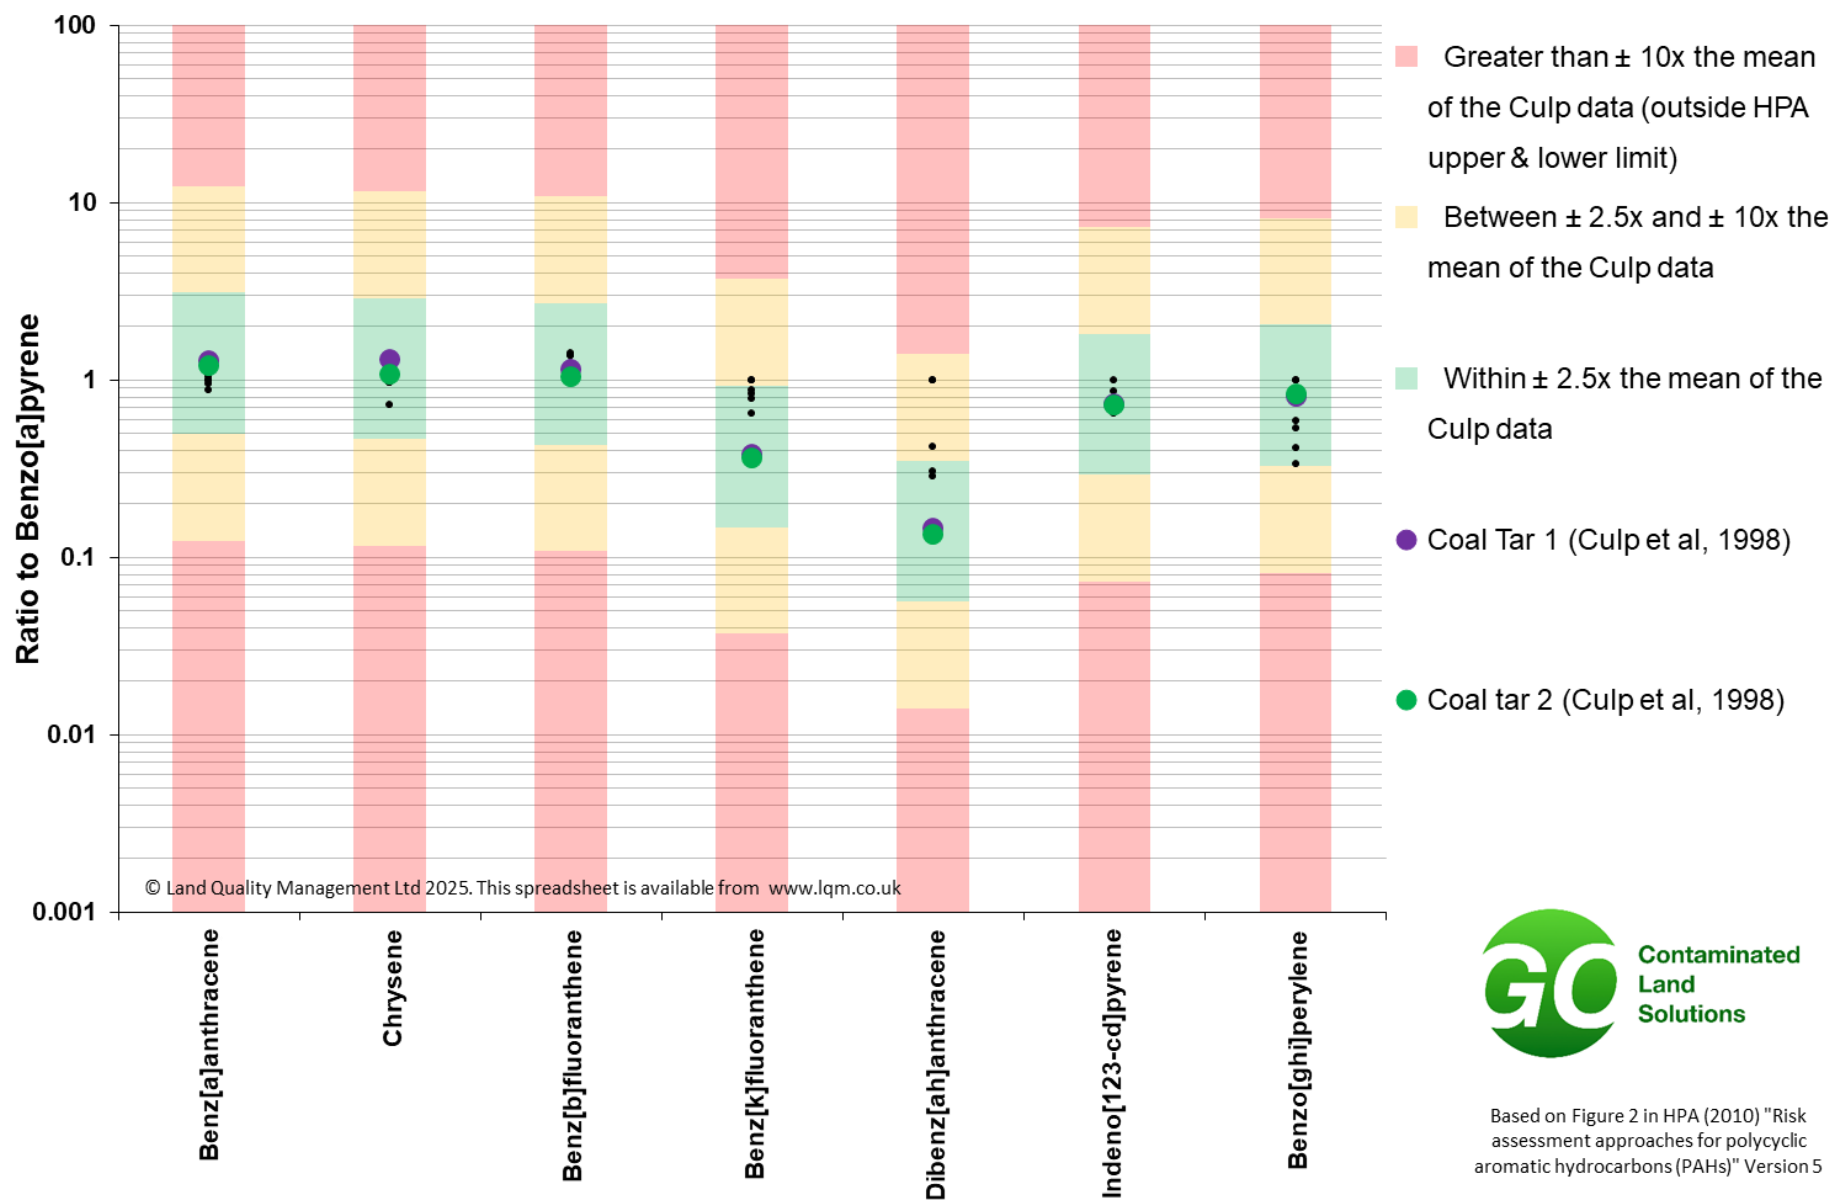
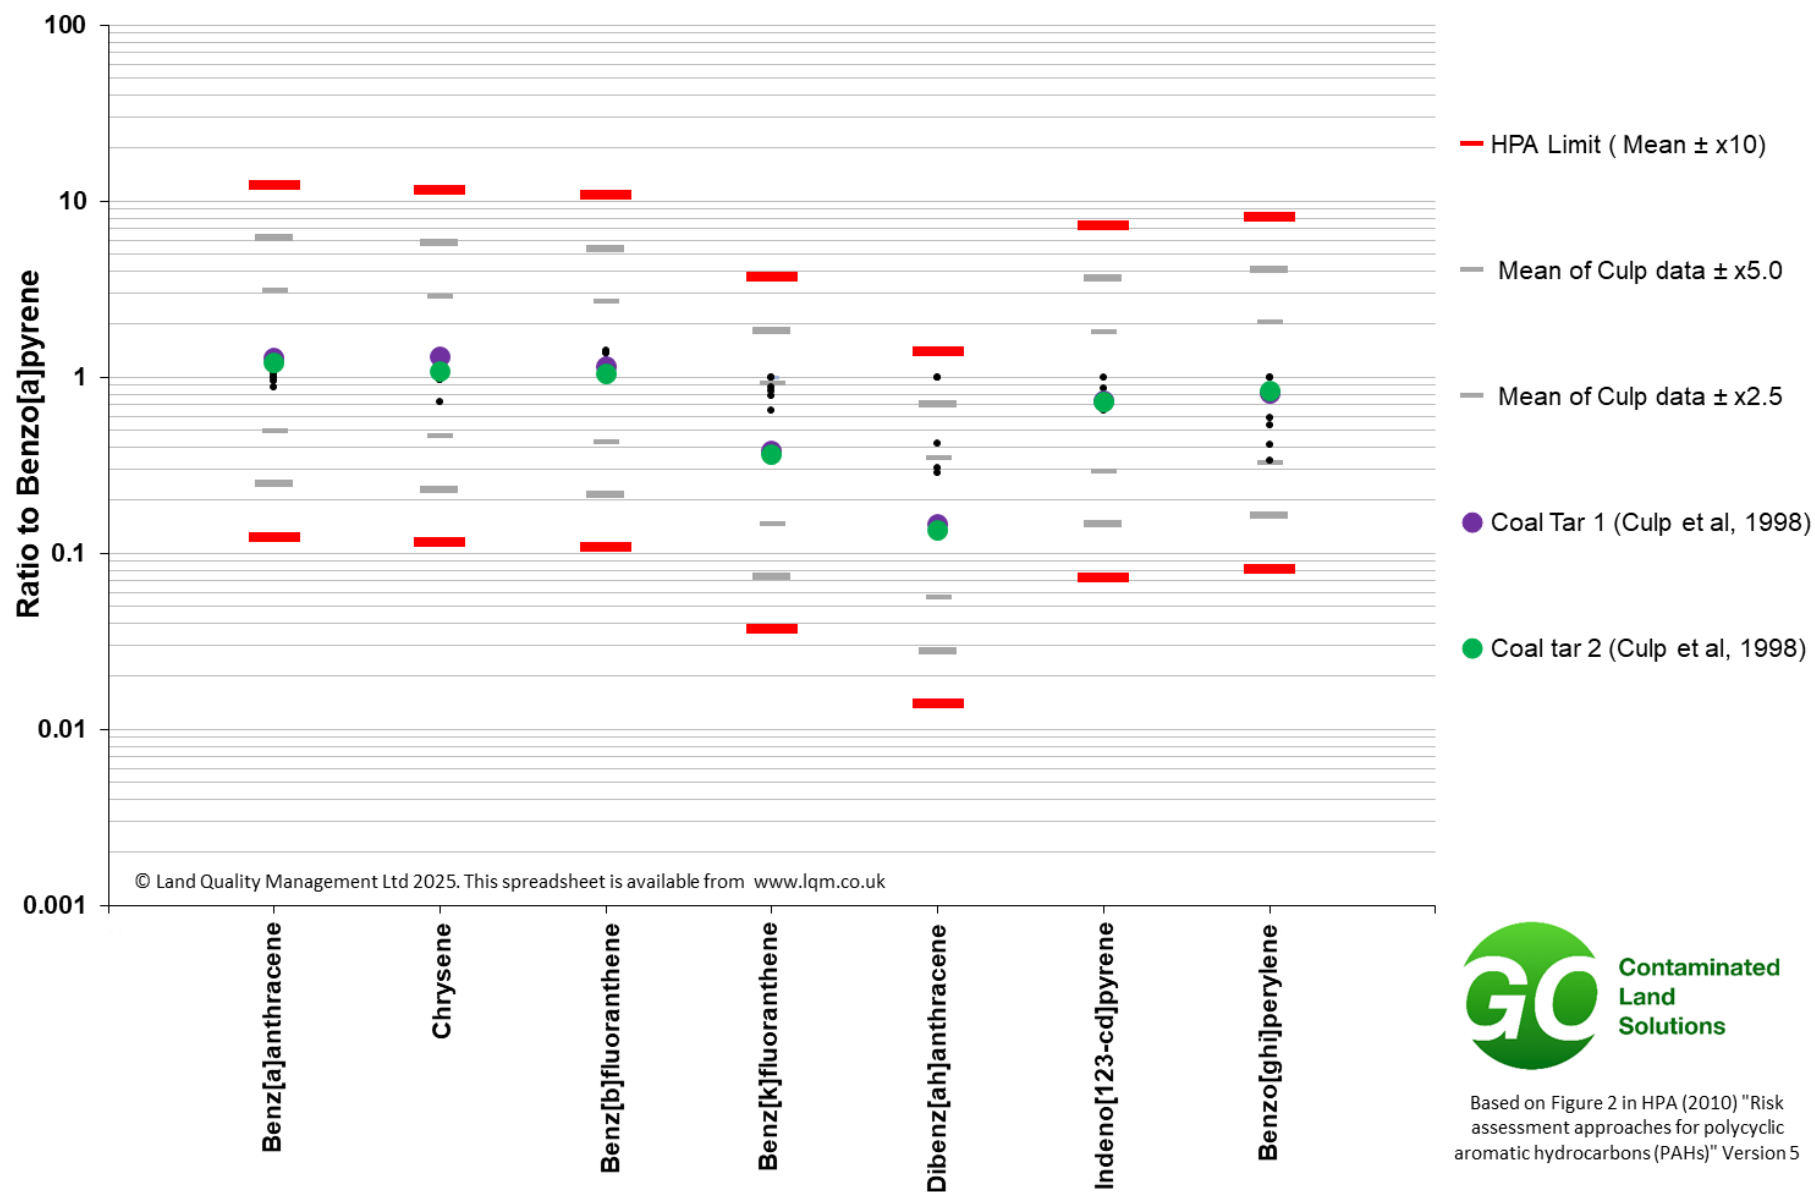
## **Appendix L – LQM Benzo(a)pyrene Surrogate Marker Approach**

Based on Figure 2 in HPA (2010) "Risk assessment approaches for polycyclic aromatic hydrocarbons (PAHs)" Version 5
