Hornsey Town Hall and the Gas and Electricity Showrooms

Conservation Management Plan, Hornsey Town Hall

May 2025

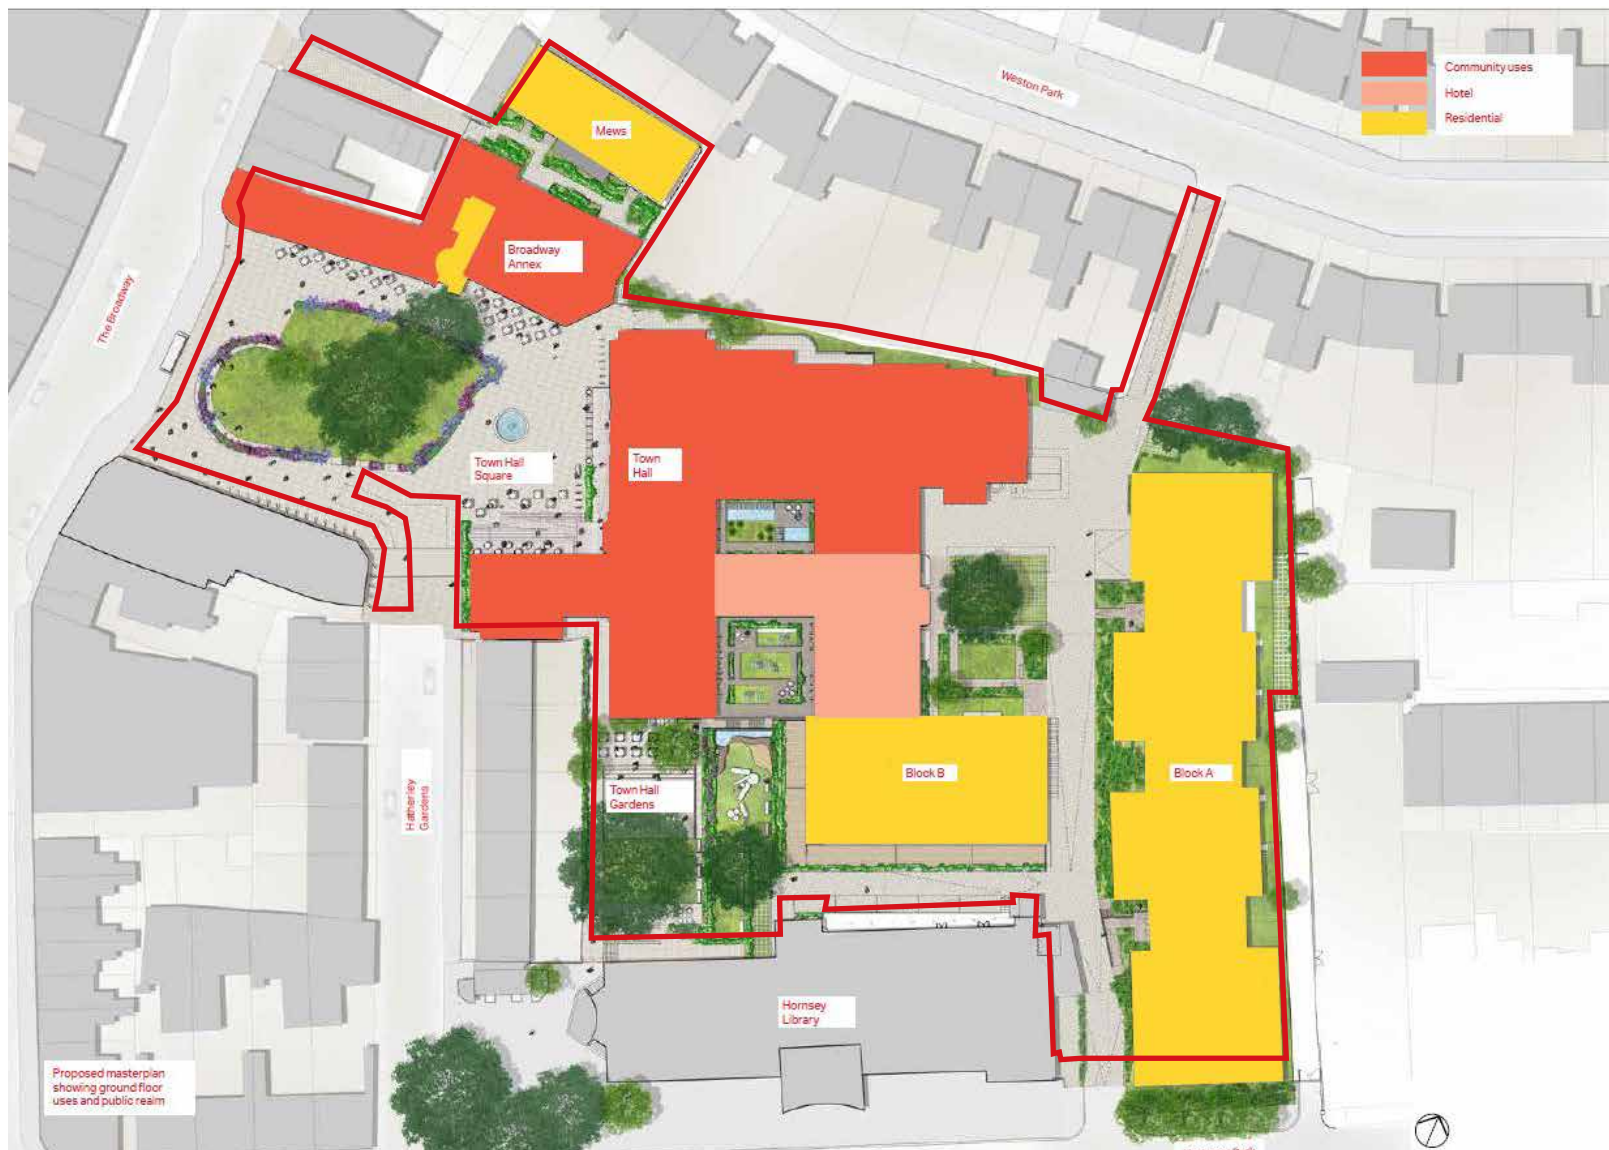
Site plan with development boundary outlined in red

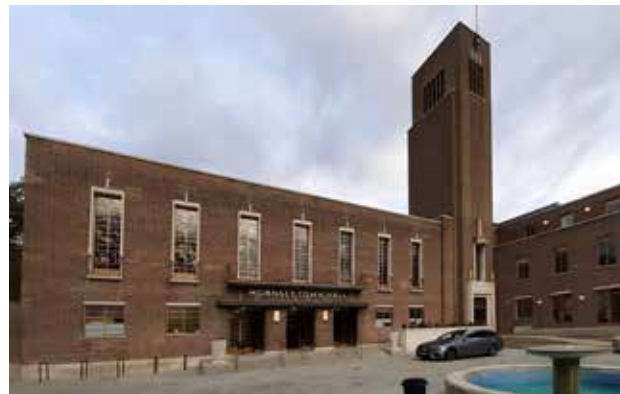
31 Front West elevation

At first floor are seven double-height bronze-framed windows, surrounded by Portland stone with slit keystone details. Fronting the three central windows is a bronze openwork balcony, and the remaining windows have individual openwork balconies.

The entrance to the Administration and Civic Block is set within the base of the tower. It is accessed via stone steps and ramps (original with some areas of earlier and more recent alteration). The entrance contains a large door with a Portland stone surround carved with Haringey coat of arms and animals. Above is a copper-grilled window surmounted by a bronze hood [plate 32]. The central bay of the tower features rusticated brickwork. Its upper stage contains four slit windows with stone strips set between. At the very top is a central flagpole, supported by curved brackets.

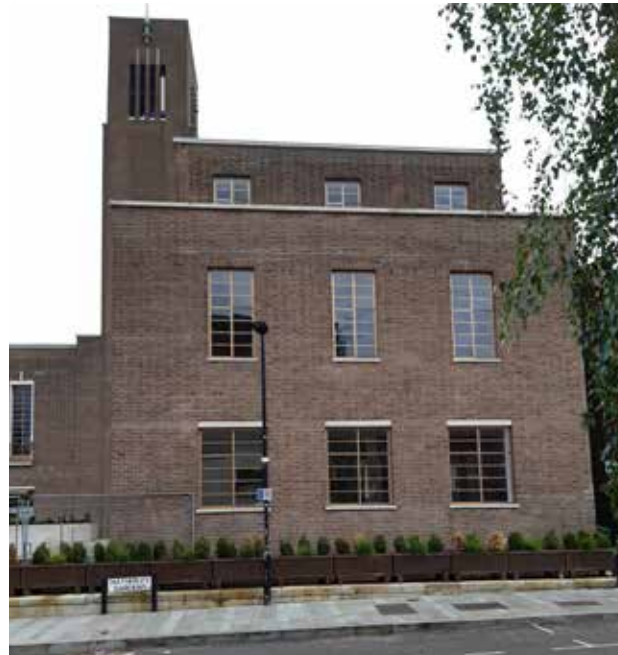
**33** West elevation to southern block

The west elevation of the south office wing is three bays wide and otherwise matches the north elevation, with three further bays to the set back second floor. There is a narrow south elevation to this block, where it abuts No.10 Hatherley Gardens. It contains steel-framed casements and a fire escape stair **[plate 33]**.

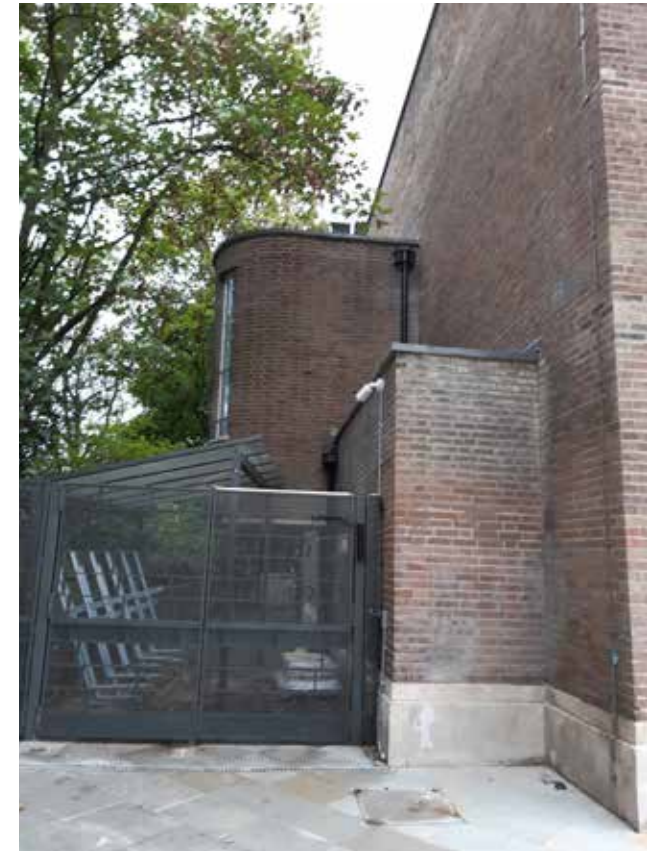
**34** North elevation of the Assembly Hall Block, cantilevered stair

The north elevation of the Assembly Hall block is largely plain except for the attractive curved cantilevered stair core, which is lit by three tall steel-framed windows **[plate 34]**. The Assembly Hall is lit by five tall narrow steel-framed windows.

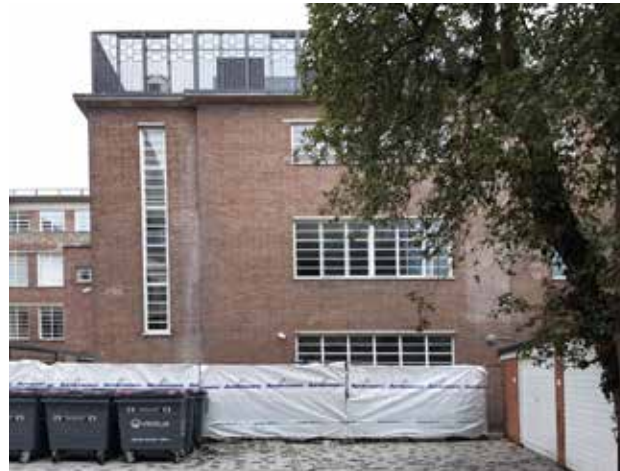
35 Rear (east) elevation of Assembly Hall Block

The rear of the Assembly Hall Block is three storeys, two bays wide and is arranged asymmetrically. The left hand bay contains a tall steel-framed strip window which illuminates the stair core. The right hand bay contains wide steel-framed windows with concrete lintels and sills on each of its levels [plate 35].

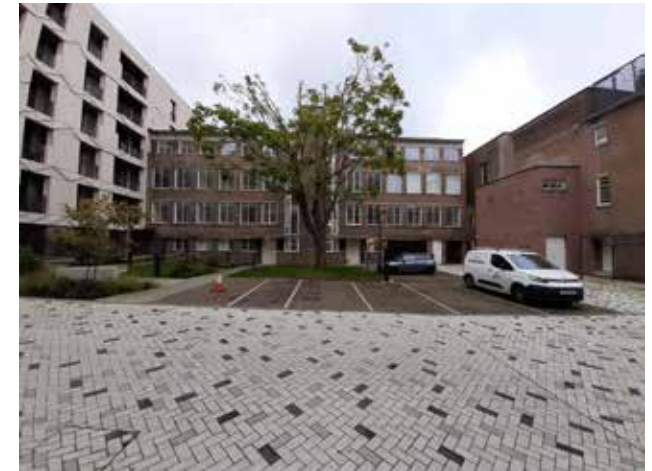
36 Rear (east) elevation of the east office wing, second floor extended to length of east office wing

The rear elevation of the east office wing is largely symmetrical. It is four storeys as it accommodates the lower ground floor. It is thirteen bays wide with its central stair and lift core flanked by the secondary entrances. The stair and lift core is the main feature of this elevation – it is oblong and features curved wrap-around windows. The remainder of the windows are steel-framed casements (like the stair, all painted white) with continuous concrete sill and lintel bands. At lower ground floor, there are entrances either side of the stair, with a large curved canopy over (half of which has been altered). To the north, the remainder of the lower ground floor contains the former car entrance to the Service Court, this has been blocked off with sheets of ply. The second floor is arranged as two bays wide either side of the stair core, again with large steel-framed windows. There is a deep stone parapet above and the core rises to accommodate the lift overrun, the second floor has been extended either side of the stair core to the full length of the building [plate 36]. There is a new residential block to the east of the Town Hall across what was a previous service court [plate 37]. The area between the Town Hall and new residential blocks has been landscaped with paving and planting of a high standard, together with the retention of the mature tree this creates an attractive setting.

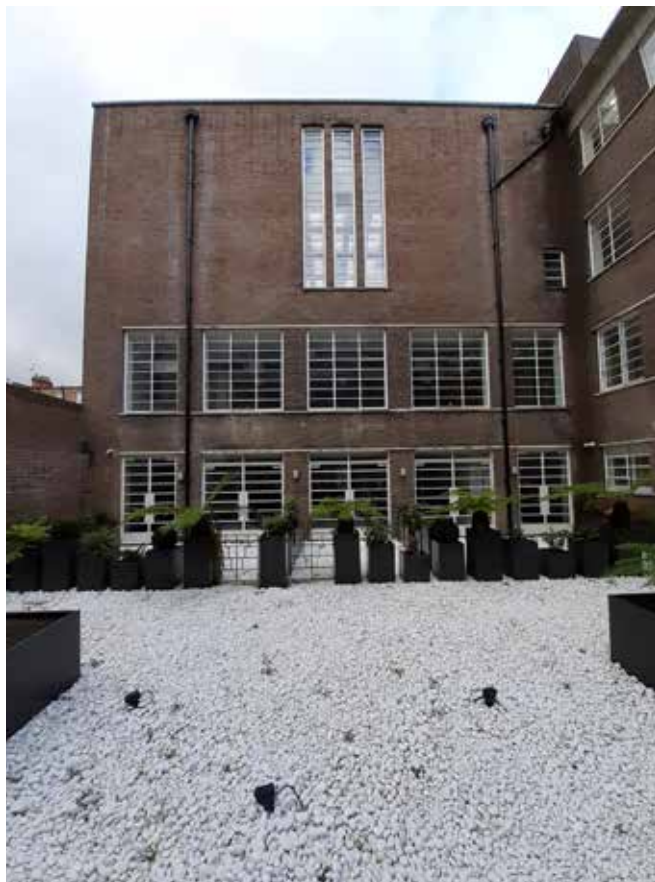
**40** *Council Chamber block around the 'Garden Court'*

The east office wing and Council Chamber block are set around the 'Garden Court', and its elevations are fairly utilitarian. A new residential block abuts the south elevation of the east wing. The south elevation of the Council Chamber block is largely blind, with the exception of two new ground floor doors providing access from the co-working space to the new public realm area which has been landscaped to a high standard, with the mature tree being a focal feature [plate 39].

Facing the Garden Court, the south elevation of the Link Block is four-storeys, six bays wide and contains large steel-framed windows at each level, linked by continuous concrete lintel and sill bands. The return elevation of the east wing is four storeys and ten bays wide, with steel-framed windows at each level. The Council Chamber Block is four storeys; at lower ground level, the former Caretaker's room (now hotel rooms) have large steel casements, which are in keeping with the original style of windows. Five large steel casements illuminate the former General Clerk's offices (now providing co-working space) and the Council Chamber above is lit by three narrow double-height steel-framed windows [plate 40, 41].

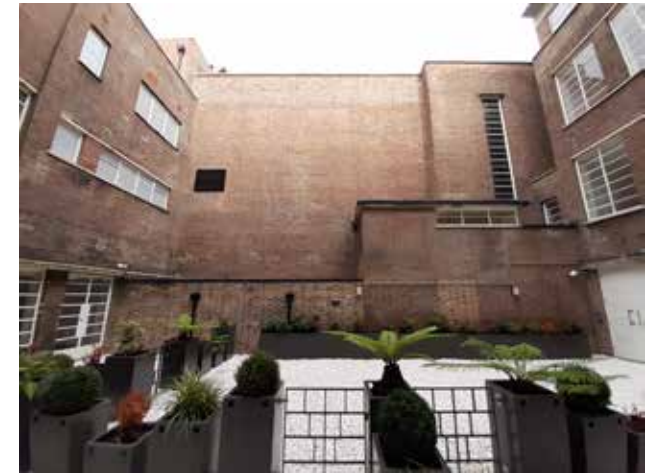
42 Service Court elevation looking north

(formerly known as Service Court) The south elevation of the Assembly Hall has a largely blind elevation, except for the two entrances at lower ground floor level. The west elevation of the east office wing rises four storeys and is four bays wide; the lower ground floor contains large openings which formerly provided access for cars, but these spaces have now been converted to hotel rooms with new doors in a different style to the existing windows. The ground and first floors contain large steel casements, linked by stone sill and lintel bands. The north elevation of the Link Block is three storeys, plus a set-back third floor and is six bays wide [plate 42, 43]. The ground and first floors contain large steel casements, linked by concrete sill and lintel bands. The set back third floor is nine bays wide, faced in concrete, with a deep parapet and overhanging cornice; this floor has been extended on the north section of the east wing. The remaining elevation is four storeys and is asymmetrically-arranged. The ground floor contains a very wide steel casement, which illuminates the main entrance hall and adjacent are high-level casements for the WCs. The first floor contains three tall narrow steel casements and adjacent, windows lighting further WCs. The second floor contains three tall narrow steel casements and adjacent is a projecting bay with wrap-around steel casements.

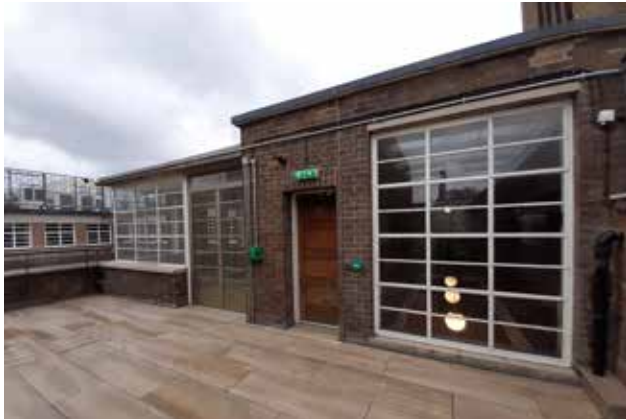
44 Flat roof over Assembly Hall Block

The roofs over the Assembly Hall and Council Chamber are pitched and slated. The remaining flat sections of roof now have a new decking with stairs and ramps for accessibility [plate 44].

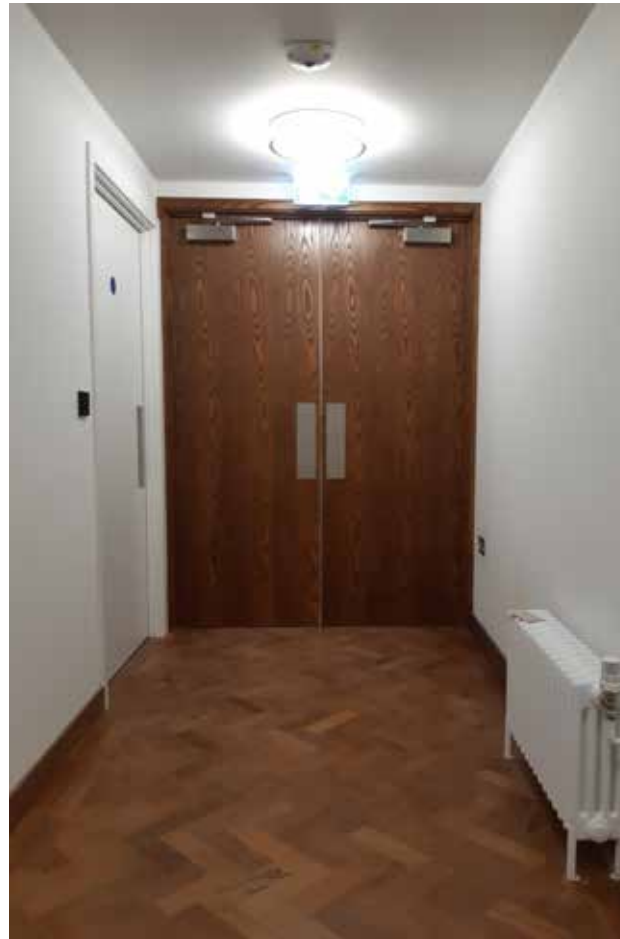
**51A** LG.07 Lobby

**General Description:** New Lobby corridor south of lift tower, mainly modern finishes.

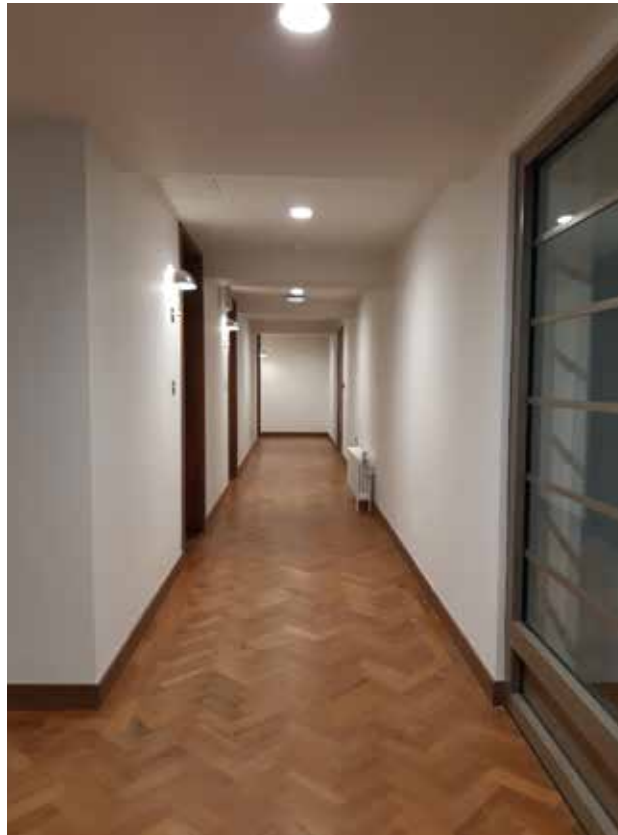
59 LG.28a Corridor

**Floor:** Historic timber parquet.

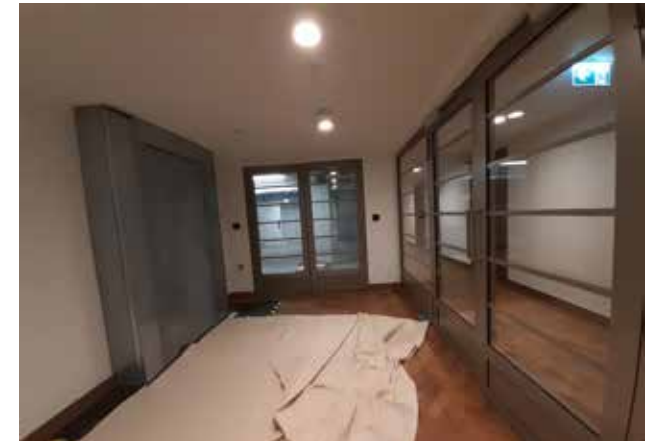
59B LG.28b Corridor floor showing parquet floor

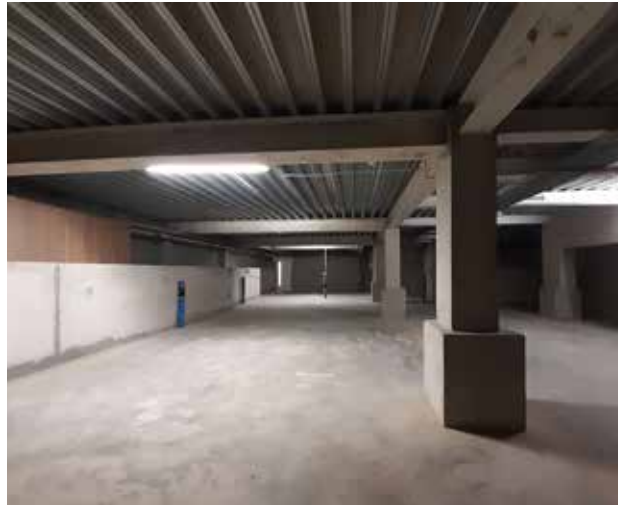
**60** *LG.31 Restaurant Main Kitchen and BOH*

**General Description:** Servicing to new area to form main kitchen and BOH.

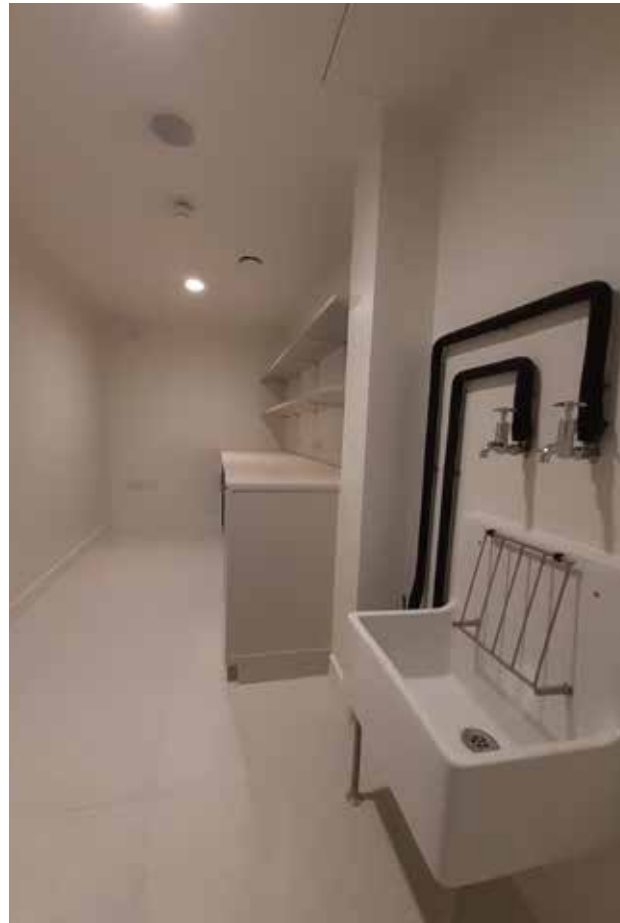
**60A** LG.31a Laundry

**General Description:** Hotel Laundry

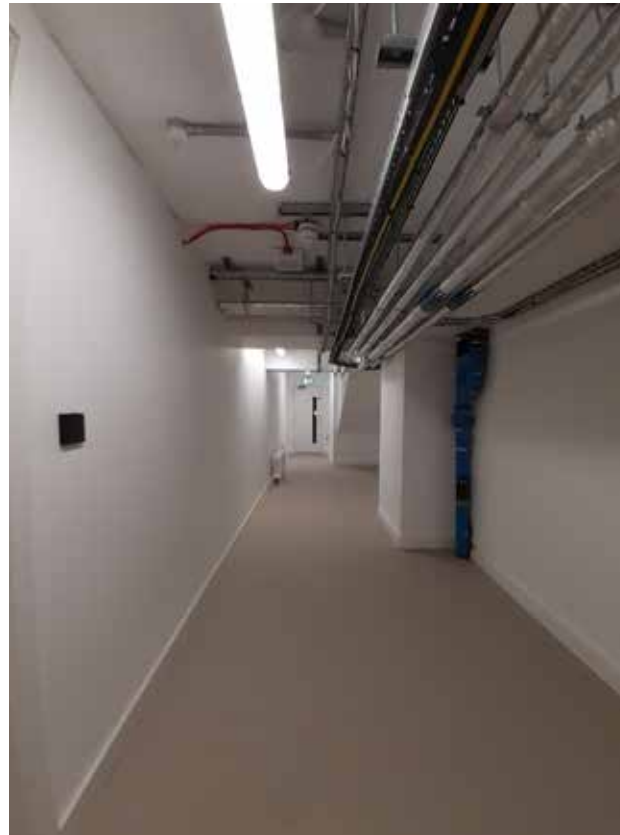
**60B** LG.31b Corridor

**General Description:** New corridor formed behind lift.

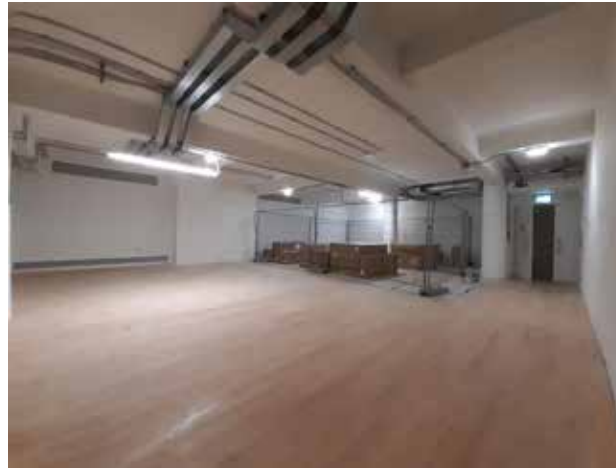
**63** LG.40 Supper Room

**Floor:** Historic timber floorboards to LG.40 Supper Room. Modern to other rooms

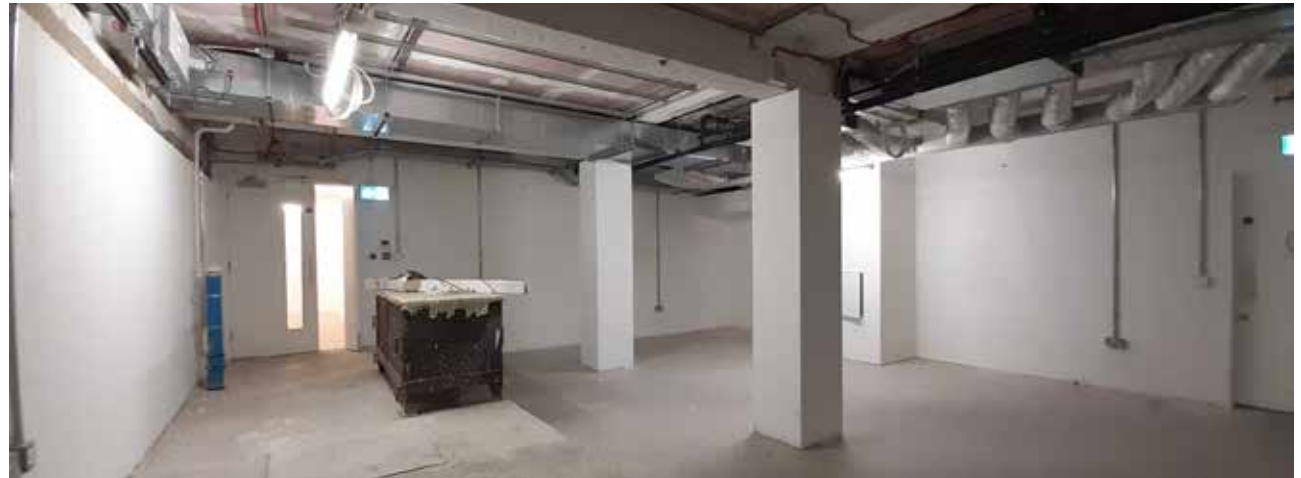
64 LG.42 Kitchen and Bar

**General Description:** Kitchen and Bar adjacent to the Supper Room. There is a level difference with some items of furniture remaining.

**Fittings:** Double dumbwaiter (original) and metal Kitchen Counter retained.

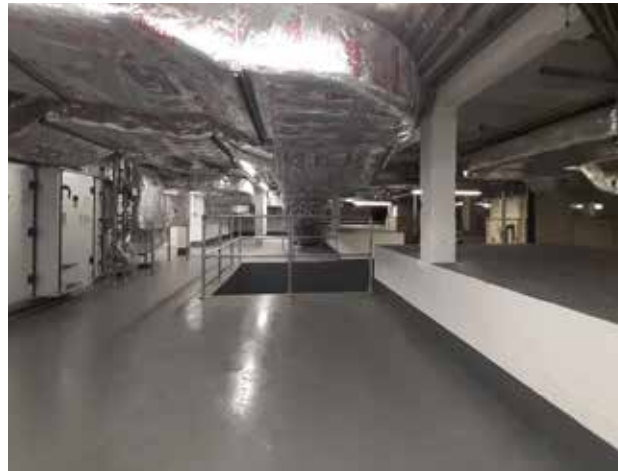
**65** LG.43 Plant Room beneath Assembly Hall 1

**General Description:** Plant Room, set beneath Assembly Hall Block.

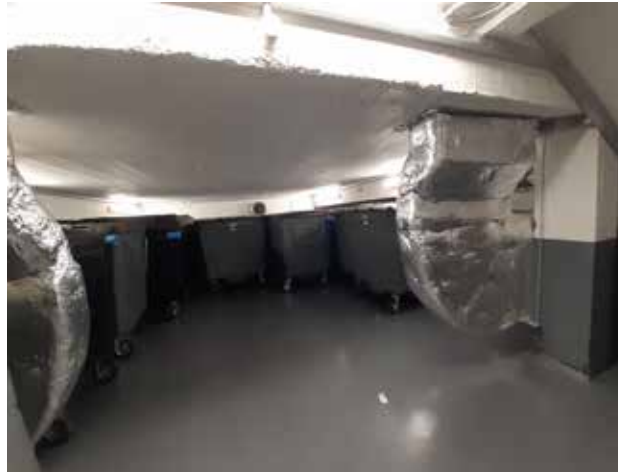
**65C** LG.45a Refuse store

**General Description:** Town Hall Refuse housed in previous Cycle Store LG.45

**Floor:** Granolithic finish.

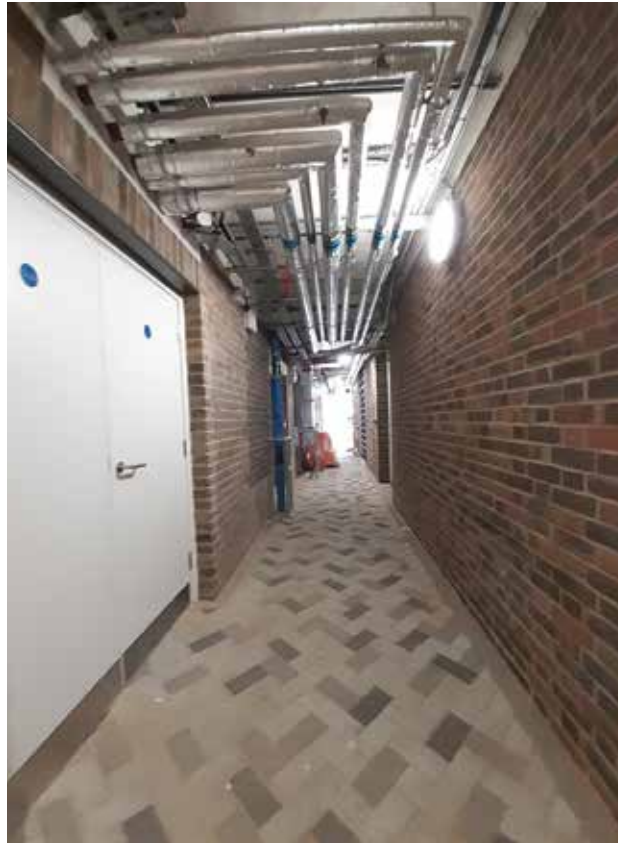
**66** LG.45f New covered corridor near Plant and Refuse Store

**General Description:** New covered (outdoor) access corridor built in former Service Court.

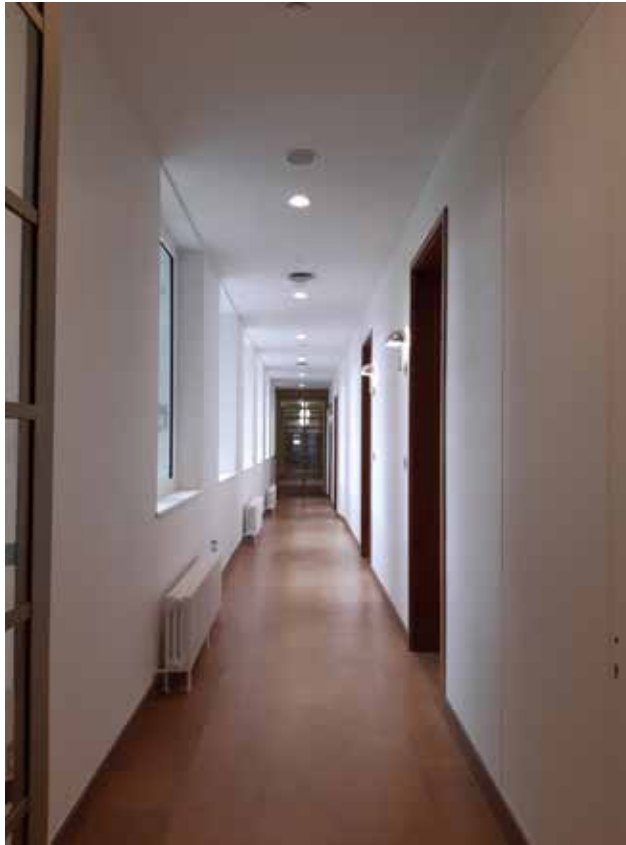
**72** G.4 Corridor looking west to entrance hall (courtyard on left)

**Room: G.4 Corridor [plate 72]****General Description:** Corridor

This was the main office corridor in the Link Block, which is accessed off the Entrance Hall and connects the west block to the east block (now mainly hotel). There were large screens with nickel-plated frames and double doors, which divide the office corridor from the Hall [Plate 72A, 2017]. They contained Georgian wired glass (non-original). There are glazed screens with single doors onto the former General Clerk's Office (now part of G.3 Room) and the Lounge (G.29), again with their glazing replaced.

**Floor:** Historic cork [Plate 72B, 2017].

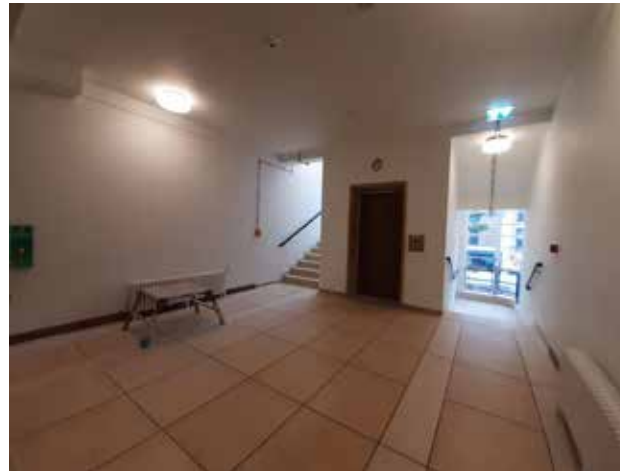
**78** G.17 Ground Floor Landing - 1

**General Description:** Ground Floor Landing; eastern lift and stair core.

**Floor:** Historic terrazzo with bitumen joints.

**Fittings:** Lifts with terrazzo surround and clock above.

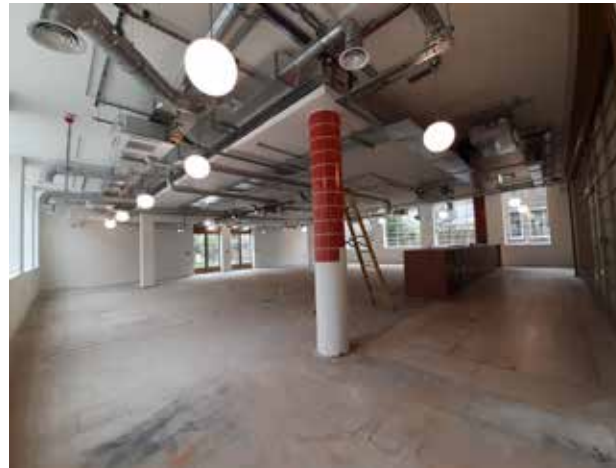
80 G.29 Co-working space view 1

**General Description:** Co-working space; this single larger space previously housed several Clerks offices, book room and a public access space for dealing with the rates office. The 2017 inspection notes: This is the former General Clerk's Office, which was used as a rates collection office. The space is currently occupied as a gallery. There are large screens with nickel-plated frames and a single leaf door onto the main office corridor (G.4), the glazing replaced with Georgian wired glass. There have been earlier changes to the layout of these areas, with new partitions. [plate 80D]

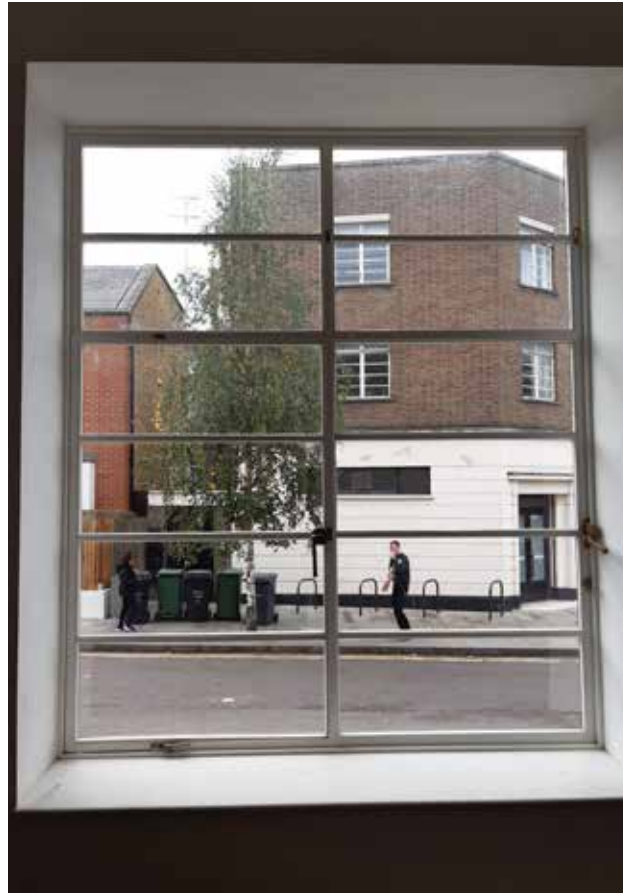
**81C** G.38 F&B Restaurant windows (original)

**Windows:** Original Bronze-framed casements to west  
elevation [plate 81C].

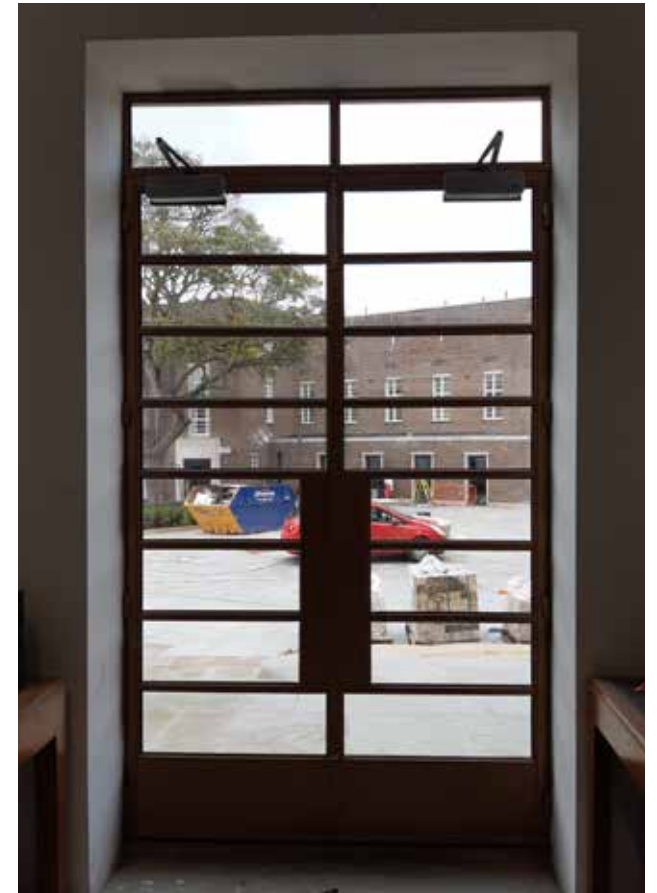
**81D** G.38 F&B Restaurant doors (new double glazed)

**Doors:** New double-glazed bronze casement doors  
[plate 81D. Door to G.38 is original but has been  
shifted, the door and borrowed lights to G.38a  
are non-original.

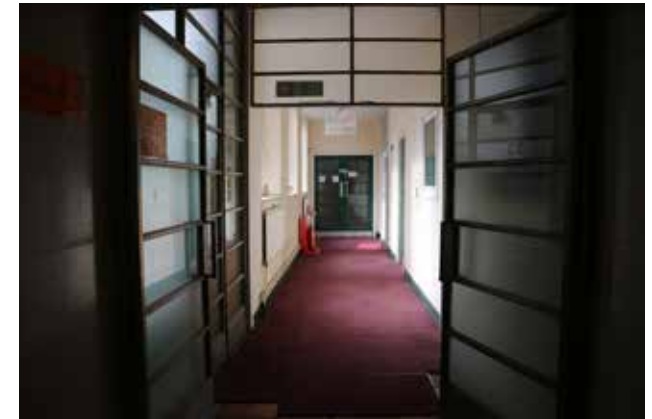
**82A** Ground Floor, G.4 from the Entrance Hall (2017)

**Doors:** New external doors and original doors were part of the glazed screens [see plate 82A]

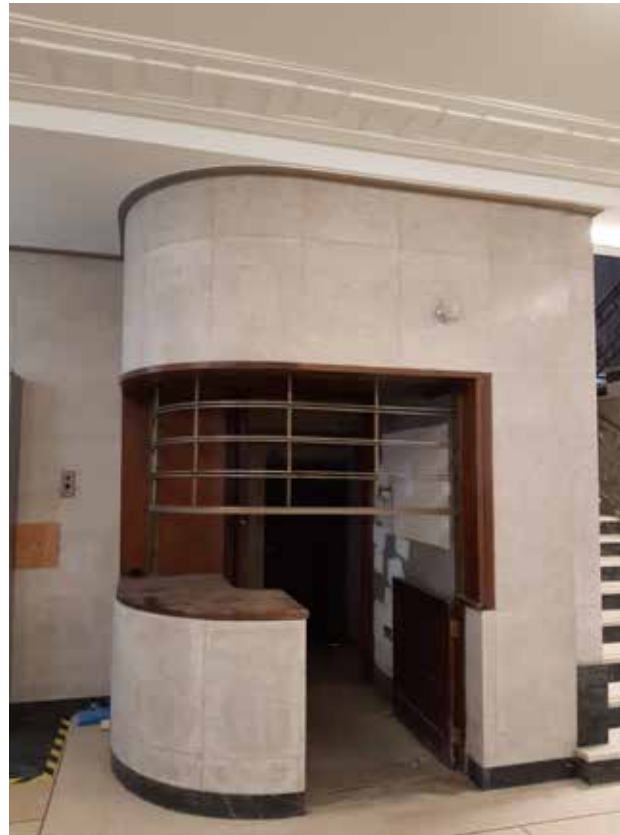
**84A** Ground Floor, Main Entrance Hall (2017), G.41 looking to Hall Porter's kiosk. (2017)

**General Description:** Barista, formerly Hall Porter's kiosk, balancing the form and function of the enquiry desk opposite (now G.2 Concierge). This space was boarded up during the site visit, but a previous image is shown from 2017 [plate 84A].

**Fittings:** Curved counter lined with stone and timber worktop.

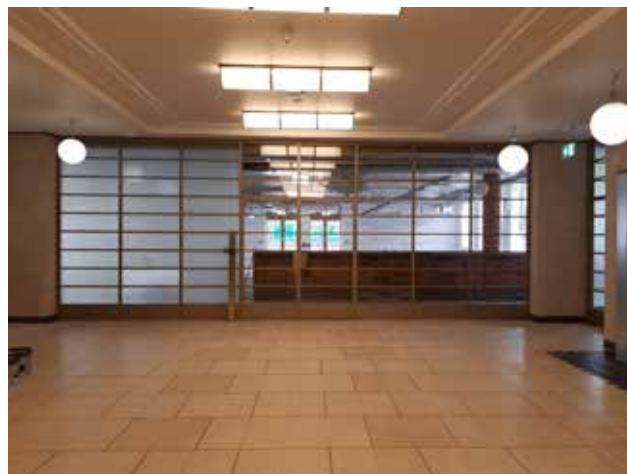
**85D** G.41 Entrance Hall screen at south end

Full-height screens (nickel-plated) divide the Entrance Hall from the former Rates Office, the Assembly Hall Foyer and the former General Clerk's Room, the glass is etched and has the geometric pattern, found elsewhere in the building. There are further matching doors with overlights dividing the office corridor from the Hall. Some of the glass to the Rate's Office screen and those to the office corridors been replaced by Georgian wired glass [Plate 85G].

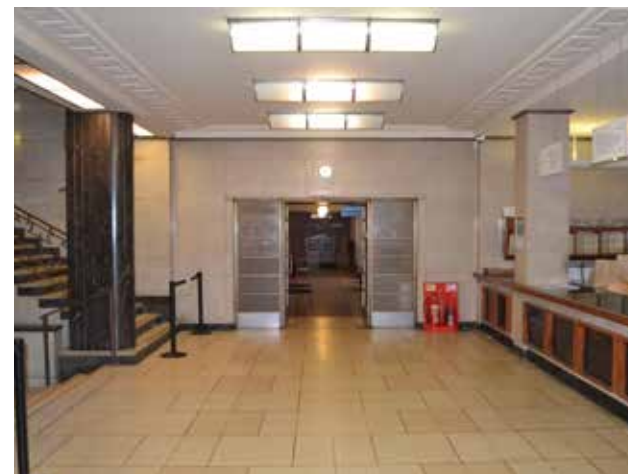
**85F** Ground Floor, Main Entrance Hall, G.41 (2017)

**Ceiling:** Original half-barrel strip lights to the ceiling (removed during site visit), globe pendants and flush light boxes to the underside of the stair [plate 85F].

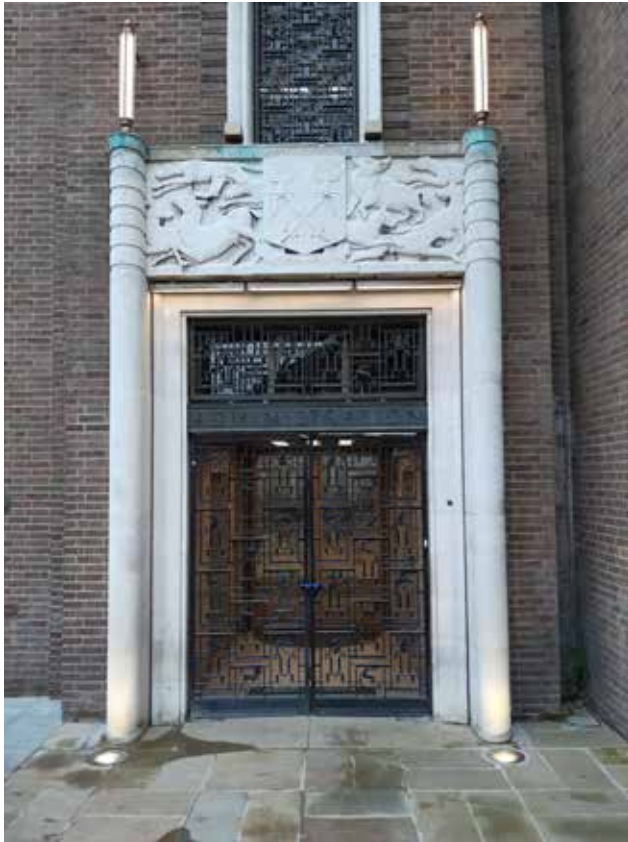
**86A** G.43 Vestibule

**Doors:** It has decorative bronze gates which were presumably closed at night; they feature stylised animals including horses, squirrels, owls and storks [plate 86A]. There is a matching bronze grille fitted externally over the overlight. There are two panelled timber doors off the vestibule, leading to ST.08 and G.39. G.42 is set beneath the main staircase.

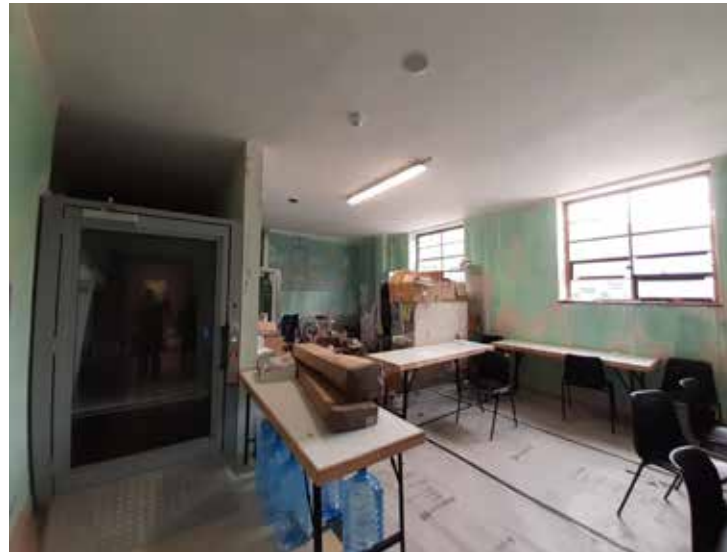
88 G.48 Cafe

**Floor:** Part terrazzo and part parquet.

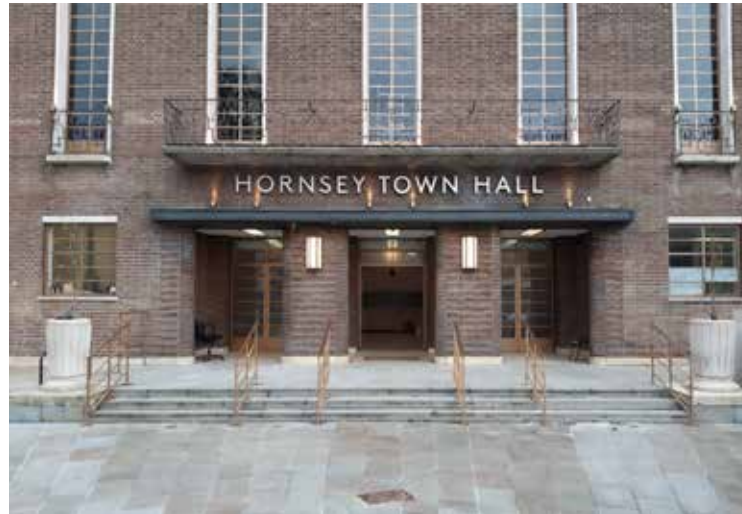
**89** G.49 Vestibule external

**General Description:** Vestibule to Assembly Hall Foyer. The inner reveals of the three main entrance doors are clad in Ashburton-marble (to G.55 Foyer). Two of the outer entrances have been temporarily closed with a temporary door in the outer door in the remaining outer entrance.

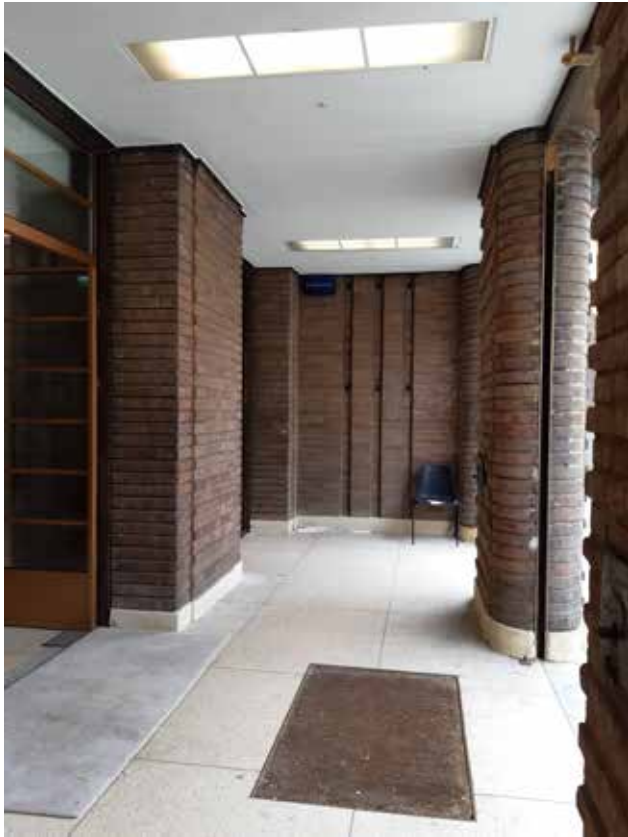
**89A** G.49 Vestibule looking south

**Floor:** Cream terrazzo, with a pale blue threshold.

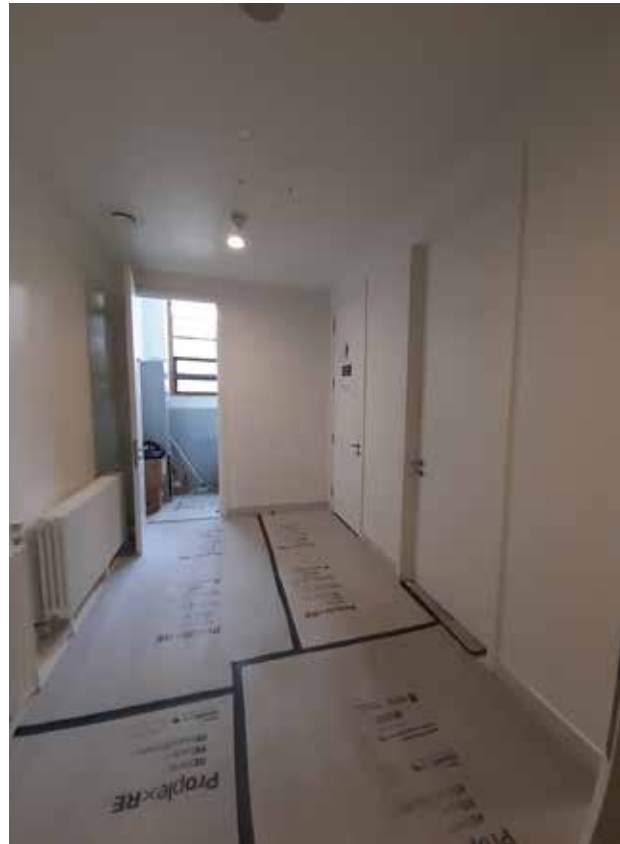
91 G.50a Public Lavatories

**General Description:** Public Lavatories which include a Unisex disabled WC.

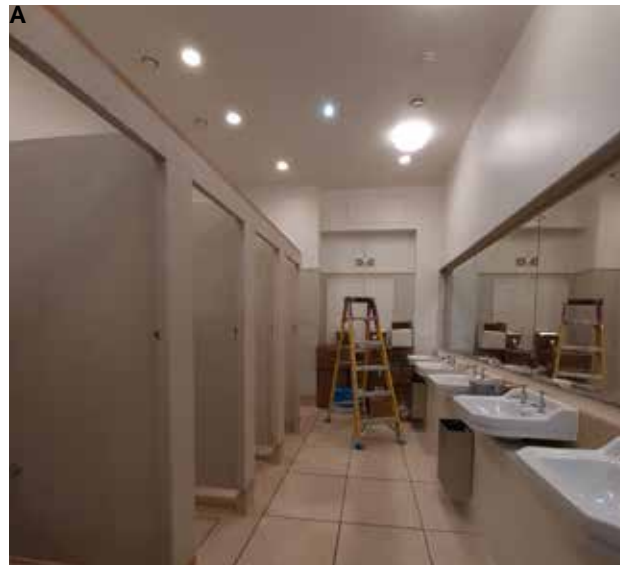
92 G.54 Ladies Lavatory looking back to entrance door

**Fittings:** Terrazzo cubicles.

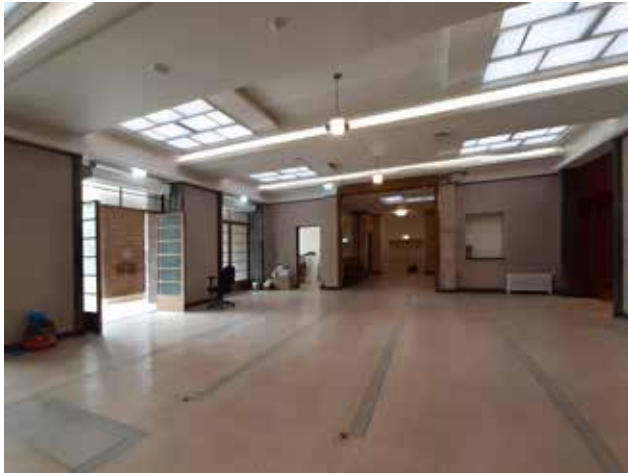
**93** G.55 Foyer looking towards G49 Vestibule entrance

**General Description:** This is the Foyer to Assembly Hall, another of the building's prominent public spaces, though it is less elaborate than the Entrance Hall. There are two sets of double doors to the Assembly Hall, these are veneered with portholes (with later wired glass) brass pull handles, with fluted timber friezes over and are framed by Ashburton marble jambs and reveals [plate 93E]. Between these doors the former Ticket Office is set into the wall, which is fronted by silver openwork screens.

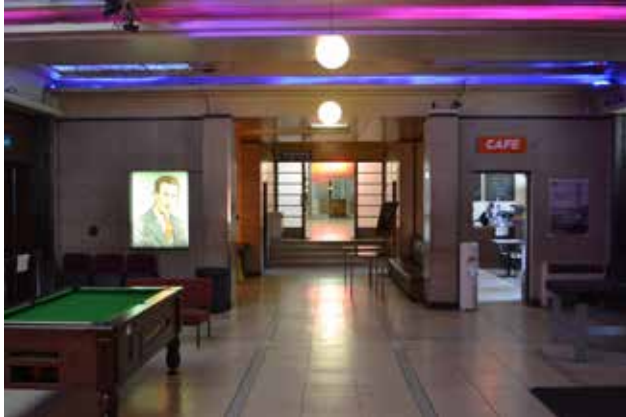
**93F** Ground Floor, Assembly Hall Foyer, G.55 (2017)

There are male and female cloakrooms and WCs arranged off the Foyer via the corridors G.46 and G.52. These spaces have veneered doors and retain original ironmongery, although there has been some change to the internal layout and finishes of these spaces. There are terrazzo lined steps and etched glass screens with double doors through to the Entrance Hall [plate 93F].

There were a number of appealing additional features and fittings in this area mentioned in the 2017 inspection, including the ceiling-hung 'WAY OUT' signs and cigarette butt plates. There is modern illuminated artwork (depicting the architect - Uren) and signage attached to the walls [plate 93F].

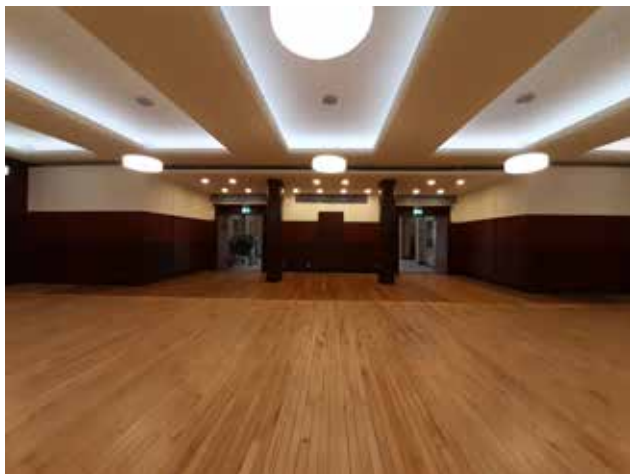
**94** G.55a Function Room looking towards G.55 Foyer

**General Description:** This is a new space Function Room, previously part of G.57; the original ceiling layout has been retained, with much of the panelled walls to be reinstated, see historic photo [plate 94C]. There are two new lobbies at either corner of the room, which leads into G.57a Assembly Hall.

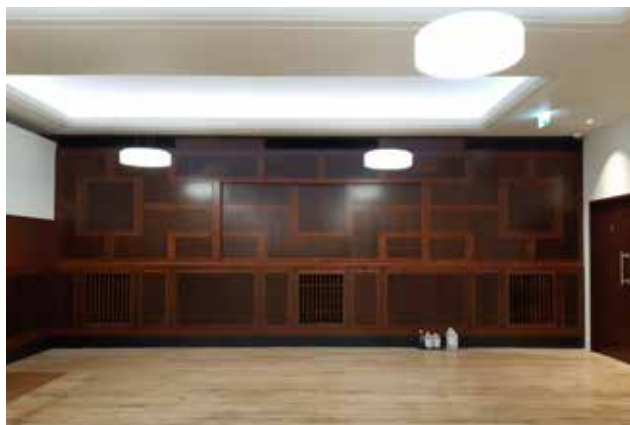
**94B** G.55a Function Room, looking towards G66 Servery Pantry, image shows panelled wall to this north side of the room

**Walls:** Painted plaster and panelled walls (some areas to be reinstated – construction works ongoing during site visit, Dec 2022). The walls here are panelled with veneered walnut, set out in geometric pattern. There is a timber panelled hatch through to the servery (G.66) [plate 94B]. The vents for the heating system are framed by timber architraves with timber louvers. There are two veneered columns behind the Box Office.

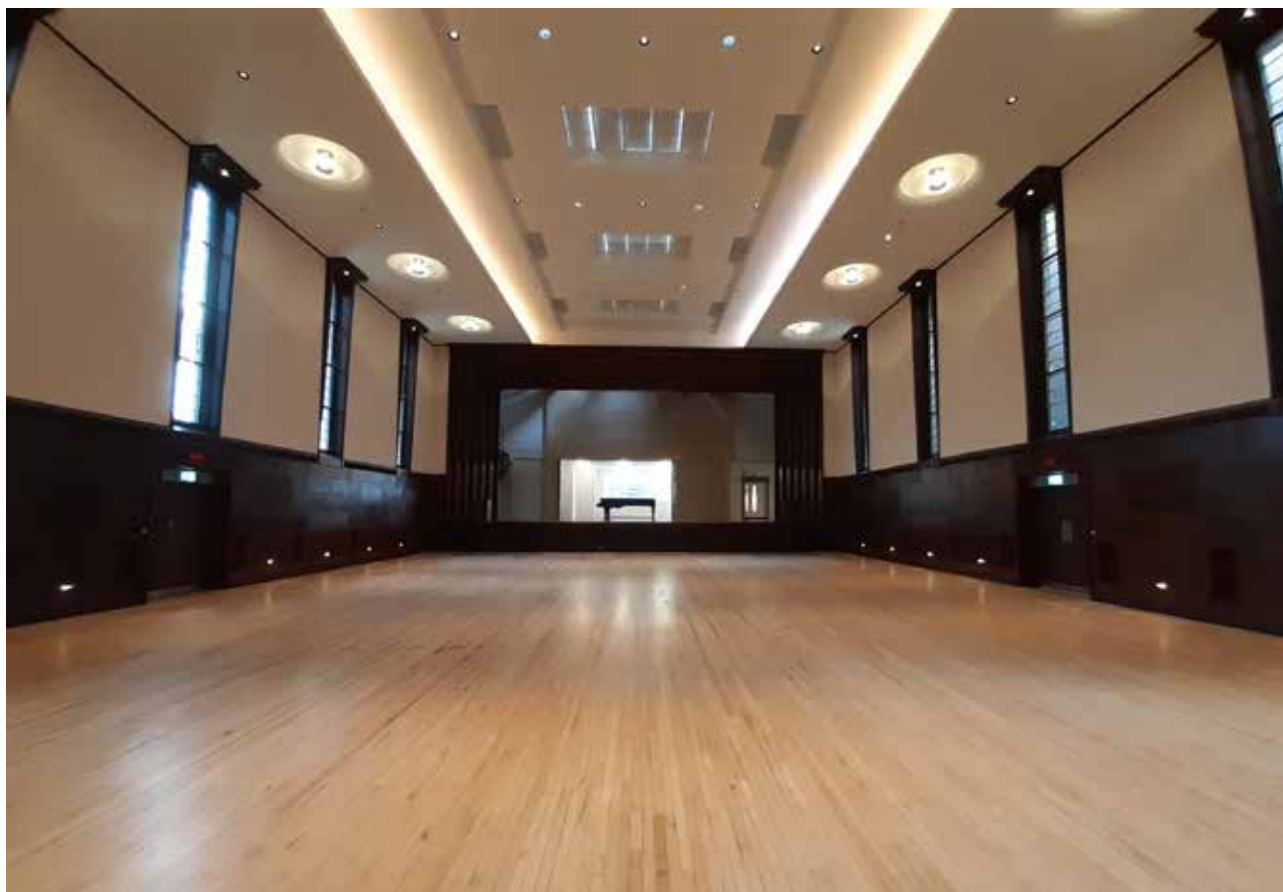
**95** G.57 Assembly Hall looking to east (stage)

**Ceiling:** The ceiling is deeply coffered (containing the radiator panels) and has small disc pendants. **[Plate 95F and 95].** The ceiling has been repaired and redecorated in flat white.

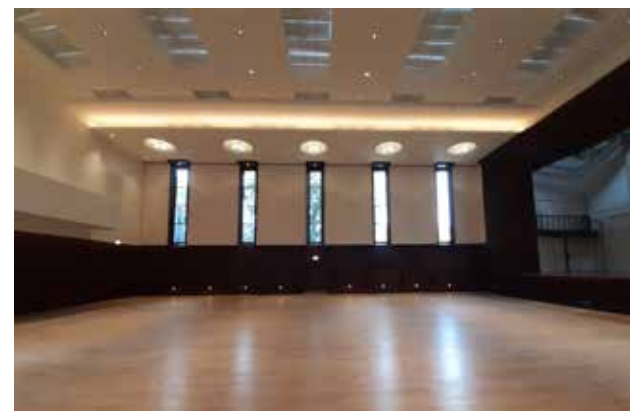
**95A** G.57 Assembly Hall looking north

**Walls:** The walls here are panelled with veneered walnut to the underside of the tall windows, set out in geometric pattern. The vents for the heating system are framed by timber architraves with timber louvers. The walls above the panelling have been repaired and redecorated in flat white.
