Hornsey Town Hall and the Gas and Electricity Showrooms

Conservation Management Plan, Hornsey Town Hall

May 2025

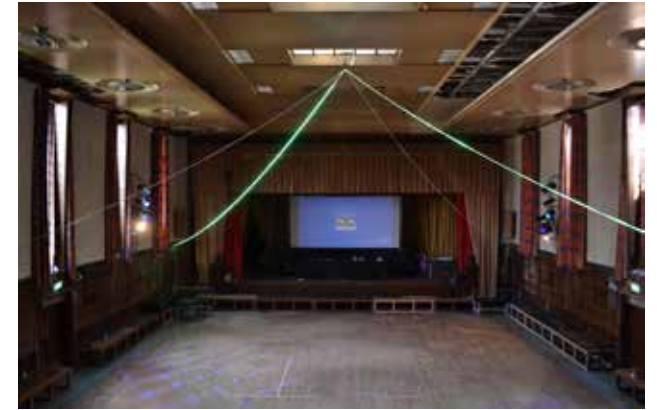
**95E** Ground Floor, Assembly Hall, G.57 (2017)

The main space of the Assembly Hall is finished with the same timber wall panelling. The floor was covered during the site visit and would be the same as the Function Room (with perimeter linoleum). Above the panelling, the walls are finished in acoustic plaster. The panelling contained timber louvres for ventilation interspersed between the inset metal panel radiators, in the original arrangement. The ceiling is finished in fibrous plaster; it contains large flat metal-framed rooflights at the centre and lower sections of ceiling along the north and south walls; which contained large disc-shaped pendants, which could be raised or lowered (light fittings not present during site visit). There are five tall narrow steel-framed casements line the north and south walls, framed with walnut. Panelled fire exit doors in the north and south walls have 'WAY OUT' signs. The proscenium arch has a shallow stepped profile. Some of the velvet stage curtains are original. The stage front is panelled in the same design as the walls. Historic photos are plates 95E and 95F.

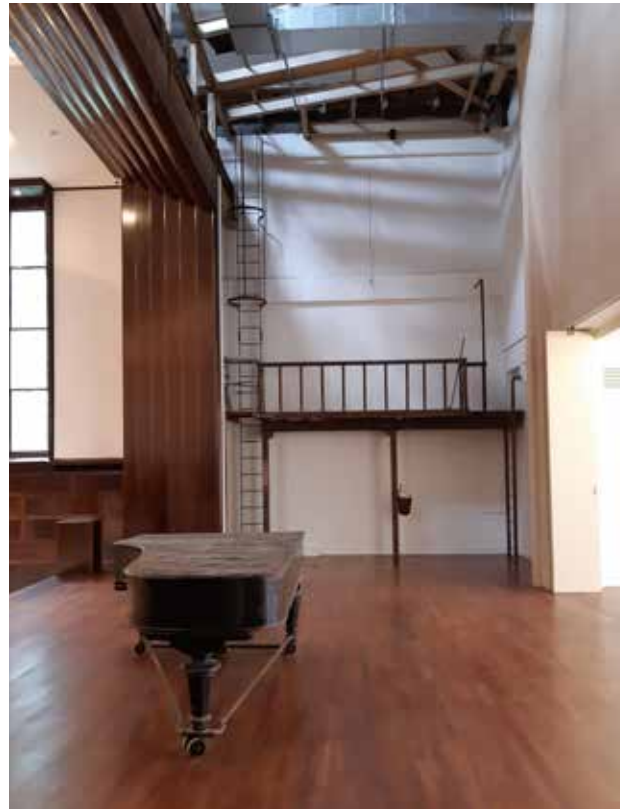
96 G.62 Stage looking north to G.63 Stage Wing

**Floor:** Timber floorboards, dark stain.

**Fittings:** None (2017 inspection noted that some of the velvet curtains were original).

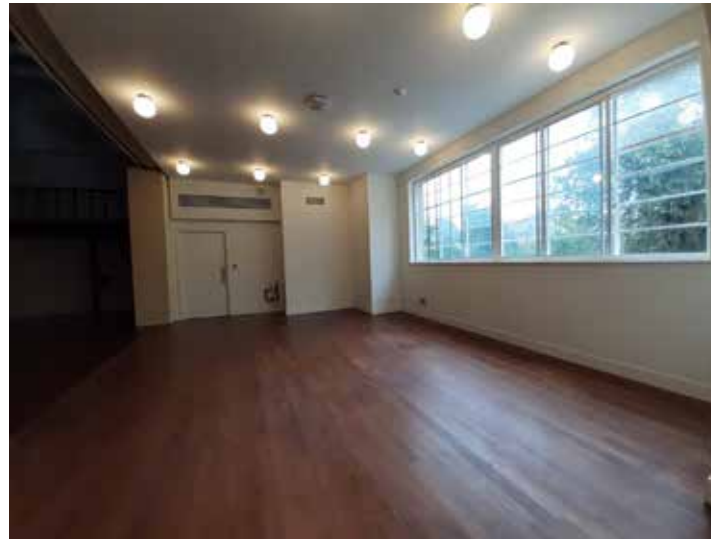
**97** G.61 Green Room looking north with G.62 Stage on the left of the image

**Fittings:** None. (The 2017 inspection noted that there are several interesting features and fittings including the illuminated 'SALIDA' box sign above the exit.)

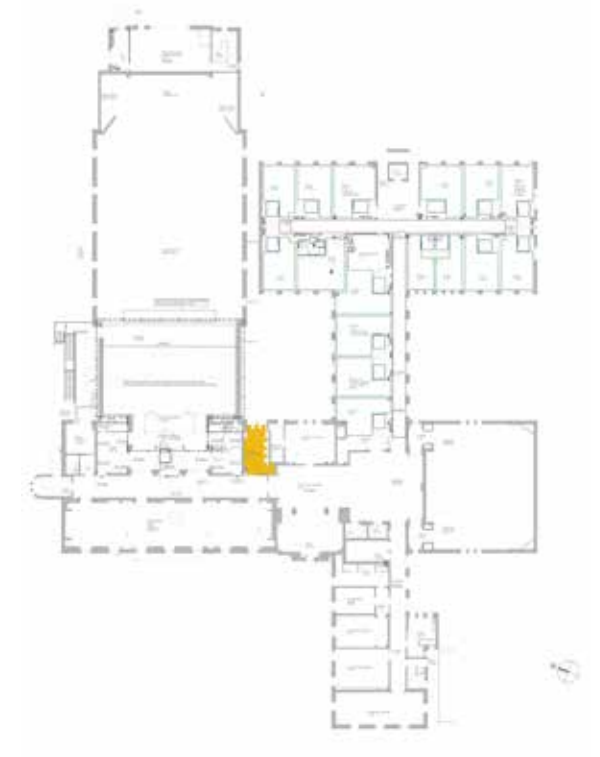
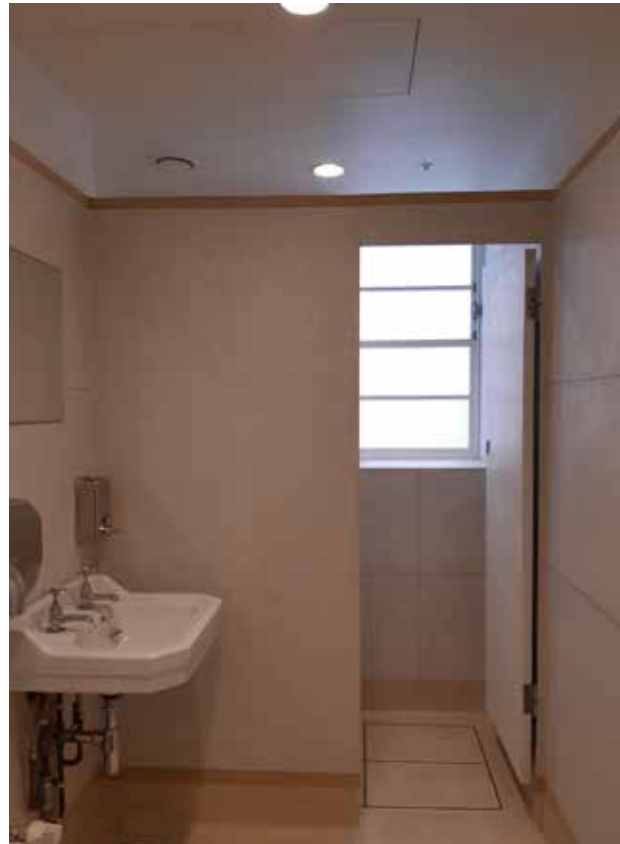
**101** *F.2 Mayor's Lavatory*

**Room: F.2 Mayor's Lavatory [plate 101]**

**General Description:** Mayor's WC with access from F.3 Mayor's Parlour only, now with most of fixtures and fitting removed.

**Floor:** Historic terrazzo tiles.

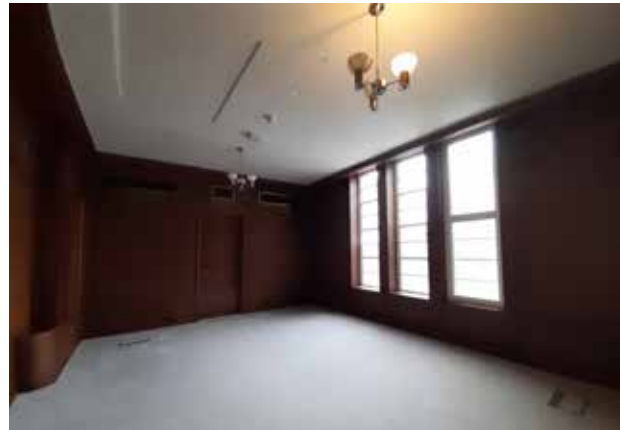
**102** F.3 Mayor's Parlour looking north

**Room: F.3 Mayor's Parlour**  
**[plate 102, 102A and 102B]**

**General Description:** Mayor's Parlour, this panelled room has built in cupboards either side of the entrance door and a large window to the east elevation overlooking to the inner courtyard.

**Fittings:** Marble and stone radiant heater; clock; nickel-plated chandeliers There is a 1930s vanity with keyhole-shaped mirror (from elsewhere). Original curtains lost.

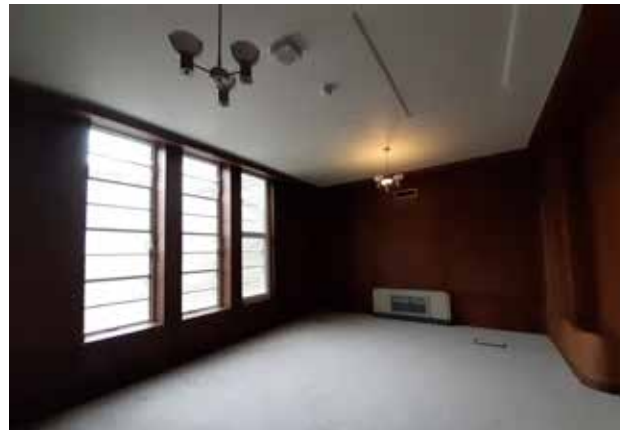
**102A** F.3 Mayor's Parlour looking southeast

**Windows:** Three tall bronze-framed casements with etched glass in the east wall, set in walnut reveals [plates 102A and 102C].

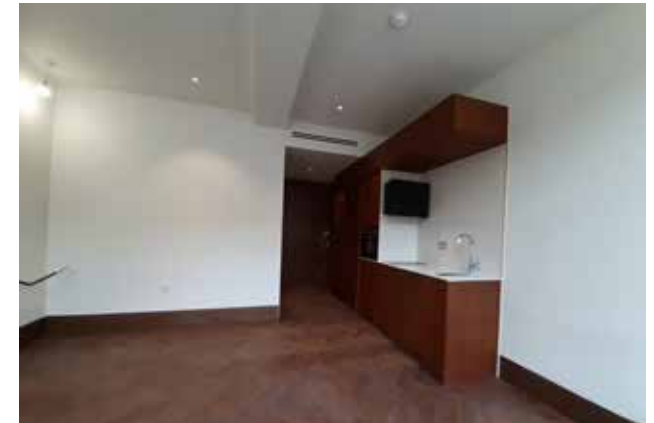
104A F.6 Hotel Room Former Deputy Town Clerk's Room

**F.6 Room (Former Deputy Town Clerk's Room) [plate 104A]**

**Fittings:** Original cupboards modified and fitted to room F.6.

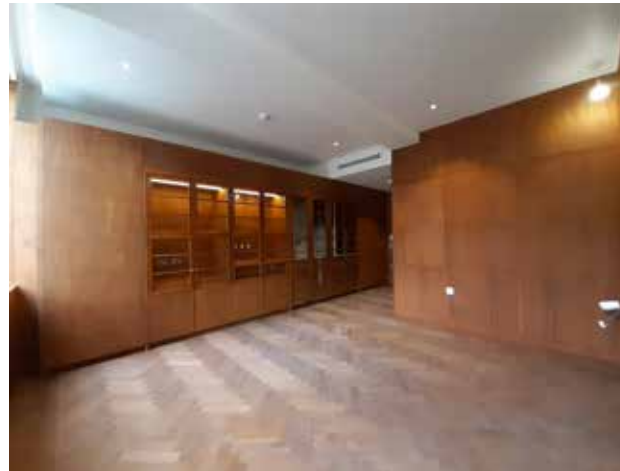
**105** F.9 Hotel Room Former Town Clerk's Office

**Room: F.9 Room (Former Town Clerk's Office) [plate 105]**

**Fittings:** Original cupboards modified and fitted.

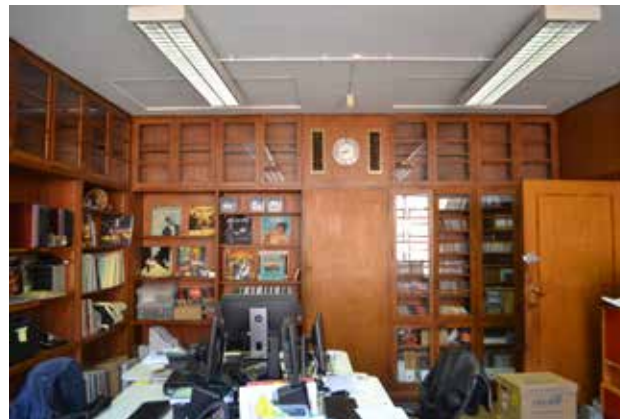
**105A** First Floor, former Town Clerk's Room, F.9 (2017)

**General Description:** Ensuite hotel room accessed from F.30 Corridor, previously fitted with full height panelled cupboards [plate 105A].

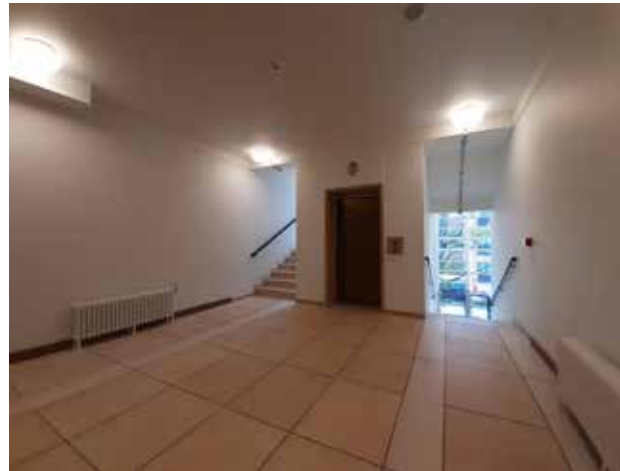
**108** *F.17 First floor landing*

**Room: F.17 First Floor Landing [plate 108]**

**Floor:** Historic terrazzo with bitumen joints.

**Fittings:** Lifts with terrazzo surround and clock above.

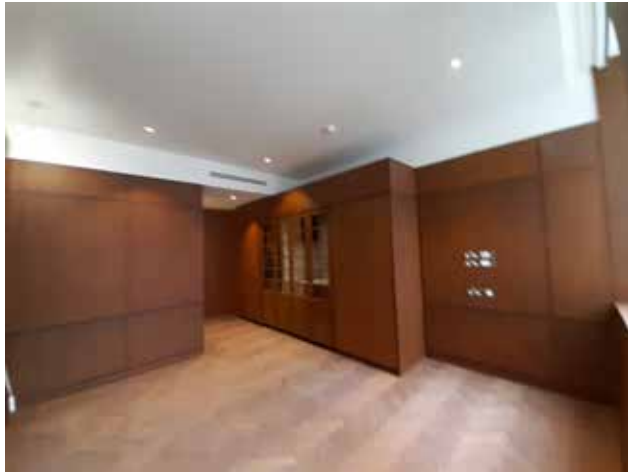
**109B** *F.21 Hotel Room (Former Medical Officer's Room)*

F.21 Room (Former Medical Officer's Room) [plate 109B]

**Fittings:** Some original cupboards re-fitted in F.21 Former Medical Officer's Room (previously this room was panelled full height with built in cupboards).

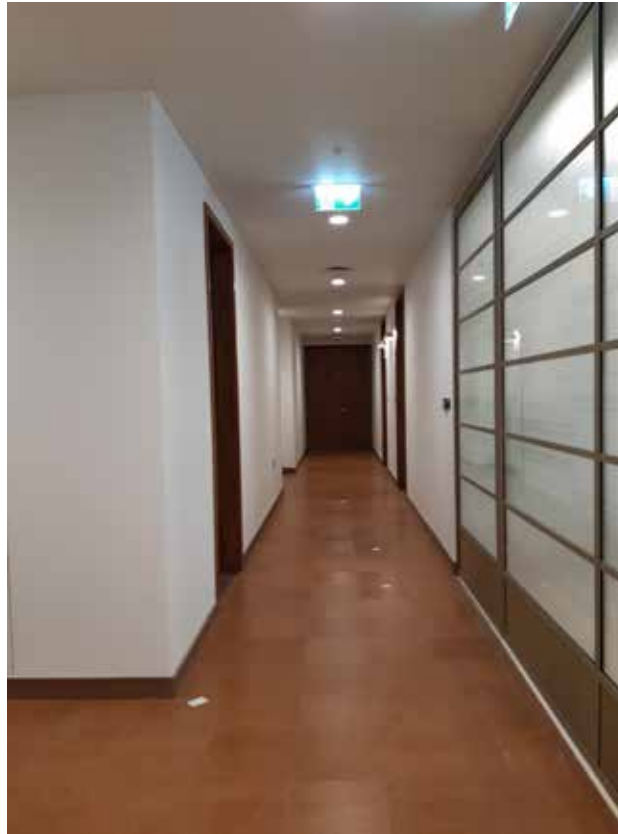
**110** F.28 Corridor [resaved as file corrupt]

**Room: F.28 Corridor [plate 110]**

**General Description:** Corridor which runs north-south in the east wing, now the main circulation route for hotel rooms. Historic photo plate 110A.

**Floor:** Historic cork.

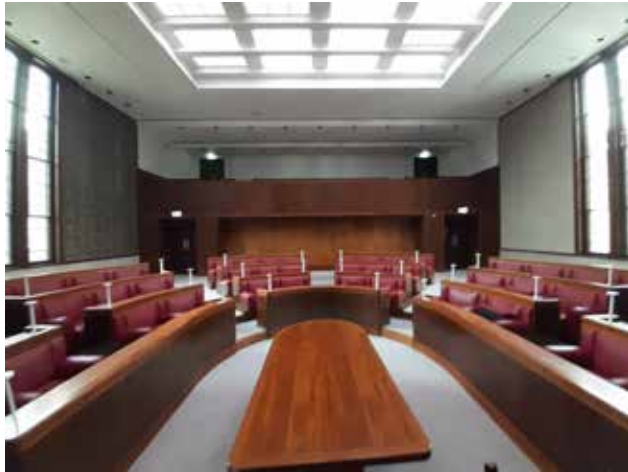
**112** F.33 Council Chamber looking north to Public Gallery

**General Description:** This is one of the principal spaces on this floor which housed the formal functions of the Council; it is arranged much like a court room with seating arranged in a horseshoe configuration and a gallery at second floor level, all facing the Mayor's rostrum. Materials are good quality but not extravagant.

**Ceiling:** Very large rooflight with stepped sections above public gallery and a sloped ceiling above the former Mayor's rostrum.

**Walls:** Panelled half-height in walnut, with decorative banding around framing the clock behind the Mayor's rostrum, and the upper half is plastered.. There is a narrow gallery at second floor level, set against the south wall. The walls beneath the gallery are faced in cork.

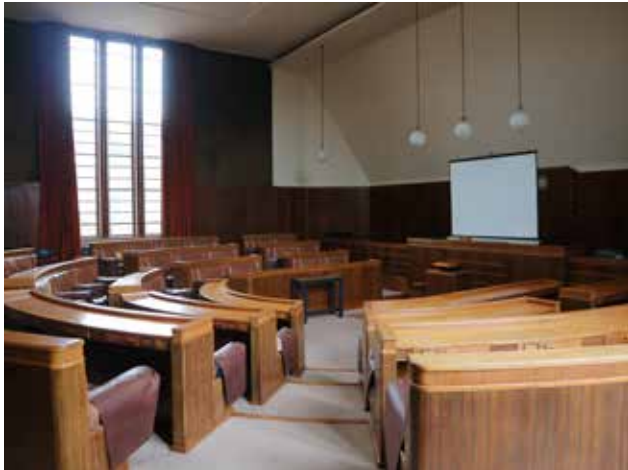
**112C** First Floor, former Council Chamber, F.33 (2017)

**Fittings:** Much of the original seating has been repaired and arranged in tiers, with integrated writing desks with drawers. The bench seats are Australian walnut and teak and upholstered with leather. Two mayoral and council member chairs behind the rostrum, others not present during site visit (could be stored elsewhere in the building). Semi-circular-ended table in the centre of the horseshoe is free-standing. See plate 112 C.

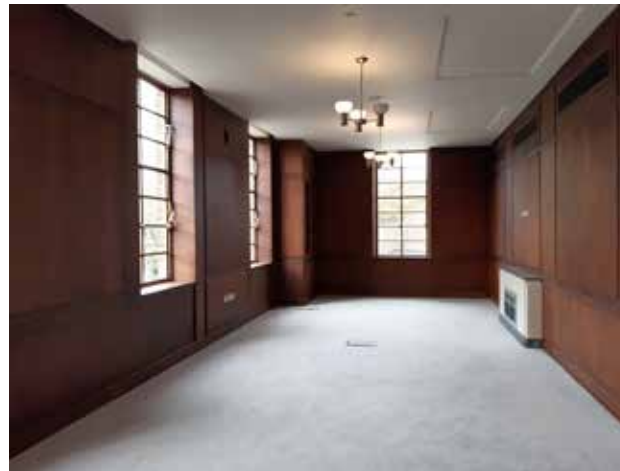
**115B** F.37 Member's Room looking north

**Ceiling:** Plastered ceiling - there is a cut back junction at window heads for curtains[**Plate 115B**].

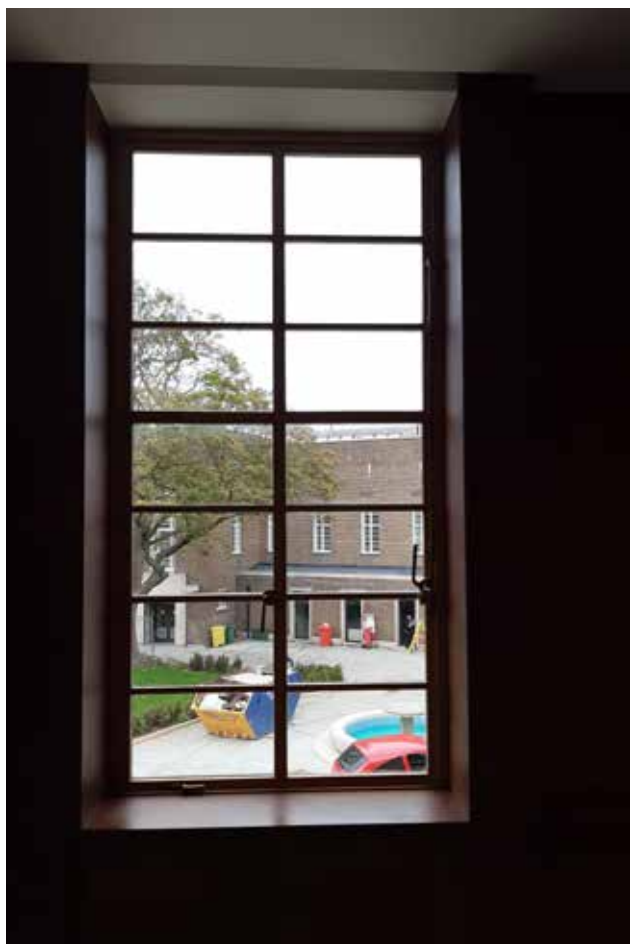
**115A** *F.37 Member's Room, typical window to room*

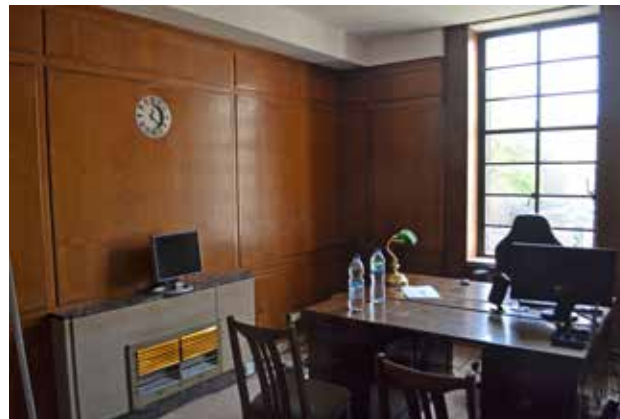
**117A** First Floor, former Lady Member's Room, F.39 (2017)

**Fittings:** Marble and stone radiant heater and clock [plate 117A].

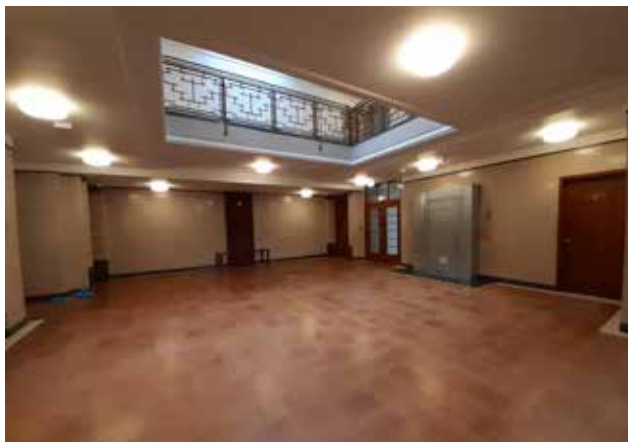
**General Description:** The first-floor landing is one of the most successful spaces in the building due to its use of refined materials and fine detailing. Light floods into the landing via a series of lightwells, which visually connect this formal space with the ancillary office spaces above. It is reached by ST.03: an elaborate Imperial staircase, which is framed by Ashburton marble columns, with Perrycot stone treads and Ashburton marble risers. The balustrades are bronze openwork, with bronze handrails.

**119B** F.44 First floor landing south lightwell, looking west to F.37 Members Room

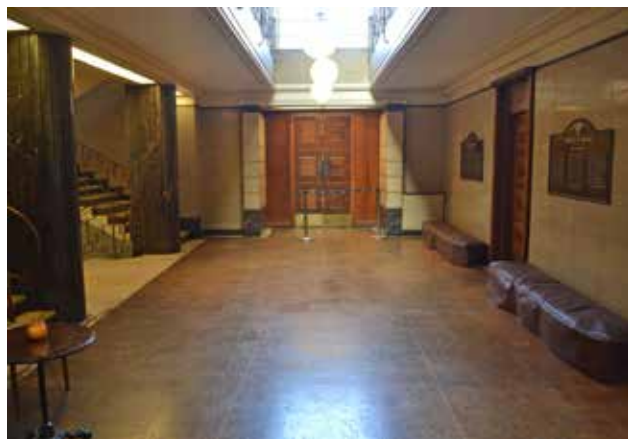
**119D** First Floor, landing, F.44 (2017)

**Fittings:** There is a range of original light fittings and switch plates **[plate 119C]**, including flush lighting panels beneath the stair and over doorways and squat domed ceiling lights. Two bronze plaques flank the door to the Mayor's Parlour; containing lists of past mayors **[plate 119D]**. There is a Second World War memorial at the centre of the south wall, from Hornsey County School (installed in the 1980s, covered during site visit). The lift is fronted by walnut doors and retains its lift car. There is a range of original furniture in this space, including the reception desk from the Entrance Hall, leather-covered benches and velvet-covered bucket seats, all of which were not inspected (covered during site visit).

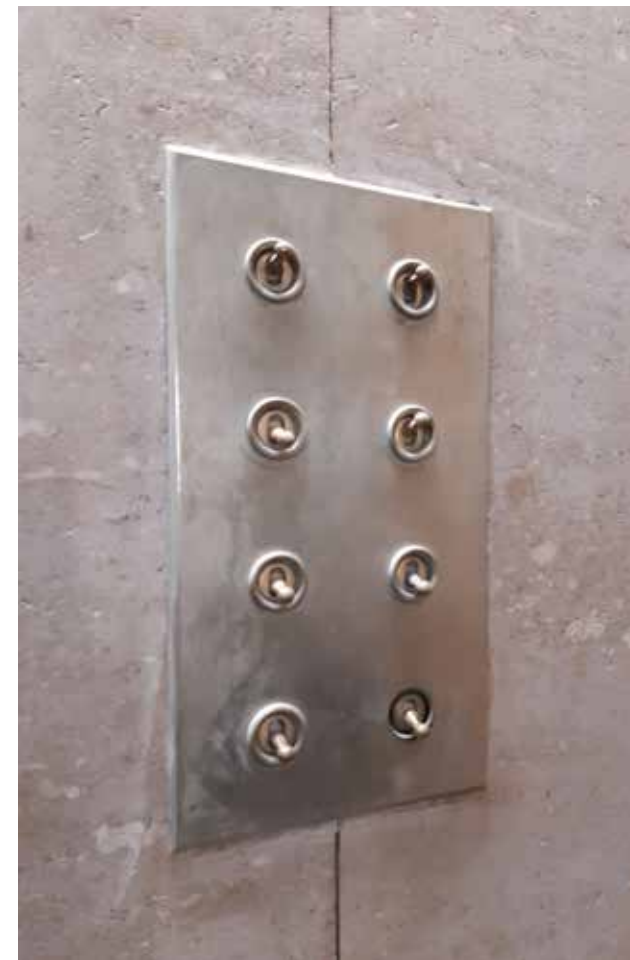
**119C** F.44 First floor landing fittings

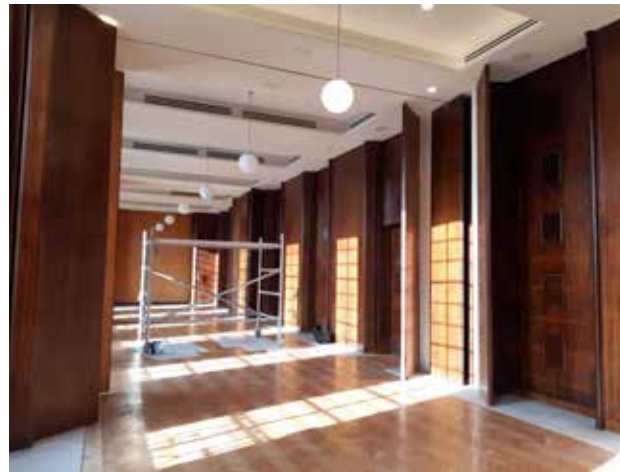
120 F.46 Committee Room, looking south

**General Description:** These grand rooms (formerly Committee Rooms) are set over the Foyer to the Assembly Hall; they are currently in use as a single room, though have the capacity to be broken down into three rooms by concertina doors, hidden within the full-height walnut panelling [plate 120B].

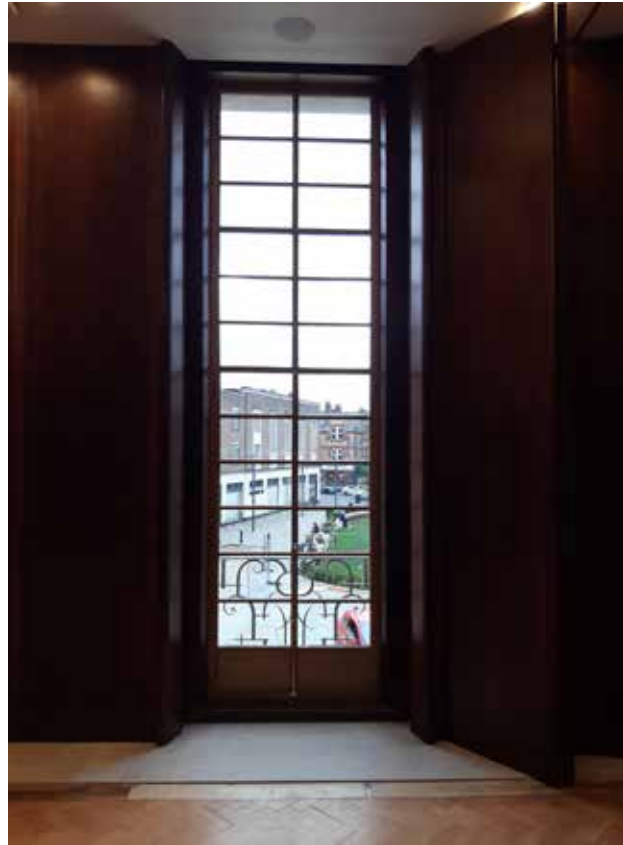
**Windows:** Seven tall bronze-framed casements with timber beading in the west wall [plate 120B].

**120B** F.46 Committee Room, typical tall glazing to west elevation

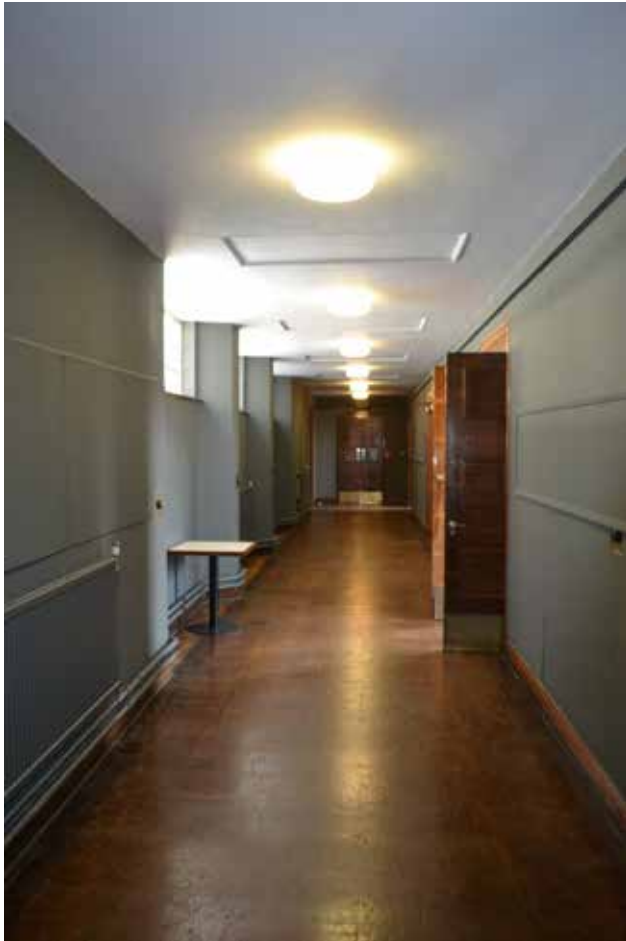
**121A** First Floor, Committee Room corridor, F.49 (2017)

**Doors:** The two sets of double doors into the Committee Room are panelled walnut (lettering: 'COMMITTEE ROOM' in the frieze of the architraves and original brass-coloured Britten door closers removed [see historic images, plates 121A and 121B]).

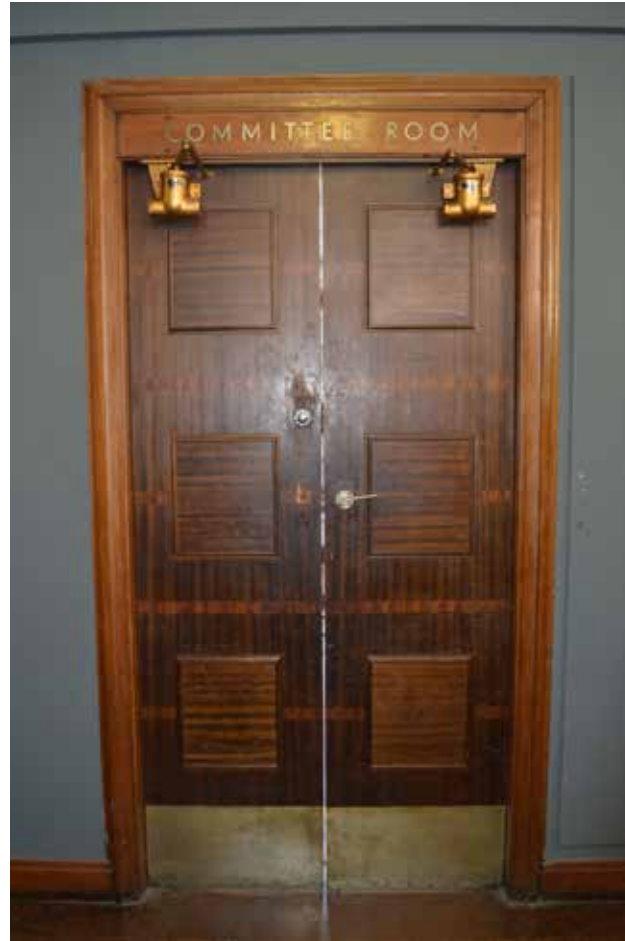
**121B** First Floor, Committee Room doors, F.49 (2017)

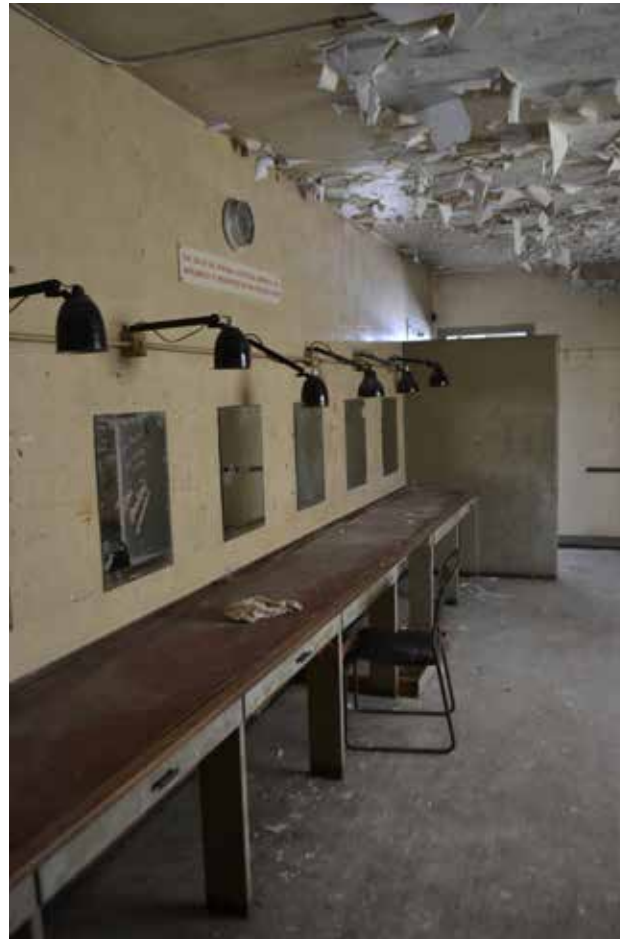
**123A** First Floor, former ladies' dressing room, F.51 (2017)

**Fittings:** Anglepoise task lights and globe ceiling pendants [plate 123A]; with some furniture being reassembled,

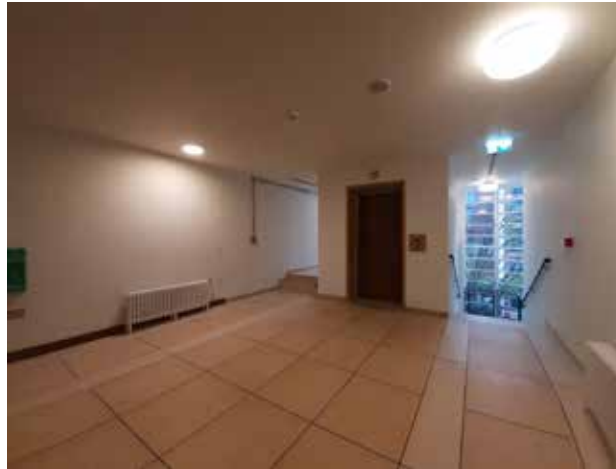
**134** S.11 Second floor landing (east stair) - 1

**General Description:** Second floor Landing; eastern lift and stair core.

**Floor:** Historic terrazzo with bitumen joints.

**Fittings:** Lifts with terrazzo surround and clock above.

**Room:** S.11 Second Floor Landing [plate 134 and 134A]

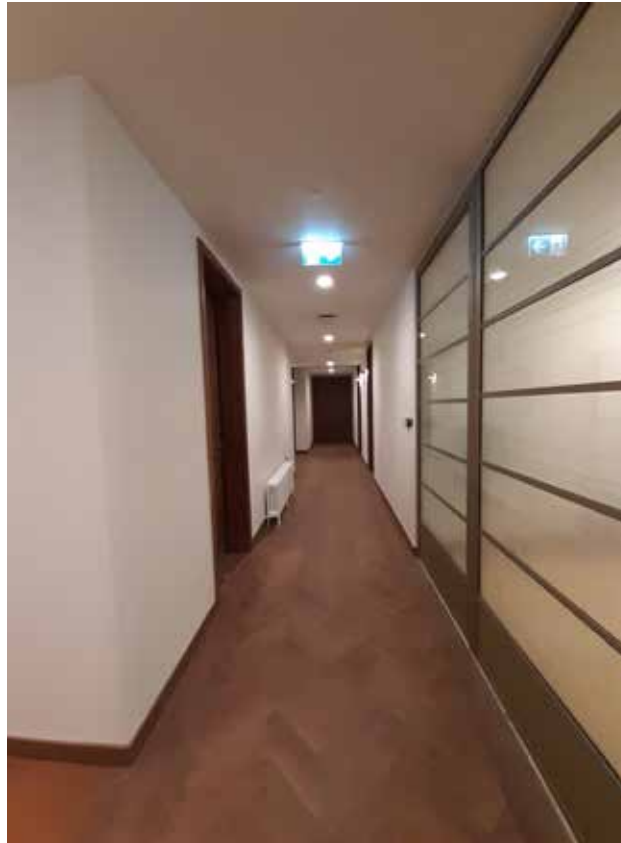
**137** S.16 Corridor looking south from second floor landing S.11

**General Description:** Corridor which runs north-south in the east wing, now the main circulation route for hotel rooms. Historic photo plate 137A.

**Floor:** Modern timber parquet.

**Room: S.16 Corridor [plate 137]**

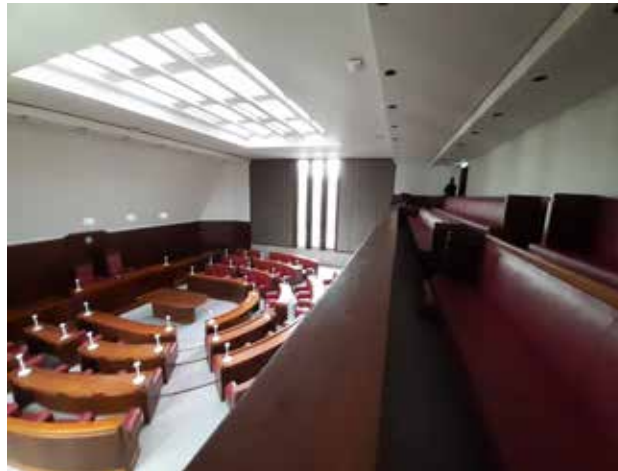
**141** S.32 Public gallery

**Floor:** New carpet.

**Fittings:** Refurbished Oak benches with new leather cushions [historic image, see plate 141A].

**Room: S.32 Public Gallery [plate 141]**

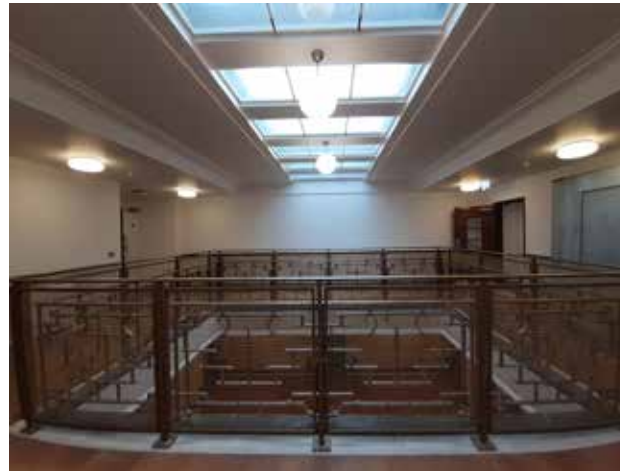
142 S.32 Open lightwell looking south

**Staircase:** Balustrades over Stair No.3 and lightwell opening have had a secondary taller balustrade of mesh screen, uprights and flat horizontal bar added for safety.

**Room:** S.32 Open Well (southern) [plate 142]

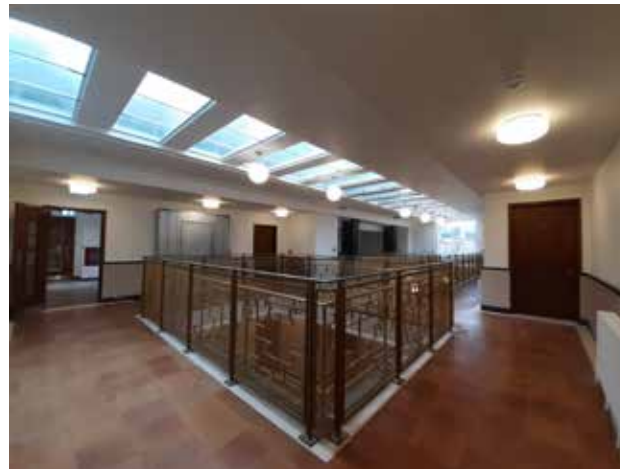
142A S.33 Second floor landing with S.32 in foreground and S.34 in background

**General Description:** Second floor landing at west wing (admin block). This is an attractive space lit from above by large rooflights and linking visually with the first-floor landing below via oblong lightwells. See historic image, plate 142B.

**Fittings:** Squat domed ceiling lights and globe pendants [plate 142A & B].

**S.33 Second Floor Landing** [plate 142A]

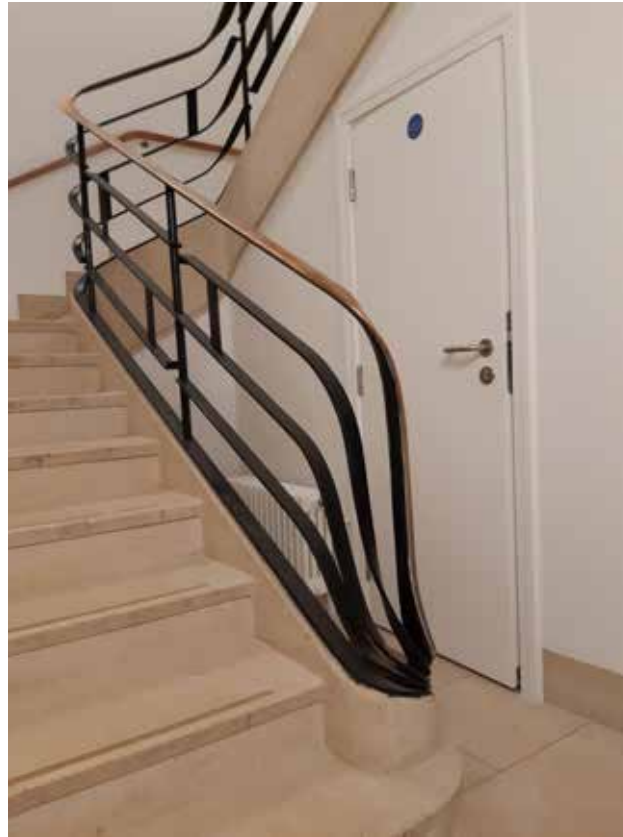
**150D** ST.02 balustrade detail

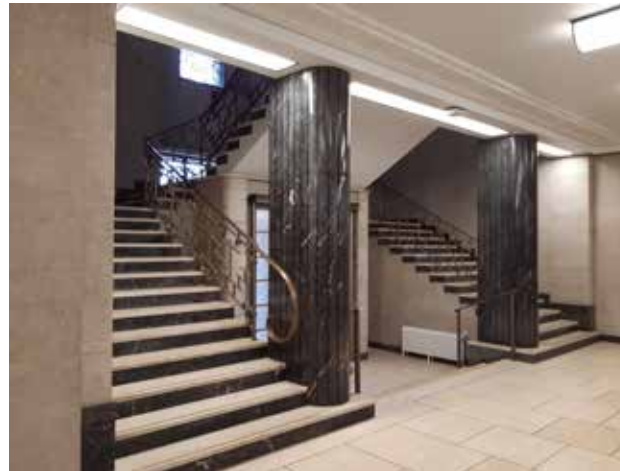
**151** ST.03 ground floor

**General Description:** This is the main stair in Administration Block; and it forms a fundamental element of the Entrance Hall. It is a spectacular Imperial staircase leading from ground to second floor. It is framed by columns clad in fluted Ashburton marble. The treads are Perrycot stone and the risers again Ashburton marble. The balustrades are bronze openwork, with bronze handrails. The half-landing between ground and first is lit by a tall bronze-framed window fronted by an iron openwork screen, which contains the same stylised animals found in the administrative entrance gates.

**Floor:** Historic precast terrazzo treads, tiles at landings and risers and stepped skirtings.

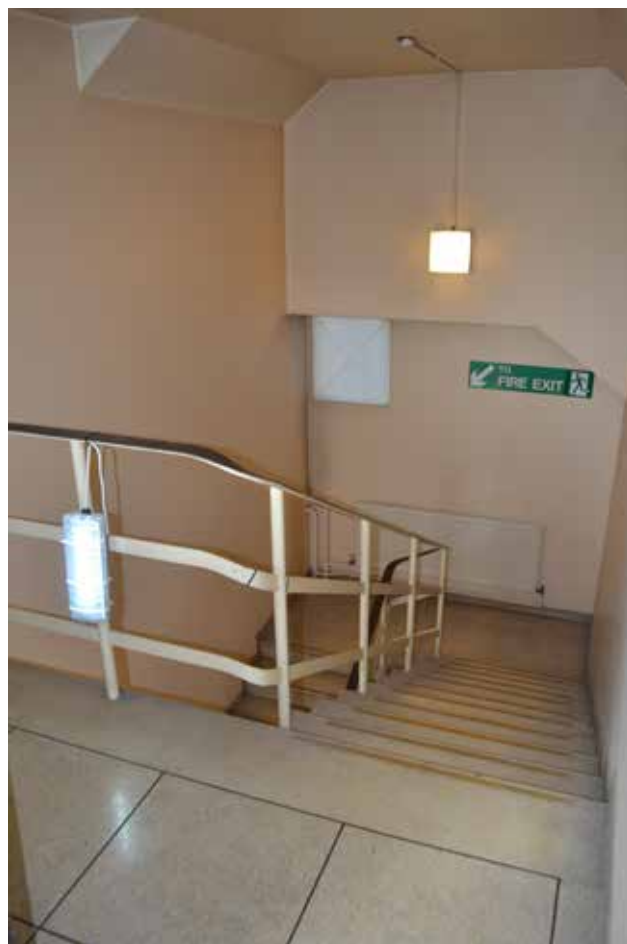
**152B** Second Floor, ST.04 (2017)

**Handrail & balusters:** Tubular steel handrail and balusters linked by flat rails between ground and second floor [plate 152B].

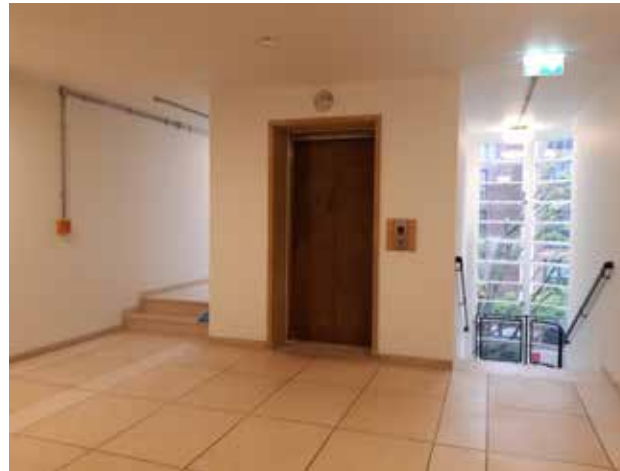
**154** ST.06 second floor

**General Description:** This is the main stair in east office wing, which served the offices. It wraps around Lift No.1. Steel railings also front the original curved windows, which are the most striking element of the stairwell [plate 154C].

**Handrail & balusters:** Painted steel handrails are supported on brass wall brackets.

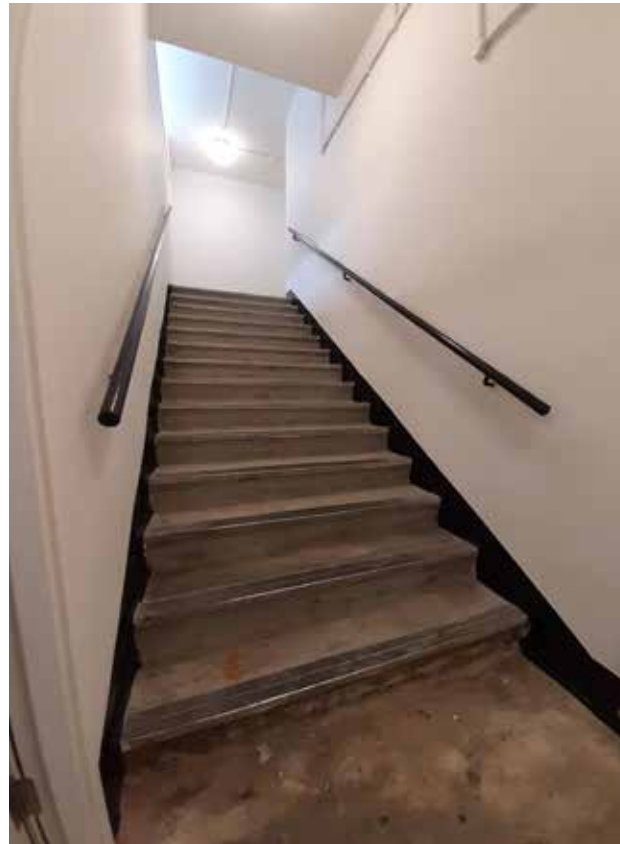
**157** ST.10 basement to ground

**General Description:** This is a utilitarian escape stair located at the southern end of the Assembly Hall and runs from the basement to ground floor only.

**Handrail & balusters:** Tubular metal handrail, painted black.
