**SITE INVESTIGATION REPORT**

**MALLINSON SPORTS CENTRE, HIGHGATE SCHOOL  
BISHOPSWOOD ROAD, LONDON N6 4PH**

**SCL Report ref:** **9916/JRCB/OT**

**Date:** **22<sup>nd</sup> February 2016**

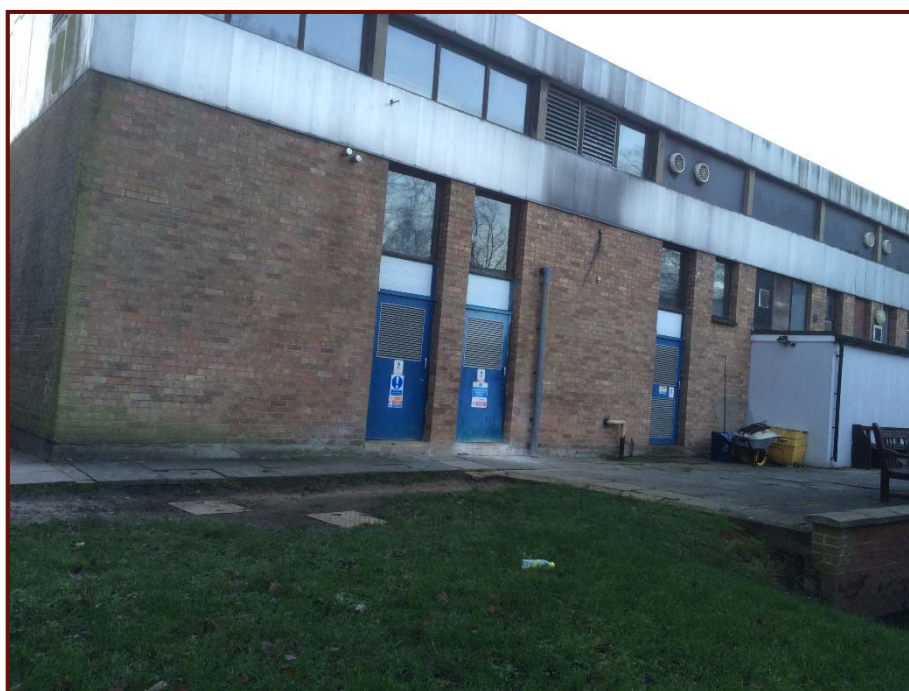
**Swimming pool building showing plant rooms (looking S)**

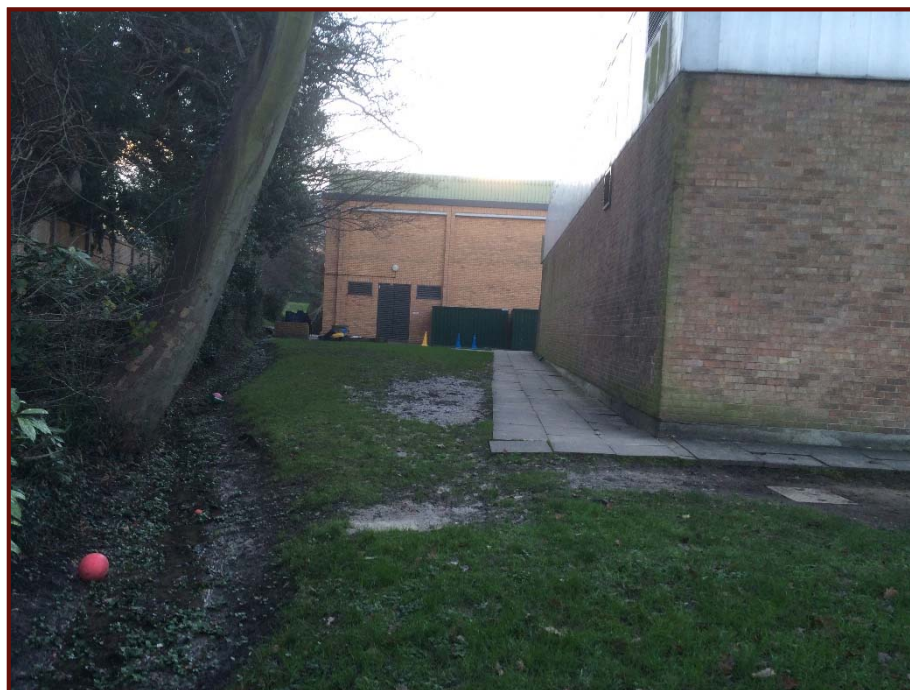
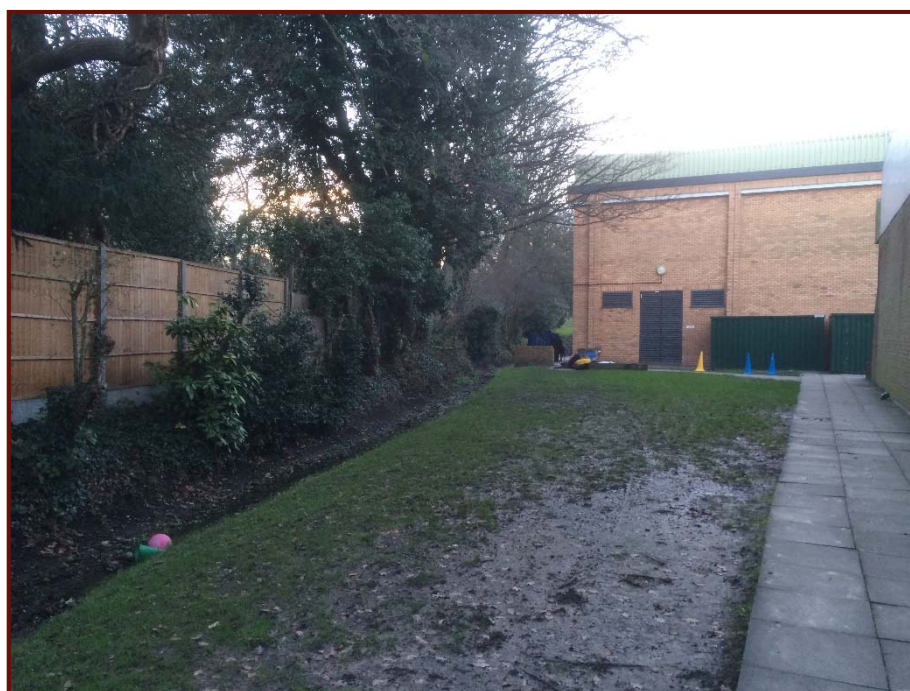
**Shallow tree-lined drainage ditch to NE of swimming pool (looking SE)**
