**REPORT ON SUPPLEMENTARY GROUND INVESTIGATION**

**MALLINSON SPORTS CENTRE, HIGHGATE SCHOOL  
BISHOPSWOOD ROAD, LONDON N6 4PH**

**SCL Report ref:** **9916A / MR / JRCB**

**Date:** **6<sup>th</sup> February 2019**

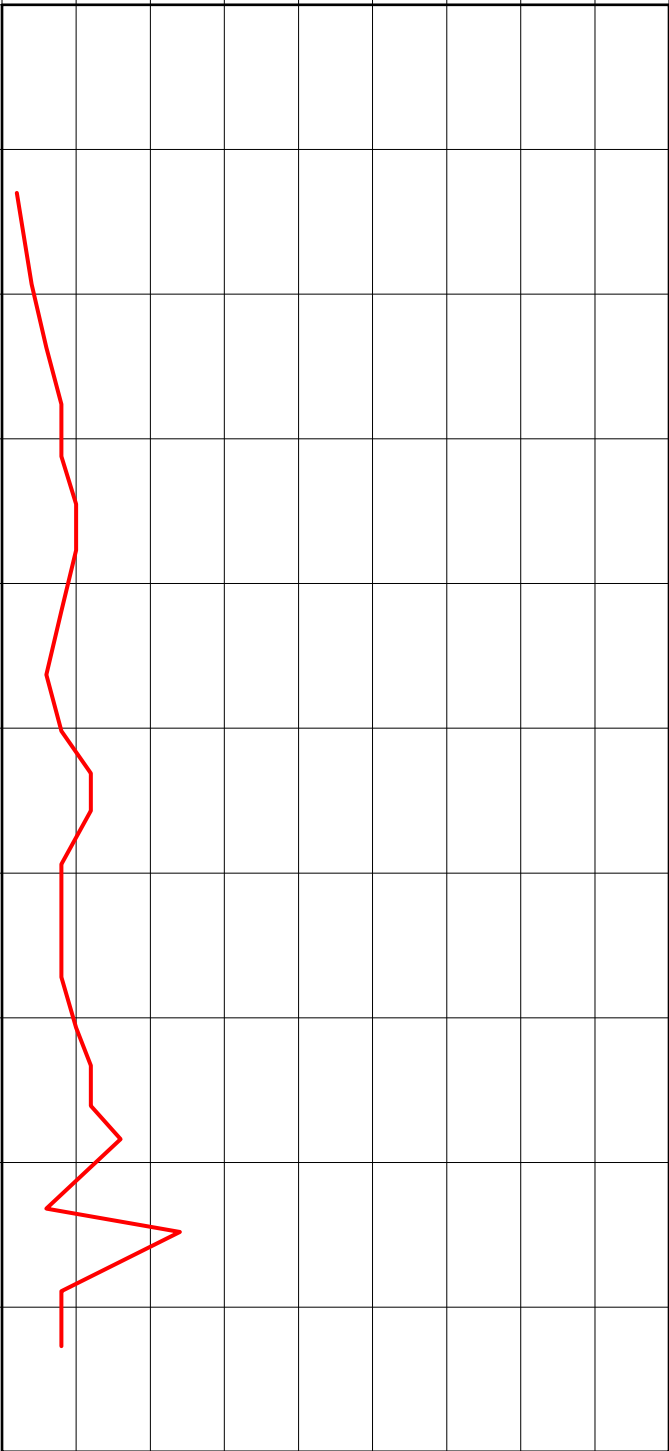
| Blow Count | Depth (mm) | mm per blow | CBR (%) | PLOT OF CBR VS DEPTH | | |

Three in-situ CBR tests were carried out using the TRL Dynamic Cone Penetrometer (DCP). Bulk samples were also retrieved at the same locations for laboratory remoulded CBR tests.

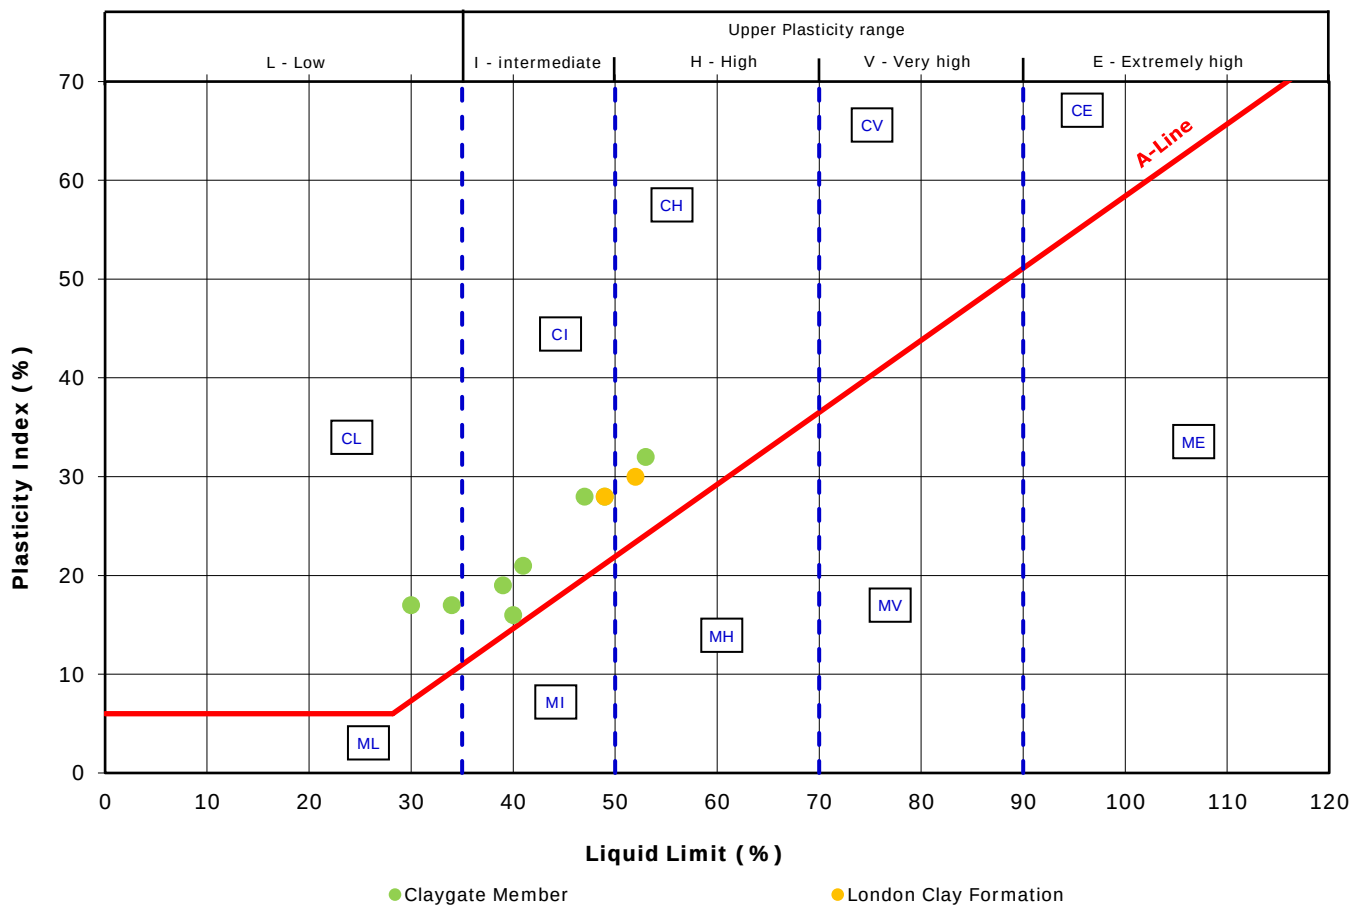
### Plasticity Chart

M - SILT [plots below the A-Line]

C - CLAY [plots above the A-Line]

Classification in accordance with BS5930:2015 "Code of practice for site investigations"

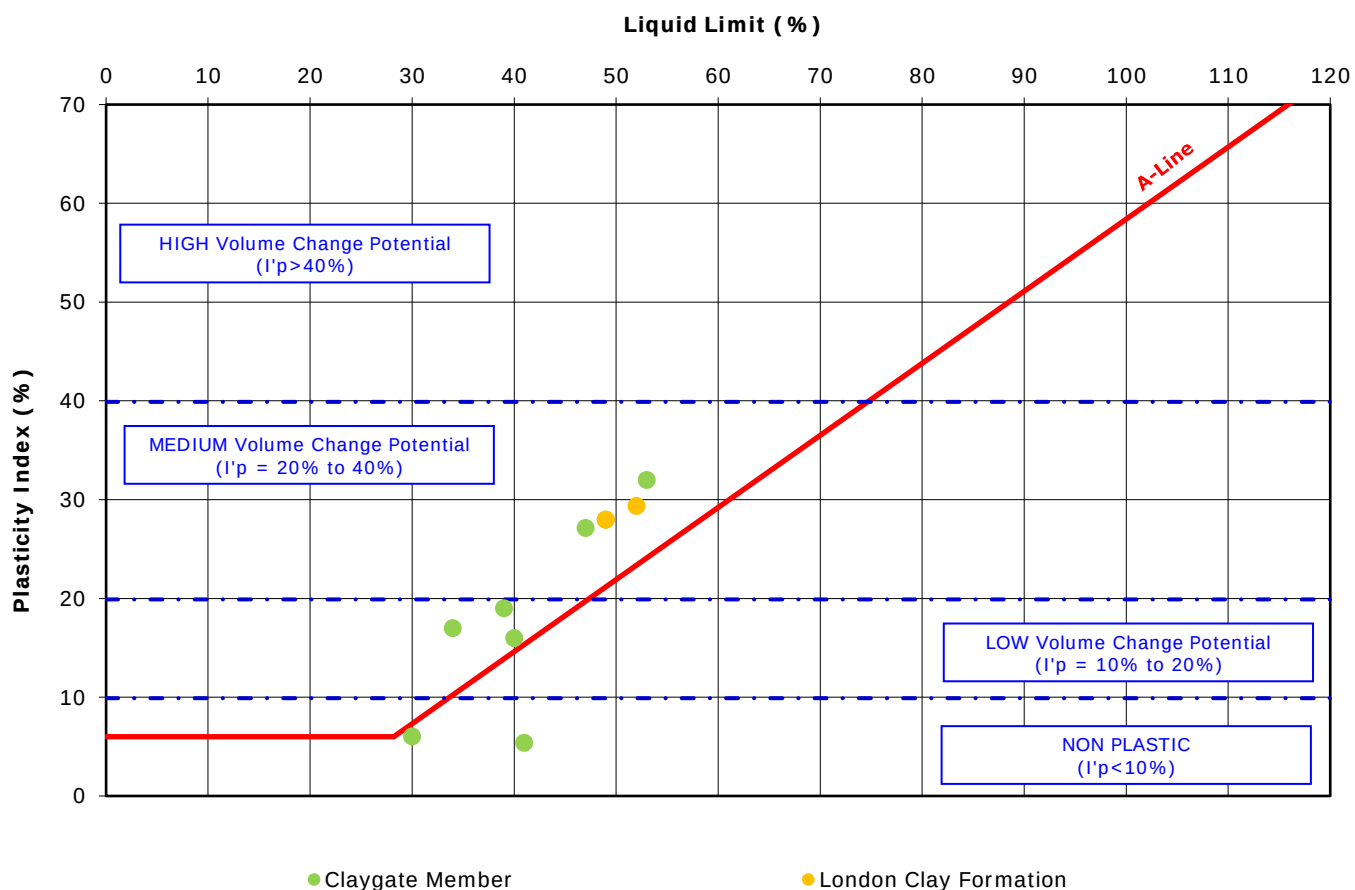
### Plasticity Chart

Modified Plasticity Index, I<sub>p</sub>:

$$I_p = \frac{I_p \times (\% \text{ passing } 425\text{mm})}{100\%} \quad (\text{where } I_p = \text{Plasticity Index})$$

Classification in accordance with NHBC Standards, Part 4 'Foundations', Chapter 4.2 'Building near trees'

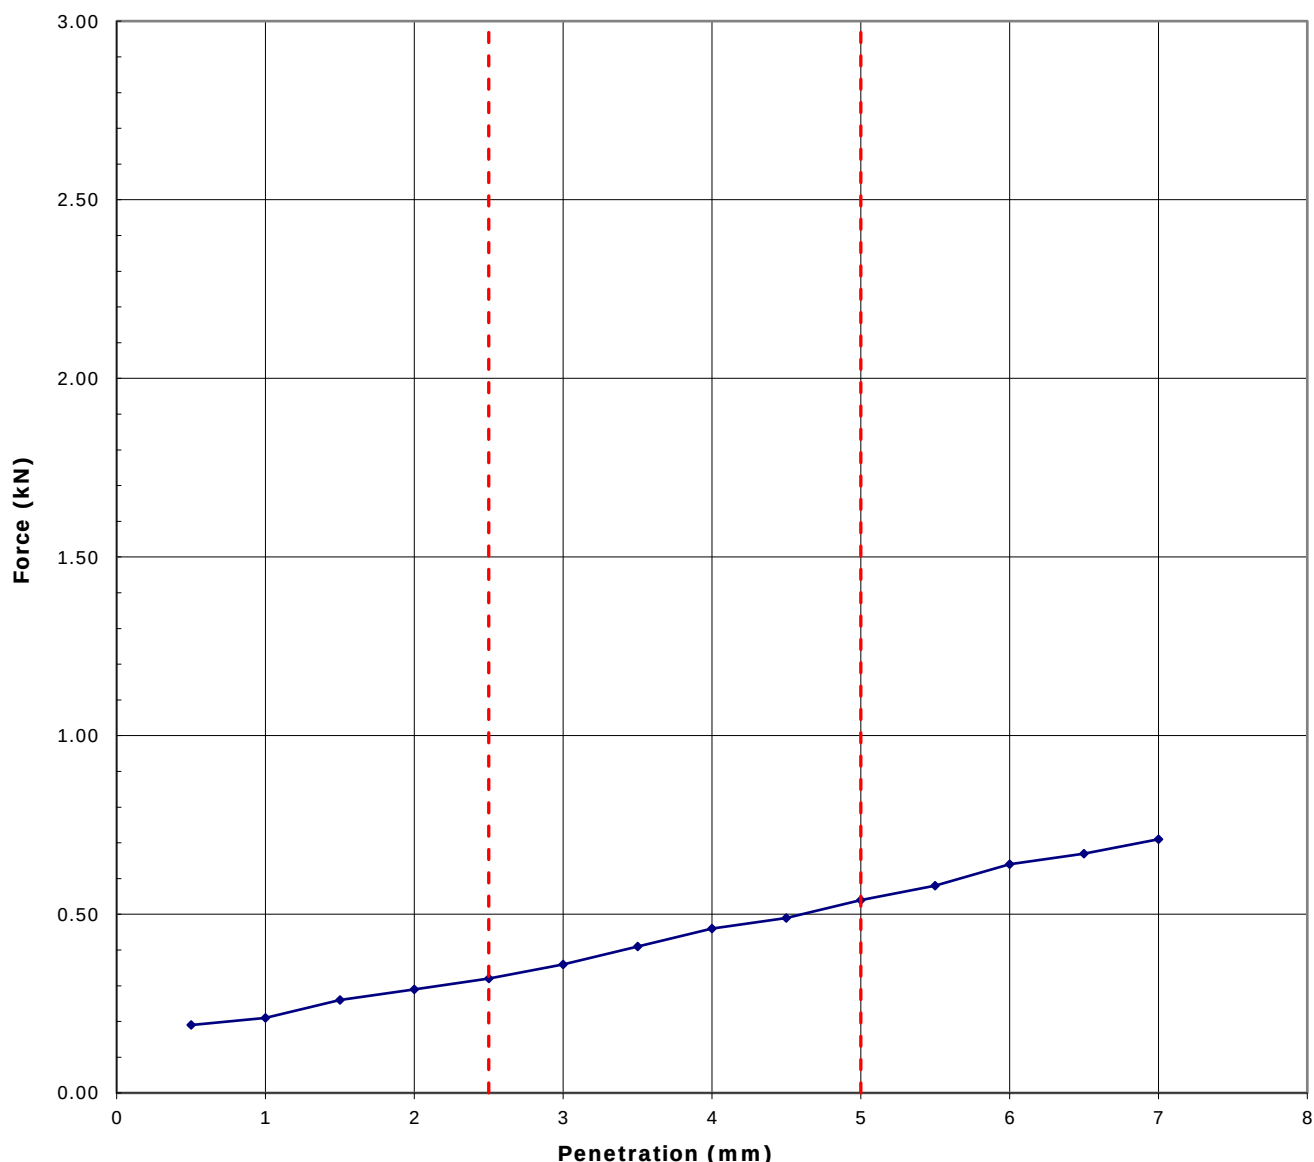
**Determination of California Bearing Ratio**  
**(In accordance with: BS1377:1990, Part 4, Clause 7)**

| Location ID: | <b>CBR1 (Top)</b> | Stratum at test depth: | MADE GROUND: dark brown / black silty very clayey topsoil with occasional gravel. Gravel is fine to coarse subangular brick and masonry. Occasional live roots. |
| Depth: | 0.50m | | |
| Moisture content: | 24.3% | | |

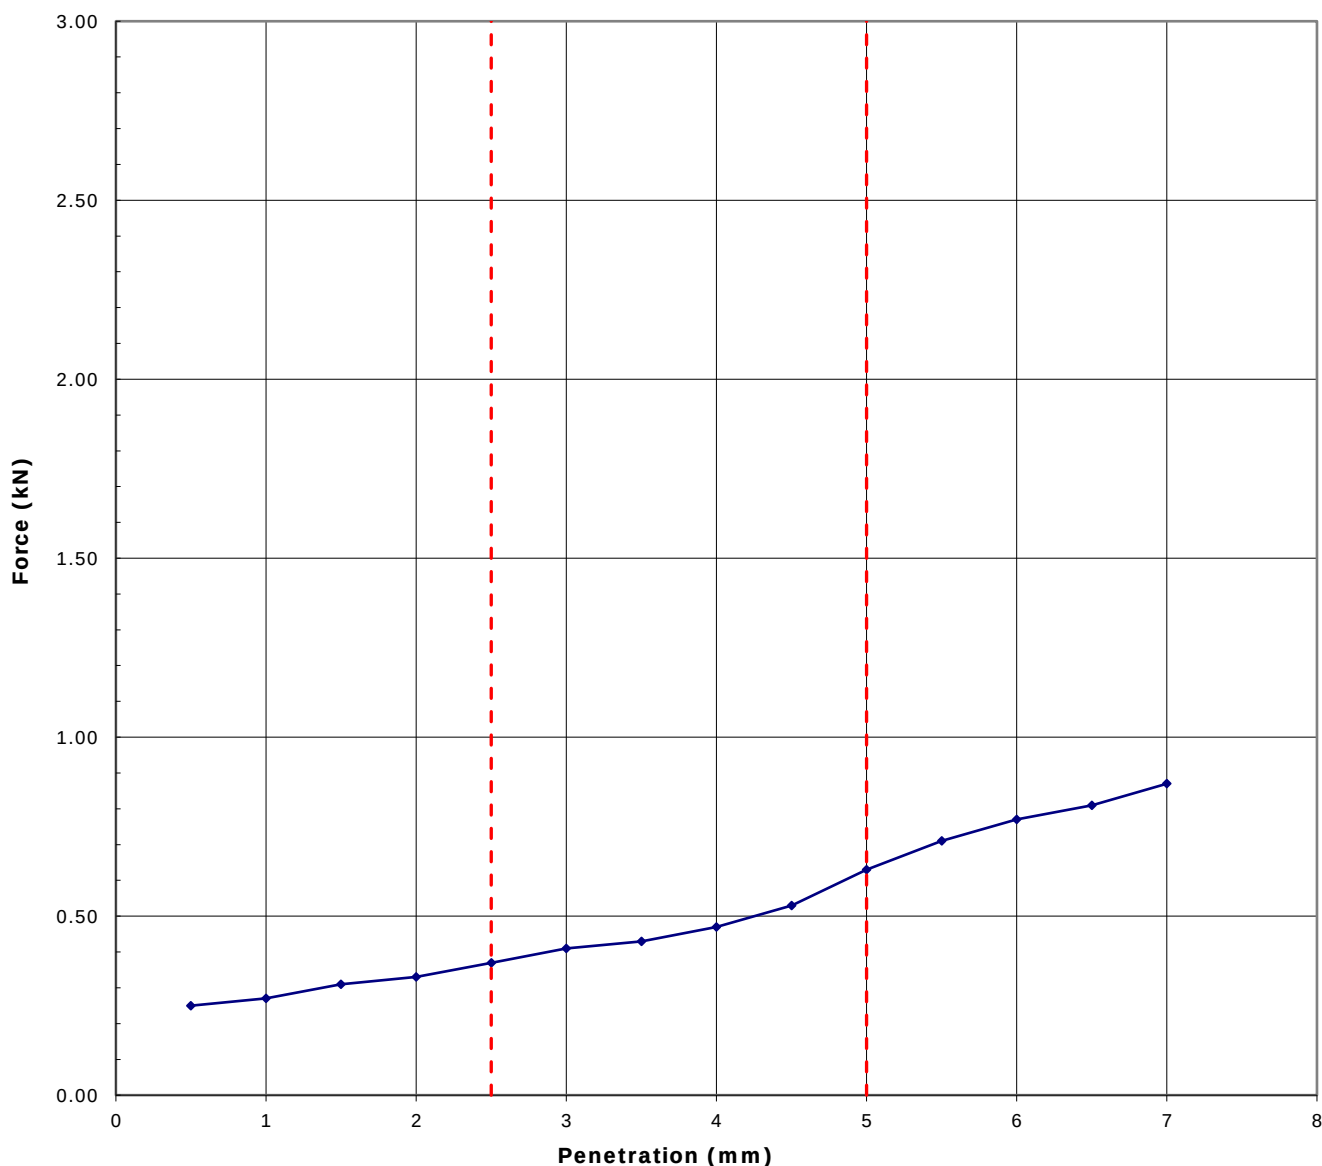
**Determination of California Bearing Ratio**  
**(In accordance with: BS1377:1990, Part 4, Clause 7)**

| Location ID: | <b>CBR1 (Base)</b> | Stratum at test depth: | MADE GROUND: dark brown / black silty very clayey topsoil with occasional gravel. Gravel is fine to coarse subangular brick, flint and masonry. Occasional live roots. |
| Depth: | 0.50m | | |
| Moisture content: | 22.7% | | |

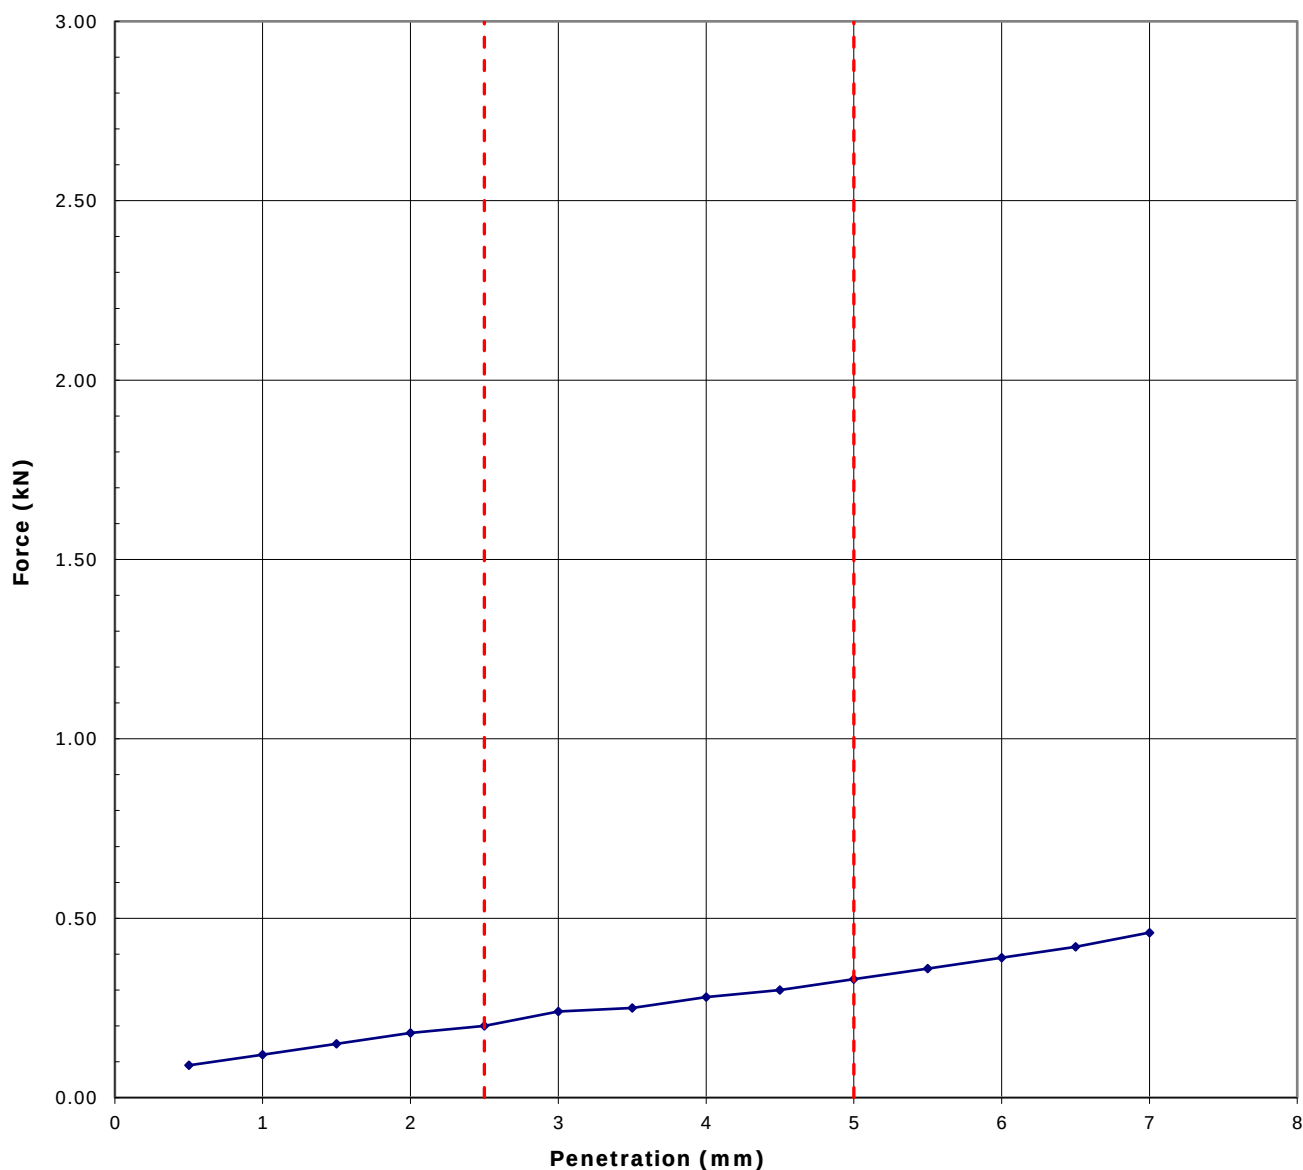
**Determination of California Bearing Ratio**  
(In accordance with: BS1377:1990, Part 4, Clause 7)

| Location ID: | <b>CBR2 (Top)</b> | Stratum at test depth: <b>MADE GROUND: dark brown slightly sandy clayey silty topsoil with occasional gravel. Gravel is fine to coarse subangular brick and flint. Rare live roots.</b> |
| Depth: | 0.50m | |
| Moisture content: | 28.4% | |

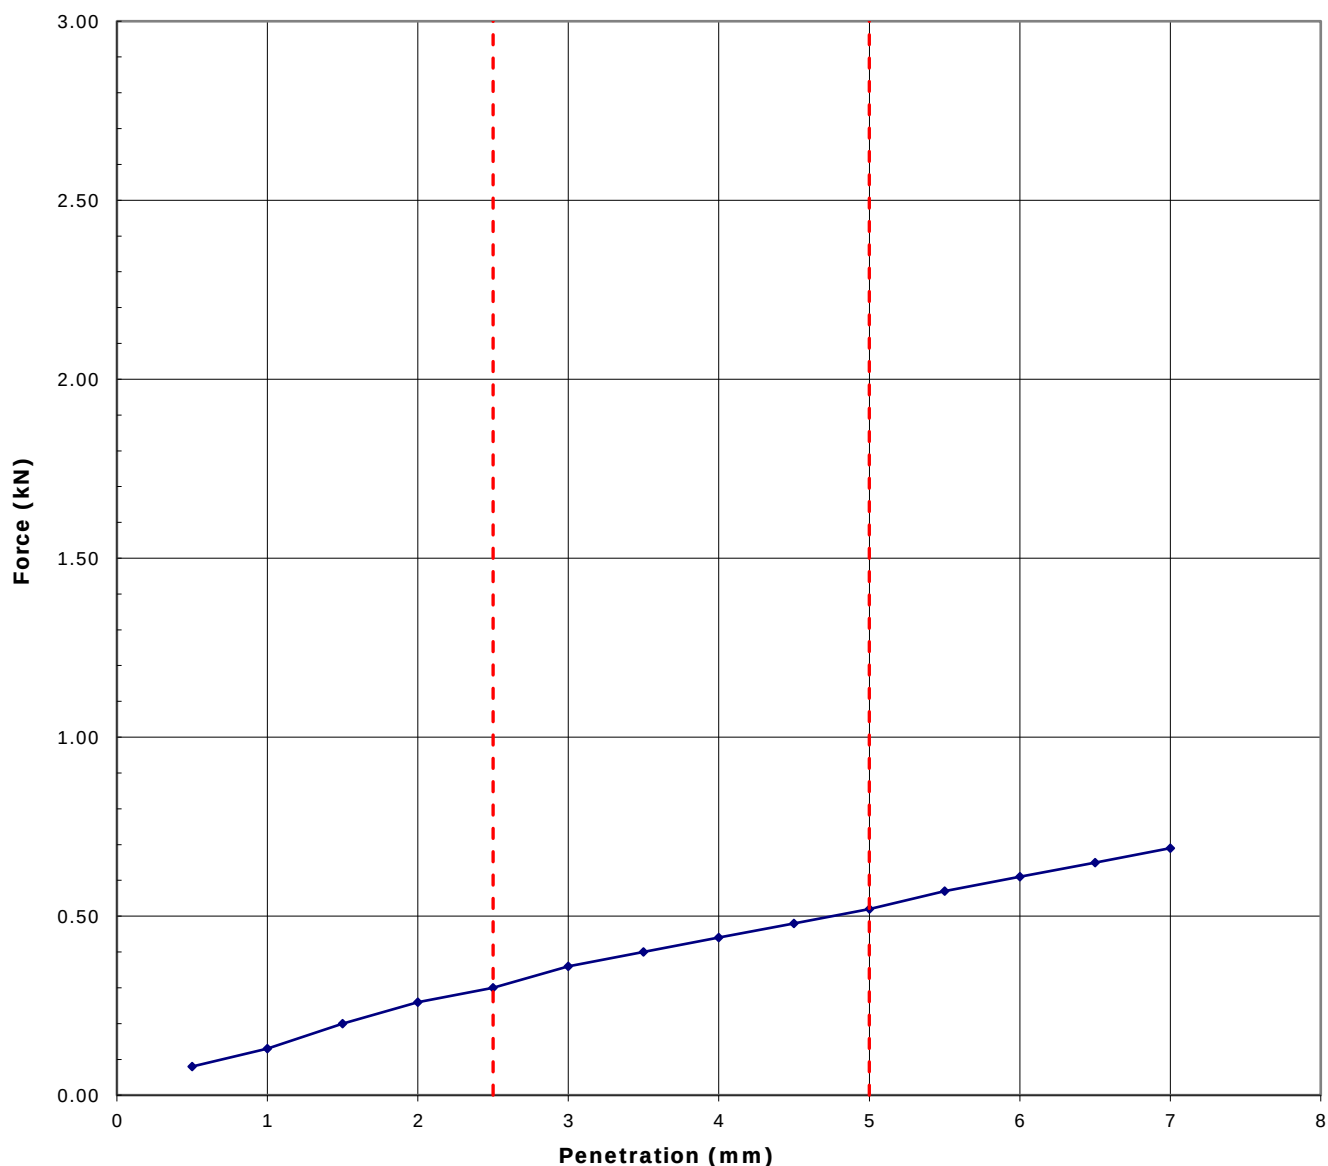
**Determination of California Bearing Ratio  
(In accordance with: BS1377:1990, Part 4, Clause 7)**

| Location ID: | <b>CBR2 (Base)</b> | Stratum at test depth: | MADE GROUND: dark brown slightly sandy clayey silty topsoil with occasional gravel. Gravel is fine to coarse subangular brick and flint. Rare live roots. |
| Depth: | 0.50m | | |
| Moisture content: | 27.6% | | |

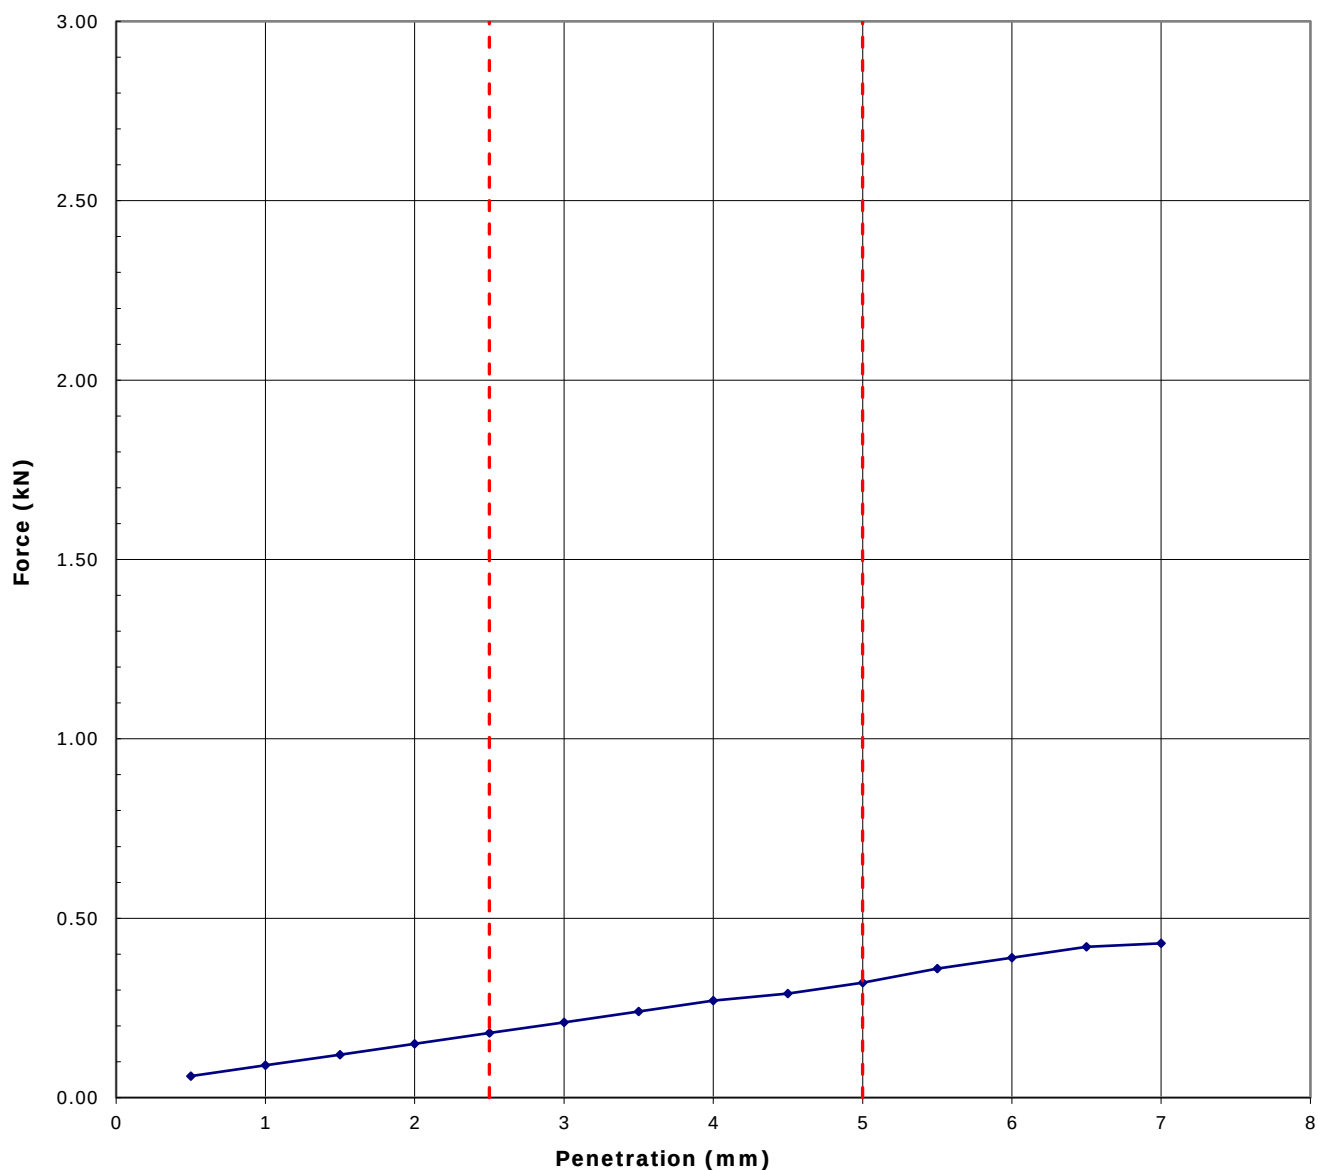
**Determination of California Bearing Ratio  
(In accordance with: BS1377:1990, Part 4, Clause 7)**

| Location ID: | <b>CBR3 (Top)</b> | Stratum at test depth: <b>MADE GROUND: dark brown / black slightly clayey silty sandy topsoil with occasional gravel. Gravel is fine to coarse subangular brick and masonry. Occasional live roots.</b> |
| Depth: | 0.50m | |
| Moisture content: | 28.8% | |

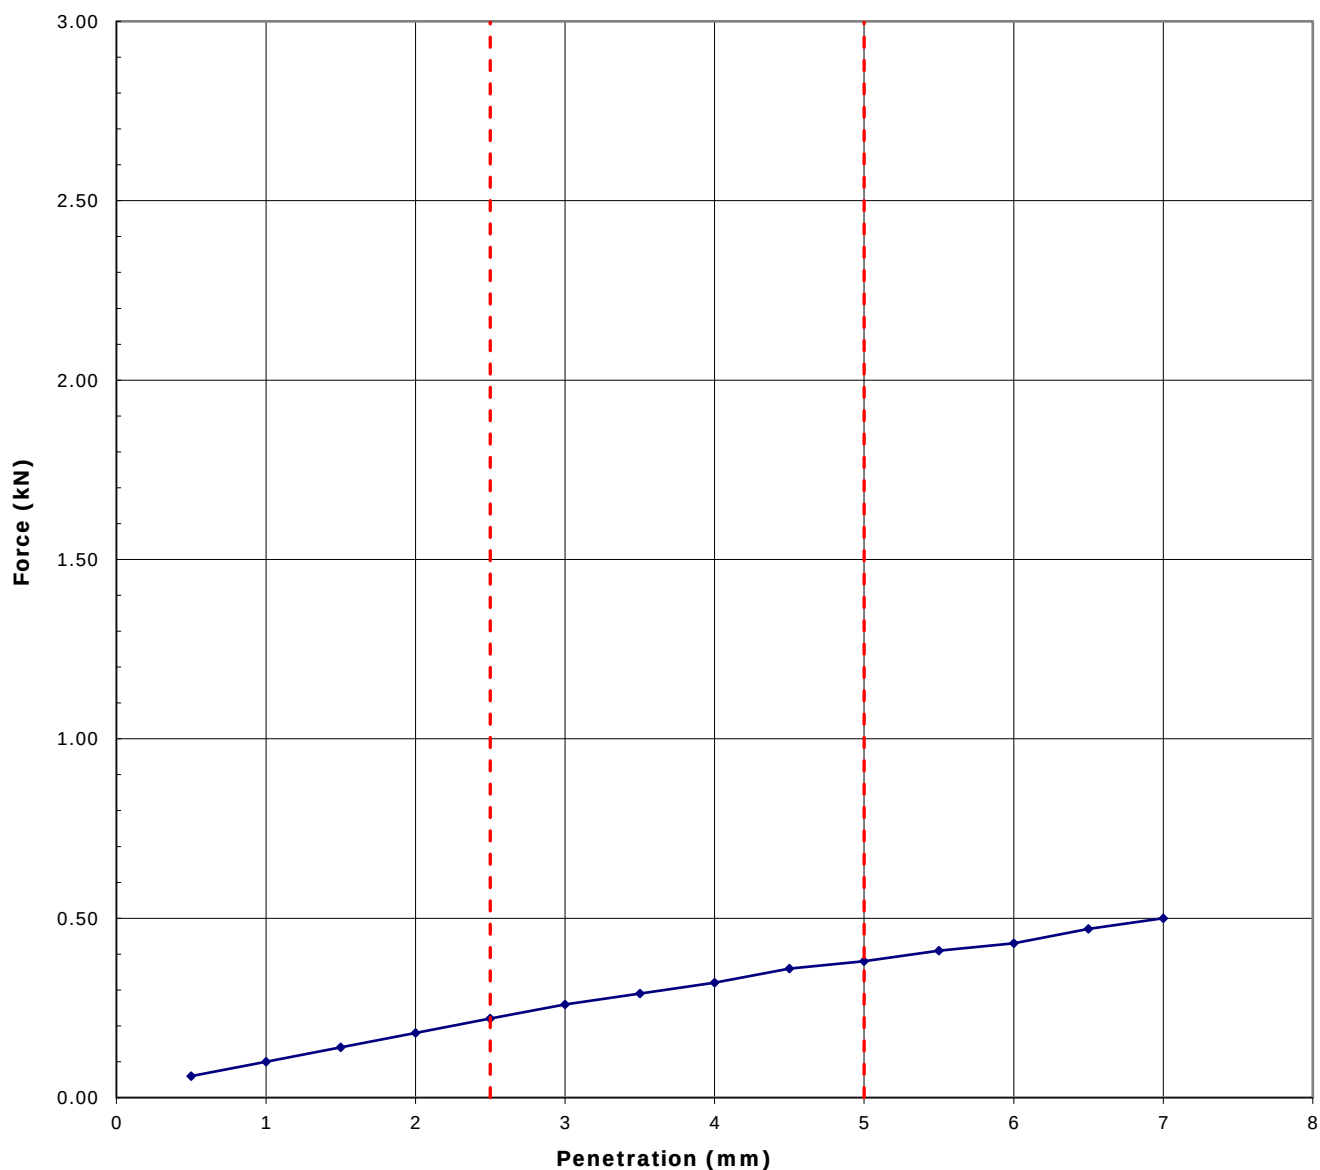
**Determination of California Bearing Ratio  
(In accordance with: BS1377:1990, Part 4, Clause 7)**

| Location ID: | <b>CBR3 (Base)</b> | Stratum at test depth: | MADE GROUND: dark brown / black slightly clayey silty sandy topsoil with occasional gravel. Gravel is fine to coarse subangular brick and masonry. Occasional live roots. |
| Depth: | 0.50m | | |
| Moisture content: | 29.0% | | |

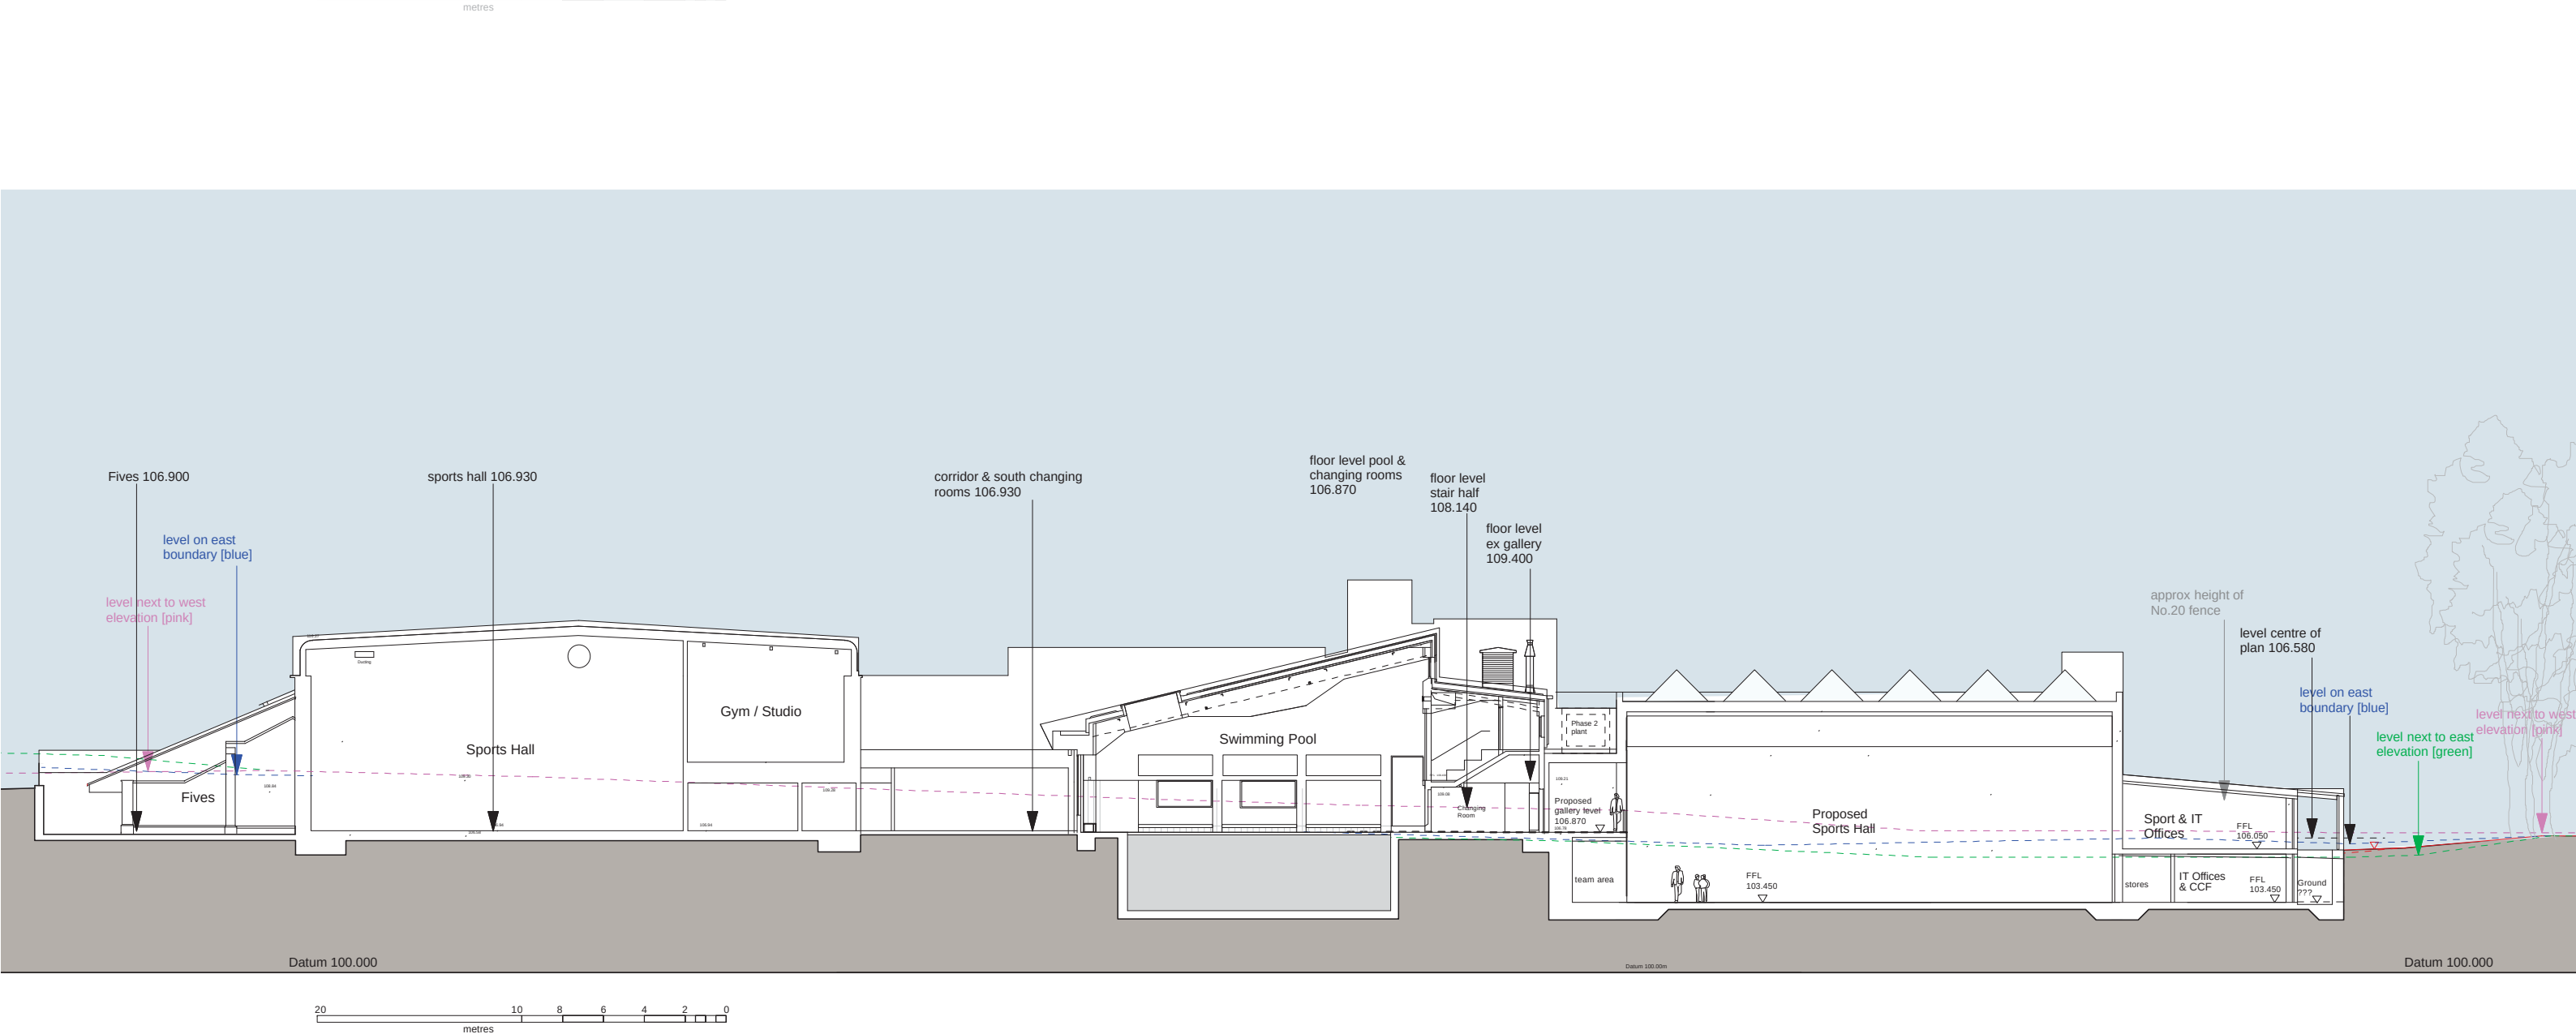
MSC Development with North extension north-south section / part elevation  
[combined section/elevation for design development only]

Proposed section (Ed Toovey architects, Drawing No: 1182/GS/01, Aug 2018)
-
