**FACTUAL REPORT ON GROUND PRELIMINARY INVESTIGATION**

**MALLINSON SPORTS CENTRE PHASE 2**

**HIGHGATE SCHOOL, BISHOPSWOOD ROAD, LONDON N6 4NY**

**Report ref:** **10930/OS**

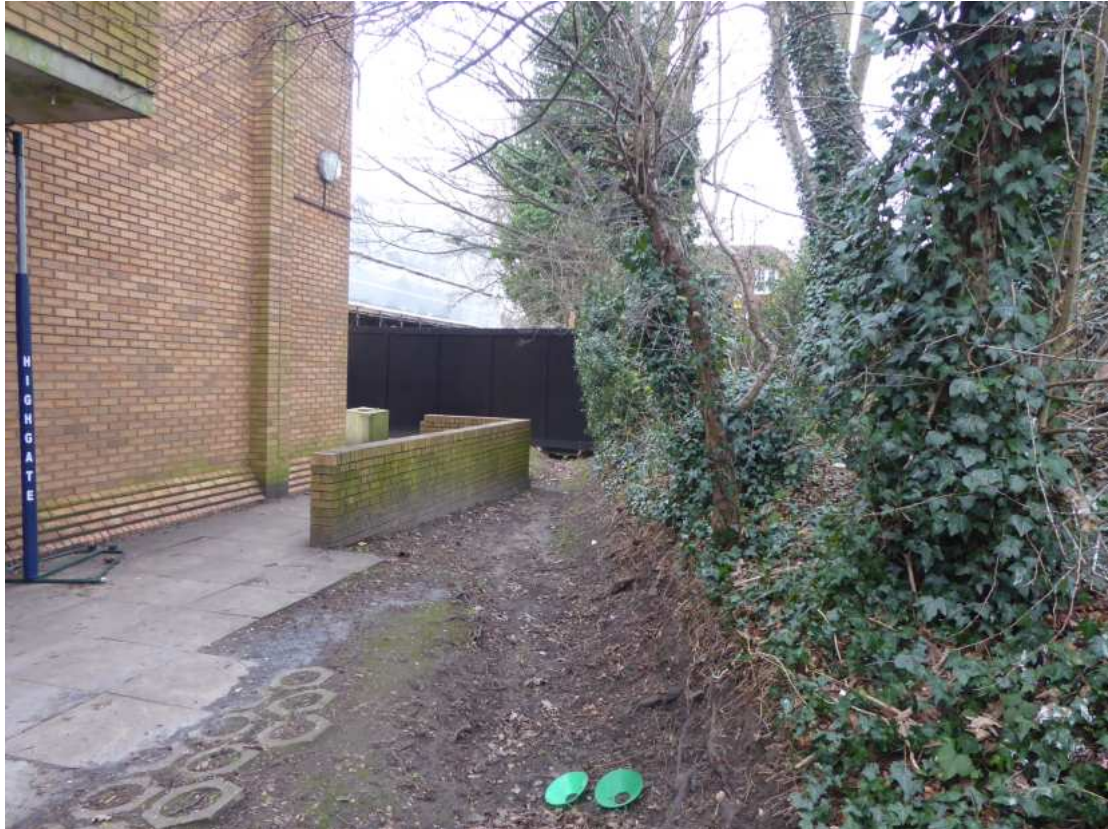
**Figure 2.4: Existing ditch to the rear of the existing Mallinson Sports Centre requiring clearance and improvement.**

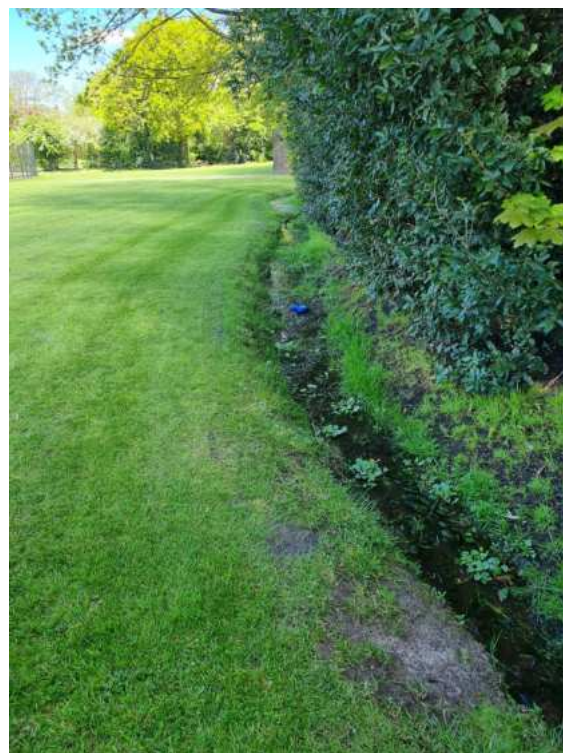
**Figure 2.5: Existing swale to the east of the sports pitches requiring clearance and improvements to increase capacity.**

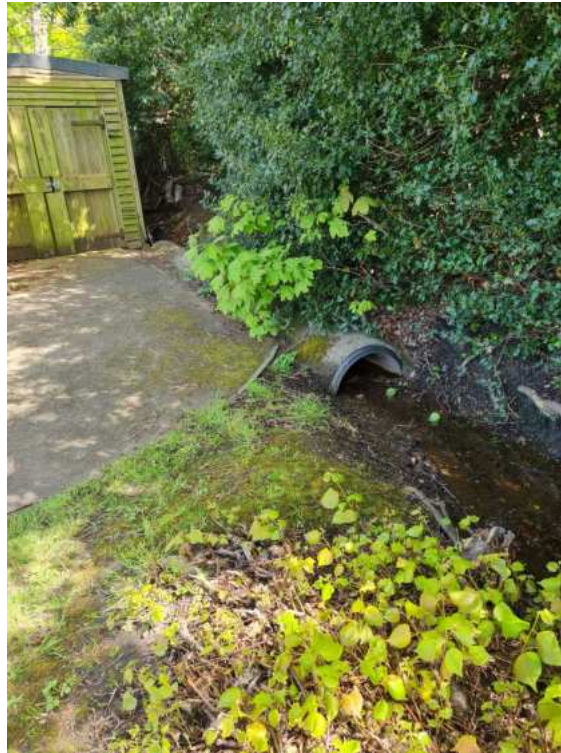
**Figure 2.6: Existing culvert to the rear of the rifle range requiring jetting.**

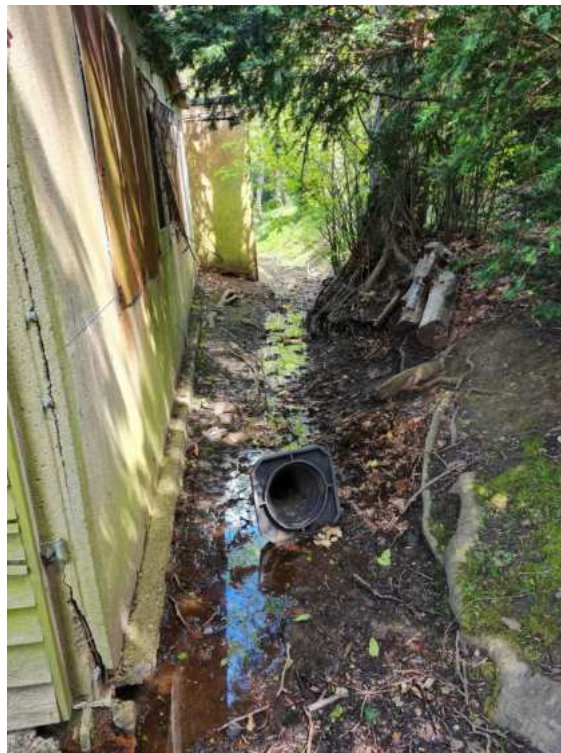
**Figure 2.7: Existing ditch to the rear of the rifle range requiring clearance and improvements to increase capacity.**

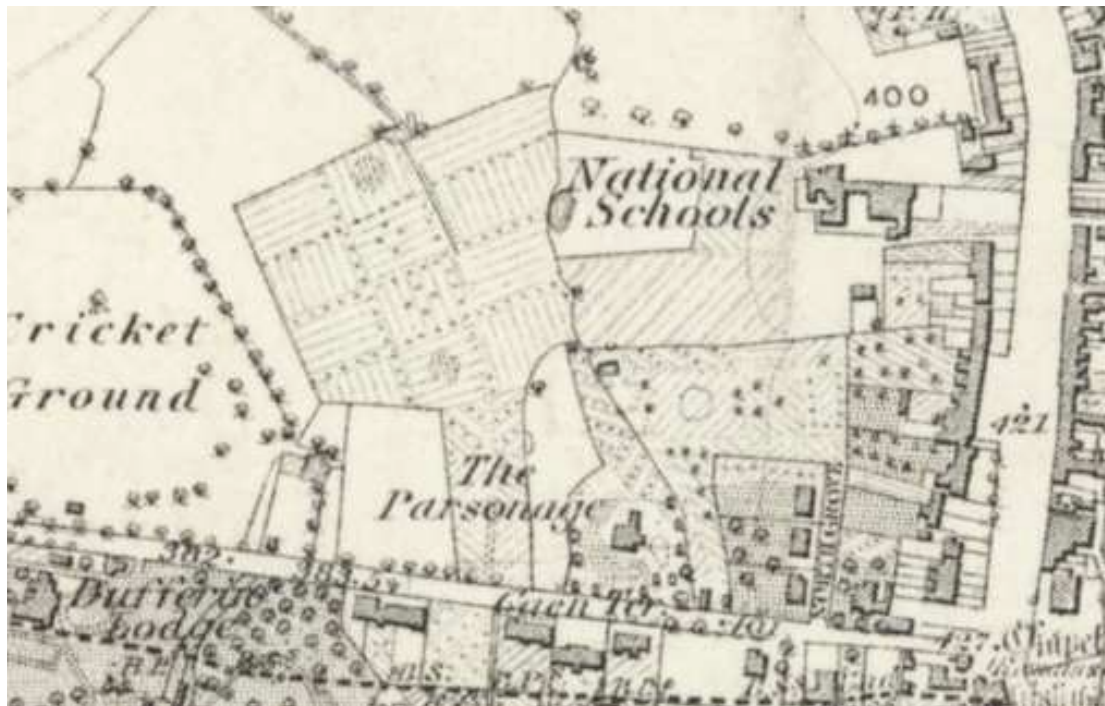
Figure 4.2: 1873 Ordnance Survey mapping (reproduced with the permission of the national library of Scotland)

It unlikely that there were watercress meadows on, or adjacent to, the school site. Watercress requires a constant supply of preferably fresh flowing water, and this is not the case given the small size of the watercourses. The area identified by the Highgate Society as possible watercress pasture (i.e the parallel rows) is more likely to be orchards or nurseries which the 1865 mapping tends to suggest is the case (see Figures 4.1 and 4.2).

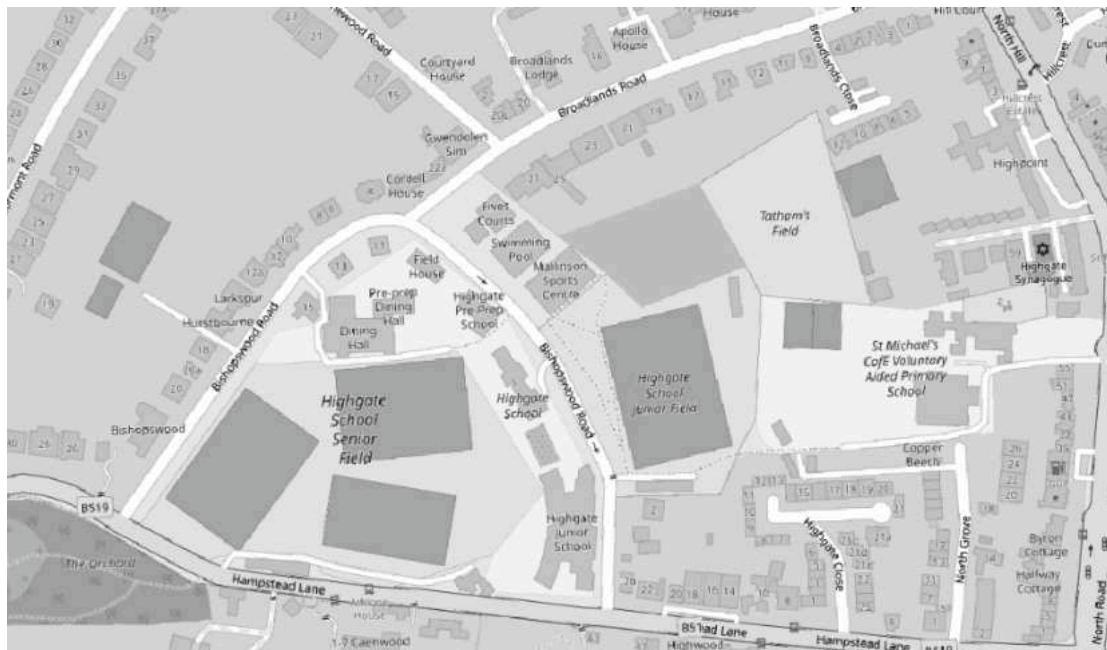
**Figure 4.4: Flood Risk for Planning**

A copy of the "long term flood risk mapping" shown on the UK government website<sup>2</sup> is shown in Figure 4.4. This shows the extent of flooding on the - adjacent to the site. The development is deemed to be at a Low risk of fluvial flooding.

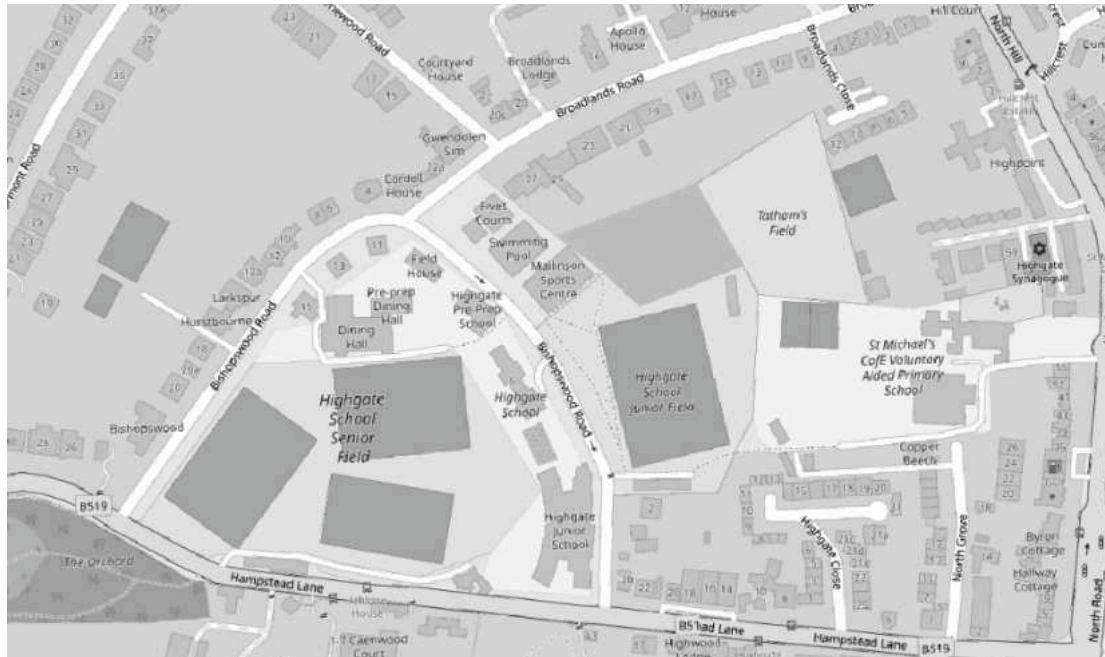
**Figure 4.8: Reservoir Inundation**

A copy of the Reservoir Inundation mapping is shown in Figure 4.8. There are no issues associated with reservoir inundation.

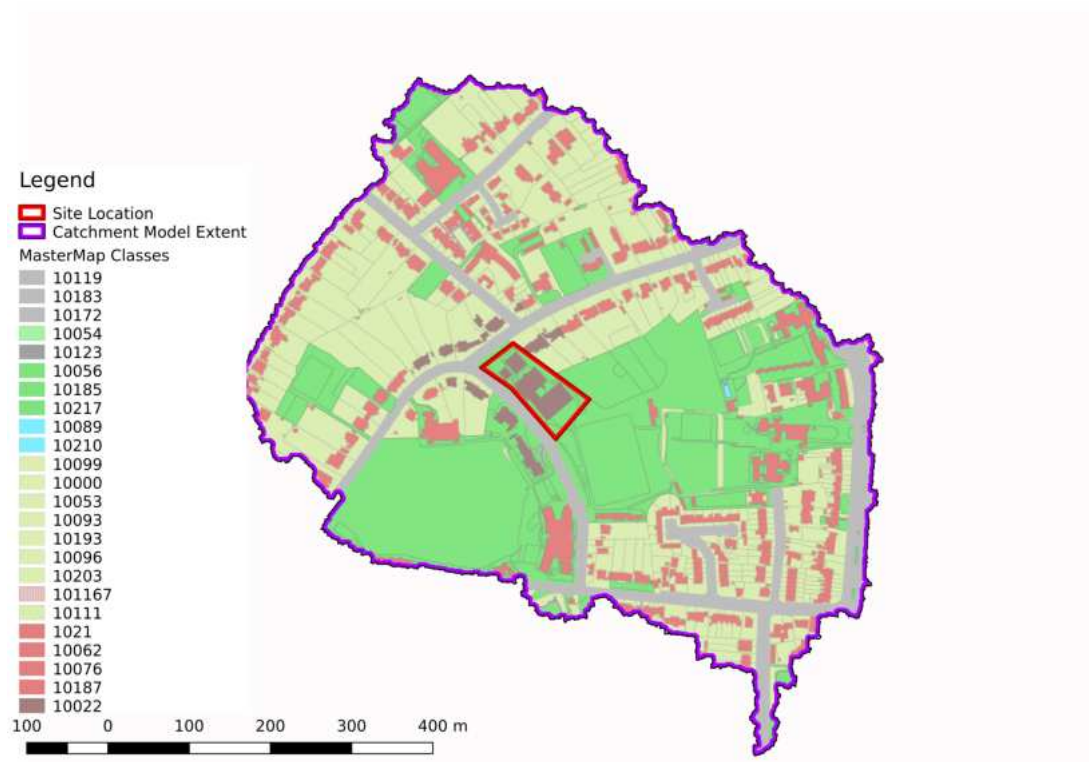
**Figure 5.3: Coverage of different land-use classes to be assigned different roughness parameter values**

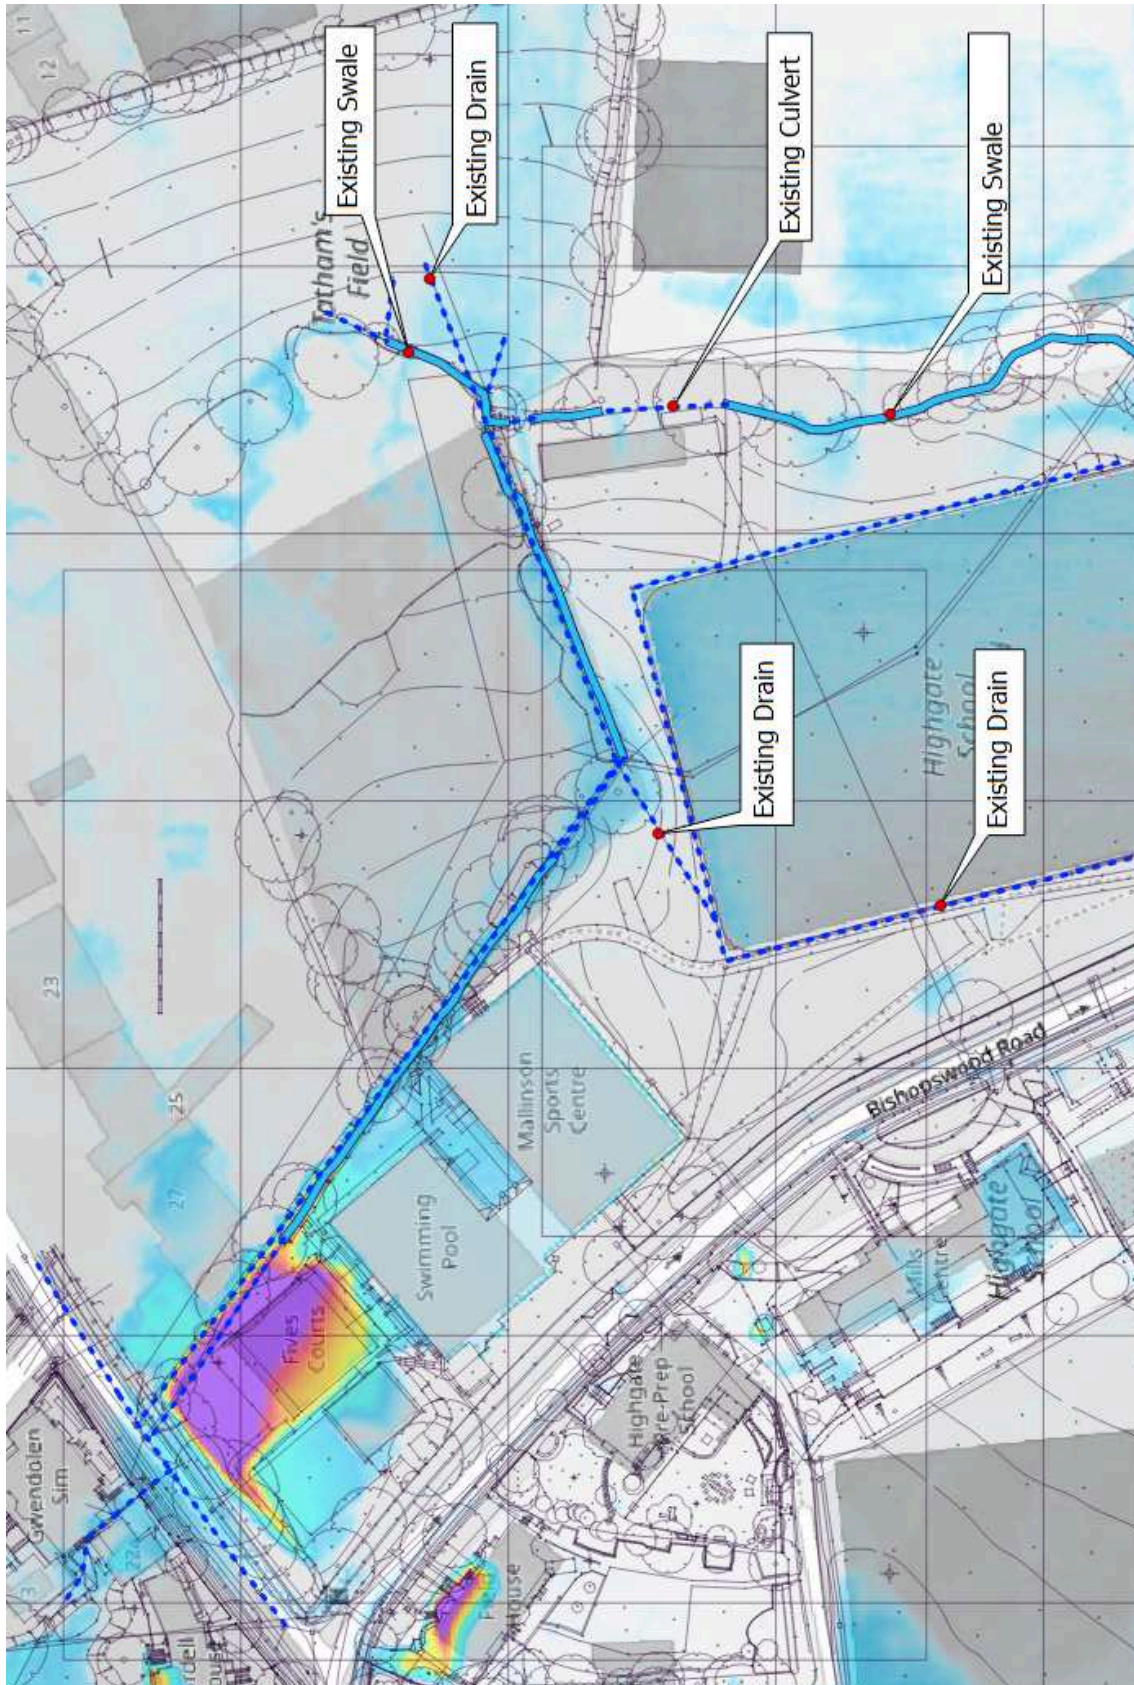
Figure 5.6: Baseline case, maximum flood depths: 1 in 100 year design event + 40% climate change allowance
