## **White Hart Lane Local Implementation Plan Scheme**

# White Hart Lane - Proposed Improvements

## **PROJECT REPORT CPR2111**

#### **PERS Assessment**

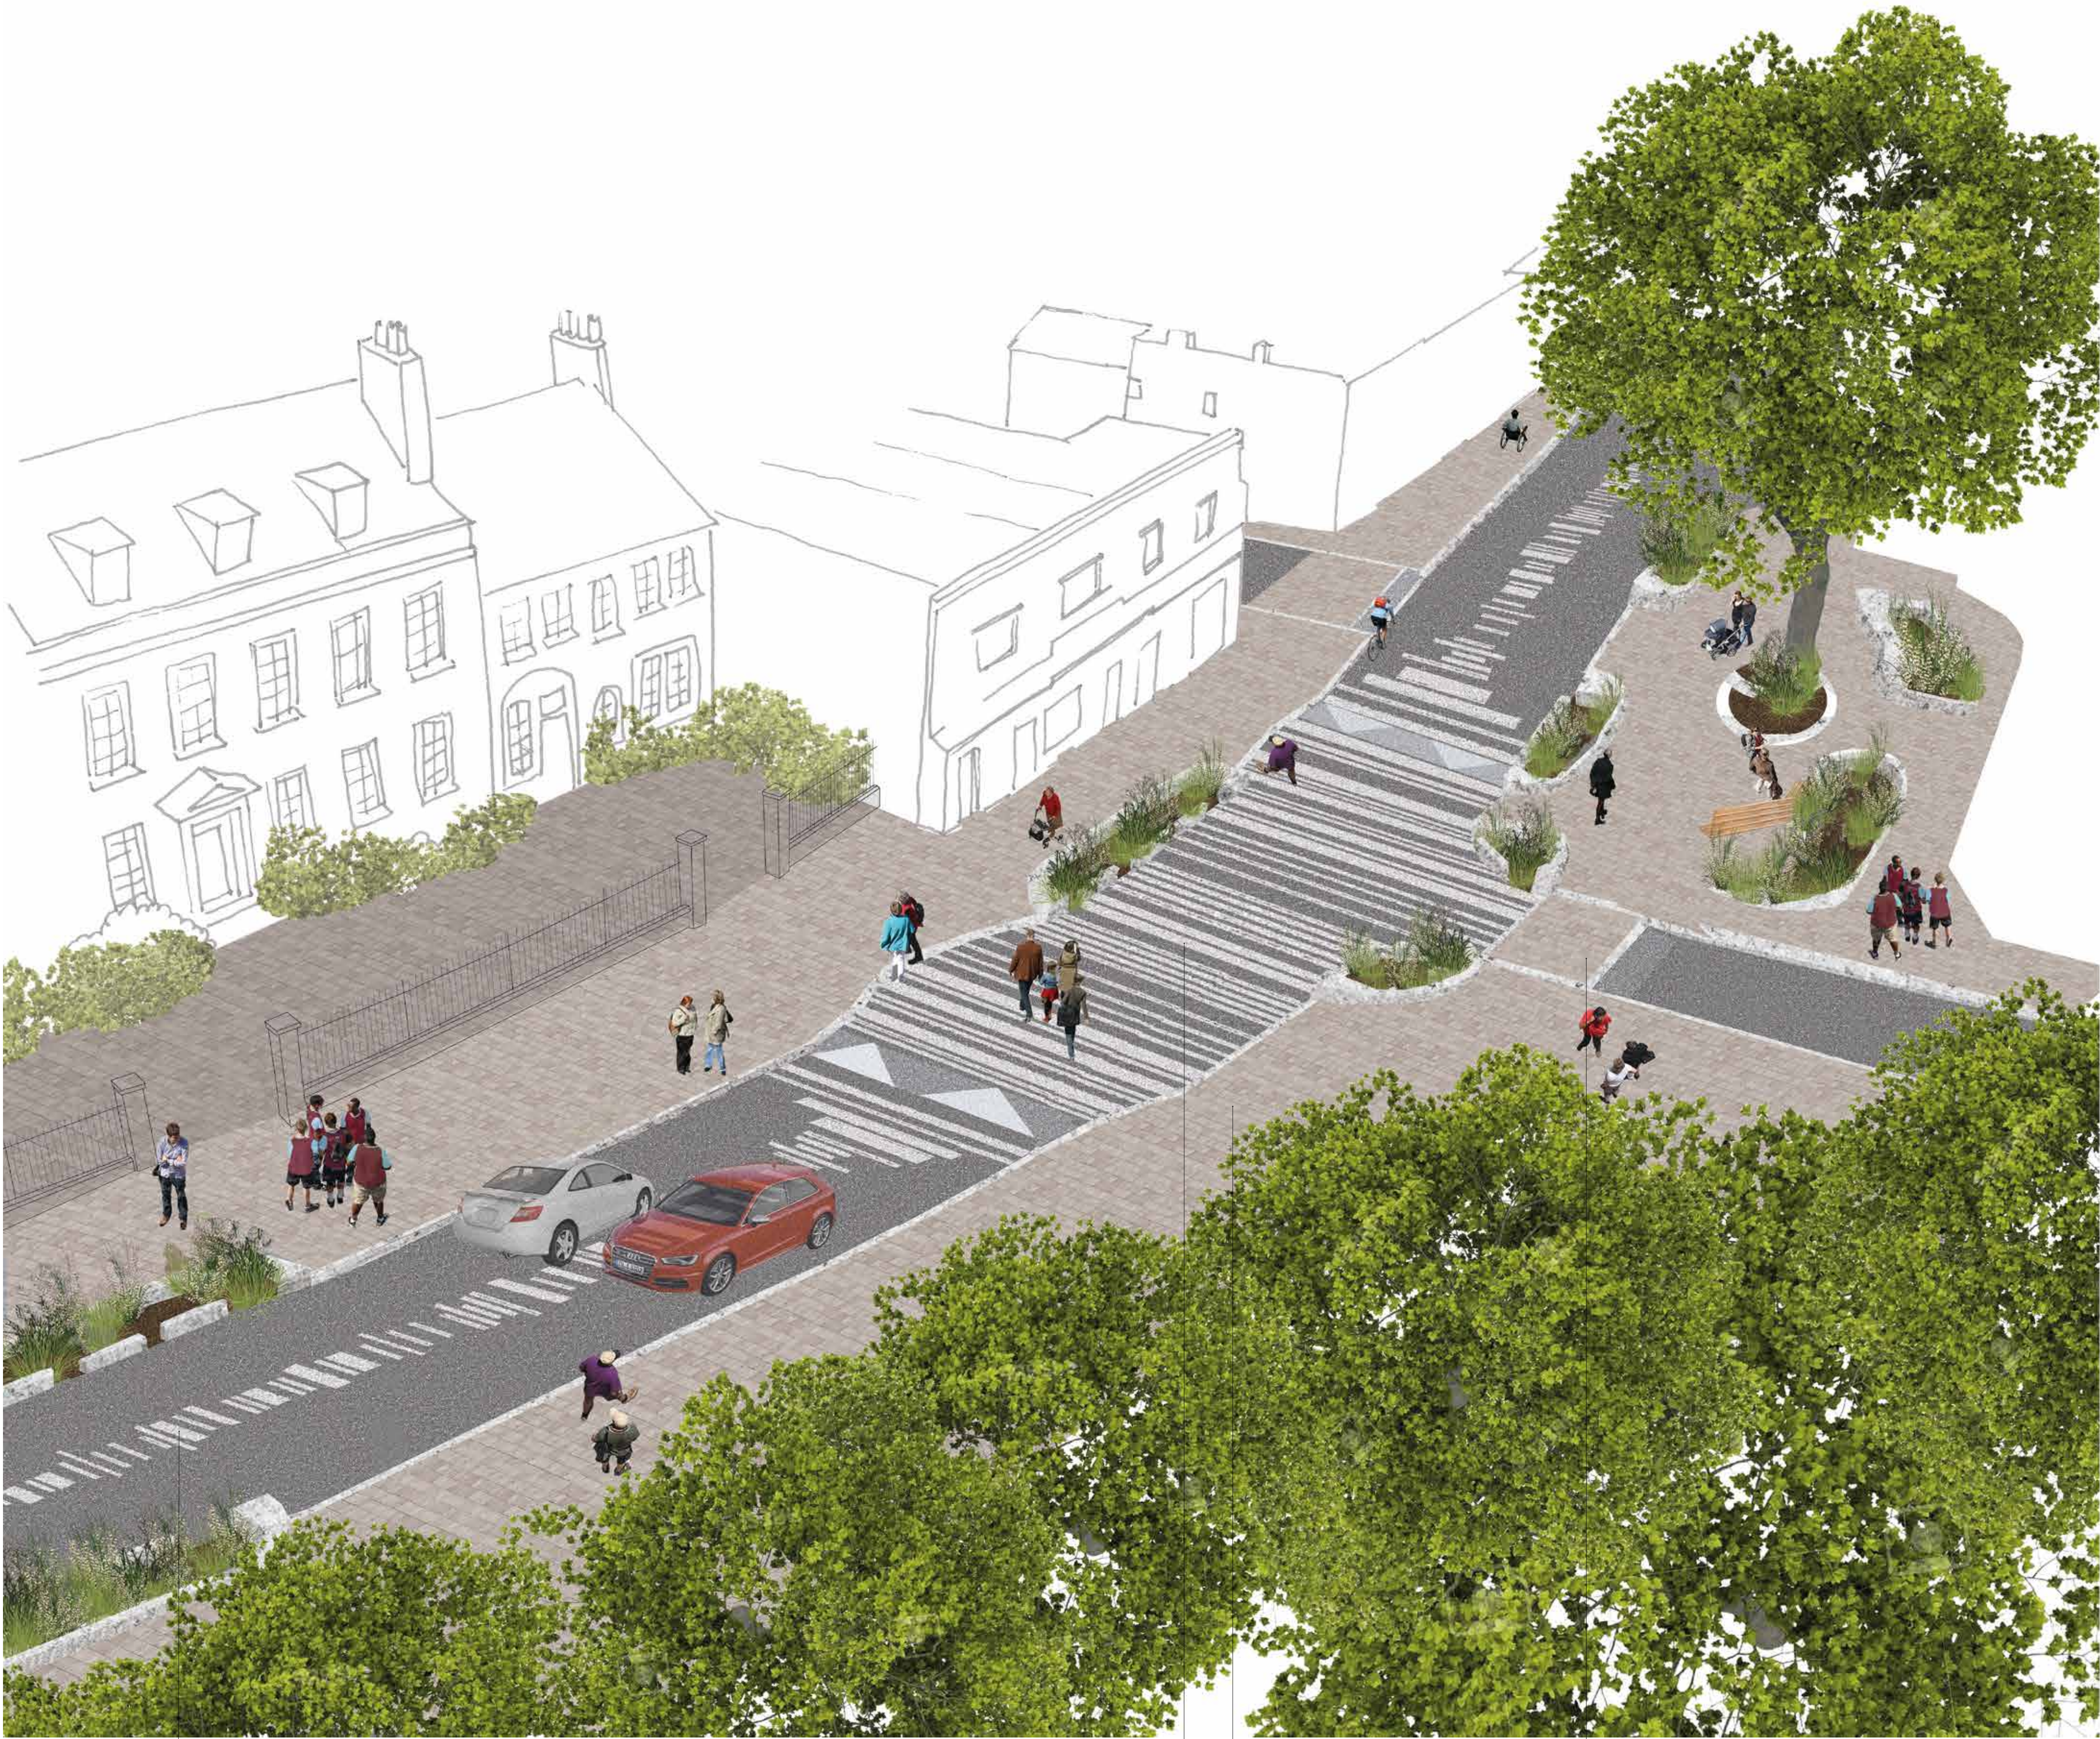
The carriageway width is reduced from 4800mm to 3400mm, the difference is shown in the drawings below, in addition a central pattern runs along the centre of the road giving the impression the road is narrower than it is. This width was agreed with Transport for London who run the buses, the emergency services, to ensure ambulances have room to pass, and Haringey 14%, the local access group. Reducing the carriageway will increase the width of the pavement all along White Hart Lane.

At intervals along the road we will raise the road up to the same level as the pavement. In these sections the road is treated with a contrasting material. The combination of the ramp up and down and the visual patterning reduces the tendency to speed and keeps traffic within the 20mph limit.

Central patterned strip to give the impression the road is narrower than it is

Raised table with a ramp up and down and a pattern surface to break of the linearity of the road

Pavement continues over side streets to make level crossings

Narrower carriageway results in wider pavements

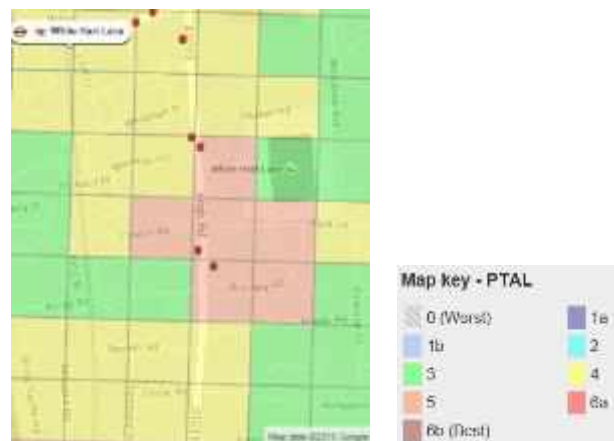
**Figure 3.2 - WebCAT Graphic for local area**

Based on TfL information for 2011, the TfL WebCAT graphic (see Figure 3.2) shows that the Public Transport Accessibility Level (PTAL) ranges between PTAL 3 and PTAL 5 for the local area within the vicinity of the stadium.

According to TfL's Planning Information Database, the PTAL ratings vary across the PERS audit area from a PTAL 3 at Northumberland Park Station through to a PTAL 6b at Seven Sisters Rail Station. The stadium development site is shown to achieve a PTAL 5 along its western boundary on High Road and a PTAL of 4 along its eastern boundary on Worcester Avenue. This shows that the area has between an 'average' (PTAL 3) and the 'best' (PTAL 6a/6b) level of accessibility to public transport services.

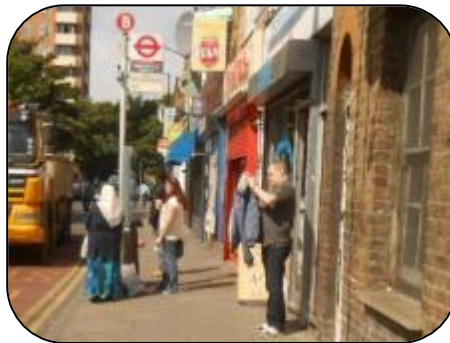
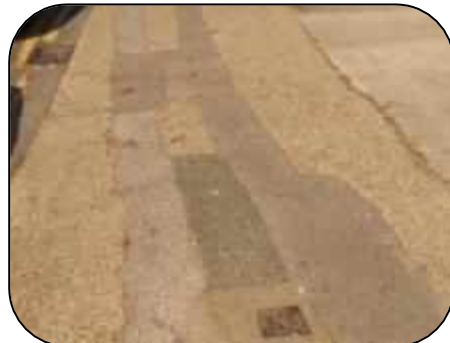
| Descriptor | Ref | RAG | Comments | Photographs |
|---|---|---|---|---|
| N-Side of White Hart Lane, between opp. Love Lane and A1010 | L4 | -67 | <p>This link runs along the northern side of White Hart Lane between (opposite) Love Lane and the A1010. It scored particularly poorly for the parameters: <b>effective width, user conflict, surface quality, obstructions, tactile information</b> and <b>colour contrast</b>.</p> <p>The link is very narrow in places (particularly due to the location of the on-street bus stop) with a reasonable pedestrian flow, and therefore the <b>effective width</b> is substandard. Due to the narrowness of the footway and the need for queuing bus passengers to stand within the footway itself, there is potential for <b>user conflict</b>.</p> <p>The footway <b>surface quality</b> along the link is poor, uneven and broken up in places which looks unsightly and can also result in trip hazards.</p> <p>Street furniture <b>obstructions</b> along the link include Bus Stop B and a Sheffield cycle stand which (particularly if a bicycle was parked there) act to considerably narrow the effective width of the footway. Other obstructions along the link included a stack of shopping baskets and fruit/veg crates on the footway outside a small retail store.</p> <p>There is a lack of <b>tactile paving</b> provision and <b>colour or tonal contrast</b> along the link which can be hazardous for sensory impaired and partially sighted pedestrians. Tactile paving is required to improve legibility for sensory impaired pedestrians.</p> <p>The above issues would need to be addressed in order for this link to achieve a better overall score.</p> | |

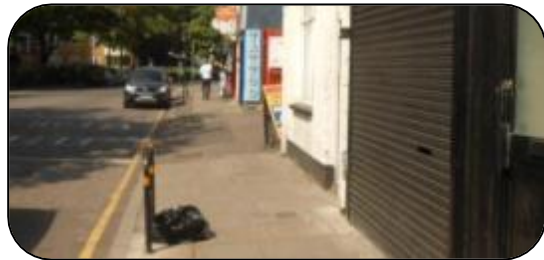
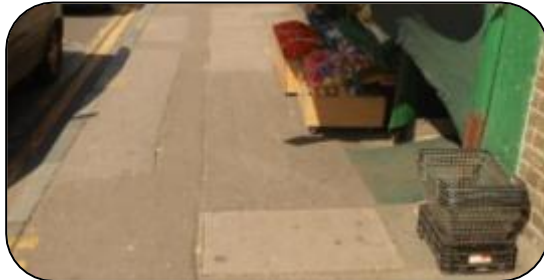
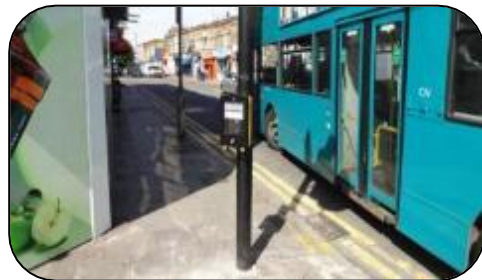
| Descriptor | Ref | RAG | Comments | Photographs |
|---|---|---|---|---|
| S-Side of White Hart Lane, between Love Lane and the A1010 | L3 and L5 | -51 and -61 | <p>These two links run along the southern side of White Hart Lane between Love Lane and the A1010. Both links scored particularly poorly for the parameters: <b>effective width, user conflict, dropped kerbs, obstructions, tactile information</b> and <b>colour contrast</b>.</p> <p>The <b>effective width</b> of the footway is considerably narrow in a number of places along the link due to the location of street furniture (poles, bollards, a phone box and a bus shelter), a large tree with roots and on-street rubbish. Narrow footways are more likely to become congested at peak times.</p> <p>There is potential for <b>user conflict</b> along the link due to the narrowness of the footway and street furniture <b>obstructions</b> around the bus shelter. Pedestrians travelling along the footway might conflict with those waiting for or alighting from a bus.</p> | |

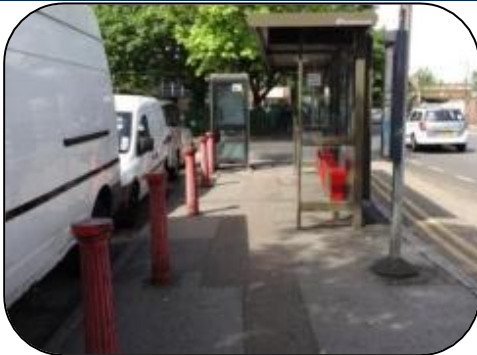
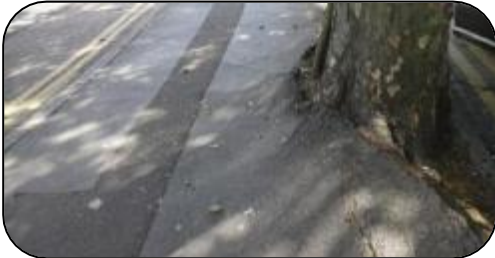
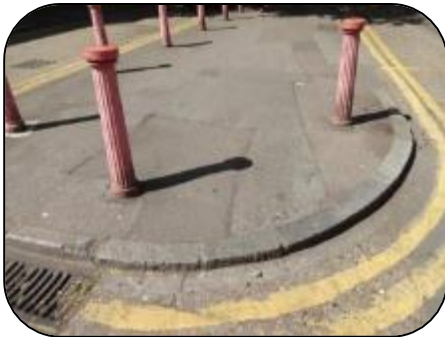
| Descriptor | Ref | RAG | Comments | Photographs |
|---|---|---|---|---|
| | | | <p>There is a lack of <b>dropped kerbs</b> and a poor footway surface quality along the link which cause trip hazards and can cause difficulties for those with mobility impairments such as wheelchair users.</p> <p>There is also a lack of <b>tactile paving</b> provision and a lack of <b>colour or tonal contrast</b> along the link. Tactile paving is required to improve legibility for sensory impaired pedestrians. Colour contrast aids in the navigation, orientation and protection of hazards for partially sighted pedestrians. An obstruction will therefore represent a hazard rather than an inconvenience.</p> <p>The above issues would need to be addressed in order for these links to achieve better overall scores.</p> | |

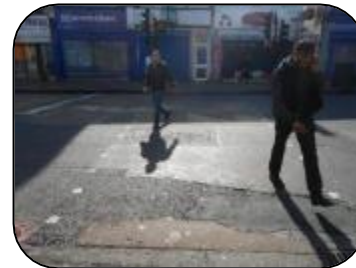
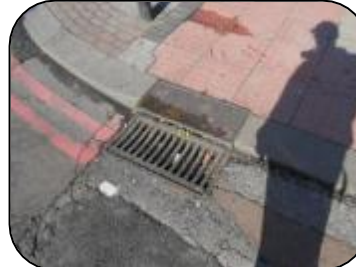
| Descriptor | Ref | RAG | Comments | Photographs |
|---|---|---|---|---|
| | | | <p>trip and slip hazard, particularly in conjunction with the high upstand on the kerb.</p> <p><b>Maintenance</b> scored poorly due to the poor surface quality of the carriageway, slight ponding on the northern side and also evidence of gum staining and litter.</p> | |

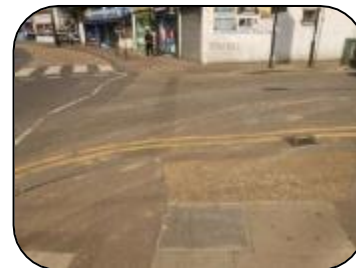
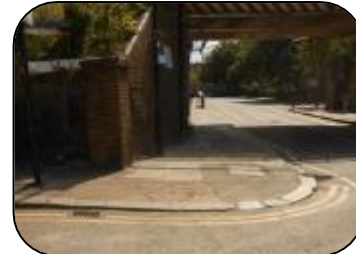
| Descriptor | Ref | RAG | Comments | Photographs |
|---|---|---|---|---|
| Crossing Pretoria Road, north of junction with White Hart Lane | C37 | -15 | <p>This crossing scored particularly poorly in relation to <b>surface quality, legibility</b> and <b>legibility for sensory impaired people</b>.</p> <p>The <b>surface quality</b> is poor, with different materials used, a lack of consistency in surface type and undulations and uneven surfaces which represent a trip hazard. The different surface types make the crossing difficult to navigate for those with visual impairments.</p> <p><b>Legibility</b> scored poorly because the crossing has no delineation or infrastructure to indicate its presence, or to encourage users to cross at a certain point.</p> <p>The lack of tactile paving provision puts those with a <b>sensory impairment</b> at risk, and this is compounded by the lack of colour contrast.</p> | |

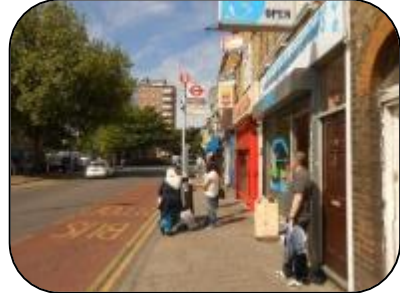
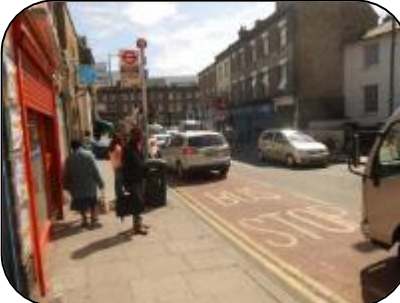
| Descriptor | Ref | RAG | Comments | Photographs |
|---|---|---|---|---|
| Bus Stop B - White Hart Lane Station | PT7 | -11 | <p>This bus stop scored particularly poorly in relation to <b>quality of the environment</b> and <b>waiting area comfort</b>.</p> <p>The <b>quality of the environment</b> is low because of significant amounts of litter, poor quality frontages and due to the adjacent road which has traffic noise and there are fumes from queuing traffic. In addition, the footway is of poor quality and is uneven in places.</p> <p>The <b>waiting area comfort</b> scored poorly since there is no provision of a shelter and the bus stop is exposed to the elements. The adjacent footway is narrow and there is a high flow of pedestrians, which acts to limit the capacity of the waiting area and increase user conflict.</p> | |

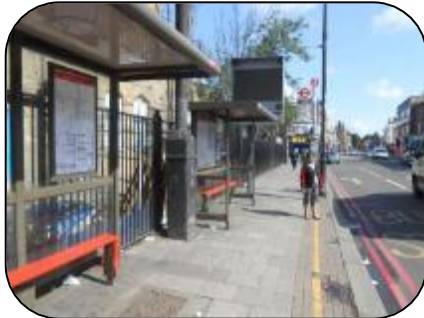
| Descriptor | Ref | RAG | Comments | Photographs |
|---|---|---|---|---|
| Bus Stop J - Bruce Grove Station | PT17 | +3 | <p>This bus stop scored particularly poorly in relation to <b>infrastructure to the waiting area, quality of the environment</b> and <b>maintenance and cleanliness</b>.</p> <p><b>Infrastructure to the waiting area</b> scored poorly because of the lack of any convenient crossing provision to access the bus stop. The nearest formal crossing point is approximately 25 metres to the north of the bus stop. The footway quality is generally poor with unevenness and trip hazards.</p> <p><b>Quality of the environment</b> is reduced by the poor aesthetics of the frontages, poor quality of materials surrounding the waiting area and the traffic noise and fumes nearby. There is also a poor level of <b>maintenance and cleanliness</b> as the shelters are in a poor state of repair and are dirty and scratched with graffiti. The area around the shelters also has lots of litter present, despite the bin provided.</p> | |
