# STANHOPE ROAD BRIDGE

Preliminary Risk Assessment

**PROJECT NO. 70077287**

**DATE: SEPTEMBER 2021**

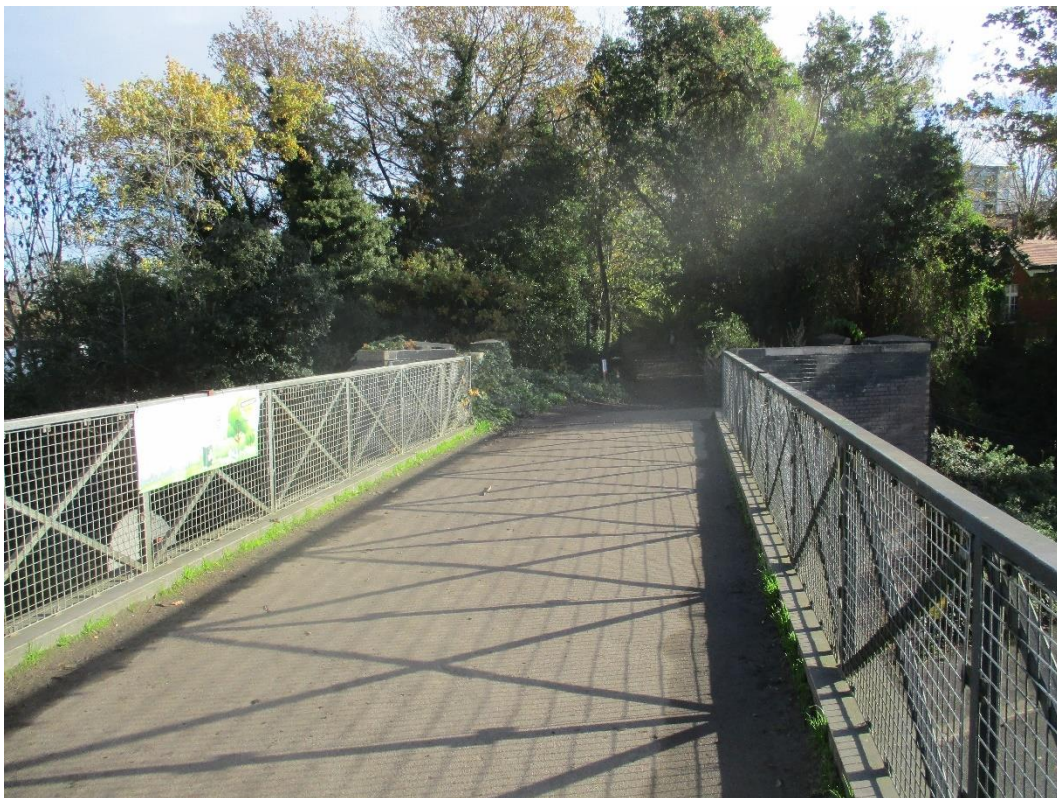
**Photo 2:** View of the bridge over Stanhope Road, looking towards the east.

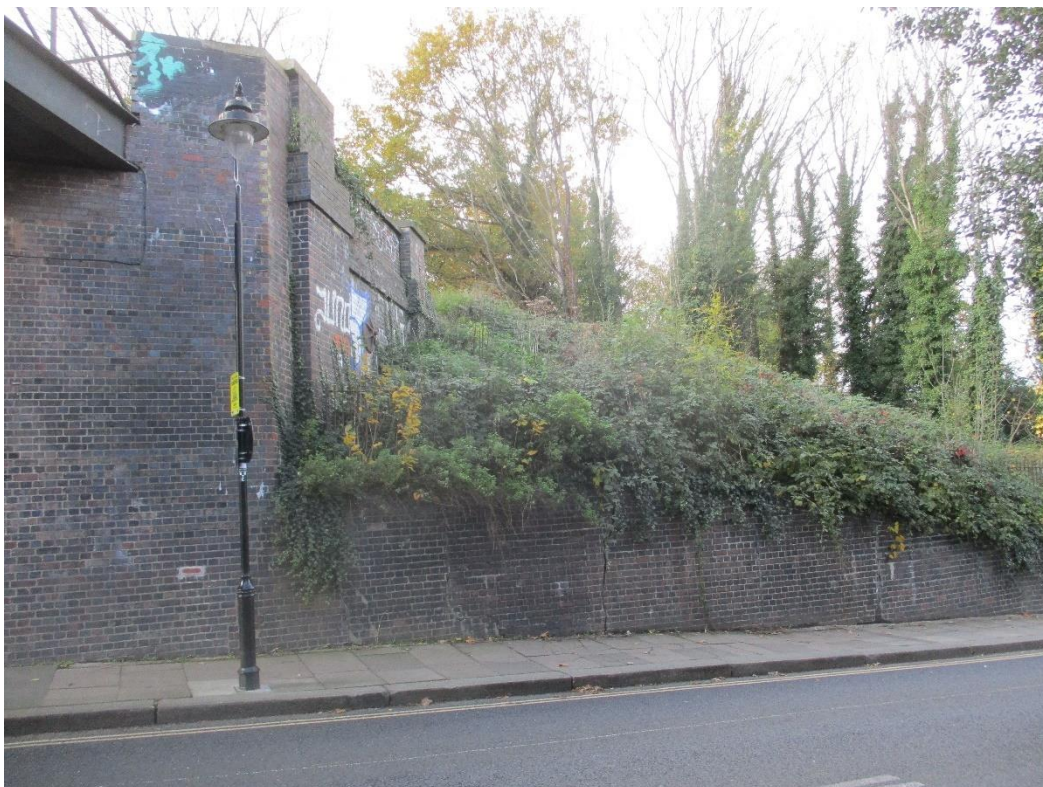
**Photo 4:** View of the vegetated embankment in the central part of the Site. View looking west from Stanhope Road.

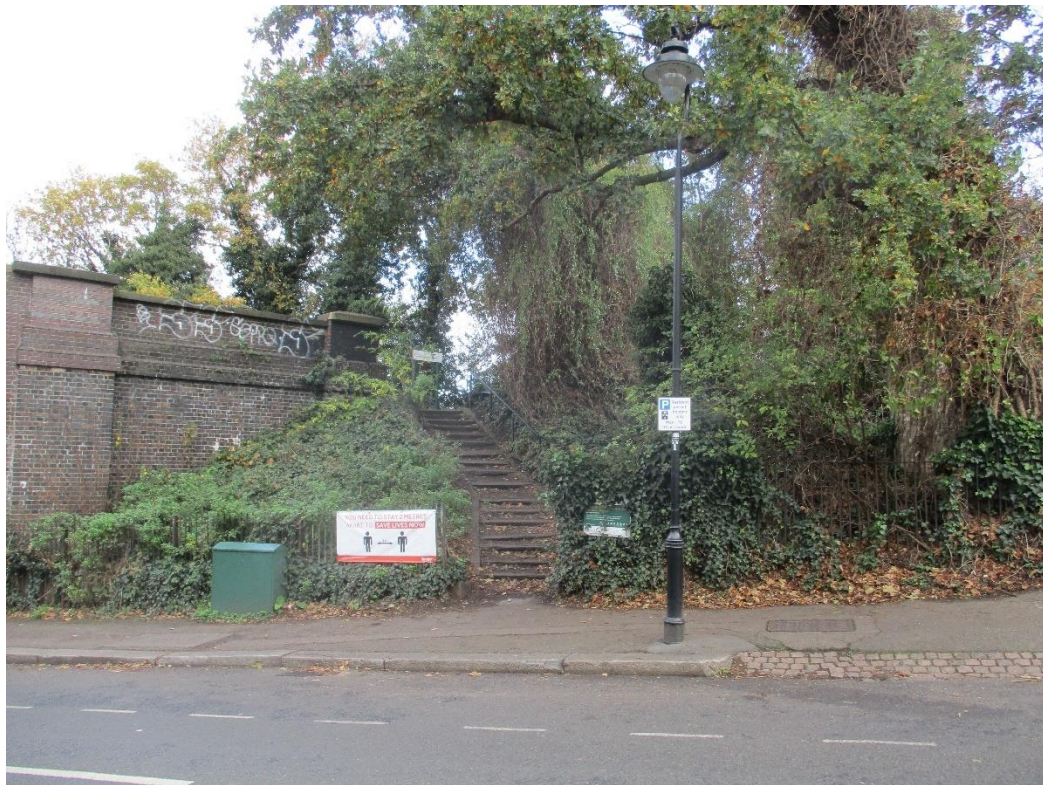
**Photo 5:** Pedestrian access steps from Stanhope Road to Parkland Walk. View from Stanhope Road looking towards the north east.

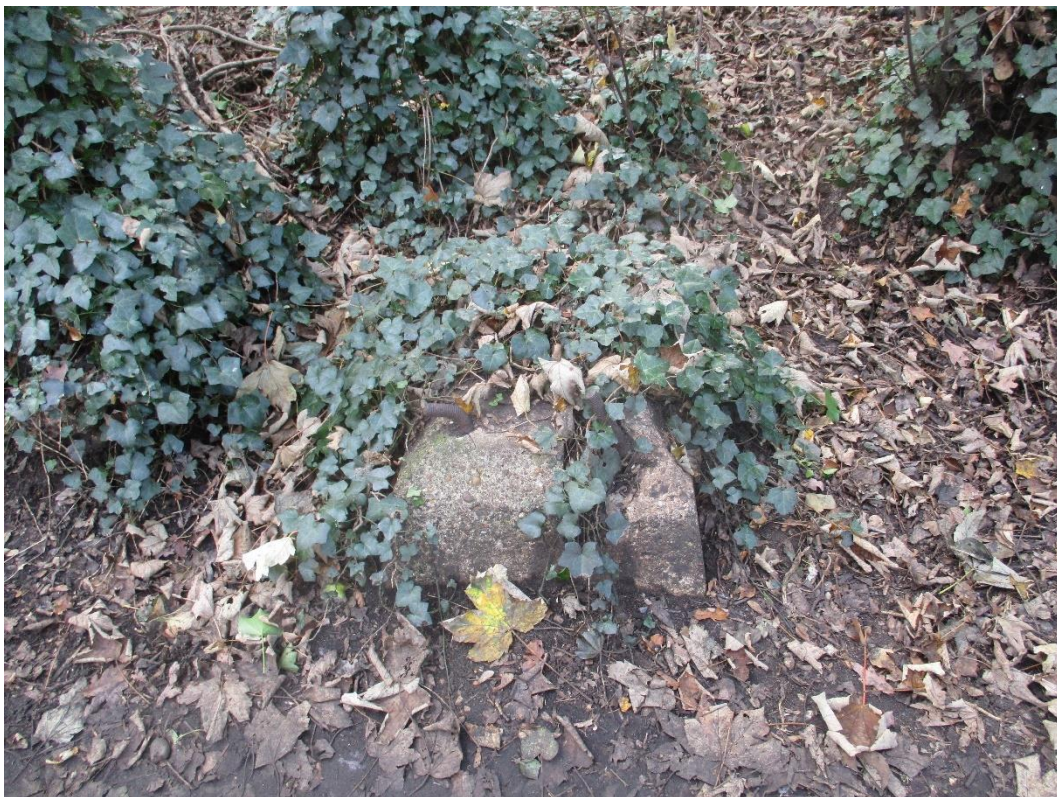
**Photo 6:** Example of the concrete blocks present on the site, potentially related to the former railway.

| Detail | Comment |
|---|---|
| Waste | Occasional litter and blocks of concrete (potentially from the former railway) were noted during the walkover. Waste bins were present at multiple locations along the length of the path. |

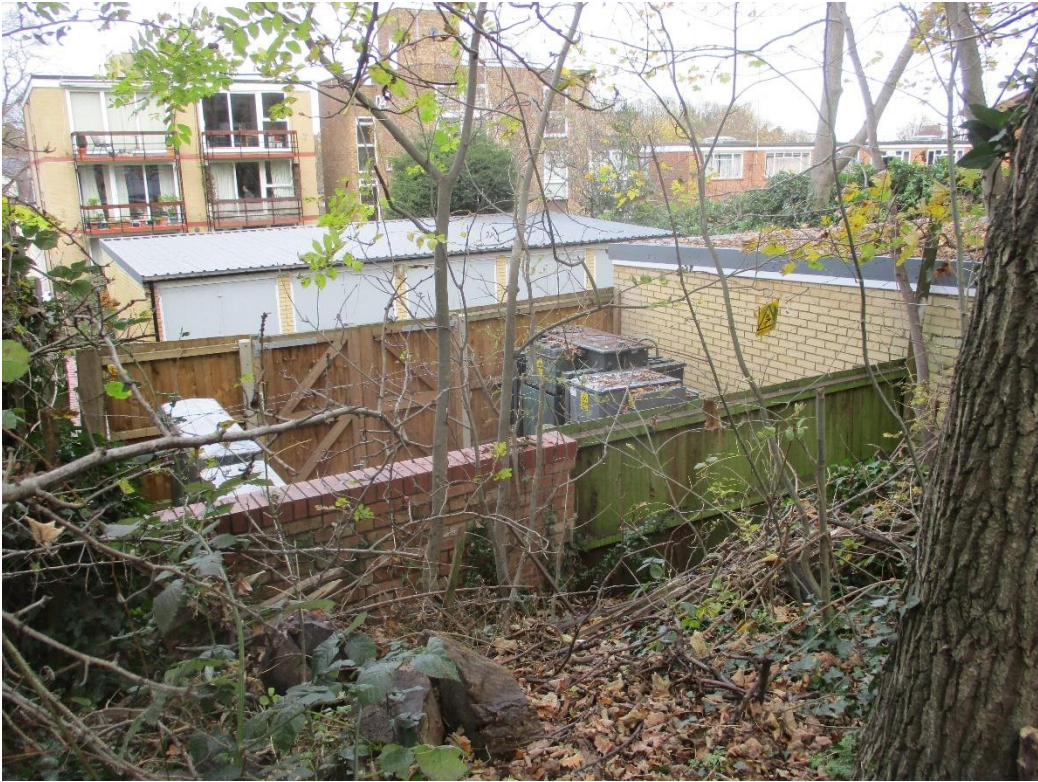
**Photo 11:** Photo of the electric substation located adjacent to the north east of the Site. Photo taken from the Site looking towards the north.

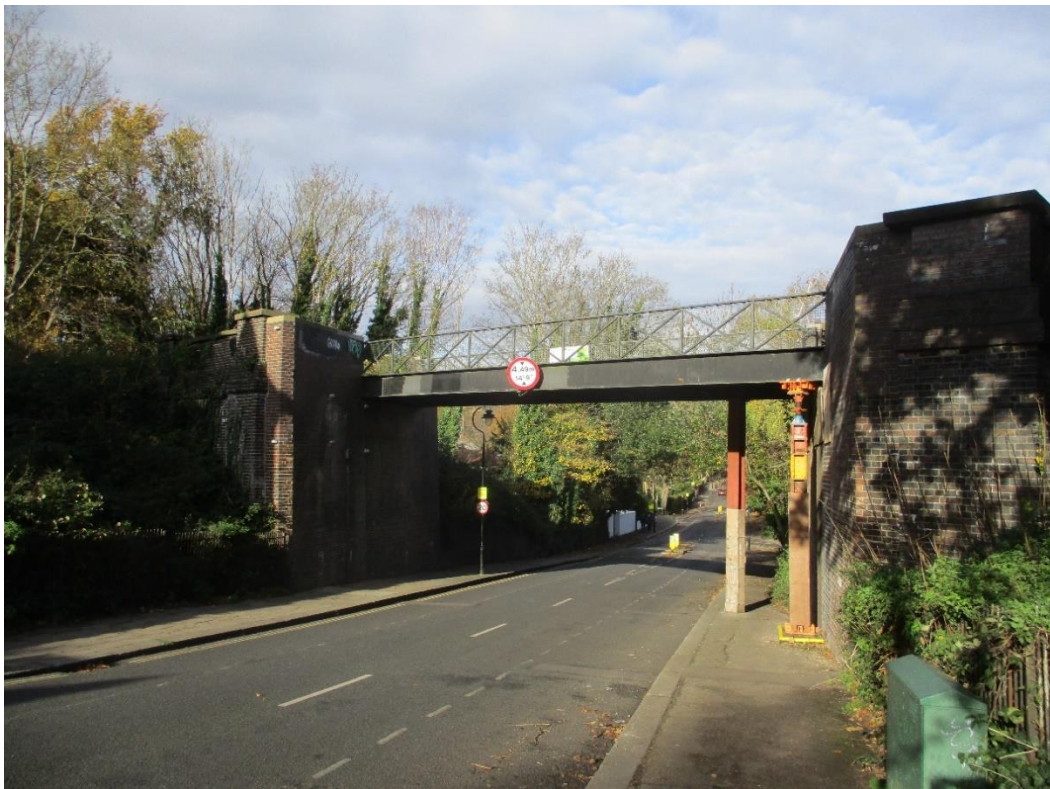
**Photo 12:** Bridge that crosses Stanhope Road. Photo is taken from Stanhope Road looking towards the north.
