ARUNDEL & BALDEWYNNE  
LANSDOWNE ROAD,  
TOTTENHAM, LONDON, N17  
0LL

# STAGE 1 PRELIMINARY UXO RISK ASSESSMENT

**Client:** RSK  
**Project:** Arundel Court and Baldewyne Court, Tottenham  
**Date:** 09/08/2021

### SITE RECONNAISSANCE PHOTOGRAPHS

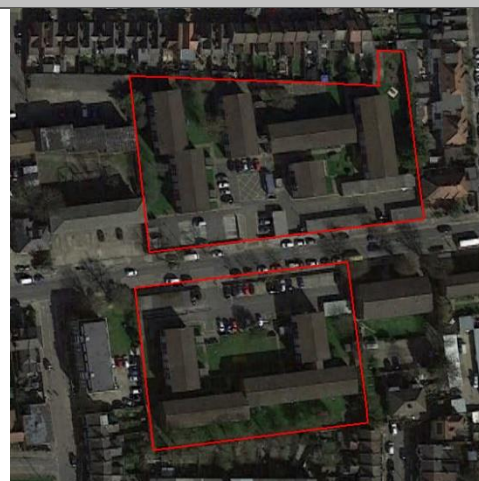
Site A comprises six three-storey residential apartment blocks. Rows of garages, alongside hardstanding parking areas, are present in the south. Garden areas are located sporadically throughout the northern section. It is bound to the north by garden areas on Hampden Road, to the east by garden areas on Baronet Road, to the south by Lansdowne Road and to the west by structures on Lansdowne Road and Hampden Lane.

Site B comprises four three-storey residential apartment blocks. Rows of garages, alongside hardstanding parking areas, are present in the north. Garden areas are located sporadically throughout the southern and central sections. It is bound to the north by Lansdowne Road, to the east by residential structures on Lansdowne Road, to the south by garden areas on Stirling Road and to the west by garden areas and residential structures on Burlington Road.

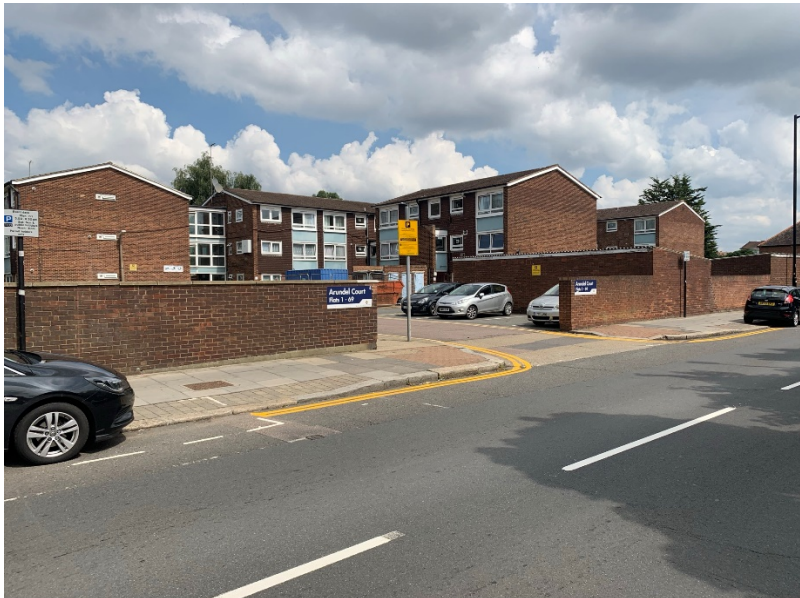
| <b>Photo no.</b><br><b>1</b> | <b>Date:</b><br>05/08/2021 | |

| <b>Description:</b><br>View overlooking Arundel Court from Lansdowne Road | | |

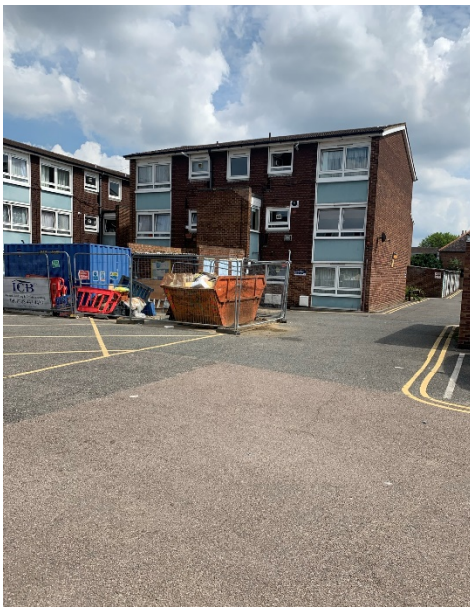
| <b>Photo No.</b><br><br>2 | <b>Date:</b><br><br>05/08/2021 | |

| <b>Description:</b><br>View of current site compound with waste storage on Arundel Court site | | |

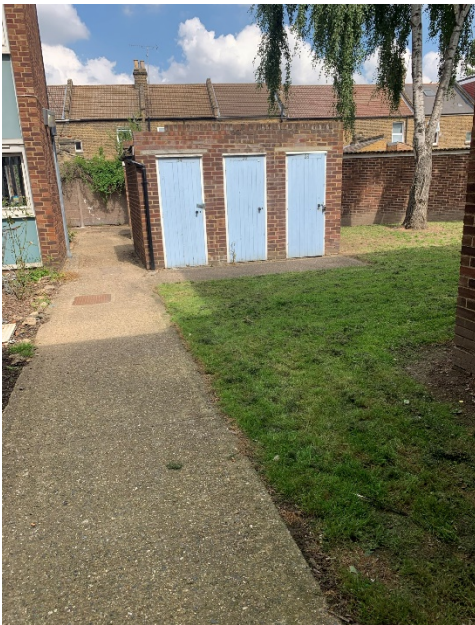
| <b>Photo No.</b><br><br>3 | <b>Date:</b><br><br>05/08/2021 | |

| <b>Description:</b><br>Assumed waste disposal storage at Arundel Court | | |

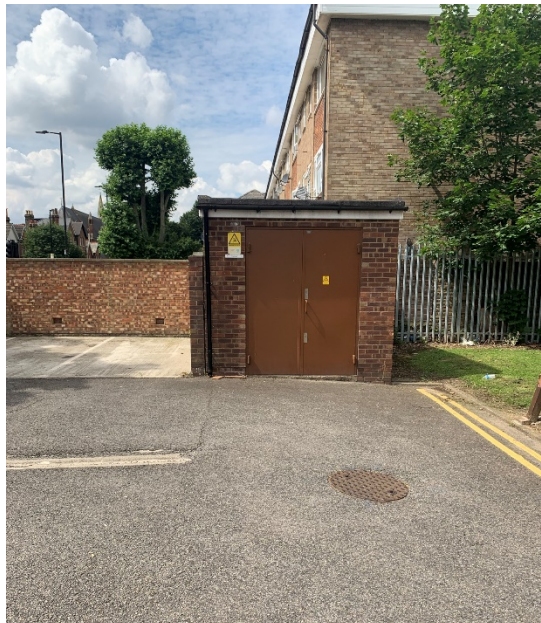
| <b>Photo No.</b><br><br>4 | <b>Date:</b><br><br>05/08/2021 | |

| <b>Description:</b><br><br>Electrical substation on western site boundary, Arundel Court | | |

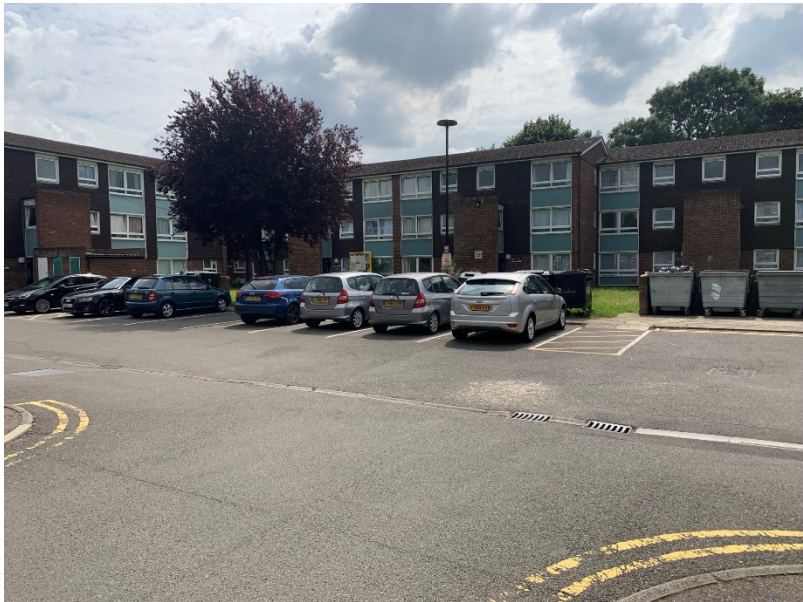
| 5 | 05/08/2021 | |

| <b>Description:</b><br>View of Baldewyne Court | | |

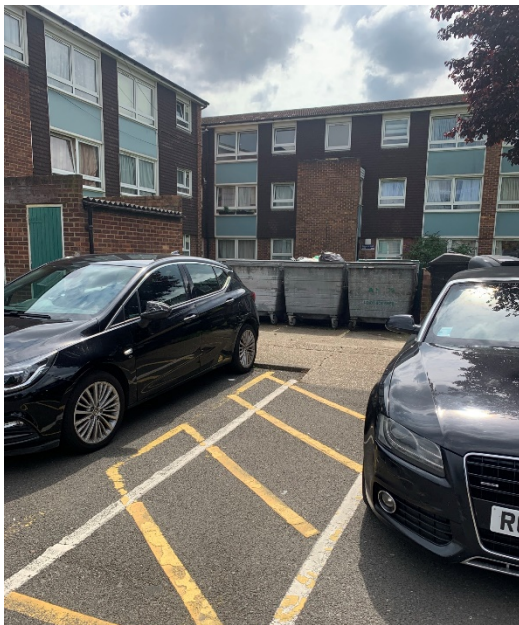
| <b>Photo No.</b><br>6 | <b>Date:</b><br>05/08/2021 | |

| <b>Description:</b><br>Some waste storage at Baldewyne Court | | |

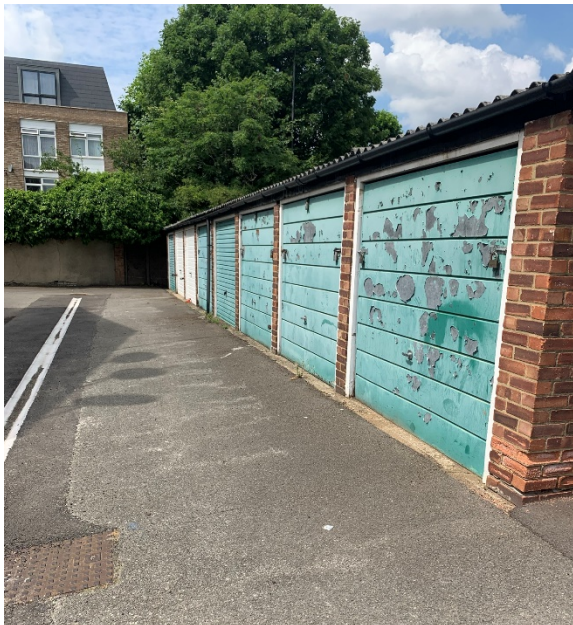
| <b>Photo No.</b><br>7 | <b>Date:</b><br>05/08/2021 | |

| <b>Description:</b><br>Garages present on the Baldewyne site | | |
