## **Ground Gas Risk Assessment**

**30 - 48 Lawrence Road, Haringey, London N15 4EG**

**Reference: 20922/GGRA/Rev1.1**  
**October 2023**

Ground Gas Risk Assessment

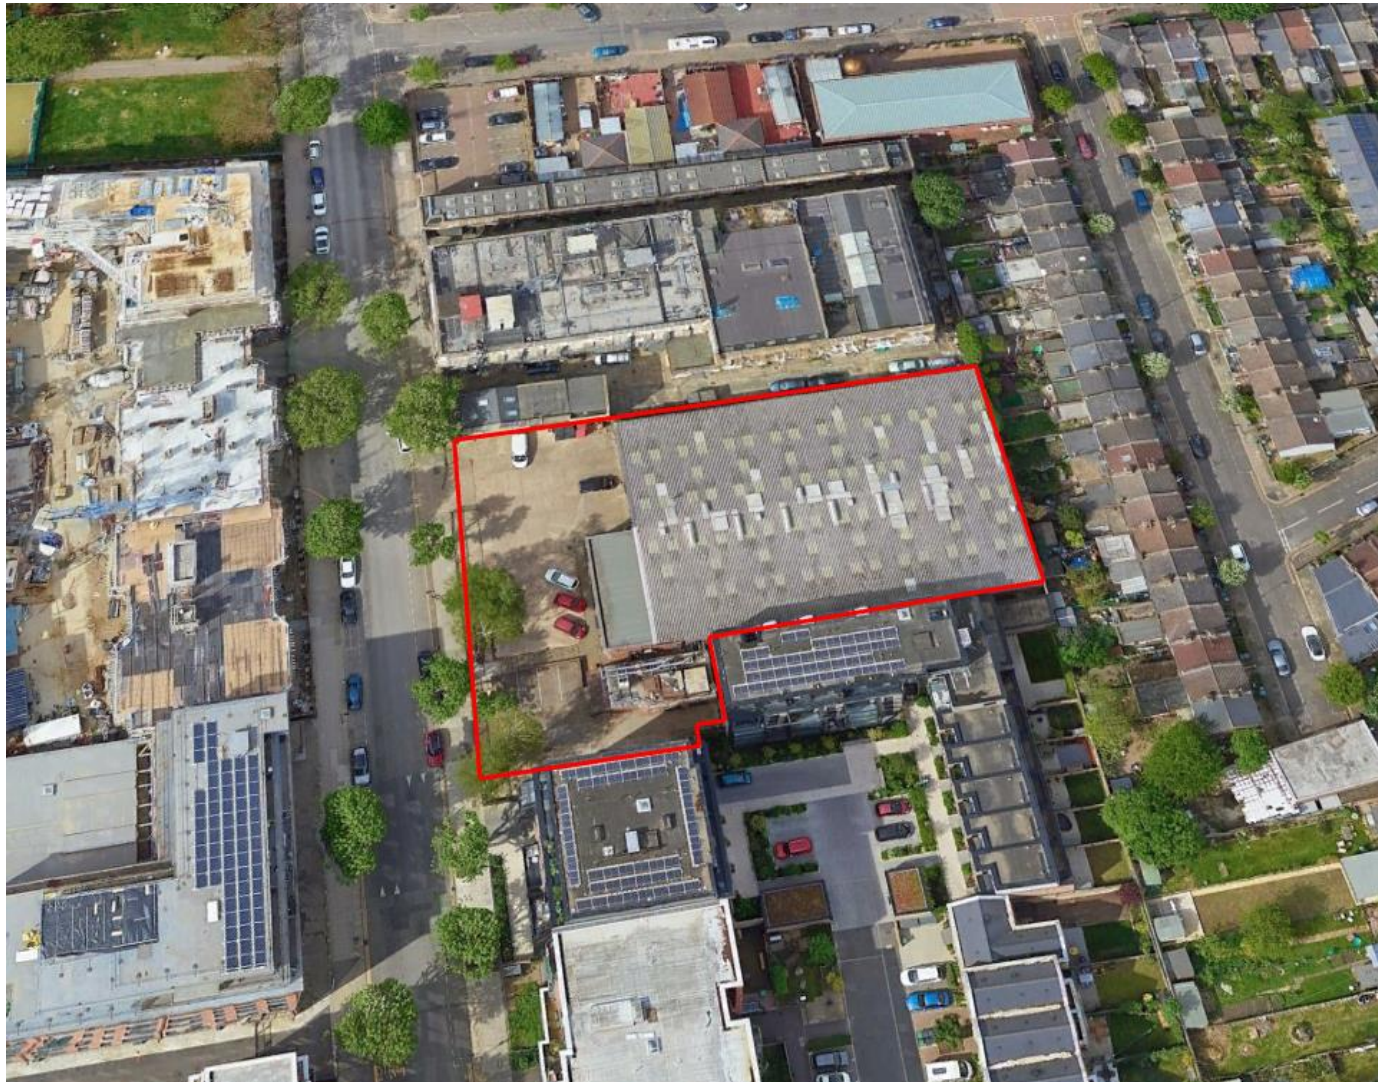
**Figure 2 – Aerial Photograph**

An aerial photograph of the site and its close environs has been included in Figure 2.

The site was located to the east of Lawrence Road, with a hardstanding car park connecting the single light industrial unit on site, with the road. Other structures on site included a two-storey office building connected to the west side (front) of the light industrial unit, and a single storey plant room on the southern site boundary. A second smaller car park with access gate to Lawrence Road existed in the southwestern corner of site. The light industrial unit, which was occupied by a dry-cleaning company, took up the majority of the site space. The site was topographically flat. Mature trees lined Lawrence Road, along the western site boundary. The site was bound to the north by residential space and a small workshop. The site was bound to the south and to the east respectively by residential flats and by residential houses with accompanying private gardens.
