# Ground Appraisal Report

Tottenham Hale, London

| Document No.: | 1305-ACE-GEO-GA-001 |

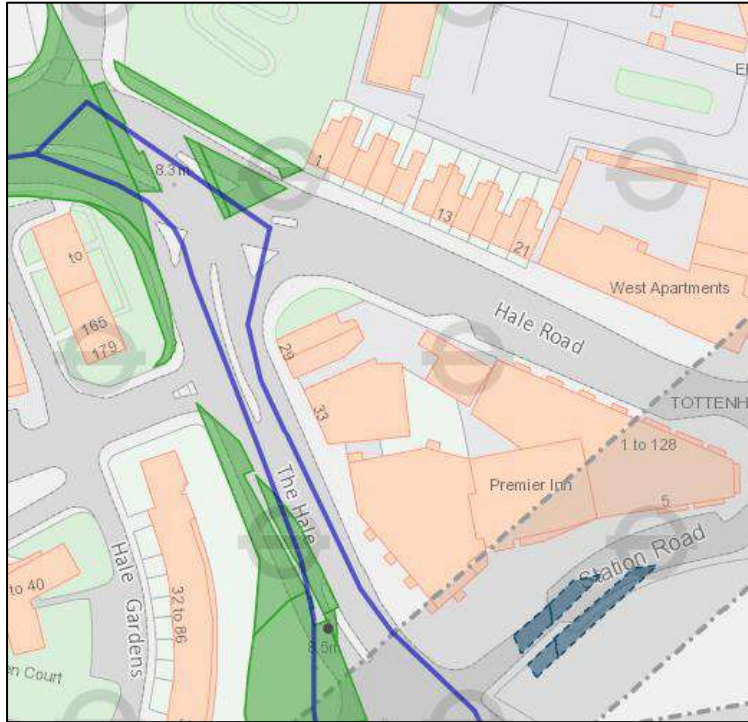
Given the site's location in central London, reference has been made to the Transport for London's Property Asset Register Public Web Map; an extract of which is shown below:

The above shows the presence of TfL's Road Network on The Hale to the west and freehold land north and west. A London Underground Zone of influence is shown c. 50m south-east associated with the Victoria Line, but no tunnels or zones of influence are recorded beneath the site.
