# Design & Access Statement

## Alexandra Palace, Great Hall Bridge

Design and Access statement for works to the Great Hall former railway bridge over the North Service Yard to include structural repairs, renewal of the waterproofing/asphalt covering and drainage strategy as well as repair works to the railings, brick vaulted structure, metal beams/columns, stone stair flights and stairs under the north abutment.

November 2024

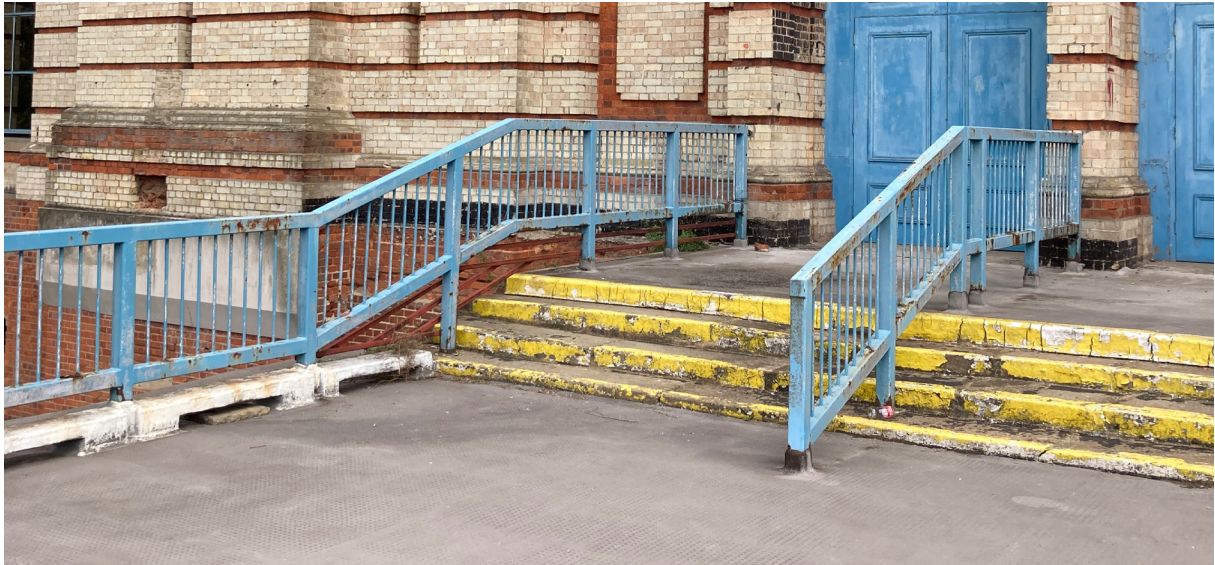
Figure 1: Existing entrance to Great Hall including asphalt covering, stone steps and metal balustrade

- New asphalt covering to replace existing
- Like-for-like repair/replacement of stone steps
- New like-for-like riser stone step to achieve new drainage falls

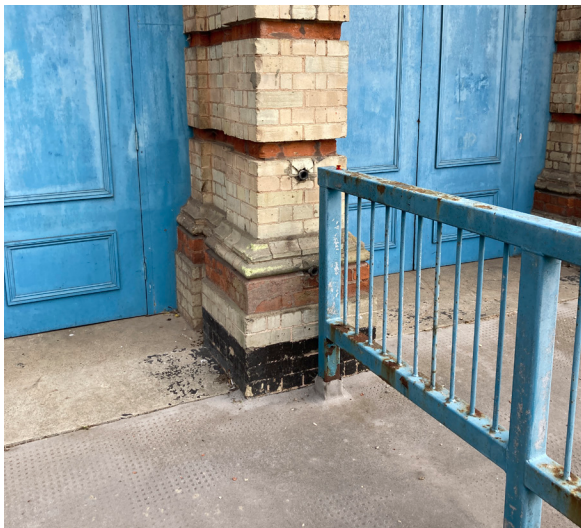
Figure 2: Existing Balustrade and entrance doors

- New metal infill panels to ensure balustrade compliance
- New corduroy adhesive strips to base of steps
- New tactile corduroy paving to steps with anti-slip stair treads

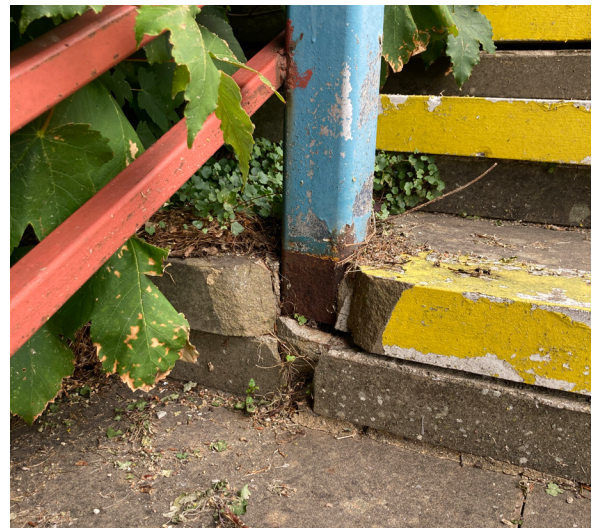
Figure 3: Balustrade stone fixing

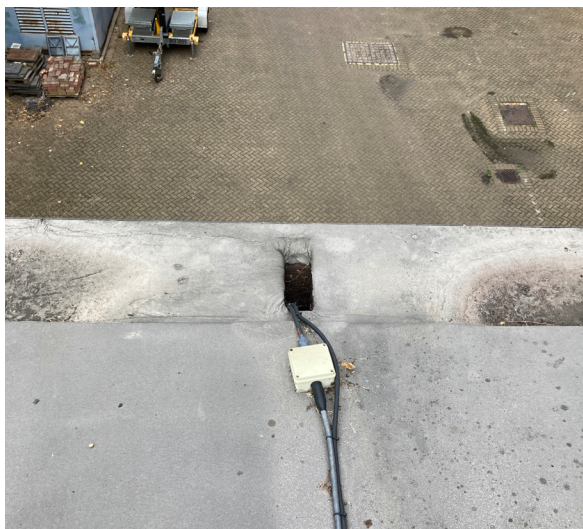
Figure 4: Existing Rainwater outlet into Cast Iron column

In order to ensure that rainwater does not cause further deterioration and compromise the bridge structure, the asphalt covering will be laid to new falls and water is redirected away from the existing cast iron into a proprietary metal gutter fixed to the side of the bridge with rainwater outlets at either end.

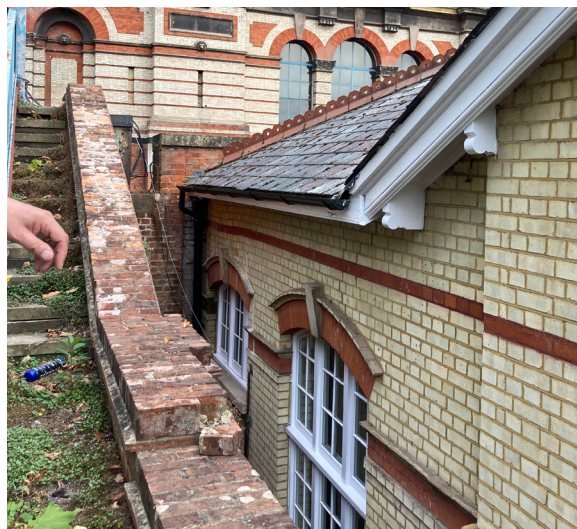
Figure 5: Brick wall to lower steps

- Existing undercroft stairs stabilised/rebuilt
- Like-for-like repairs/replacement to vaulted arch brickwork
- Like-for-like repairs/replacements to brick walls either side of stairs

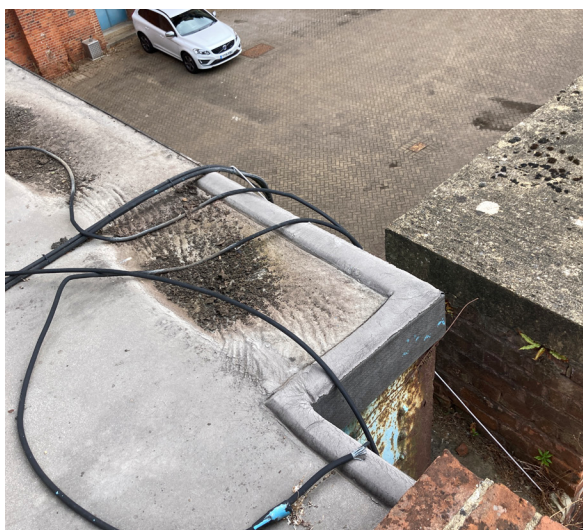
The development includes works to the Great Hall former railway bridge over the North Service Yard to provide urgent structural repairs to the existing iron columns as well as a renewal of the blistered asphalt covering where water ingress has started to saturate the concrete substrate, beams and vaulted brick arches. The extensive damage necessitates like-for-like repair works to the vaulted brick arches and low level brick wall. Part of the works will involve upgrading existing stairs, balustrading for building regulation compliance, perimeter fencing works for maintenance and anti-vandalism.

Figure 6: Blistered asphalt either side of bridge

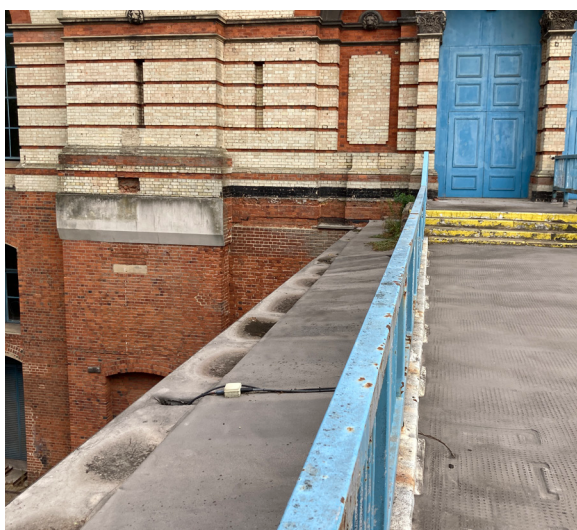
Figure 7: Blistered Asphalt to existing bridge 'gutter'

Bridge to remain as existing scale and layout, steps and balustrade to be adjusted for building regulation compliance and existing 'gutter' to be reconfigured to provide adequate fall to a new proprietary metal gutter.

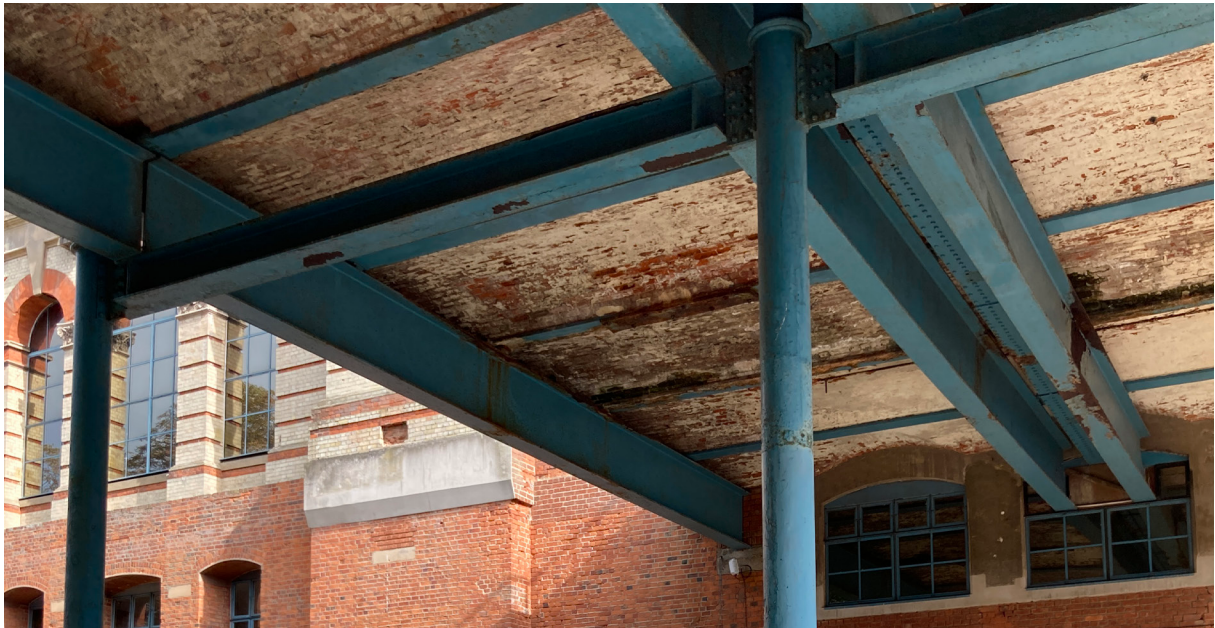
Figure 8: Underside of bridge with visible rusted beams and water ingress through brick vaulted arches

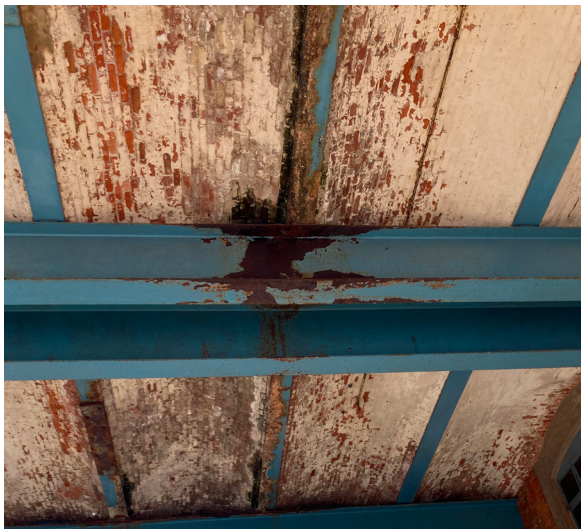
Figure 9: Beams and vaulted brickwork

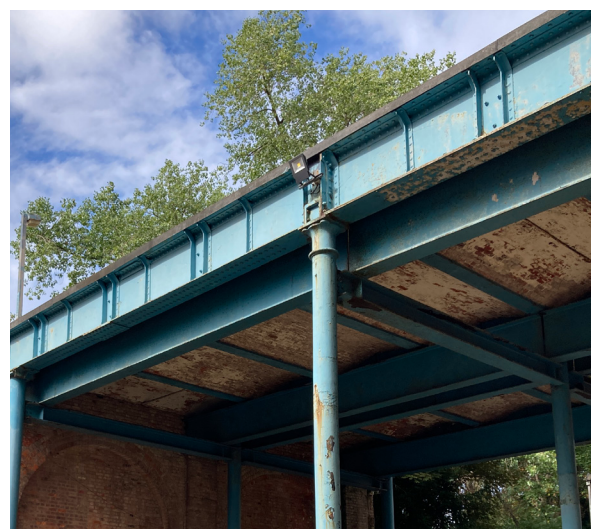
Figure 10: Bridge elevation
