Project Title: Cranwood House

Client: McAllister Group

Discipline:		Scale:	Project Phase:
Topographical Survey & Laser Scanning		1:200@ A1	Survey Information
Drawing Originator:		Drawn By:	Approval By:
Cable Tracing Services Limted		DMB	JMB
Drawing No:	Revision:	Drawn Date:	Check Date:
CTS-MC 0129 20-21(1)	B	15-12-20	17-06-21

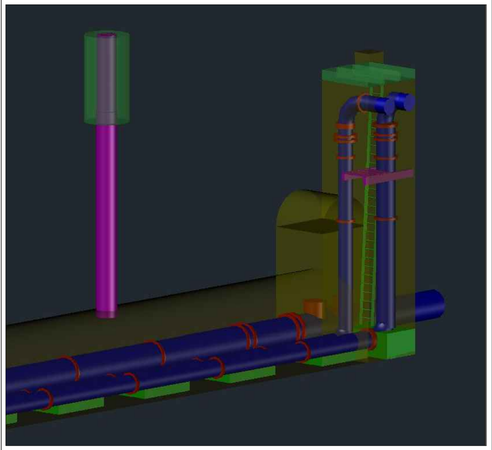
Survey abandoned: survey abandoned due to crawler unable to get pass debris in pipe, pipe has been jetted multiple times.
