Monitoring Details

Client:	Davies
Job Reference:	72228824

Occupier:	Mr Louay Nasser		
Address:	133 Morley Avenue, London, N22 6NP		
Telephone:	07983635716	**Email:**	Zklouy33@gamil.com

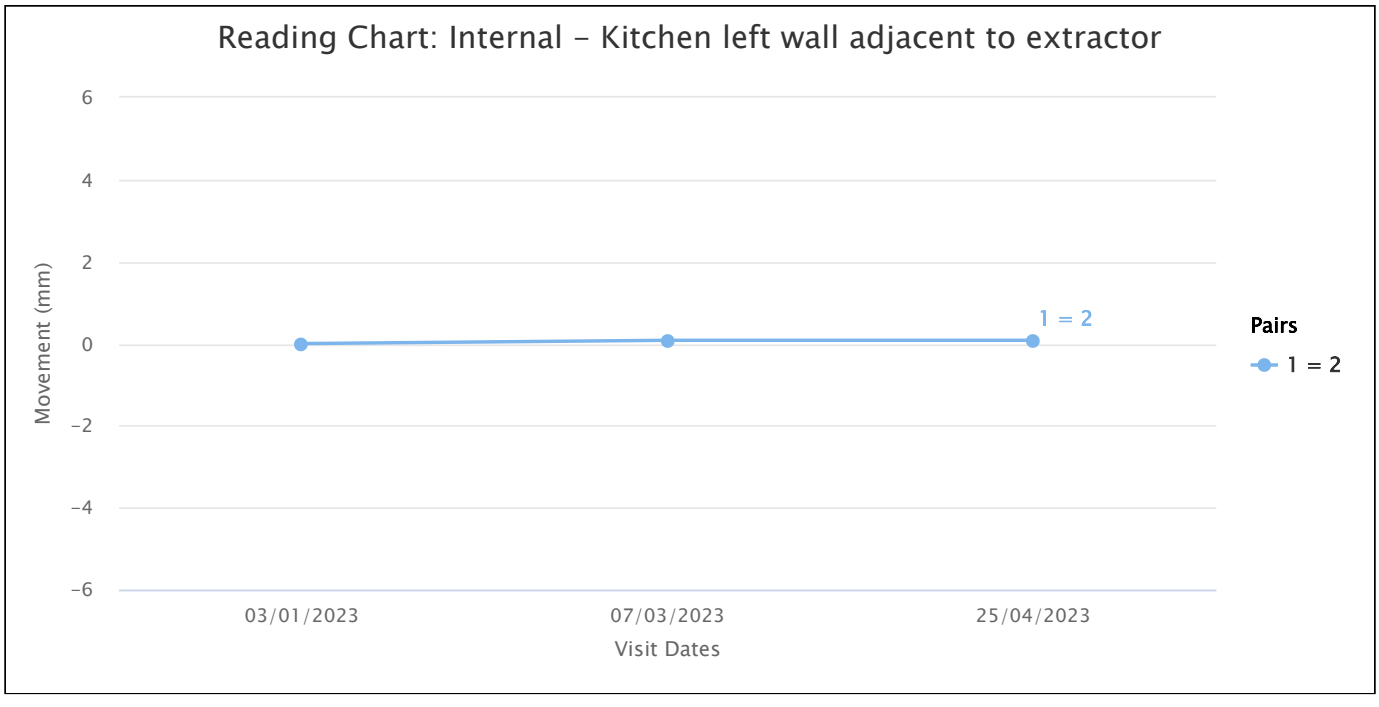
Crack Reading Chart

Crack Readings (Displayed in millimetres) - Kitchen left wall adjacent to extractor

Visits	1 = 2 H
03/01/2023	88.27
07/03/2023	88.35
25/04/2023	88.35

Crack Reading Differences (Displayed in millimetres)

Visits	1 = 2 H
03/01/2023	N/A
07/03/2023	0.08 ↑
25/04/2023	0.00 =

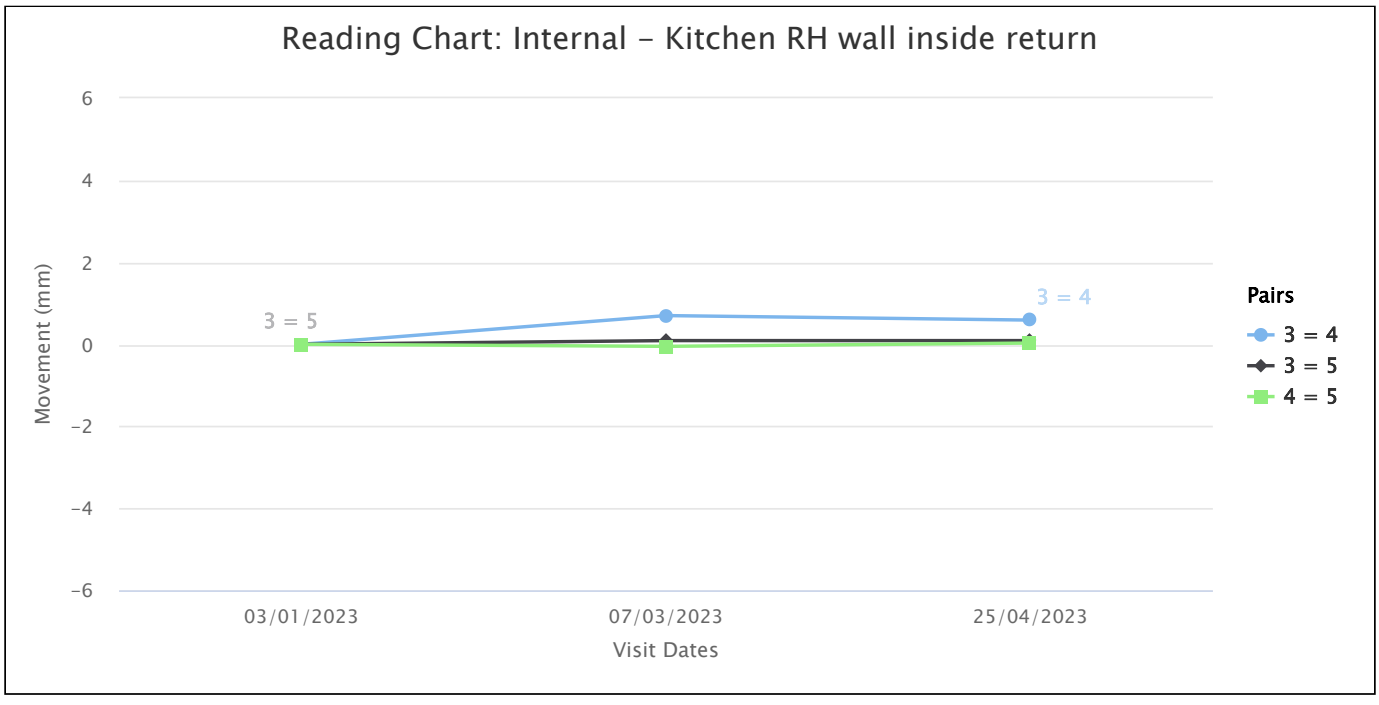
Crack Reading Chart

Crack Readings (Displayed in millimetres) - Kitchen RH wall inside return

Visits	3 = 4 H	3 = 5 V	4 = 5 DC
03/01/2023	57.16	62.82	81.36
07/03/2023	57.86	62.91	81.31
25/04/2023	57.75	62.91	81.39

Crack Reading Differences (Displayed in millimetres)

Visits	3 = 4 H	3 = 5 V	4 = 5 DC
03/01/2023	N/A	N/A	N/A
07/03/2023	0.70 ↑	0.09 ↑	-0.05 ↓
25/04/2023	-0.11 ↓	0.00 =	0.08 ↑

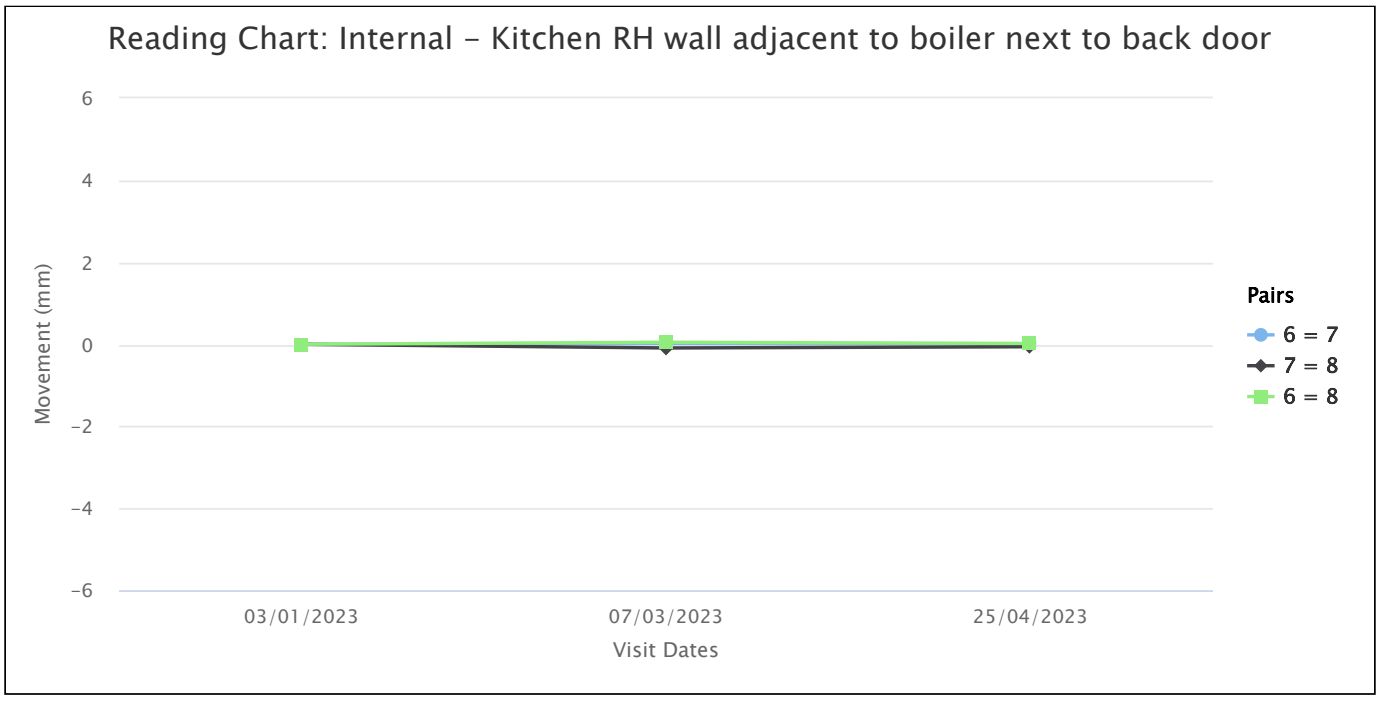
Crack Reading Chart

Crack Readings (Displayed in millimetres) - Kitchen RH wall adjacent to boiler next to back door

Visits	6 = 7 H	7 = 8 V	6 = 8 DC
03/01/2023	88.16	84.24	132.25
07/03/2023	88.18	84.15	132.30
25/04/2023	88.17	84.18	132.27

Crack Reading Differences (Displayed in millimetres)

Visits	6 = 7 H	7 = 8 V	6 = 8 DC
03/01/2023	N/A	N/A	N/A
07/03/2023	0.02 ↑	-0.09 ↓	0.05 ↑
25/04/2023	-0.01 ↓	0.03 ↑	-0.03 ↓

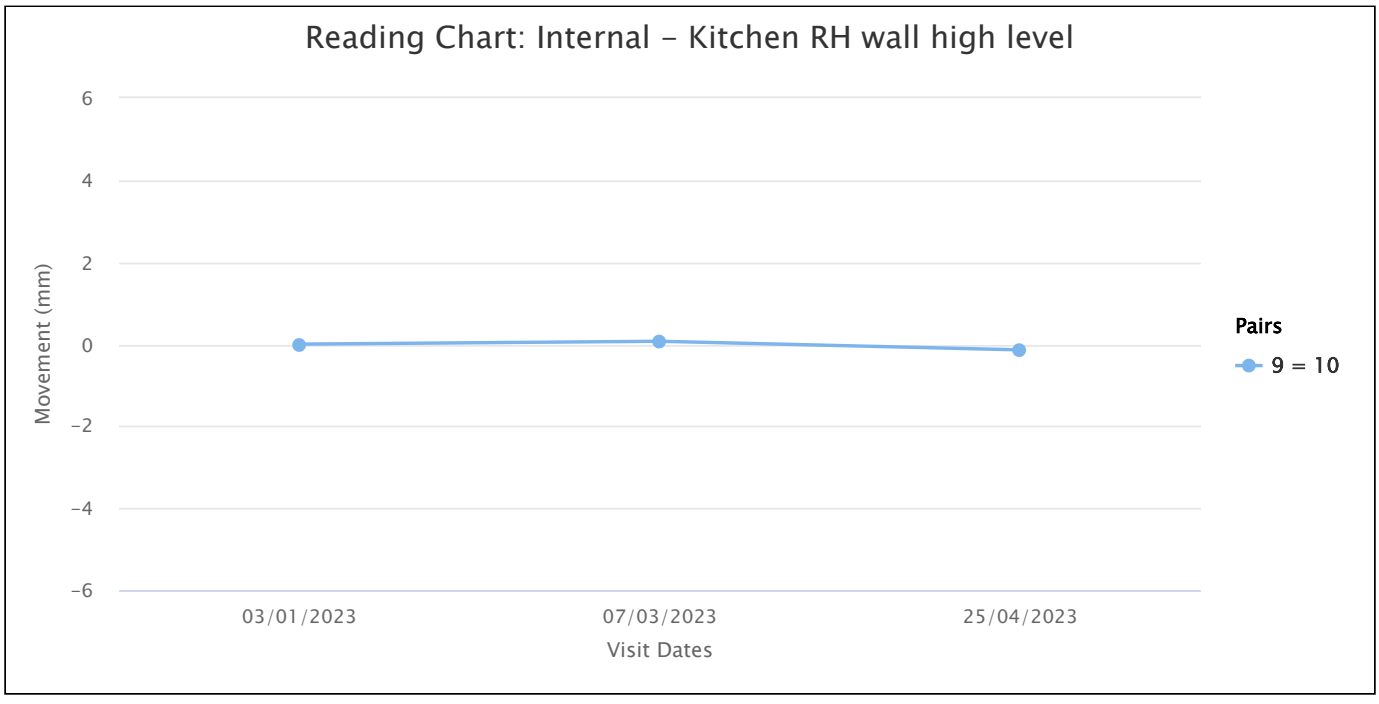
Crack Reading Chart

Crack Readings (Displayed in millimetres) - Kitchen RH wall high level

Visits	9 = 10 H
03/01/2023	99.81
07/03/2023	99.88
25/04/2023	99.67

Crack Reading Differences (Displayed in millimetres)

Visits	9 = 10 H
03/01/2023	N/A
07/03/2023	0.07 ↑
25/04/2023	-0.21 ↓
