Heritage statement & DAS  
Land to west of 2 King's road,  
London N17 8NP

Reclaimed Brick and proposed lime mortar

## Reclaimed bricks for rebuilding front wall: Enclosure strategy

**Condition 3(b)** Repair works to front existing wall:  
Retain Front External Envelope

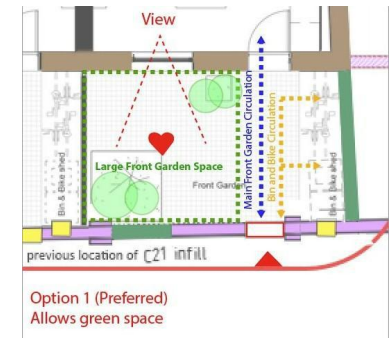
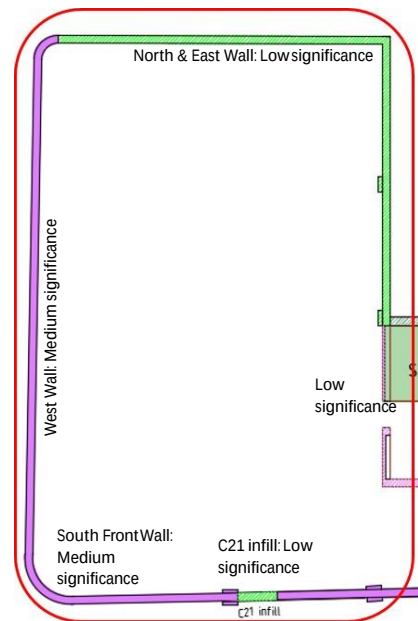
Current existing bricktype

The scheme proposed to retain and repair the medium significant as structural report also suggest that the South Wall has lateral deflection and will be require repointing and repair.

The whole wall has many damaged facing brickwork and deteriorated to such an extent that water could penetrate behind this section of brick and had forced it to bulge. The repair front garden wall brickwork will match the existing adjacent and be tuck pointed.

Following cleaning of the facade including piers and caps, an inspection will be carried out to determine the extent of brick and stone repair and pointing required. Prior to cleaning, loosely adhered deposits and growths to be removed using suitable corrosion resistant brushes with copper bristles, and scrapers/ spatulas that do not abrade or gouge the surface.

Brick repairs Minor areas of defective brick are to be cut back on individual bricks and repaired with lime mortar colored to match existing brick. Cement mortar to headers above ground floor window (far right image) is to be carefully removed for inspection, it may be necessary to cut out and replace individual red facing bricks to match existing bedded in lime mortar. Pointing - defective or missing mortar to be raked out and re-pointed in lime mortar to match existing.

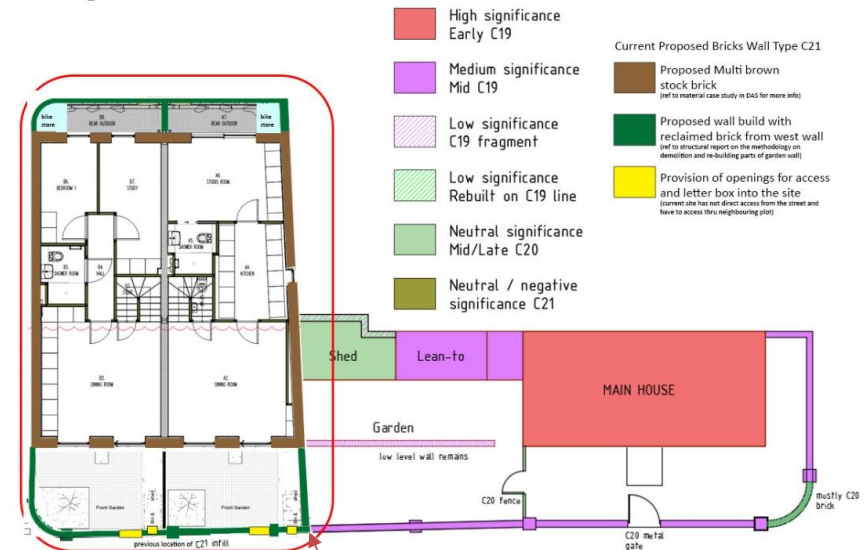
• Lateral deflections have developed due to the tree pushing against wall.

• The majority of the mortar is loose and requires to be repaired both at the front and rear.
