# Structural Report

A structural report prepared to inspect the site and appraise the condition of the south front boundary walls.

Property located in Land to west of 2 King's road N17 8NP.

Undertaken by Kenan Taylan(BEng).

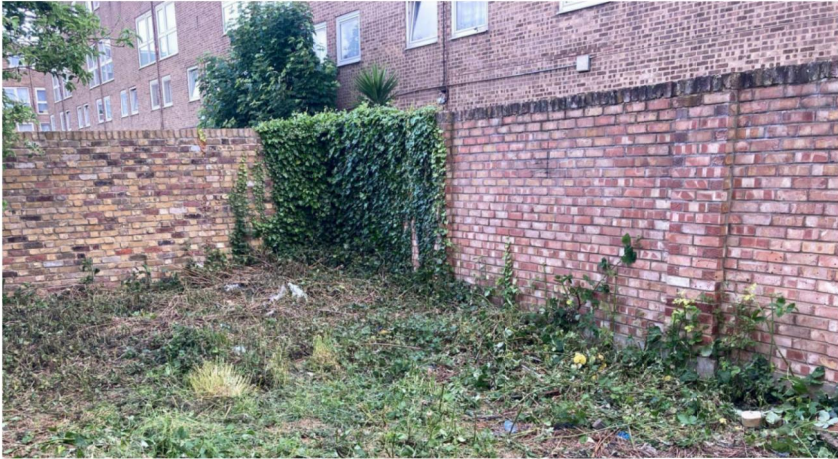
northeast facing

Northern and Eastern Walls collapsed before 2015 and was rebuilt with c20 brick by previous owners without LBC

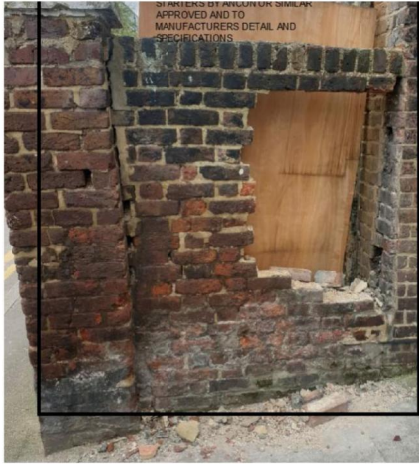
Images Extracts from structural report for planning for listed building

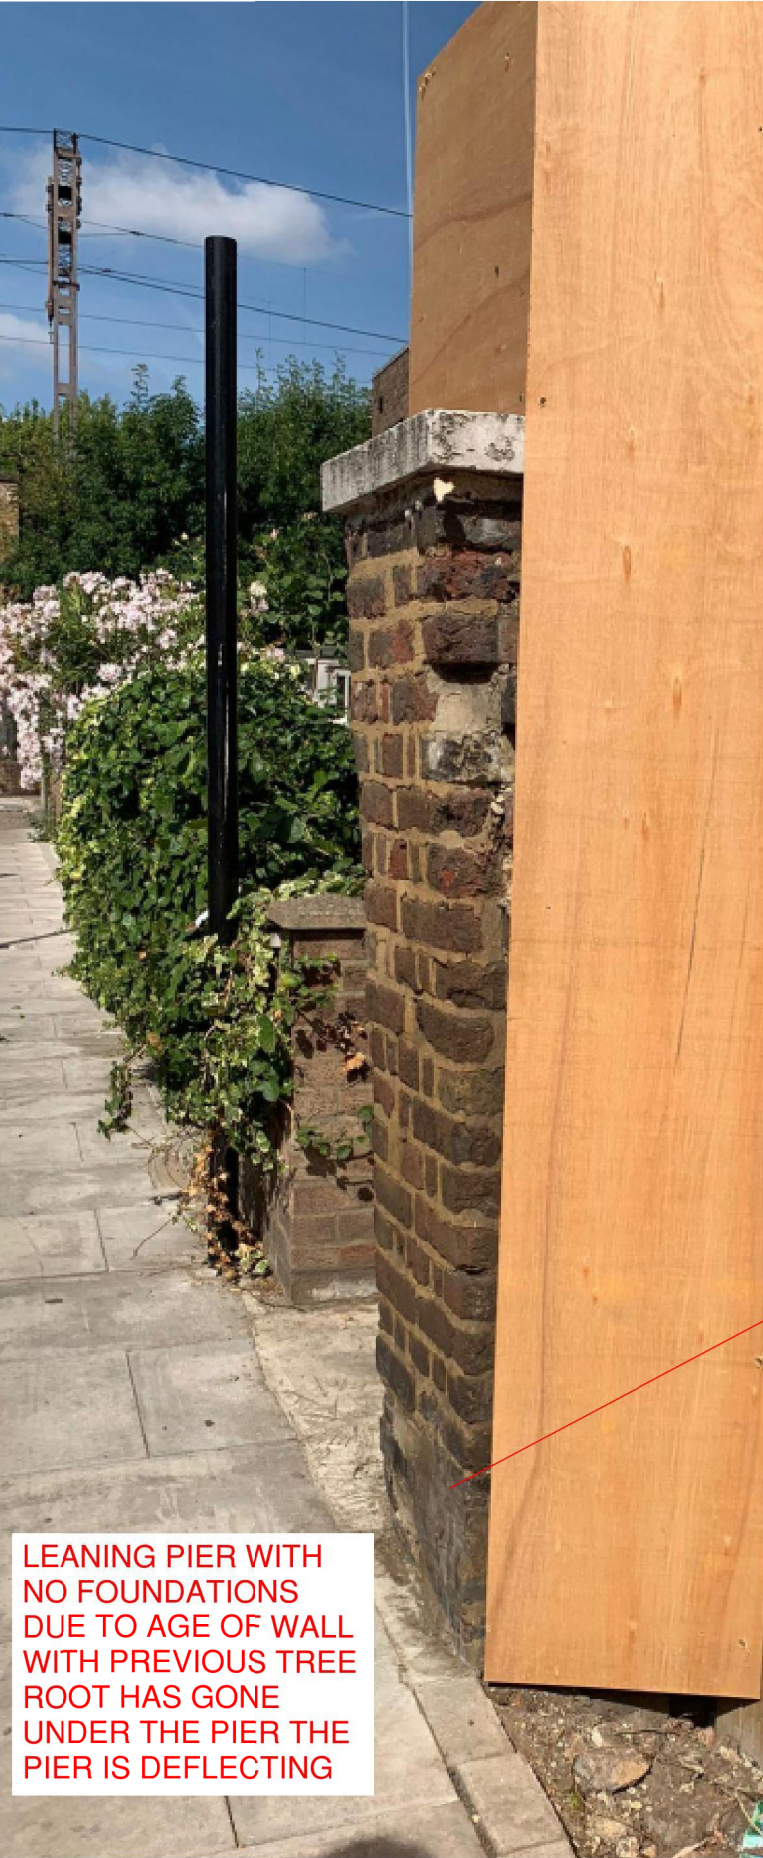
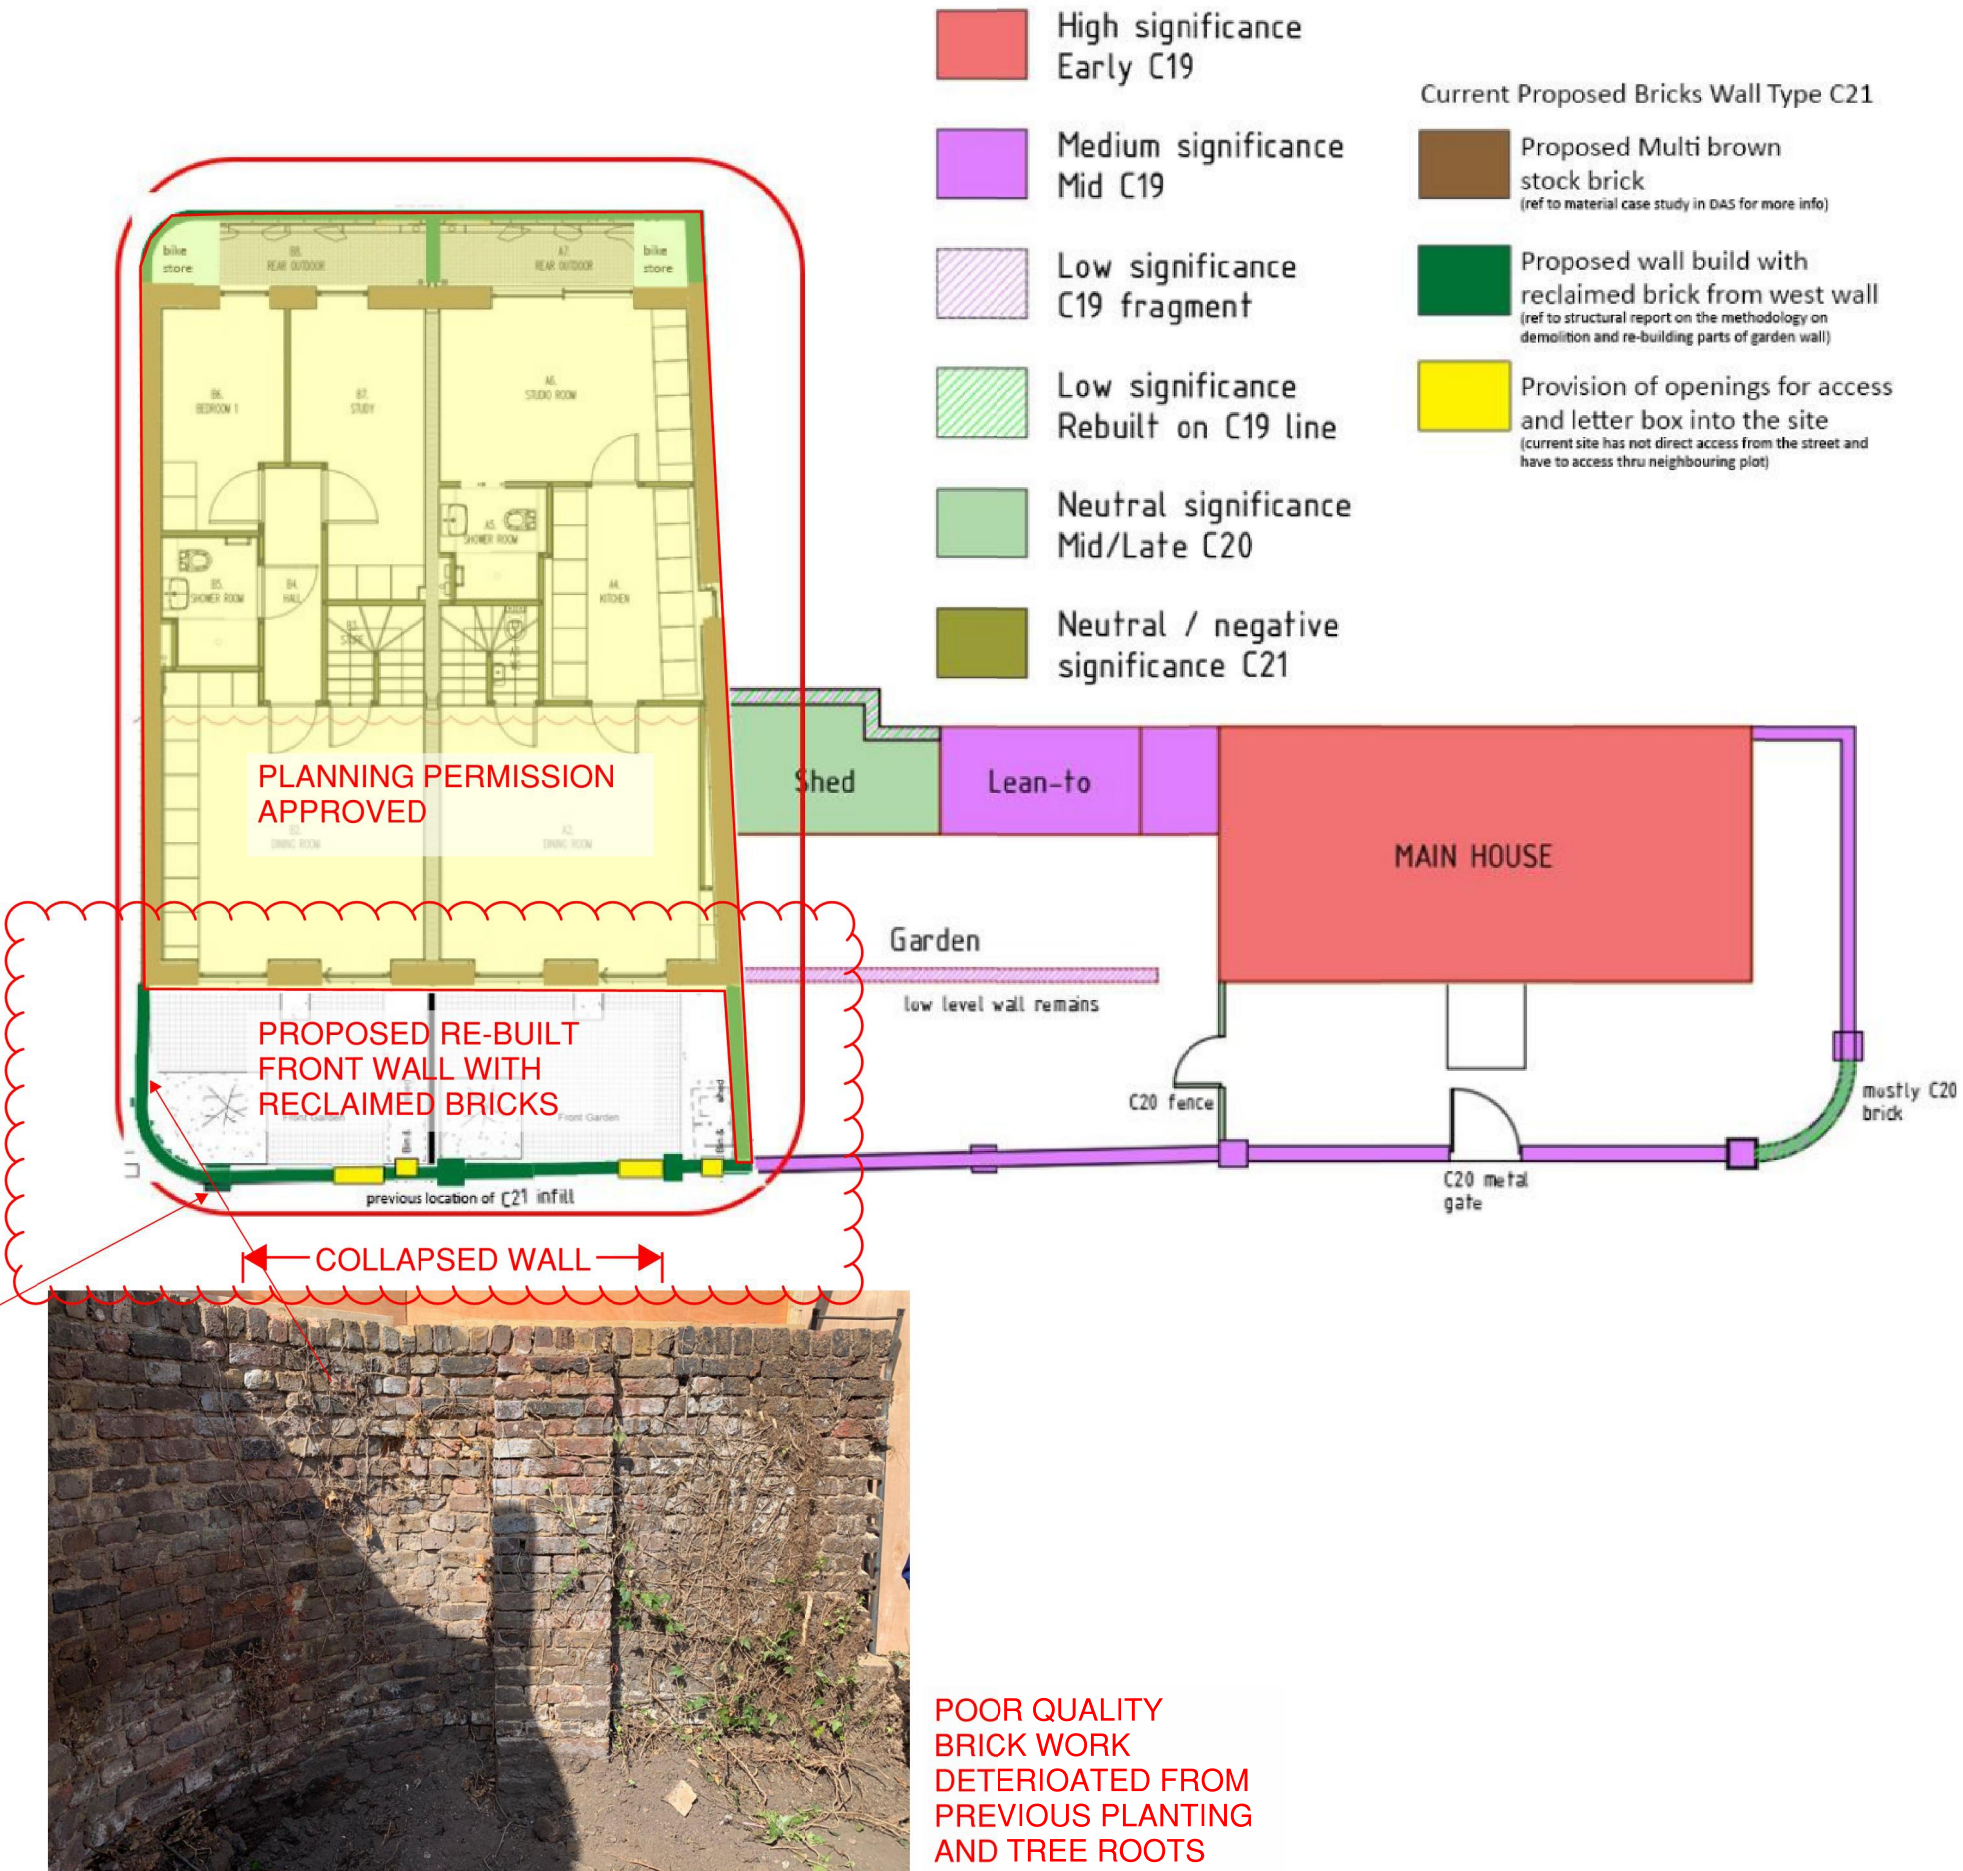
SITE CONDITION AND PROPOSED

The wall was constructed with brick with 1900 mm height with 250mm width but due to lateral load and ground movement a portion of wall collapsed and deviated laterally more than the permissible deviations for masonry elements tolerances ( BS EN 1996-2:2006). Refer to Images. Most of bed joint for brick wall losing their bonding capacity and the pier was supposed to strengthen wall laterally but unfortunately due to wall movement pier lose functionality.
