## **Heritage Statement**

**120 Crouch Hill  
Crouch End  
London  
N8 9DY**

October 2022

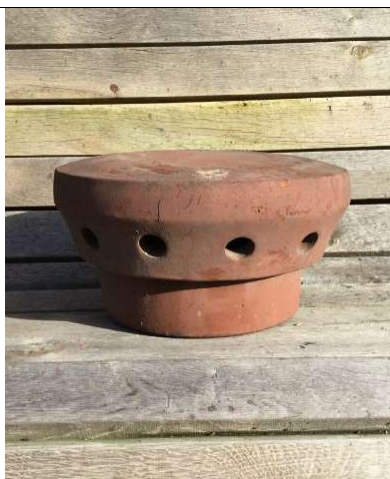
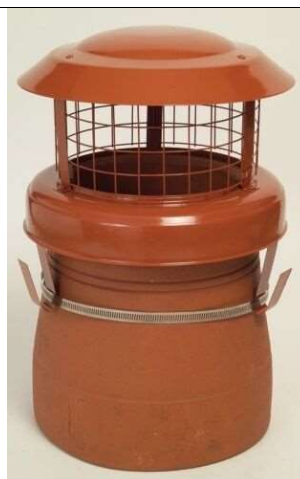
Images 14 & 15- Proposed clay pepperpot ventilation flue for (disused chimney pots)  
Powder coated metal Terracotta colored rain cowls (active chimneys)

6.8 Subject to further survey, it is proposed to install reclaimed clay ventilation flues or new rain cowls to each open chimney pot (6nr in total) to reduce the risk of rain water ingress and animal infestation. Whilst these new cowls are being added, the general condition of the chimneys is to be assessed and it may also be necessary to undertake further critical repair work to the chimneys including:-

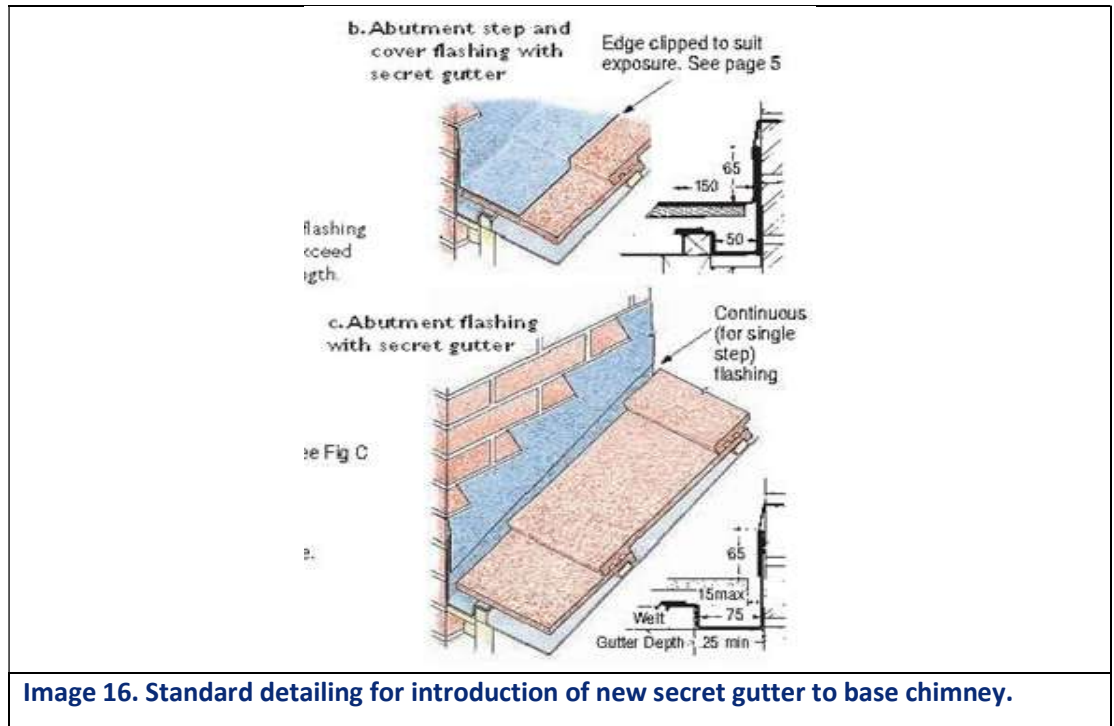
**Image 16. Standard detailing for introduction of new secret gutter to base chimney.**

- Reinstate slate tiles allowing to re-size tiles as required to avoid smaller `cut to size` tiles.
    - Laying new code 5 lead secrete gutter, with front apron, side flashings and a back gutter with cover flashings (saddles). All in accordance with accordance with Lead Sheet Training Academy Guidance.
