## **Heritage Statement**

**120 Crouch Hill  
Crouch End  
London  
N8 9DY**

October 2022

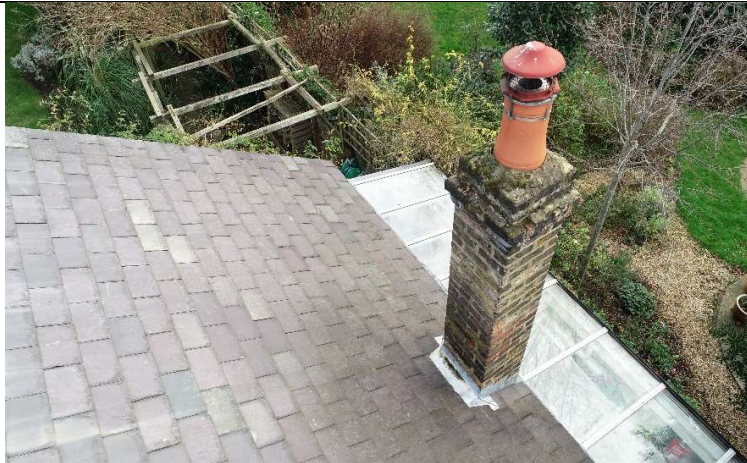
**Image 12. Chimney to rear extension with rain cap cowl fitted. (No works required)**

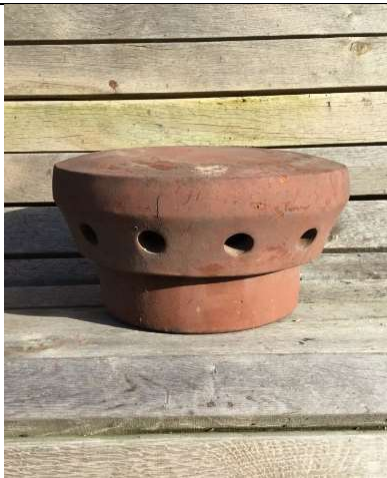
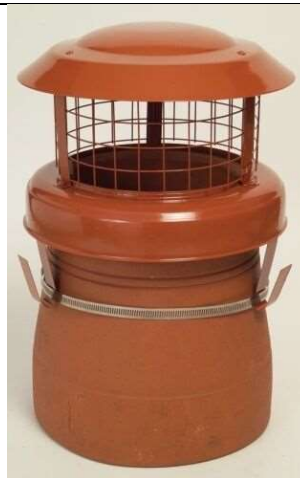
**Images 15 & 16- Proposed clay pepperpot ventilation flue for (disused chimney pots)  
Powder coated metal Terracotta colored rain cowls (active chimneys)**

6.8 Subject to further survey, it is proposed to install reclaimed clay ventilation flues or new rain cowls to each open chimney pot (6nr in total) to reduce the risk of rain water ingress and animal infestation. Whilst these new cowls are being added, the general condition of the chimneys is to be assessed and it may also be necessary to undertake further critical repair work to the chimneys including:-

- Rake off any excess moss and lichen growth from the mortar joints and re-point using lime based mortar.
- Removing and replacing and cracked/damaged clay chimney pots on a like for like basis.
- Re-flaunching around chimneys and re-pointing angle bead on brick ledge to minimize water penetration into the brickwork.
- It is proposed to introduce new code 5 lead secret gutters around the base of the chimneys whilst also addressing the issue of the mismatching roof tiles sizes used during previous repairs. Works to introduce the new lead secret gutters will generally involve:-
- Opening up around the perimeter of the chimney structures, review condition of roof timbers and carry out repairs in accordance with BRE guidance
