**CCTV REPORT FOR: 15 STANHOPE GARDENS  
LONDON  
N6 5TT**

**Insured:** Miss Z Watt  
**Reference:** 212706

**Site Visit:** 13-Apr-22  
**Report Date:** 03-May-22

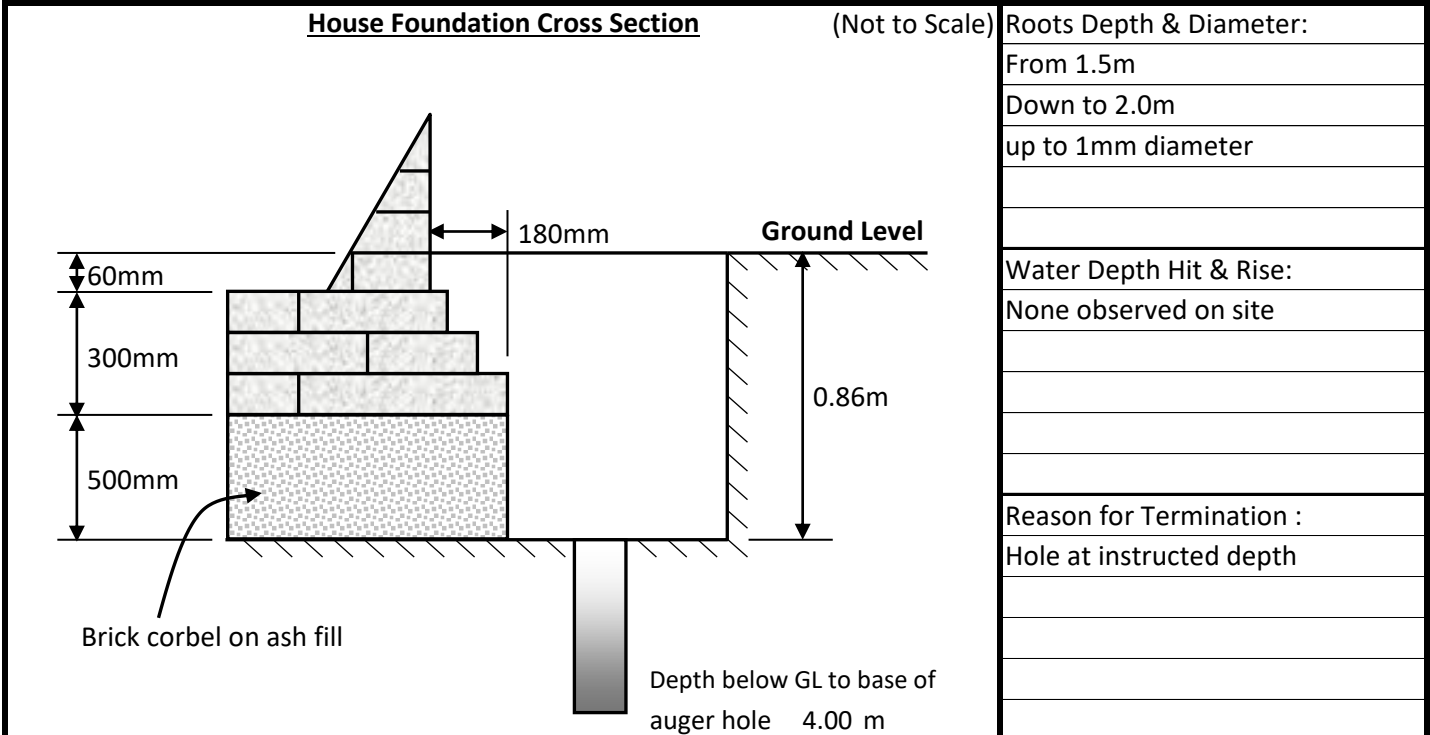
| Location: <b>Junction house and extension</b> | T/H No. <b>1</b> |

| Depth (m) | Soil Descriptions<br><i>(NB: Field crew description only)</i> | Test Type | Depth (m) | |
|---|---|---|---|---|
| 0.80 | Stiff brown mottled grey CLAY | P.P. 2.5 | 0.800 | |
| 4.00 | End of Borehole | P.P. 2.5 | 1.000 | |

| Roots Depth & Diameter: |
| From 0.9m |
| Down to 2.0m |
| up to 1mm diameter |
