# Design & Access Statement for repairs to Pier and Wall on Land Adjacent to no.86 Southwood Lane, N6 5SY

16th October 2022

Ref: SHERCO\_RP\_01 (Rev A)

**Client:** Southwood House Estates Residents Company Limited (SHERCO)

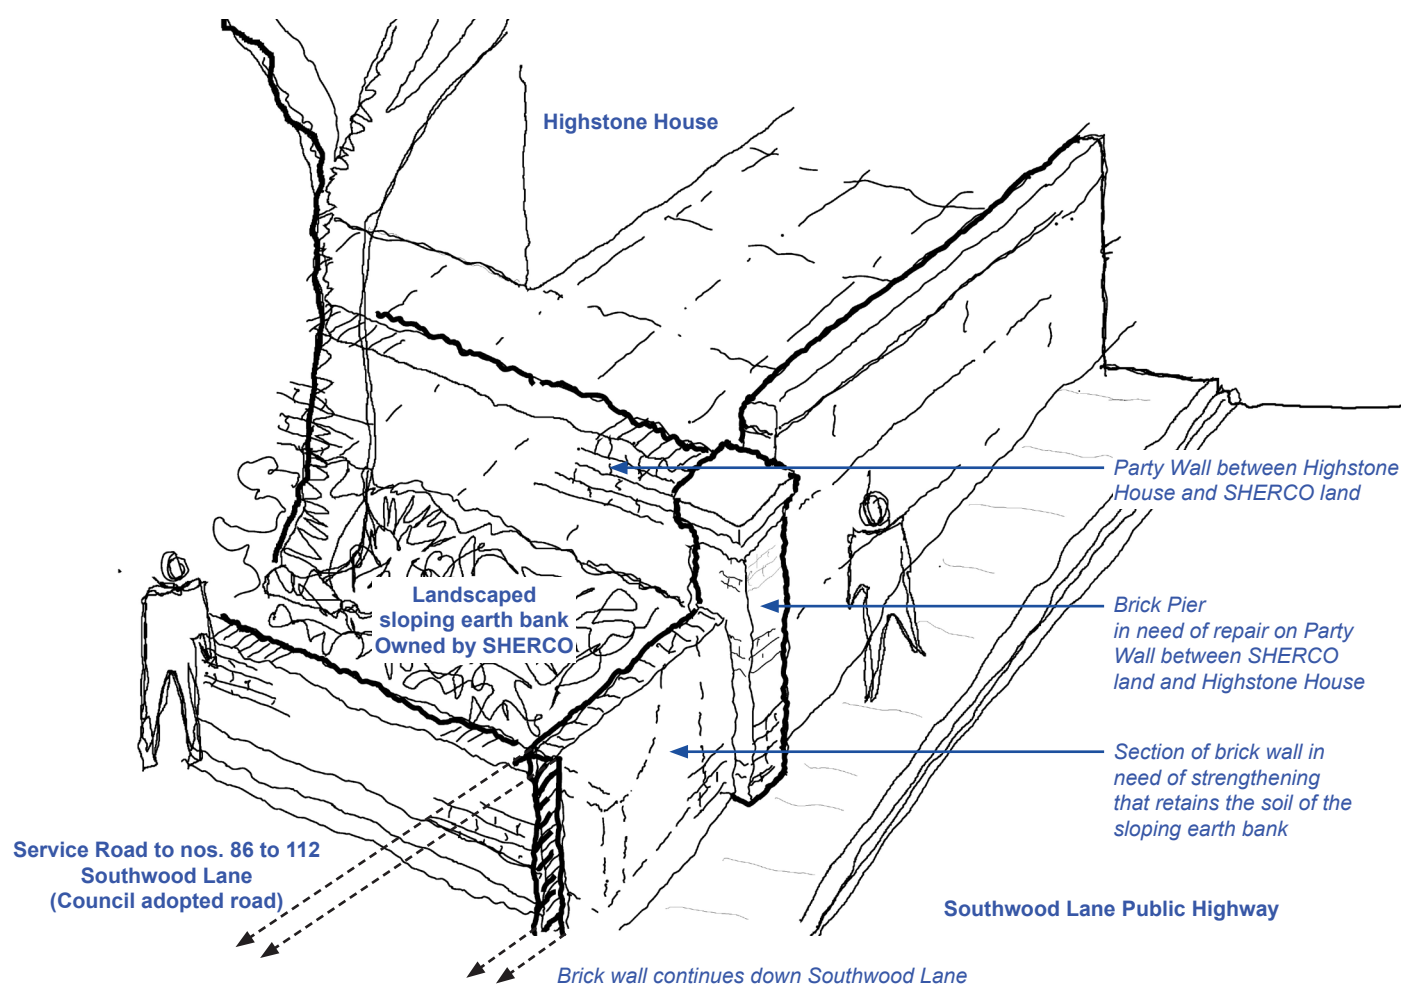
Figure 5 - Sketch showing principal components of the site and the pier and wall that are in need of repair

1. The condition of the Pier is such that it requires partial rebuilding and tying into the adjacent party fence wall.
2. The wall adjacent to the pier is recommended to be strengthened.
3. The entire length of wall should be comprehensively repointed.
