OLD SCHOOL COURT  
TOTTENHAM, NI7 6LY

REPORT INTO INVESTIGATION OF DEFECTS CAUSED BY DAMP AT  
FLATS 1, 2, 24 AND 25 OLD SCHOOL COURT

March 2022

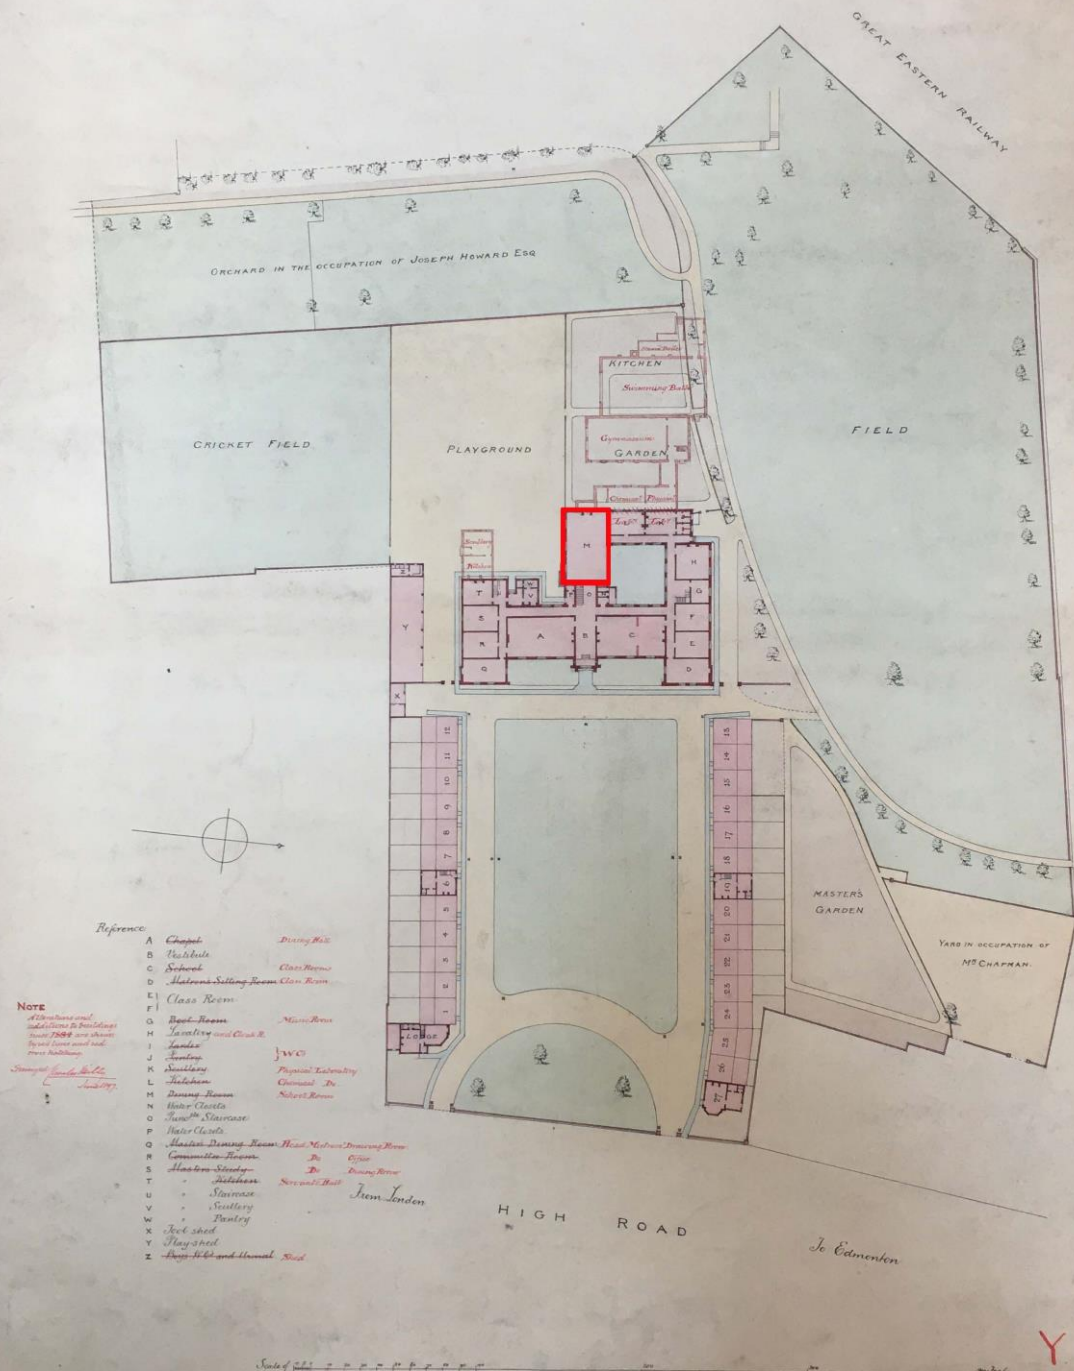
DRAPER'S COLLEGE  
TOTTENHAM.  
NOW  
TOTTENHAM HIGH SCHOOL FOR GIRLS.

*1884 and 1897 drawing by Charles Riley showing the school, almshouses and lodge, and the proposals for new buildings, including a swimming bath and gymnasium, all of which were eventually executed. Flats 24, 25 and 26 are in the block outlined in red.*

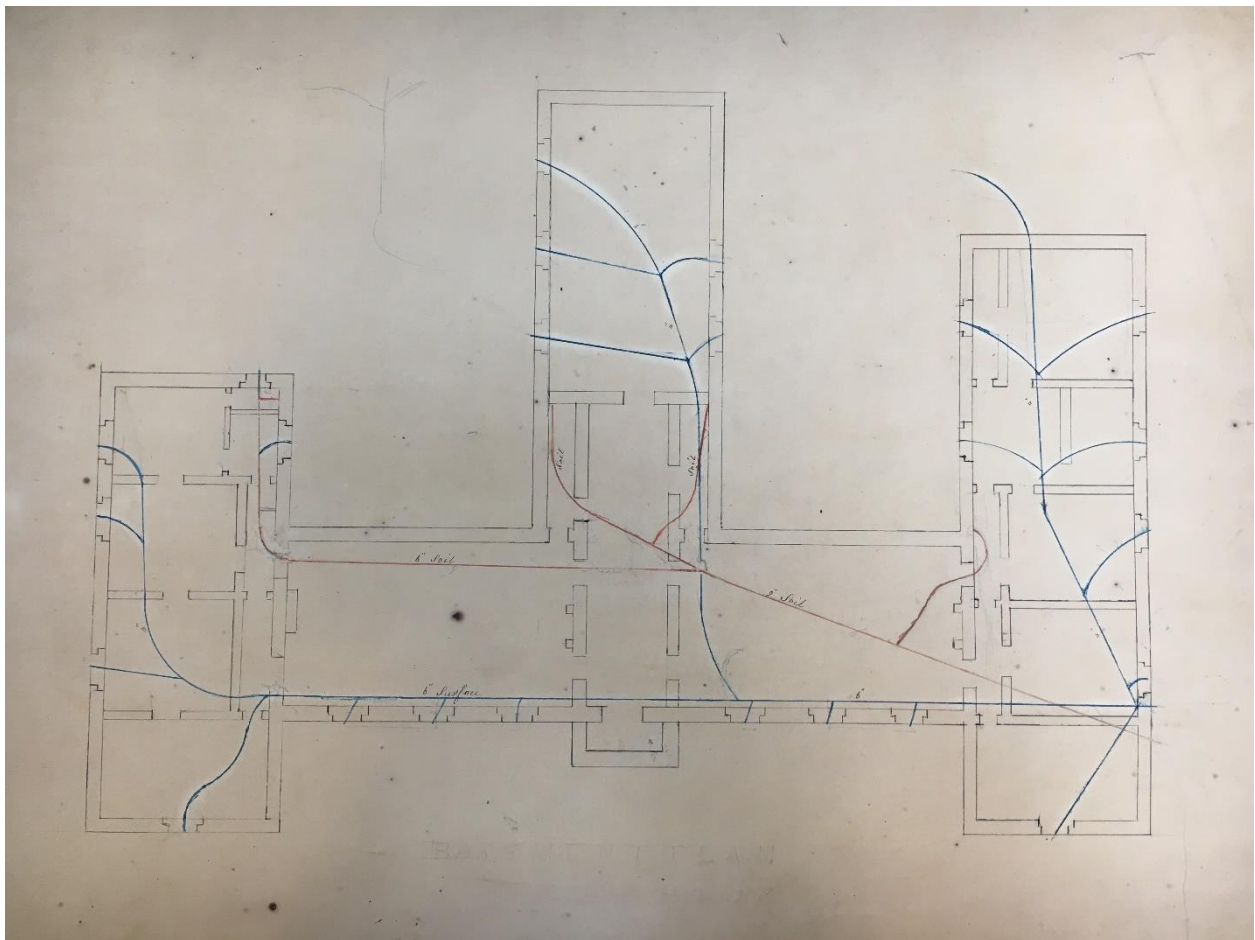
*The original contract drainage plan of the 1860 scheme. The system was “separate”, that is rainwater and foul run separately (blue and red). Note that all the drains are at very low level – running below the basement floor level and laid to swept curves.*

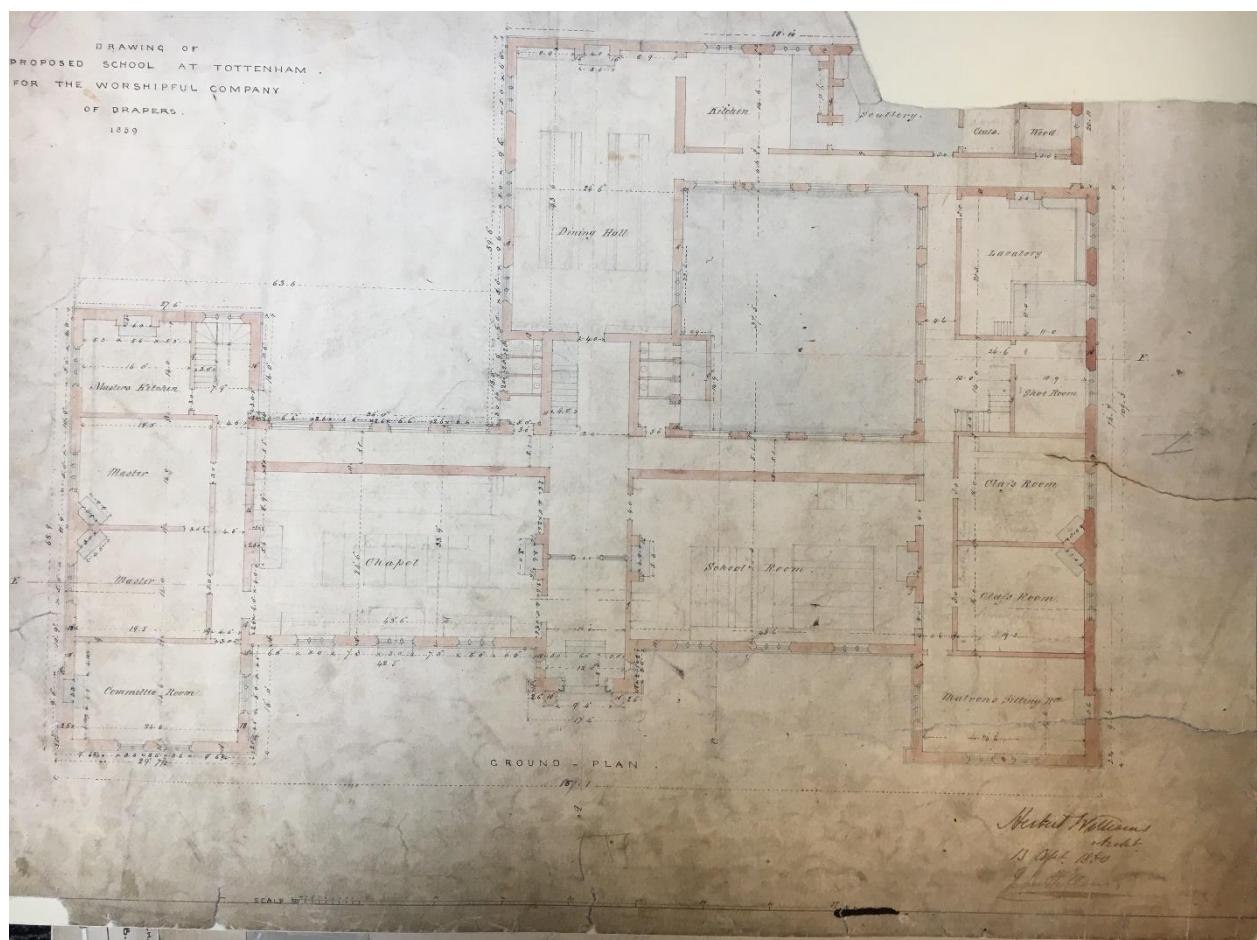
*Drawing dated 13 April 1860 Contract Drawing. This beautifully drawn plan shows the original layout. The large rooms to the centre top, the Dining Hall, is now subdivided into 3 to form flats 24, 25 and 26. All walls etc are carefully dimensioned and concur with on site observations. Note the original fireplaces, to be superseded by oil fired heating with boilers located below No. 24 and storage tanks below part of 24 and 25.*

*Conventional colours are used to denote materials; red for brick, pale yellow on plan for wooden floor, grey/blue on plan for stone floor, for example at the hearth in the dining room. Note that the corridors are marked as timber floors.*

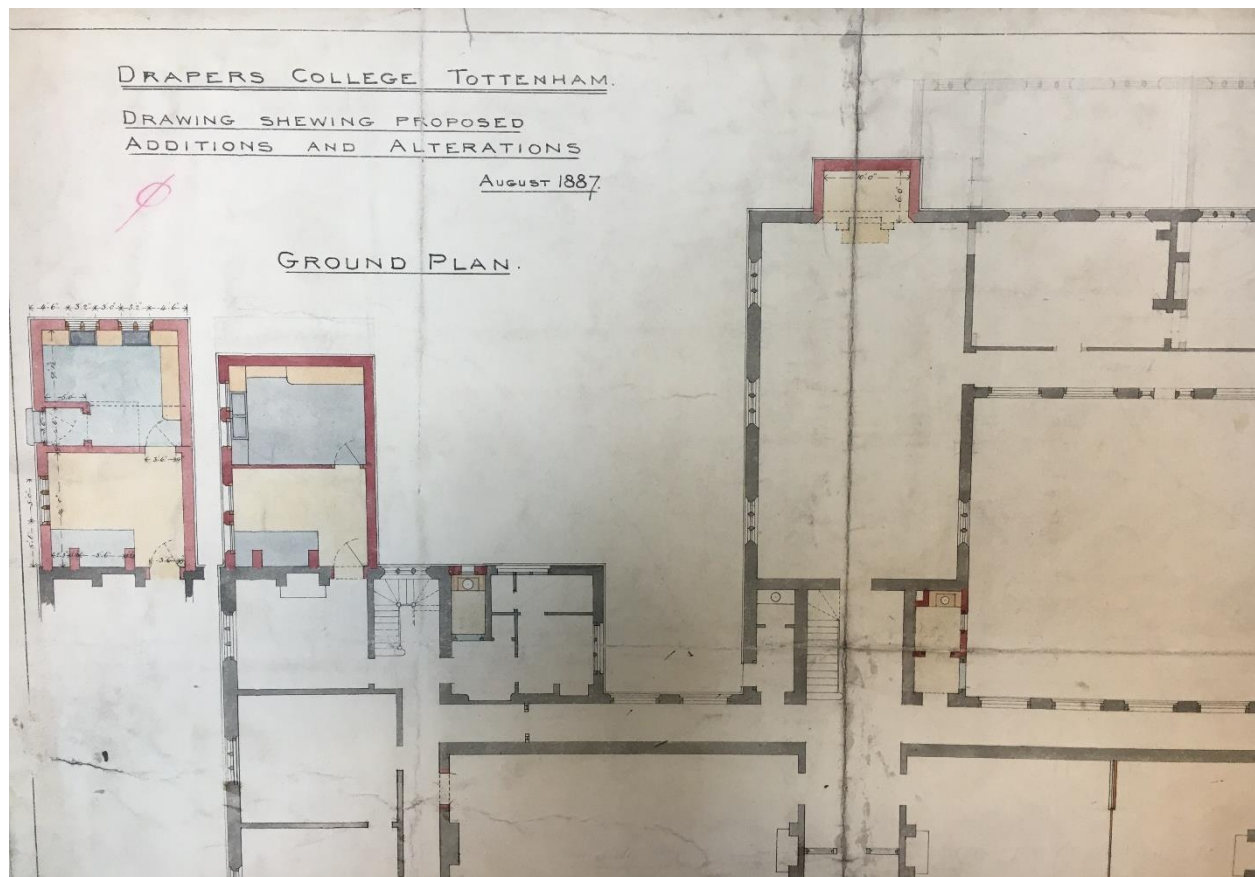
*Dated 1887 this drawing shows proposals for alterations that were executed. The dining hall is extended with a wooden floored recess at the “high end”. This space is incorporated into Flat 24.*

In 1887 various alterations and additions were drawn up and from the evidence on site we can see that they were executed. Some alterations related to the 24, 25 part of the building. The large fireplace in the dining hall (now 24) was removed and an out-shoot extension made in its place, and this is what we now see on site. Perhaps heating arrangements were revised at this time, moving from coal to oil, because there is no fireplace shown to serve the dining hall. The kitchen at 1887 still adjoins and the window into the enclosed courtyard remains in place at this stage. Amendments made in 1887 to the 1862 basement plan indicate that an external stair down to the basement (Flat 25, position as described above) was proposed. The two outer wings of the building (basement level) have designated uses, variously for coals, scullery (master’s house), larder, and 2 beer cellars! The spaces below 24 & 25 are not marked for any designated use in the 1887 drawing, but the basement plan clearly shows that all the basement open areas were fitted with wooden window frames, whereas the upper storey windows are all in Portland stone. (The drawings are coloured in the traditional convention, pink for brick, blue for stone and brown/yellow for wood). The width of all the walls is marked on plan and in sections.

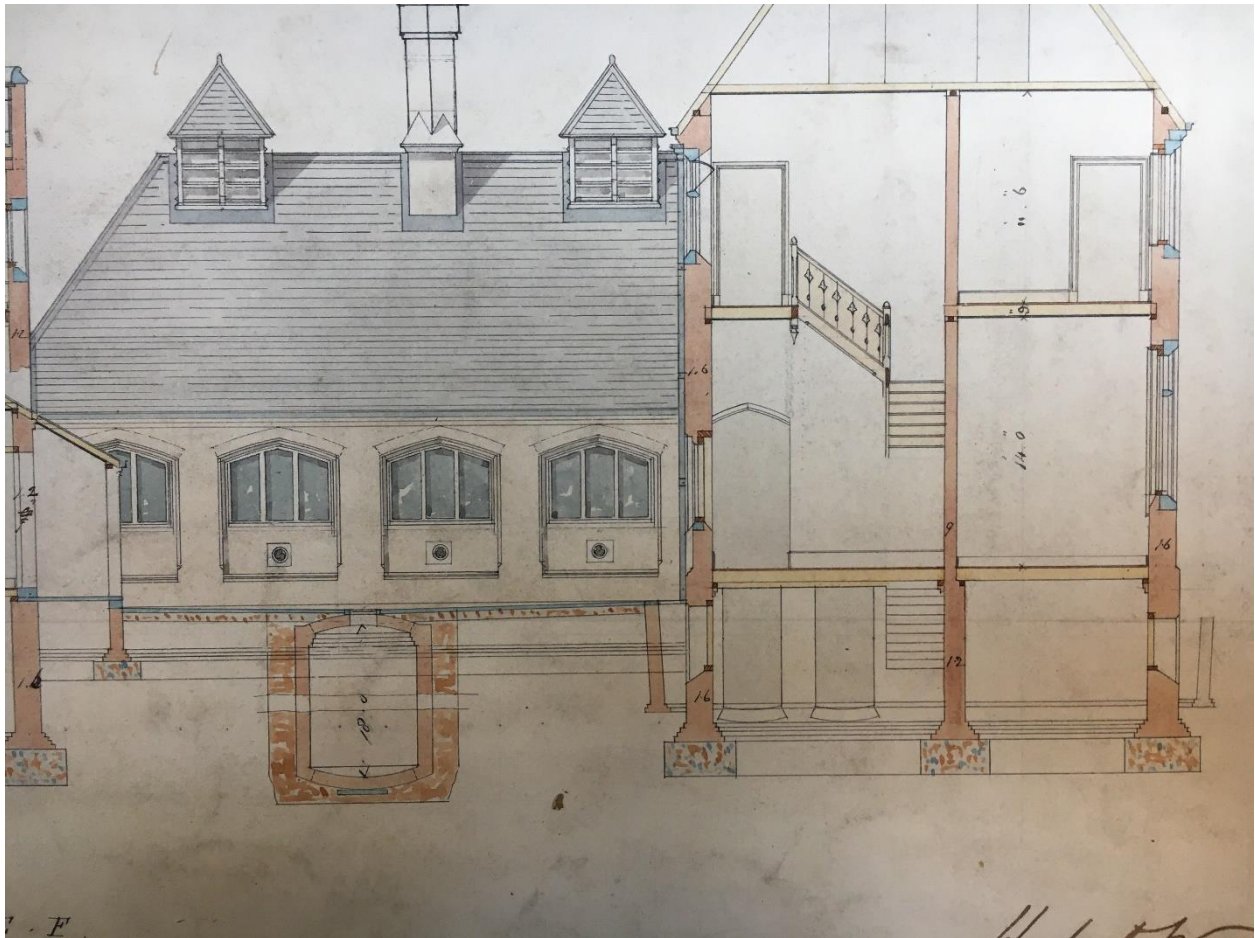
Section through courtyard (1860) looking towards the kitchen and scullery (hence large roof ventilators, all now demolished) and section through the north wing. The courtyard surface, shown as stone surface drains into a large silt catch pit. In particular note the brick retaining walls to the basement window areas. The basement windows are shown as wood set to the inner face of the wall, which is 2.5 bricks thick at the basement. Floor wall plates are shown seated on two courses of corbelled brickwork – as observed on site.

With regard to the basement/ground floor construction the section drawings (Section Lines A-B and E-F on the ground plan) are particularly informative. The section A-B clearly shows basement windows to the 24, 25 basement space and the section E-F shows the construction of the areas outside basement windows. The section E-F also shows what appears to be a drainage silt tank in the centre of what was then an enclosed courtyard.

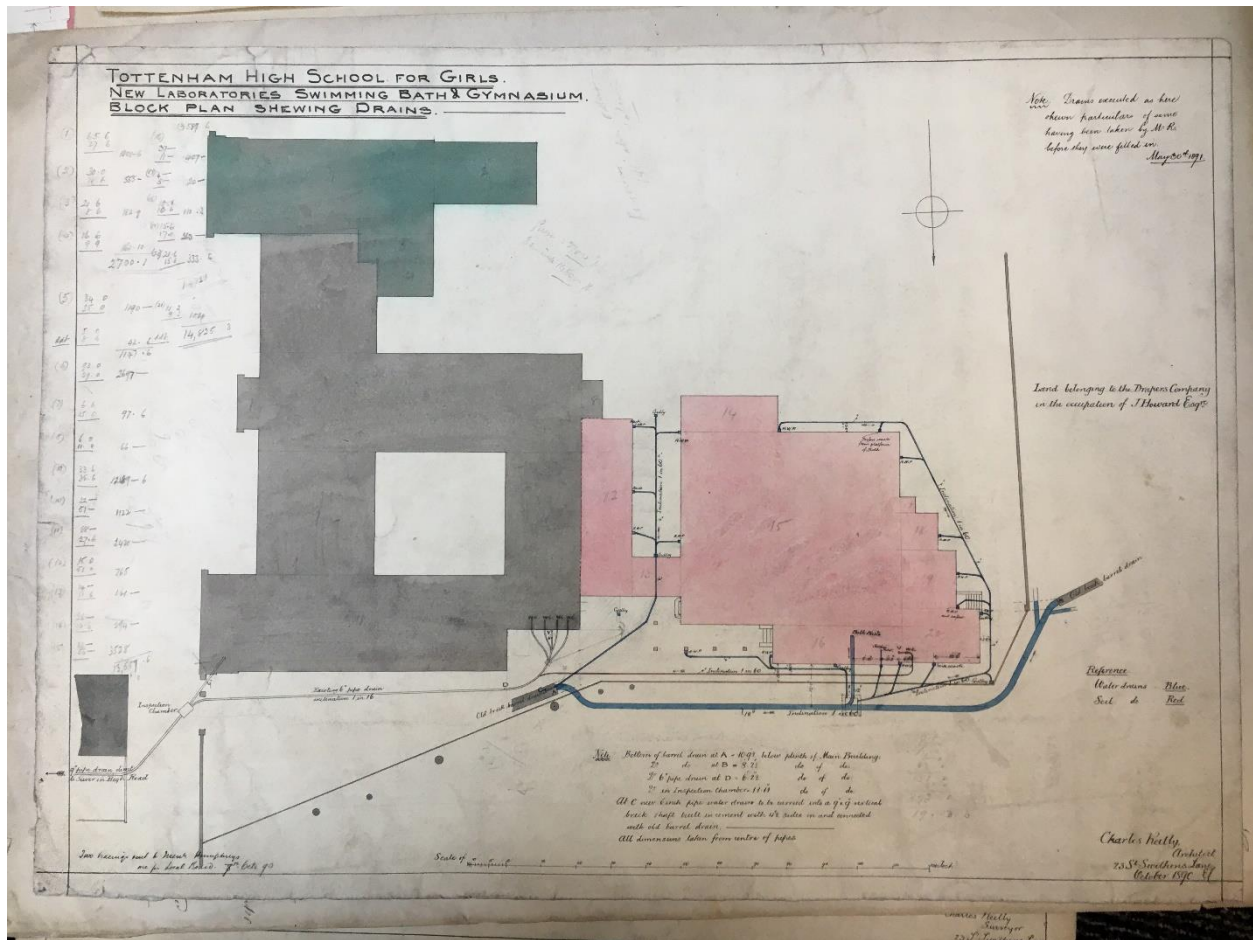
Development of the school continued and in 1890 there was a major development to provide laboratories, a gymnasium and a 50' x 25' swimming pool all drawn up by Charles Reilly (to become Head of Liverpool School of Architecture and Knighted). These buildings were built to adjoin the existing building at the kitchen and scullery wing at the back of the site. These large buildings have since been completely cleared away which brooks the question of where the demolition materials went? Was material spread across the cleared land to the rear of the school and did this result in levels being raised?
