# Site Investigation Report

140865.1.USI

| Overview | |
|---|---|
| Brief | Auger were commissioned by Crawford & Co to undertake a site investigation and CCTV inspection of the underground drainage within the area of concern (AOC) at the property. |

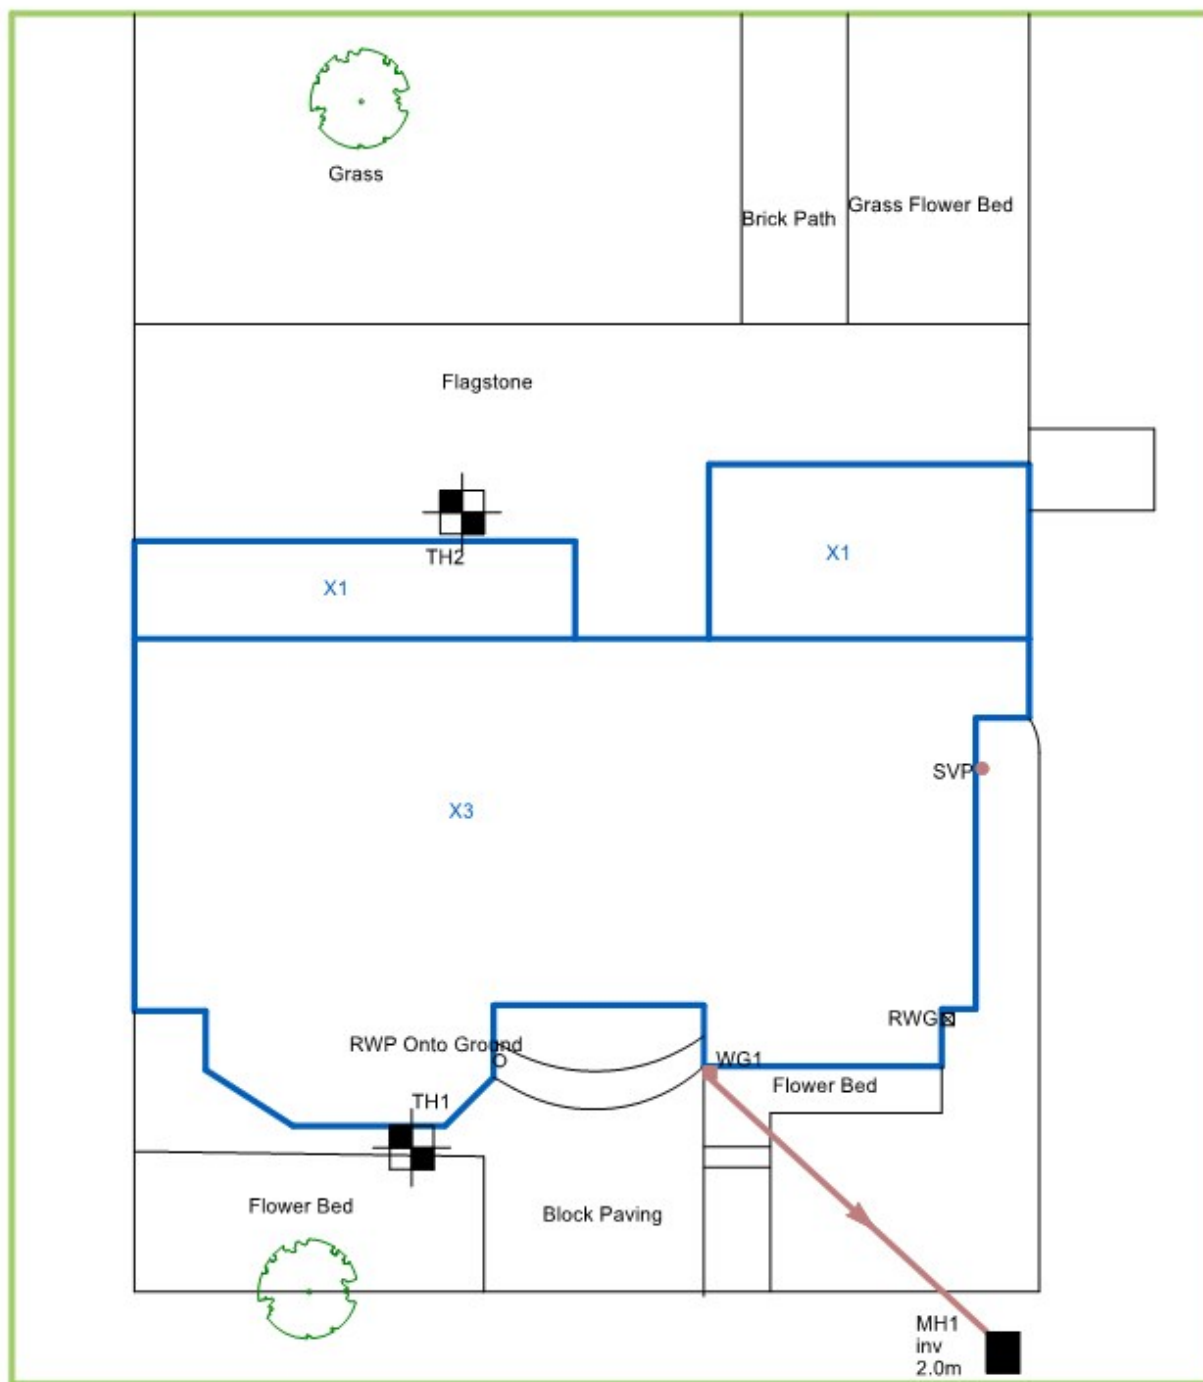
## FRONT OF PROPERTY

| Overview | |
|---|---|
| Visual Inspection | A visual inspection of the site revealed WG1 has broken/cracked. Our engineer also noticed that the trap in MH1 had a large fracture. However these were noted to be outside of the AOC. |
| | Dye testing was undertaken on WG1 to confirm it runs to MH1, the dye test did not reveal an escape of water. |
| Drain Survey | No CCTV survey of the underground drainage was undertaken whilst on site because there was No drainage within 3m of AOC |

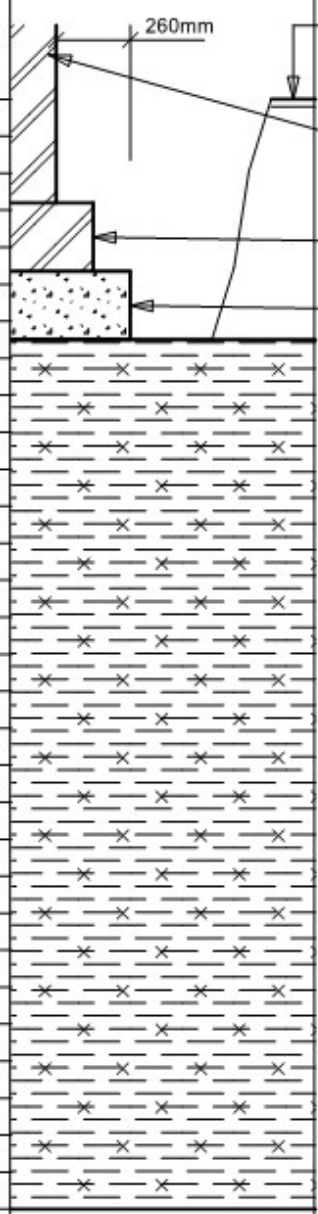
## Trial Hole Log No.2

| Overview | |
|---|---|
| Trial Hole Findings | TH1 and TH2 were able to reach the required depth in the proposed locations. Soil and root samples were taken. Water was encountered at 0.7m in TH2. |

Location: Rear projection

| Depth<br>(m) | Symbolic Log | Strata Description | Insitu Tests | | Soil<br>Sample | Root<br>Sample |
|---|---|---|---|--|---|---|
| | | Step Underpinned | | | | |
| | | Brown fine to medium gravelly silty CLAY | 70kpa | | Soil<br>@ 0.65m | |
