### No. 792 Ground Floor

3.0      **CONDITION 3 - APPROVAL OF DETAILS (PRE COMMENCEMENT)**

**(C) map of the exact location, extent, and assessment of conditions of historic stone floors to basement**

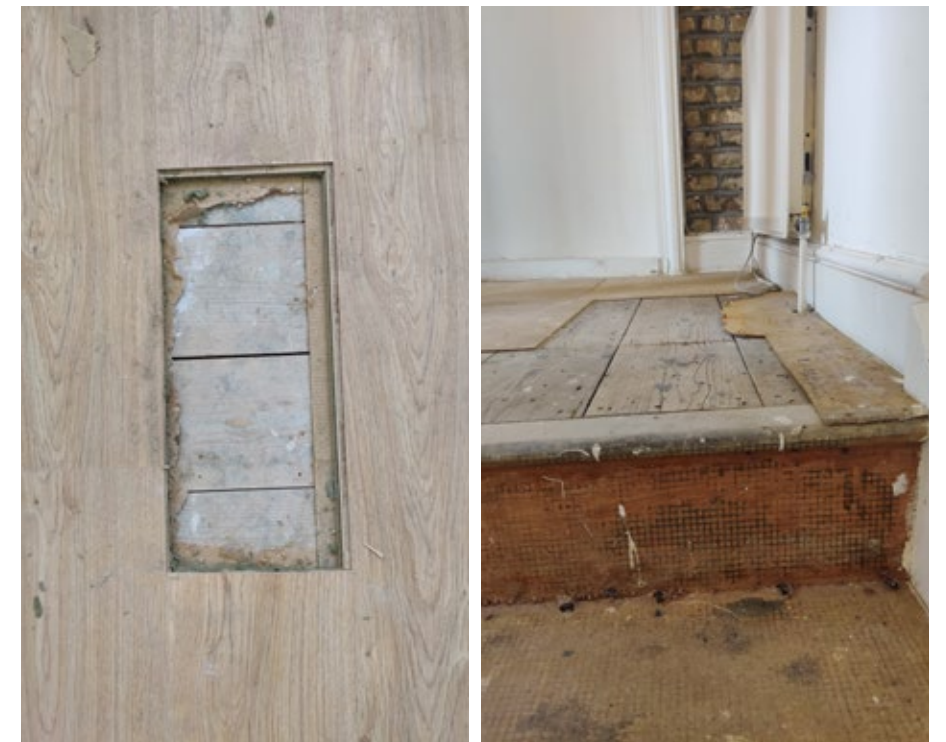
**FIGURE 38.** 794-S-06

- Investigative works were carried out by stripping out 500×500 mm of modern vinyl finish to reveal floorboards. Existing historic floor boards evident following strip out of modern finishes.
- Boards are in good condition. Allow for minimal like for like repairs required via the scarfing in of small sections of matching timber or glue sensitively where floorboards appear to be spliced with joints under 20MM wide.
- Note existing paint/adhesive marks : Sensitively use turpentine and allow for surface cleaning by hand scrapping without damaging historic fabric.

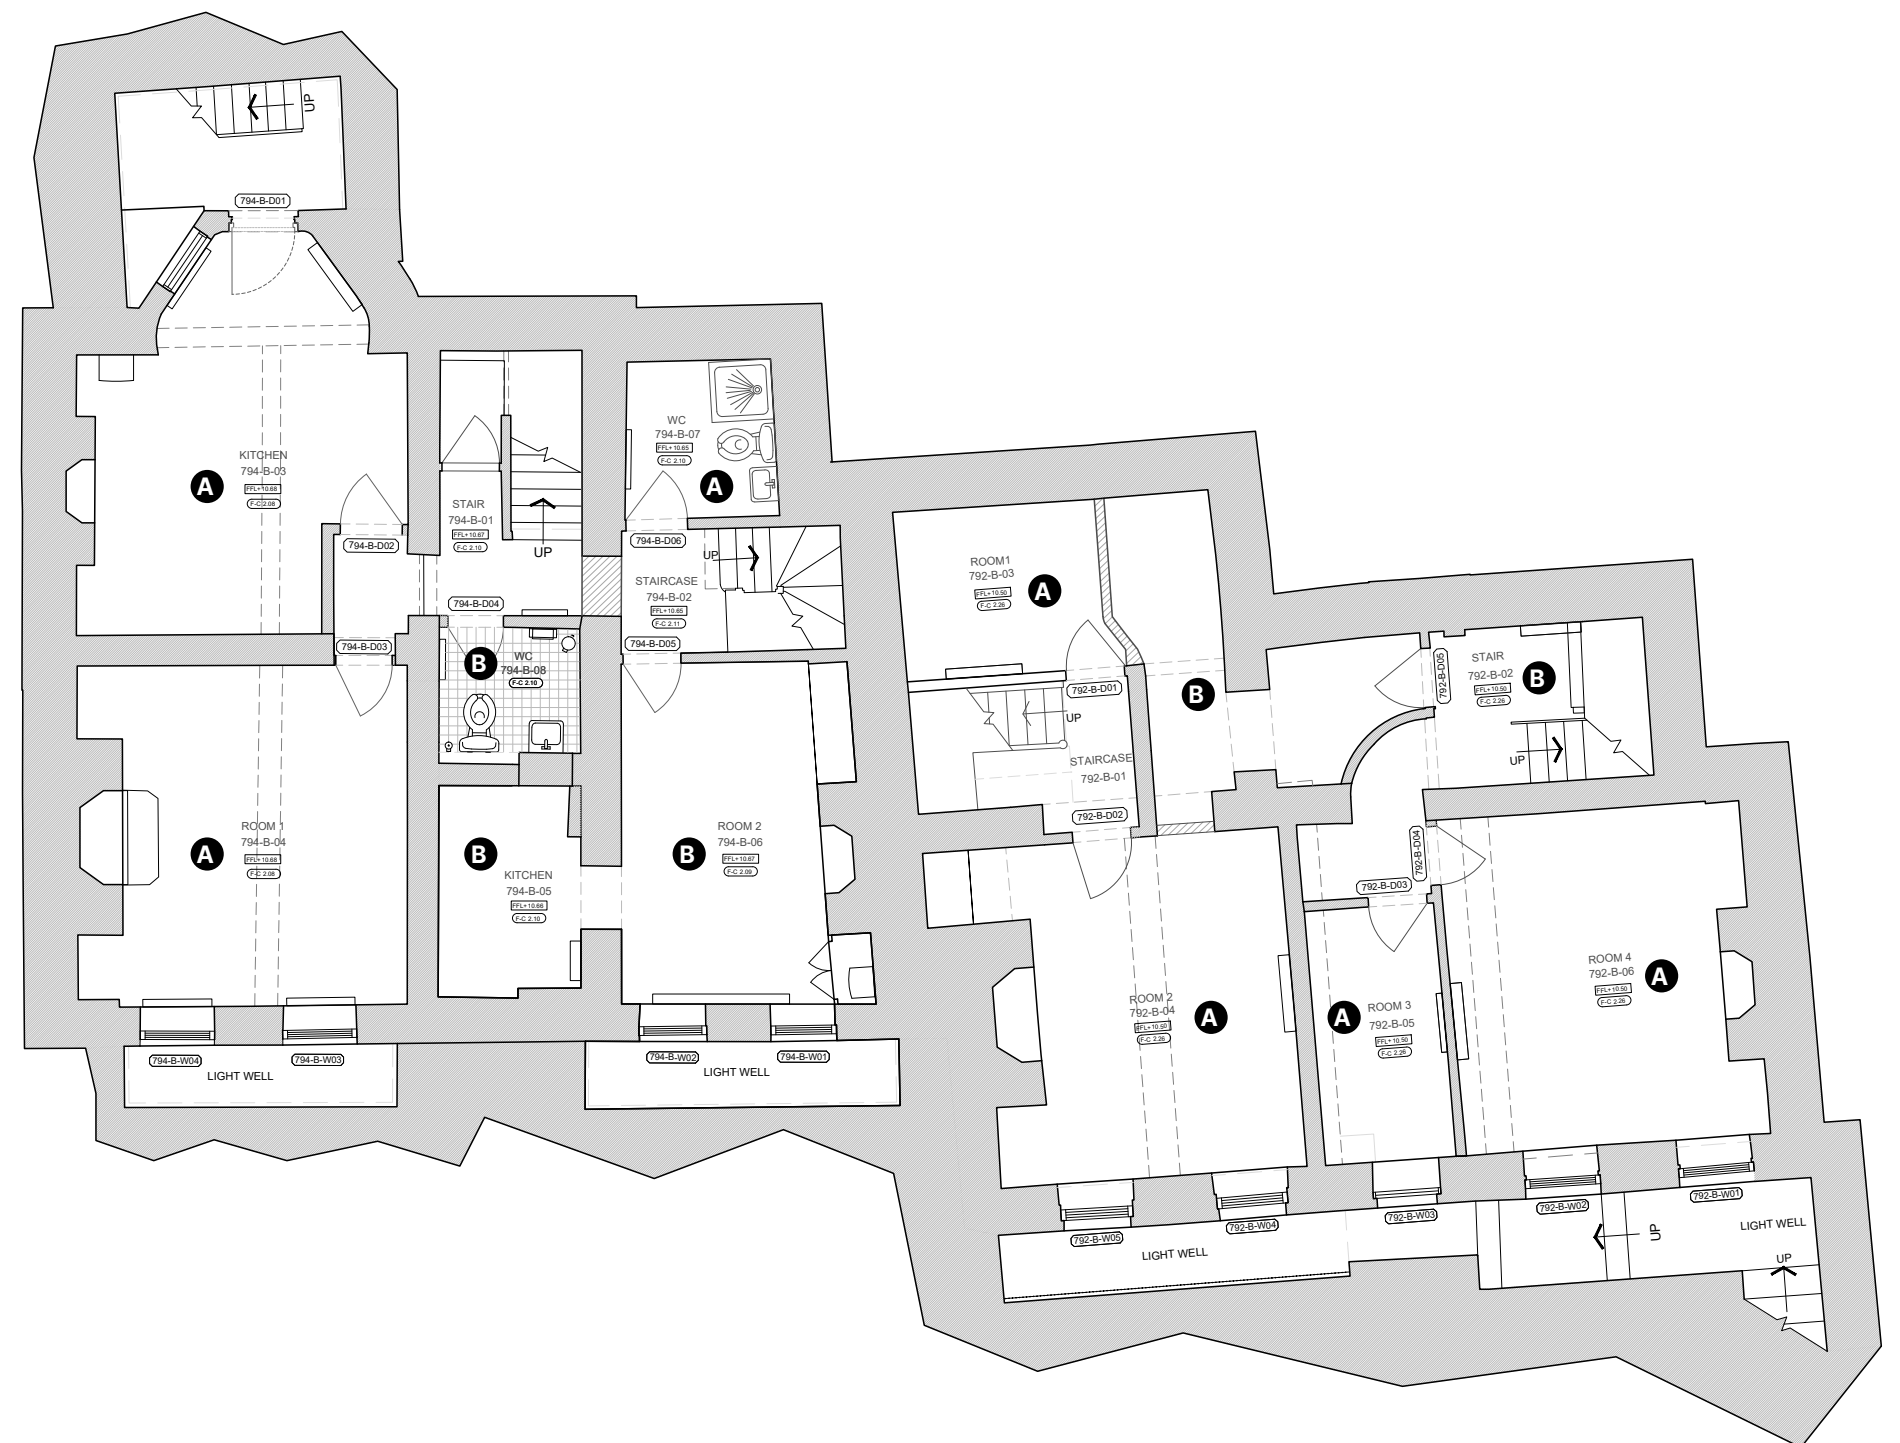
**FIGURE 40.** Existing Basement Plan

The investigative works to better understand the nature of the floor builds ups was also used to respond to this part of the condition. Unfortunately, no existing stone flooring has been found.

- A** Modern floor finishes stripped off
- B** Local investigation carried out
