# Nos. 792-794 **HIGH ROAD**

RESPONSE TO LISTED BUILDING CONSENT APPLICATION  
PART CONDITION DISCHARGE

SUPPORTING INFORMATION RELATING TO NOS. 792-794 HIGH ROAD  
LISTED BUILDING APPLICATION REFERENCE : HGY/2022/1659

NOVEMBER 2022

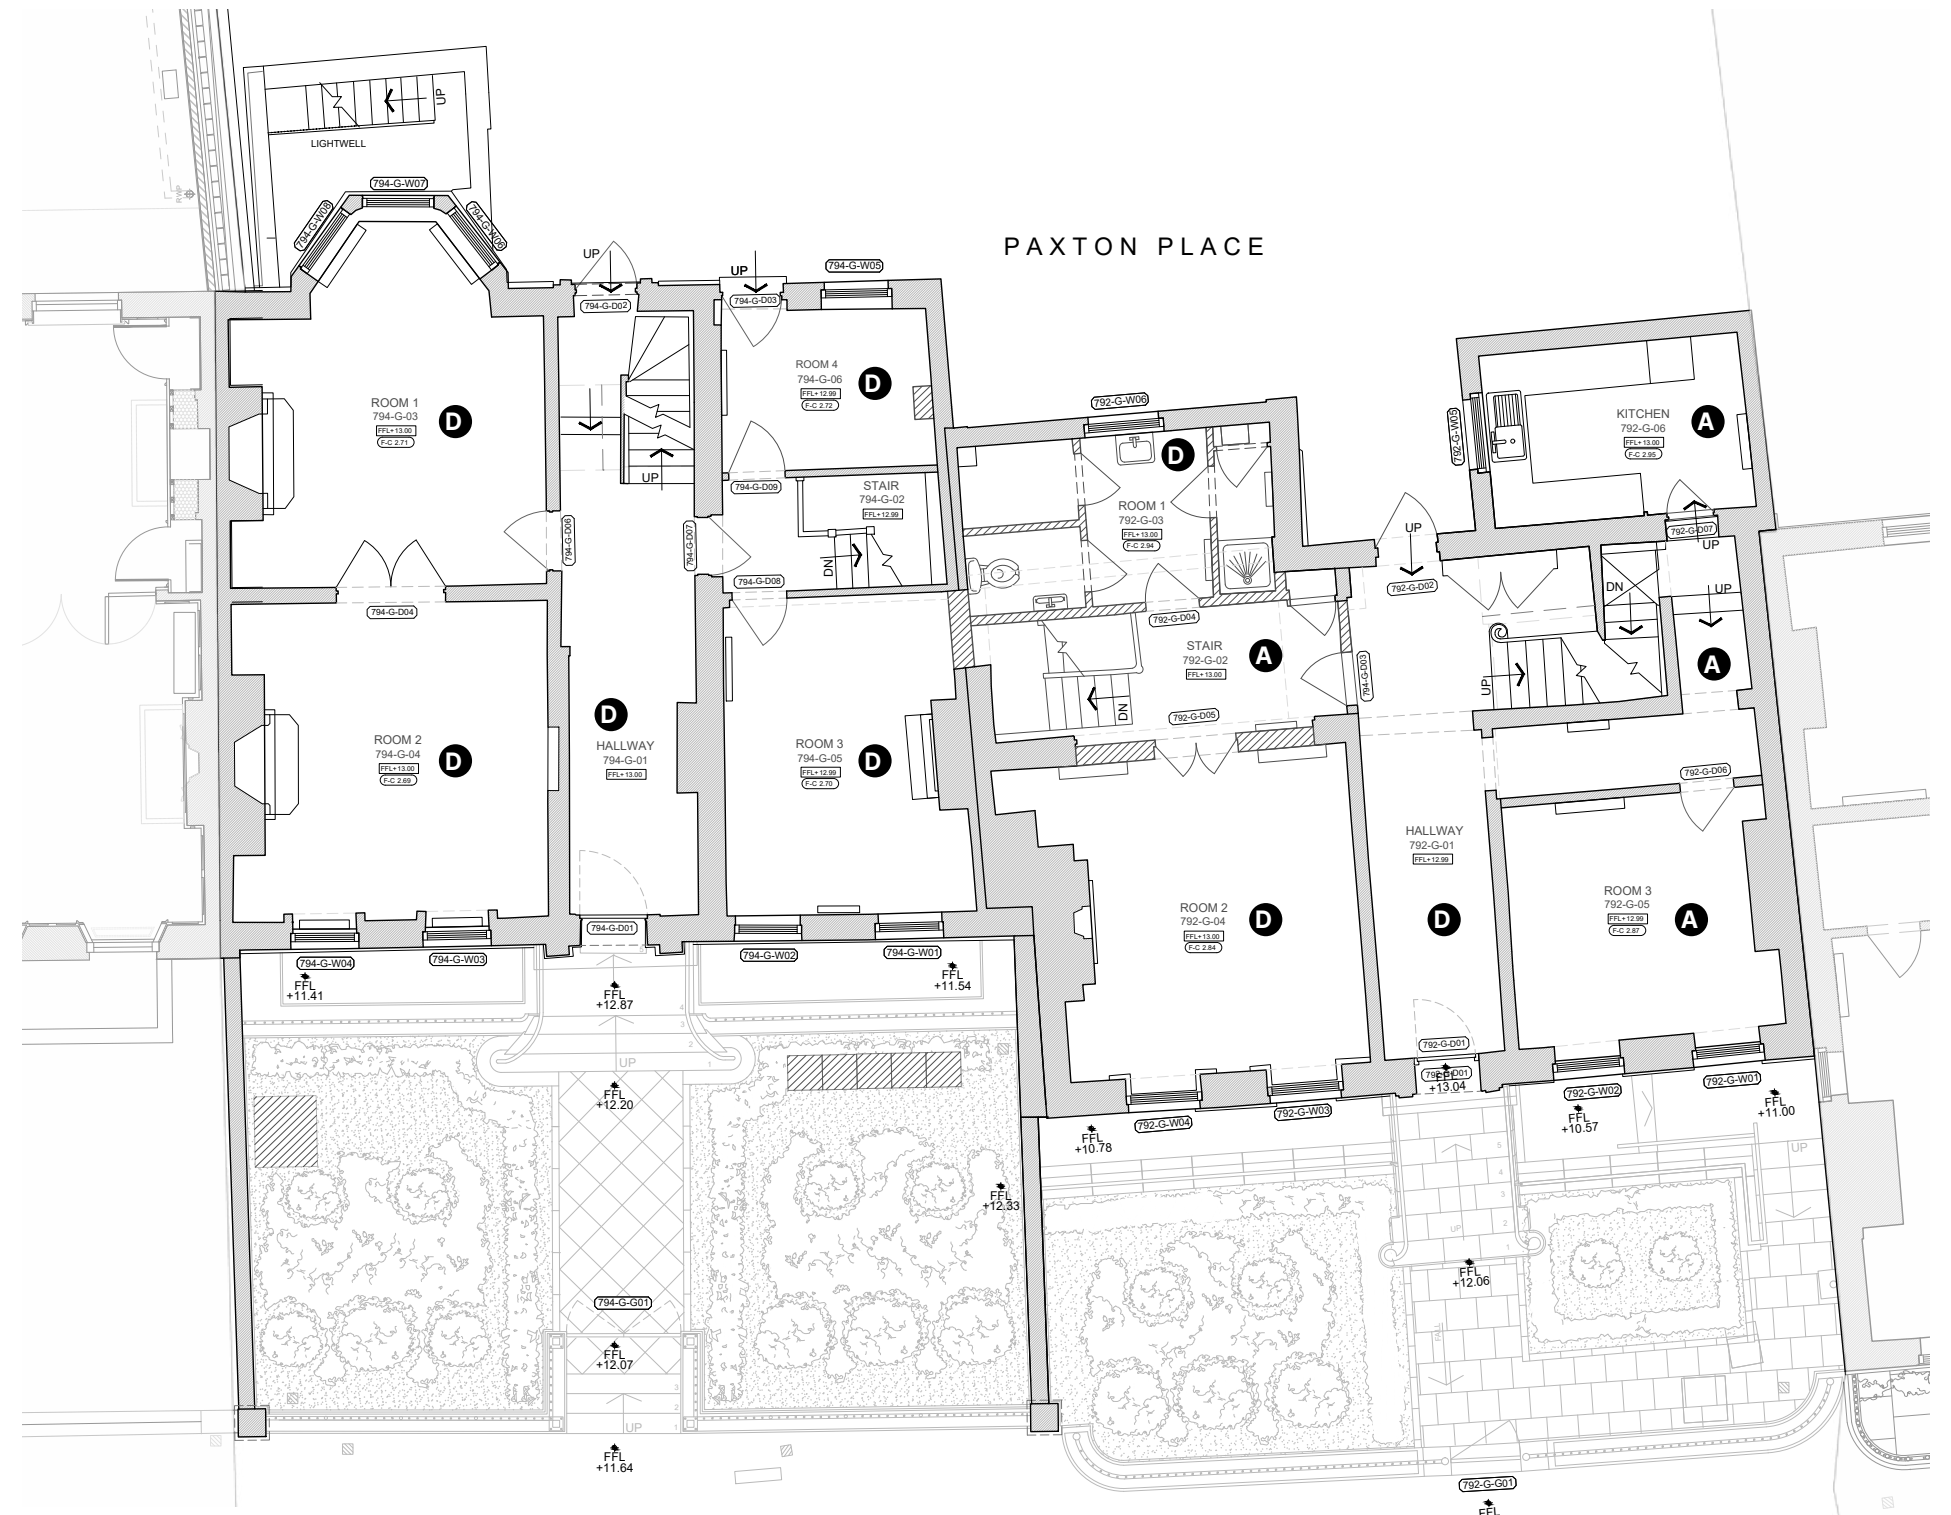
FIGURE 6. Existing Ground Floor Plan

- **ROOM 2 : 794-G-04** - At ground, the ceiling was found to be in good condition with no further works required, decoration only.
- **ROOM 3 : 794-F-05** - At first, a crack emanates from the central ceiling rose and will be repaired using like for like materials and suitable methods, by a specialist contractor.

- **STAIR : 792-G-02** - To the west of ground floor lobby, the ceiling was found to be in poor condition requiring further repair works and decoration.
