## HERITAGE STATEMENT FOR

808-812 HIGH ROAD,  
TOTTENHAM

Corrie Newell BA Arch Hons RIBA ARB IHBC

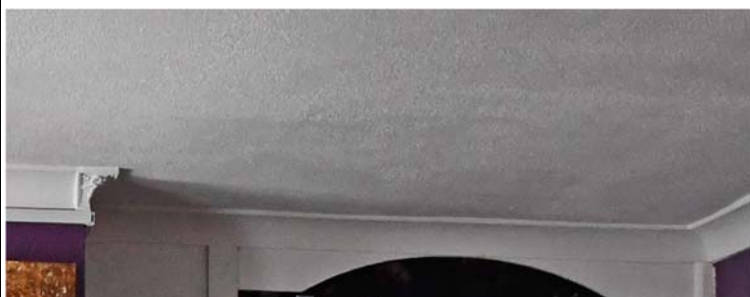
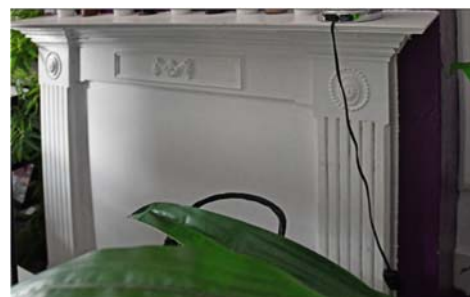
### Room SR06 (808 Front Room)

(Top) C20 plaster coving and shelving units.  
(Bottom) Blocked fireplace with C20 routed timber firesurround

| ELEMENT | HERITAGE SIGNIFICANCE | EXISTING CONDITION | EFFECT/ IMPACT |
|---|---|---|---|
| <b>Ceiling</b> | <b>Medium</b> – likely C18 with C20 applied details | <b>Good</b> | <b>Enhance</b> – Allow to remove C20 applied details and repair lime plaster. |

| ELEMENT | HERITAGE SIGNIFICANCE | EXISTING CONDITION | EFFECT/ IMPACT |
|---|---|---|---|
| <b>Doors</b> | <b>Neutral</b> C20/C21 | <b>Good</b> | <b>Enhance</b> – Replace hollow core door to match C18 door and architrave.<br><b>Neutral</b> - Remove modern door between stair and Coach House. Retain architrave. |

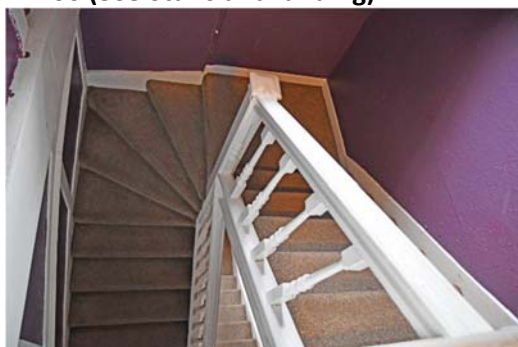
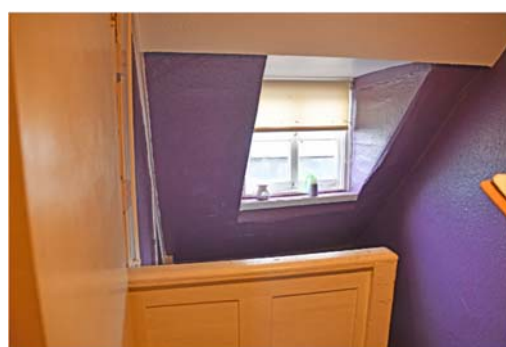
**Room TR06 (808 Stairs and landing)**

*(Left) Stair SF-TF with original open balustrade.  
(Centre) Stair upper landing with C18 panelled partition*

| ELEMENT | HERITAGE SIGNIFICANCE | EXISTING CONDITION | EFFECT/ IMPACT |
|---|---|---|---|
| Walls | High -C18 outer and central walls.<br><br><b>Neutral / Negative</b> – C20 and C20 subdivisions | Good | <b>Enhance</b> – Investigate and allow to remove C20/C21 subdivisions and bathroom fixtures and make good minimal like-for-like lime repair. |

| ELEMENT | HERITAGE SIGNIFICANCE | EXISTING CONDITION | EFFECT/ IMPACT |
|---|---|---|---|
| Doors | Neutral C20/C21 | Good | <b>Enhance</b> – Replace hollow core door to match C18 door and architrave. |

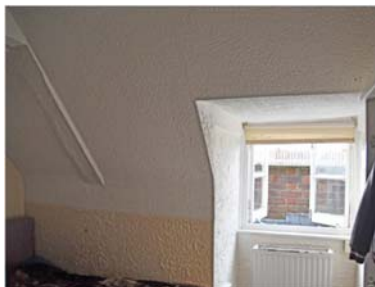
| ELEMENT | HERITAGE SIGNIFICANCE | EXISTING CONDITION | EFFECT/ IMPACT |
|---|---|---|---|
| Walls | High -C18 partition between stair and kitchen.<br>Neutral - Cladding on Kitchen side | Good | <b>Enhance</b> – Investigate and allow to provide cladding to detail on Kitchen side for 60 min FR. |

| ELEMENT | HERITAGE SIGNIFICANCE | EXISTING CONDITION | EFFECT/ IMPACT |
|---|---|---|---|
| Doors | Neutral C20/C21 | Good | <b>Enhance</b> – Replace hollow core door to match C18 door and architrave. |

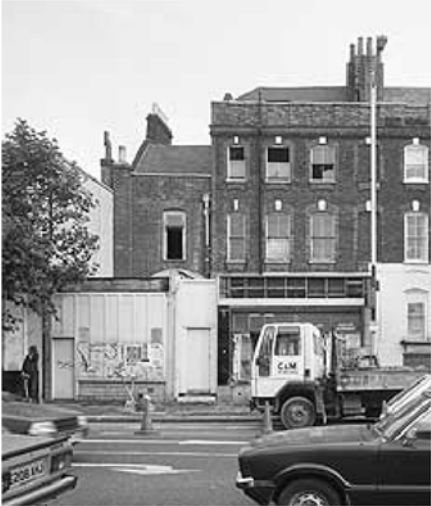
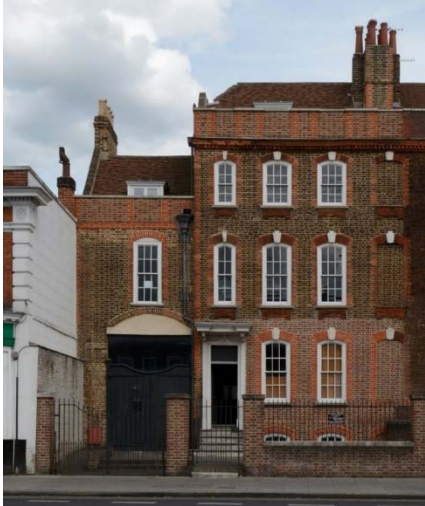
| ELEMENT | HERITAGE SIGNIFICANCE | EXISTING CONDITION | EFFECT/ IMPACT |
|---|---|---|---|
| <b>EXTERIOR</b><br><b>Front Elevation</b> <div style="display: flex; justify-content: space-around; align-items: flex-start;"> </div> <p><i>(Left) 1991 RCHM record photograph prior to C21 restoration, stabilisation and removal of extensions.</i><br/> <i>(Right) Existing front elevation with rebuilt ground floor and parapets</i></p> | | | |

| ELEMENT | HERITAGE SIGNIFICANCE | EXISTING CONDITION | EFFECT/ IMPACT |
|---|---|---|---|
| Parapet | High (C18) | Good.<br>Repaired and partly rebuilt as part of recent reconstruction. | No work required. |
| Brick façade, arches & mouldings | High (C18) | Good.<br>Repaired and partly rebuilt as part of recent reconstruction. | No work required. |
| Rainwater goods | Low (C21) but positive | Good.<br>Rebuilt as part of recent reconstruction. | Low impact & beneficial. Replace gully in cast iron to match but larger and adjust base of downpipe to reduce water discharge onto paving. |

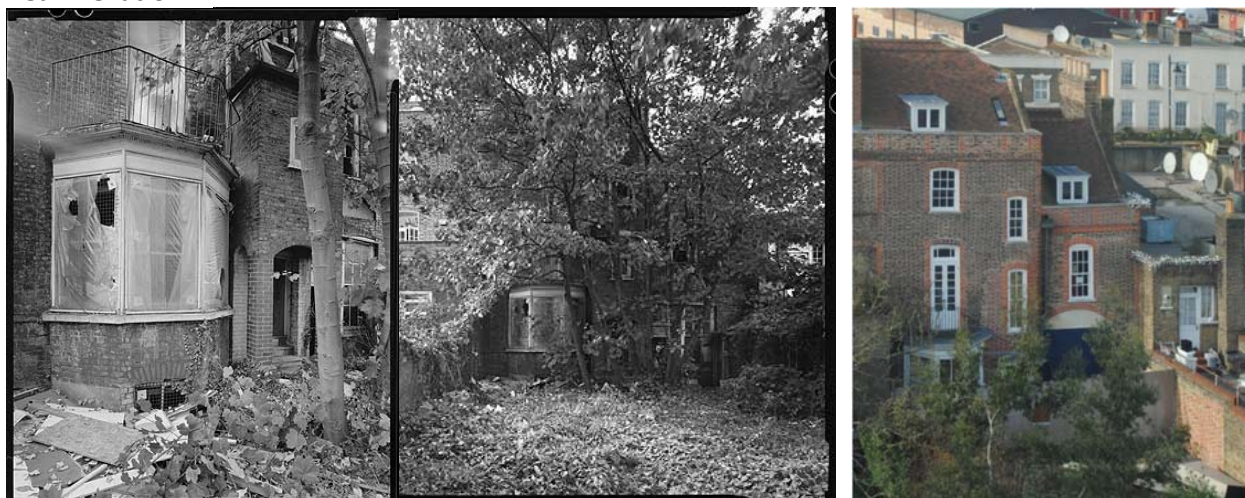
#### Rear Elevation

*(Left and centre) 1991 RCHM photographs prior to C21 stabilisation and removal of extensions.  
(Right) Existing rear elevation including rebuilt bay, rear openings and boundary wall.*

| Parapet | High (C18) | Good.<br>Repaired and partly rebuilt as part of recent reconstruction. | No work required. |
| Brick façade, arches & mouldings | High (C18) | Good.<br>Repaired and partly rebuilt as part of recent reconstruction. | No work required. |

| ELEMENT | HERITAGE SIGNIFICANCE | EXISTING CONDITION | EFFECT/ IMPACT |
|---|---|---|---|
| Red brick South wall | Medium (C18, Altered) | Poor.<br>Wall is leaning, with tree damage and eroded bricks and pointing. | Retain and carry out conservation brick repairs. Rebuild unsound and missing sections of matching brick in lime mortar to complete the wall.<br>HGY/2020/1584 & 1586 gave consent to the variations shown. |

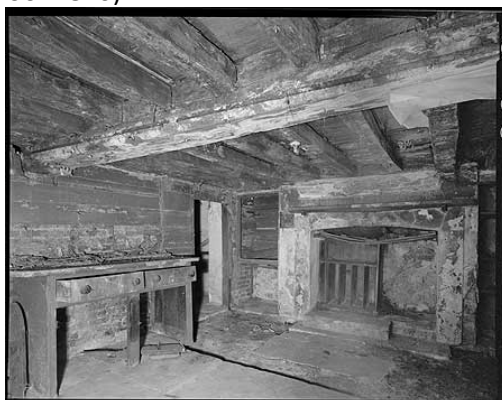
Room BR01 / BM-E-01 (Front Room 810)

*(Left) 1991 RCHM record photograph including previous opening and cupboard alongside fireplace.*

| ELEMENT | HERITAGE SIGNIFICANCE | EXISTING CONDITION | EFFECT/ IMPACT |
|---|---|---|---|
| Walls | Medium (C18 and altered) | Poor condition. Exposed brick with occasional friable / missing bricks and small patches of plaster. Most of panelling lost as a result of previous dry rot removal. Small section of panelling (4 panels and 3 boards) remains on N wall. | Retain and infill missing bricks with new handmade red bricks to match and stop in holes in lime mortar joints to match. Carry out lime plaster repairs to consolidate existing patches of plaster. Leave exposed as honest repair. Retain timber panelling and re-fix loose boards. Enhance - Extend panelling as matching cupboards along the east wall. |
| Ceiling | Medium (C18 and partly rebuilt) | Poor condition. Lathe and plaster missing. Joists repaired and some replaced in early C21. | Retain and reinstate plaster ceiling to provide 60mins FR, leaving bridging beam exposed as original. Leave recent structural fixing plate exposed as honest repair & decorate to match. |
| Floor | Medium (C18 stone slabs over part) | Poor condition. Uneven slabs remain in Northern two-thirds. Taken up elsewhere. | Retain and reinstate floor by re-laying existing uneven and loose slabs on consolidated lime earth base to match existing, suitable for non-public staff use. Extend in lime around S end of room where infill is missing as honest repair.<br>Investigate options for floor. |
| Fireplace | Medium (C18 and altered in C20 and C21) | Rebuilt in C21 with concrete bressumer and stainless steel flexible liner. | Retain and repair and make good hearth and reveals to match existing. Allow to install woodburner. Allow to provide CI floor grille for ventilation where floor adjacent fireplace has previously been taken up. |

| ELEMENT | HERITAGE SIGNIFICANCE | EXISTING CONDITION | EFFECT/ IMPACT |
|---|---|---|---|
| Cupboards | N/A | N/A | Low - Install new symmetrical cupboards on each side of fireplace, with 2-panelled doors to match adjacent doors. Install service riser in void.<br>Enhance – enclose electric main panels in a cupboard to match adjacent panelling. |

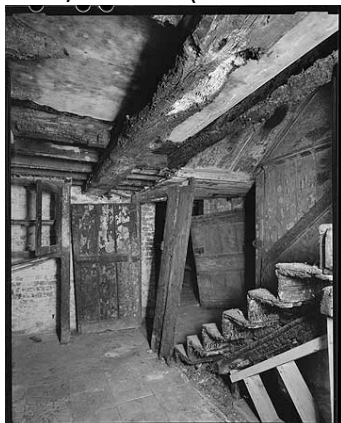
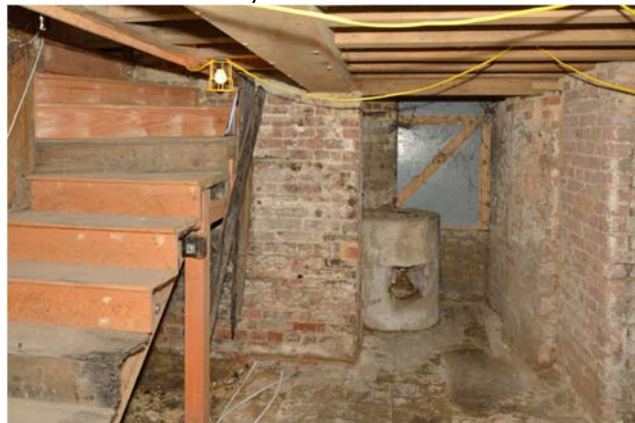
Room BR03/BM-E-02 (Basement Entrance & Staircase 810)

(Left) 1991 RCHM record prior to C21 structural work to stair and floor.

(Right) Current.

| Staircase | Medium (C18 and partly rebuilt) | Poor condition. Severe fire and water damage. Substantially rebuilt and over-clad in new timber. Original boarded partition has been lost apart from burnt remains of 3 boards. | Complete timber repairs to match and rebuild partition using evidence of planks and mortices, which indicate this was a full-height vertically boarded timber partition like the existing partition on the opposite side of the stairs. Construct this partition in timber studwork with timber handrail, and boarding both sides for 60 min FR. |
| Walls | Moderate (C18 altered) | Poor condition. Exposed brick, patches of lime plaster and limewash. No access to blocked store area. | Retain and repair brickwork and plaster like-for-like. Leave exposed as honest repair. |
| Ceiling | Medium (C18 and partly rebuilt) | Poor condition. Lathe and plaster missing. Joists repaired and some replaced in early C21. | Retain & reinstate plaster ceiling to 60mins FR, leaving bridging beam exposed as original. Leave recent fixing plate exposed as honest repair. |
| Floor | Medium (C18 stone slabs over part. Brick in store and earth below stairs) | Poor condition. Stone slabs and bricks are heavily worn and uneven. Slabs broken in Southern part of room. Slabs at entrances to stores have been disturbed. | Retain and reinstate floor by re-laying existing uneven and loose slabs and bricks on consolidated lime earth base to match existing, suitable for non-public staff use. Extend brickwork to match where missing in stores and below staircase.<br>Investigate floor. |

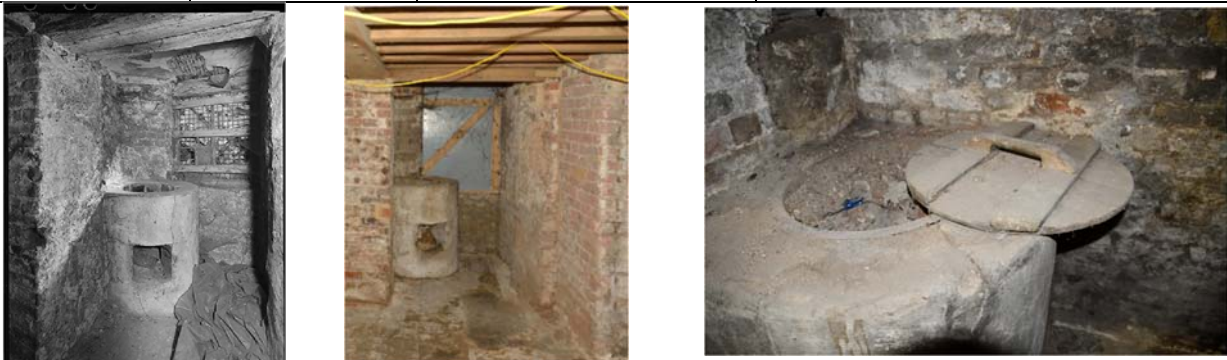
| ELEMENT | HERITAGE SIGNIFICANCE | EXISTING CONDITION | EFFECT/ IMPACT |
|---|---|---|---|
| Copper | Medium (missing fixtures) | Poor condition. Basic structure survives but copper interior and grate is broken and missing. | Retain, repair and make good plaster reveals to match existing.<br><br>Investigate and allow to repair to match more intact copper in 808. |

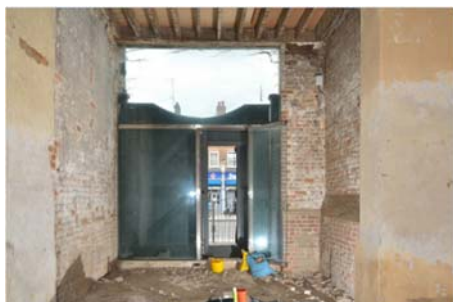
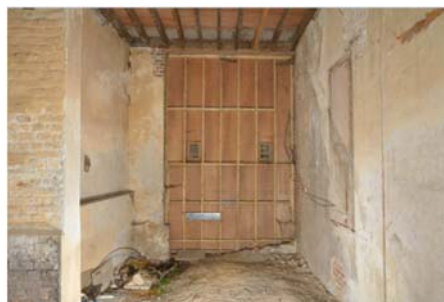
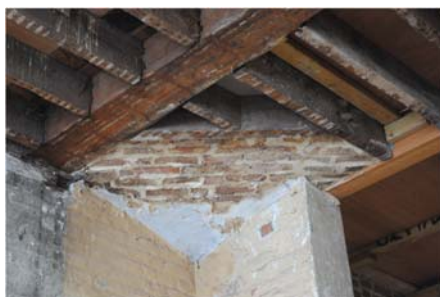
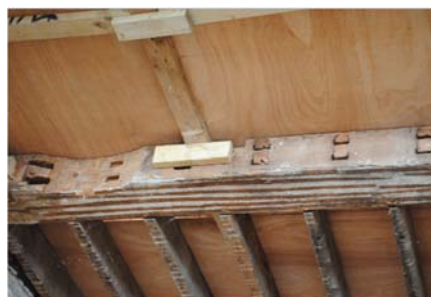
Room GR-E-02 / GR05 (812 Coach House Range Ground Floor)

*Looking towards front glass wall and gates*

*Looking to rear wall (temporary infill)*

*(Left) Underside of hearth above*

*(right) large access hatch to be infilled*

| ELEMENT | HERITAGE SIGNIFICANCE | EXISTING CONDITION | EFFECT/ IMPACT |
|---|---|---|---|
| Walls | Medium (Altered) | Reasonable condition with many C20 and C21 changes. Exposed and painted brickwork. Temporary timber infill to rear wall. Front wall comprises C21 glazed screen behind painted timber gates. | Retain exposed and painted brick finish. Enhance – Remove temporary infill to re-open rear opening to provide access to proposed single storey extension.<br>Low impact - Reduce internal brick nib which has been cut back previously. |
| Ceiling | Low (Altered and extensively rebuilt) | Incomplete rebuilt condition. Section of joists missing to provide a temporary access hatch. No plaster remains. | Retain, make good and enhance. Once access is no longer required, infill hole with new joists to match. Provide a ceiling (Finish to be confirmed). |
| Floor<br><br>Provide timber floor | N/A | Missing. Earth finish is uneven. Plinth indicates previous structure was probably timber and significantly higher than earth. | Enhance – Reinstate by providing new suspended timber floor to enable practical use of the building. The level is to align with existing doorway to 810, which appears to have been the original level. Provide steps and platform lift to provide accessible entrance at the existing front door and paving level.<br>Amendment to level of proposed timber floor to avoid steps and platform lift (reversible). Levels subject to investigation. |
| Doors and linings | Low (Altered) | Variable condition. Blocked C19 door. Rebuilt front and rear archways. | Enhance rear screen by removing temporary infill. Low impact for unblocking & adjusting door to 810 (as above). |

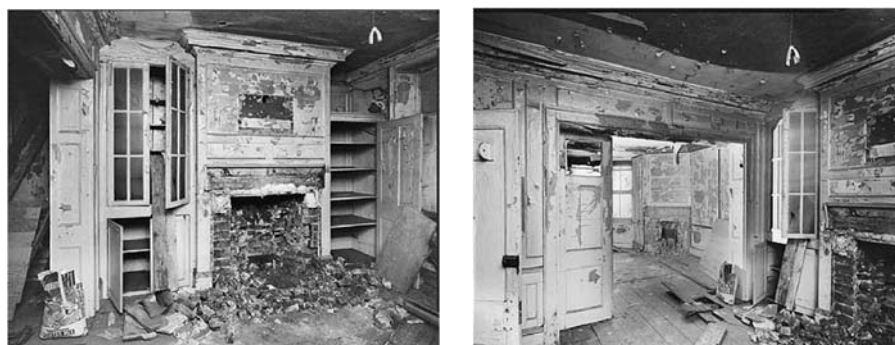
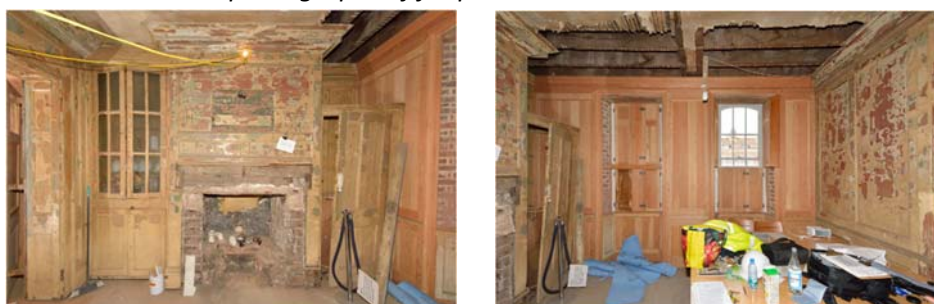
Room GR-E-03 / GR01 (Front Ground Floor Room 810)

(above) 1991 RCHM record photographs of fireplace wall and view towards rear room.

Fireplace, cupboards and section of replacement panelling and shutters on front wall from 2007-2009.

| Walls | High (C18) and Medium (C19 alterations adjacent rear room) | Mostly good condition. C21 repairs and reconstruction of panelling. Poor water-damaged condition and cracked panels around archway and cupboards. Damage to individual panels above fireplace and where doors have been removed. Section of redundant pipework adjacent fireplace. | Retain and continue as like-for-like in-situ joinery repairs to panelling. Reinstall skirtings where missing once floorboards are installed. Enhance - Remove redundant pipe and make good damaged surfaces to match historic surfaces adjacent. |

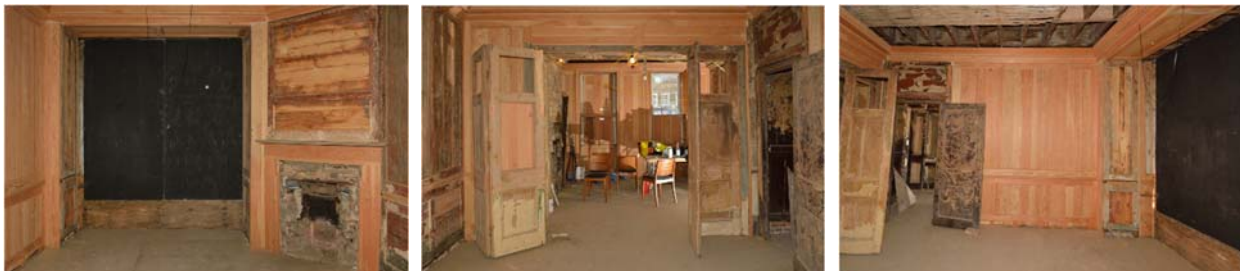
| ELEMENT | HERITAGE SIGNIFICANCE | EXISTING CONDITION | EFFECT/ IMPACT |
|---|---|---|---|
| <i>Rebuilt bay and panelling</i> <i>Looking towards front room</i> <i>Looking towards stair wall</i> | | | |
| Walls | High (C18) and Medium (C19 alterations to provide a bay and wide opening) | Mostly good condition. C21 repairs and reconstruction of panelling. Poor water-damaged condition and cracked panels around fireplace and on South wall. | Retain and continue as like-for-like in-situ joinery repairs to panelling. Reinstate skirtings where missing once floorboards are installed. Enhance - Remove redundant pipe and make good damaged surfaces to match historic surfaces adjacent. |

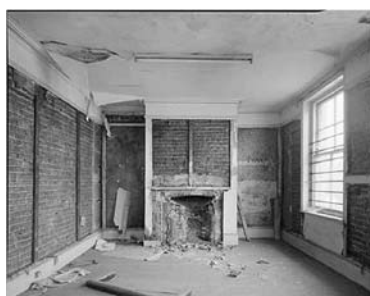
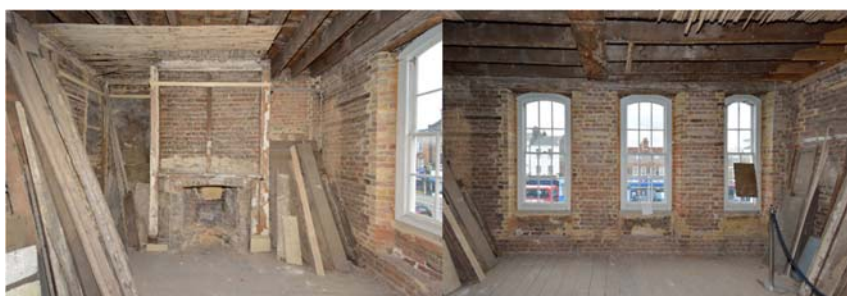
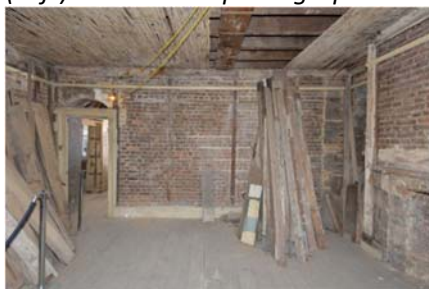
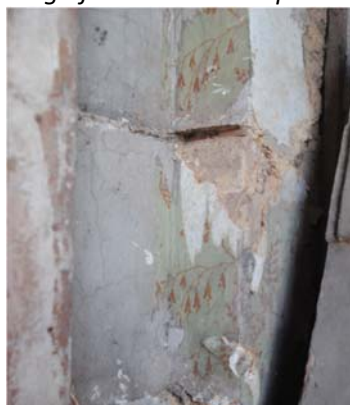
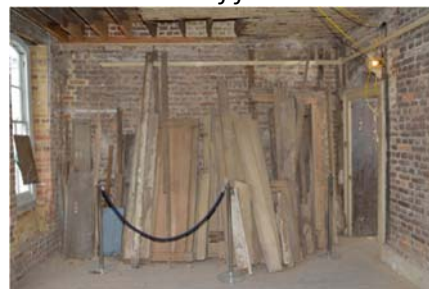
## Room 01-E-03 / FR01 (Front Room 810)

(Left) 1991 RCHM photograph

Existing after structural repairs and reinstatement of front windows

(Left) existing showing door head and ceiling after structural repairs  
(centre) wallpaper on fireplace wall

(Right) Typical extent of repairs

| Walls | Medium (C19 & C20 alterations) | Fragmentary survival of C19 hessian lining and battening. Earlier finishes substantially lost. Front (west) wall much altered for rebuilt window openings. (As above) Structural cracking above door arch. | Carry out conservation structural stitching above doorway (as above). Enhance - Reinstatement wall linings to North, South and East walls to match the C19 applied finishes and door lining as this respects the only phase for which there is significant evidence. Retain and repair wallpaper subject to specialist assessment. |

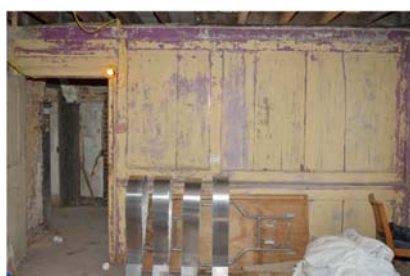
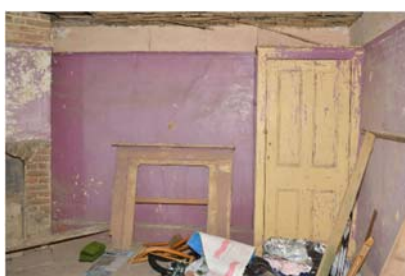
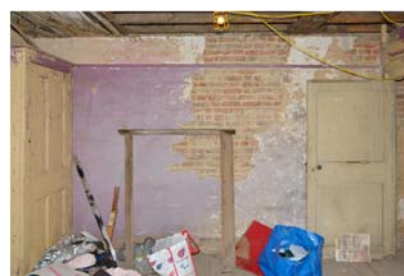
## Room 02-E-05 / SR02 (810 rear room)

Stair partition

Fireplace and cupboard

structural stitching and door

| Walls | Medium (Altered C18) | Plaster missing on south wall and around recent structural stitching on central wall. Partition adjacent staircase is water damaged, cracked and has dropped. | Repair and re-support partition as above.<br>Retain and repair like-for-like plaster, exposed brick finish and boarding. Provide like-for-like skirting board to the two walls where missing. |

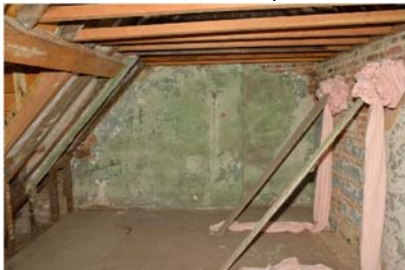
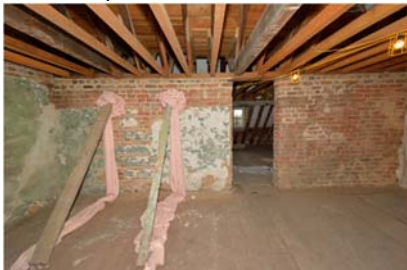
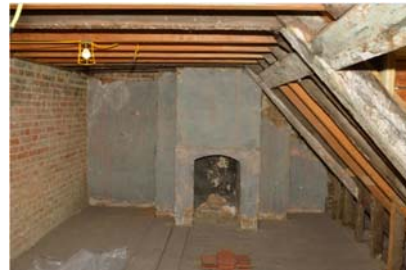
Room 03-E-02 / TR01 (810 front attic room)

*The structural works of c2007-9 including ceiling and dormer are unpainted.  
(The pink fabric was part of a public art installation held in the building).*

| Walls | Medium (C18 altered) | Plaster survives on North and South walls. Missing elsewhere. | Repair - Consolidate loose areas of remaining plaster with lime. |
