| Grade Defect Report | | | | | | | | |

## REPORT INSPECTION

## CCTV Drainage Survey

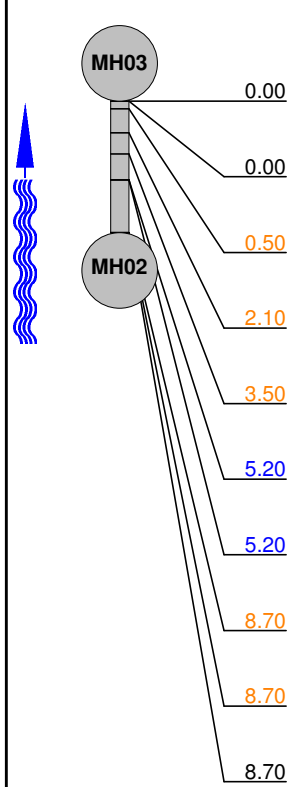
| 1:500 | Position | Code | Observation | Grade | | | | | |
|---|---|---|---|---|---|---|---|---|---|
| | 3.50 | CMJ | Cracks, multiple at joint, from 7 to 5 o'clock Remarks: Clocks vary | 3 | | | | | |
| | 5.20 | CLJ | Crack, longitudinal at joint, at 2 o'clock | 2 | | | | | |
| | 5.20 | CLJ | Crack, longitudinal at joint, at 3 o'clock | 2 | | | | | |

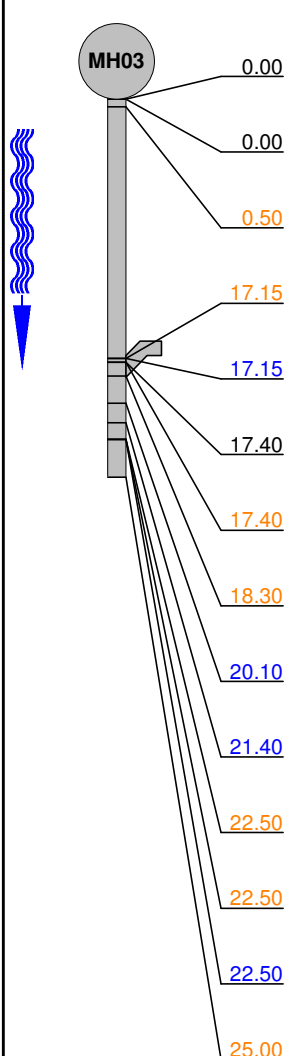
| 1:500 | Position | Code | Observation | Grade | |
|---|---|---|---|---|---|
| | 0.50 | S01 | Attached deposits, grease, from 7 to 5 o'clock, 5% cross-sectional area loss, Start | 3 | |
| | 17.15 | FC | Fracture, circumferential, from 8 to 3 o'clock | 3 | |
| | 17.40 | FL | Fracture, longitudinal, at 3 o'clock | 3 | |
| | 18.30 | FL | Fracture, longitudinal, at 4 o'clock | 3 | |
| | 20.10 | CC | Crack, circumferential, from 8 to 4 o'clock | 2 | |
| | 21.40 | CLJ | Crack, longitudinal at joint, at 9 o'clock | 2 | |
| | 22.50 | FCJ | Fracture, circumferential at joint, from 7 to 5 o'clock | 3 | |
| | 22.50 | FLJ | Fracture, longitudinal at joint, at 12 o'clock | 3 | |
| | 25.00 | FL | Fracture, longitudinal, at 12 o'clock | 3 | |

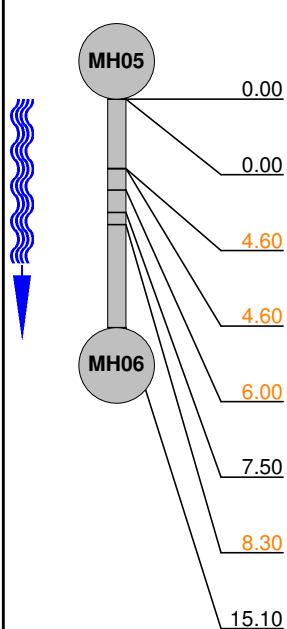
| 1:500 | Position | Code | Observation | Grade |
|---|---|---|---|---|
| | 4.60 | DEEJ | Attached deposits, encrustation at joint, from 7 to 5 o'clock<br>05% cross-sectional area loss | 3 |
| | 4.60 | FCJ | Fracture, circumferential at joint, from 7 to 5 o'clock | 3 |
| | 6.00 | FCJ | Fracture, circumferential at joint, from 10 to 3 o'clock | 3 |
| | 8.30 | FCJ | Fracture, circumferential at joint, from 9 to 3 o'clock | 3 |

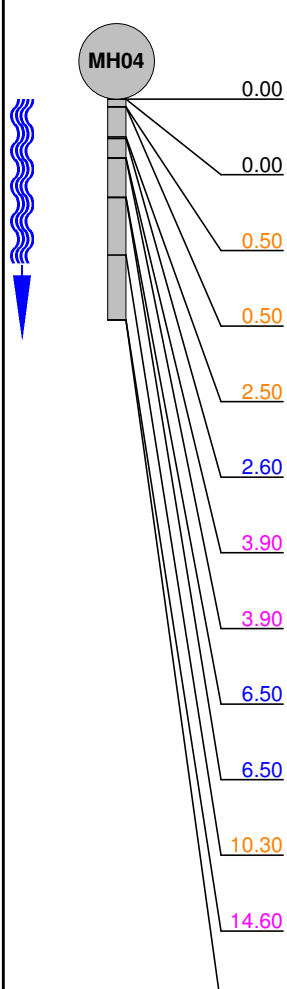
| 1:500 | Position | Code | Observation | Grade |
|---|---|---|---|---|
| | 0.50 | S01 | DEG Attached deposits, grease, from 7 to 5 o'clock, 5% cross-sectional area loss, Start | 3 |
| | 3.90 | B | Broken pipe, from 7 to 5 o'clock | 4 |
| | 6.50 | CL | Crack, longitudinal, at 12 o'clock | 2 |
| | 6.50 | CC | Crack, circumferential, from 12 to 4 o'clock | 2 |
| | 14.60 | B | Broken pipe, from 7 to 5 o'clock | 4 |

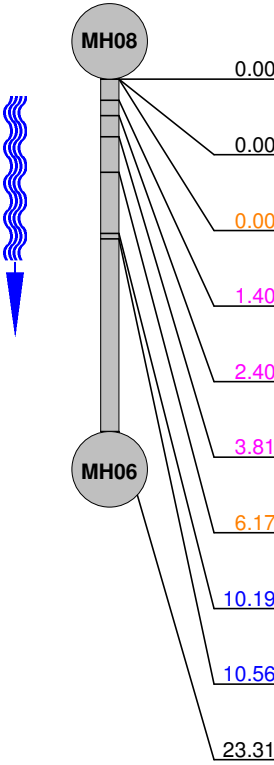
| 1:500 | Position | Code | Observation | Grade | |
|---|---|---|---|---|---|
| | 0.00 | DES | Settled deposits, fine, 10% cross-sectional area loss | 3 | |
| | 6.17 | FC | Fracture, circumferential, from 12 to 12 o'clock | 3 | |
| | 10.19 | CCJ | Crack, circumferential at joint, from 7 to 5 o'clock | 2 | |
| | 10.56 | CCJ | Crack, circumferential at joint, from 10 to 4 o'clock | 2 | |

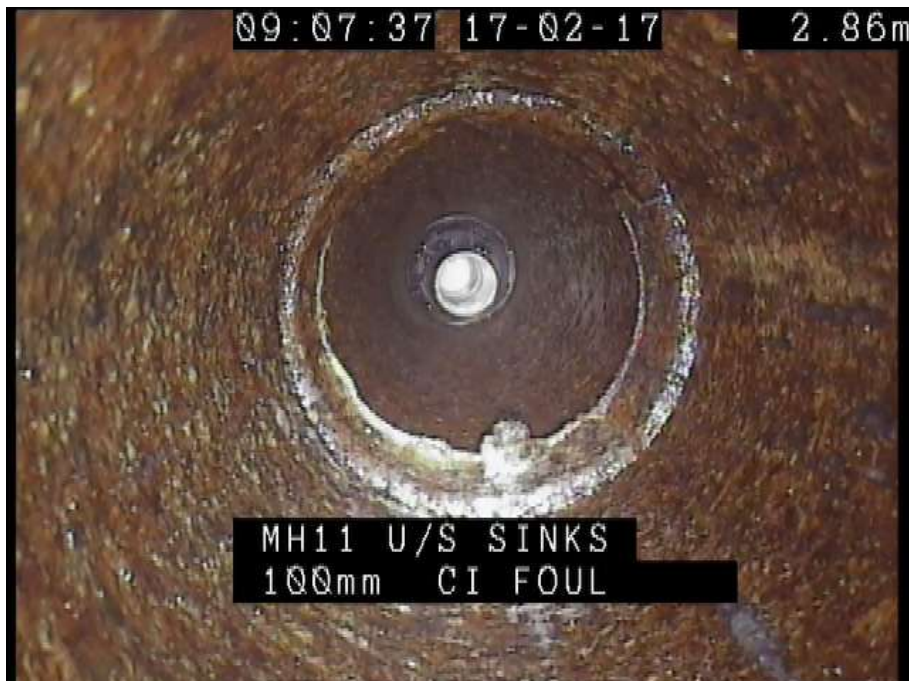
Photo: 22\_4A

2.86m, Finish node type, manhole reference number: Sinks

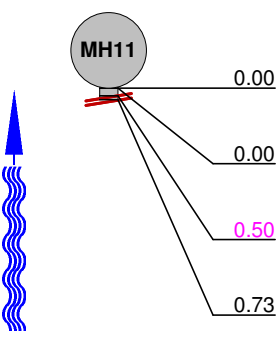
| 1:500 | Position | Code | Observation | Grade |
|---|---|---|---|---|
| | 0.50 | DEX | Settled deposits, other, 20% cross-sectional area loss<br>Remarks: rags | 4 |

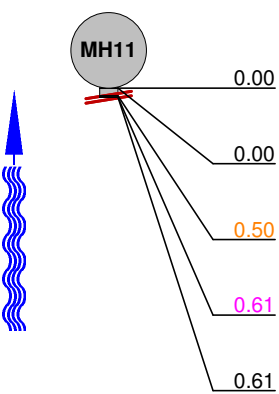
| 1:500 | Position | Code | Observation | Grade |
|---|---|---|---|---|
| | 0.50 | DES | Settled deposits, fine, 20% cross-sectional area loss | 3 |

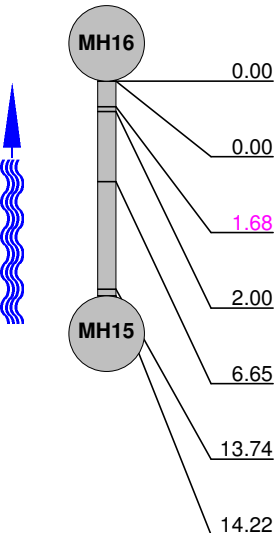
| 1:500 | Position | Code | Observation | Grade |
|---|---|---|---|---|
| | 1.68 | DEX | Settled deposits, other, 30% cross-sectional area loss<br>Remarks: rags | 4 |

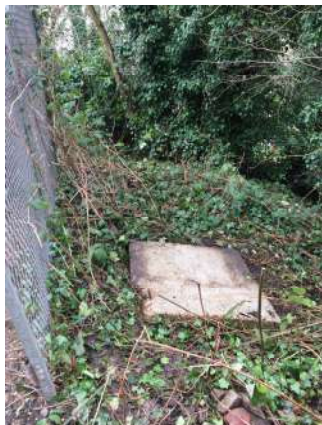
Remarks: Slab used as a cover

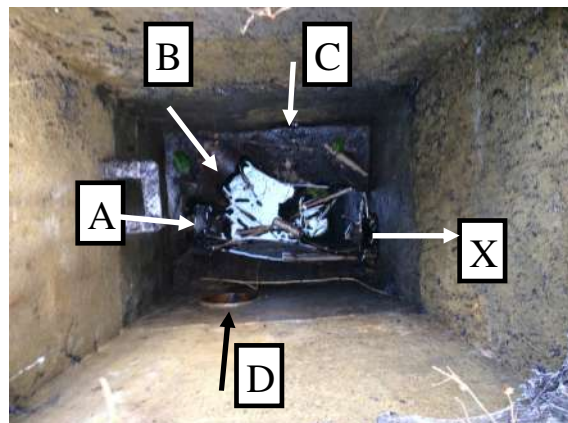
Remarks: P Trap for X Pipe

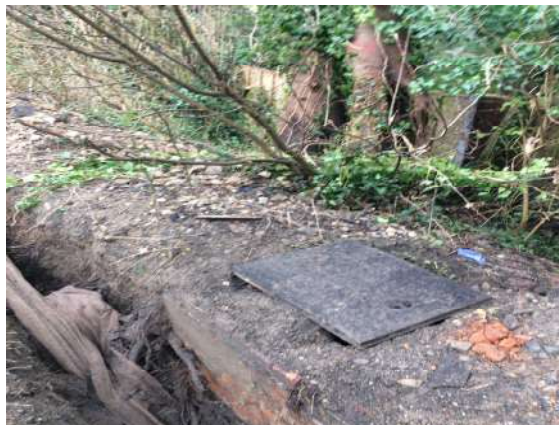
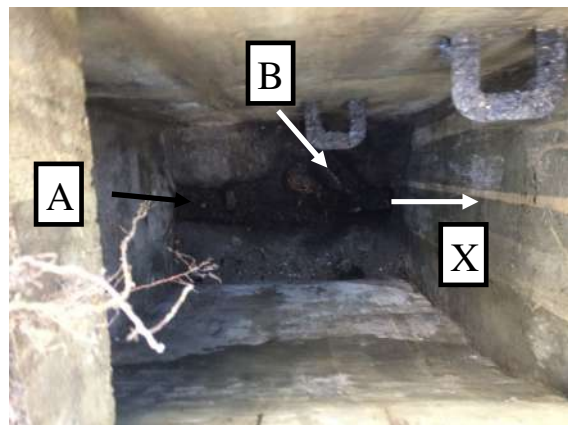
Remarks: Soffit type is tapered.

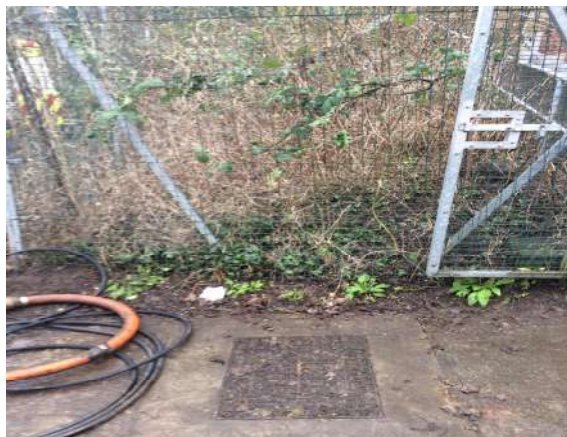
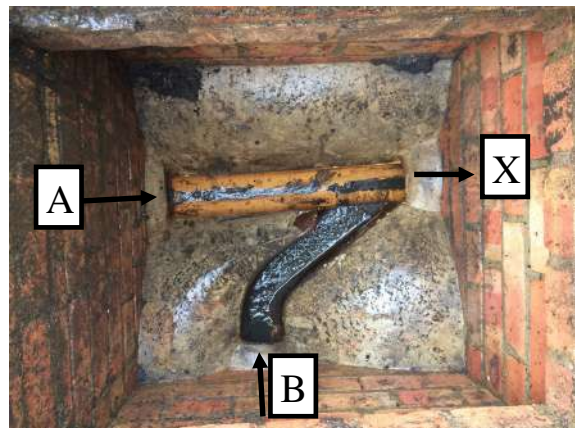
Remarks: X Pipe assumed into MH06

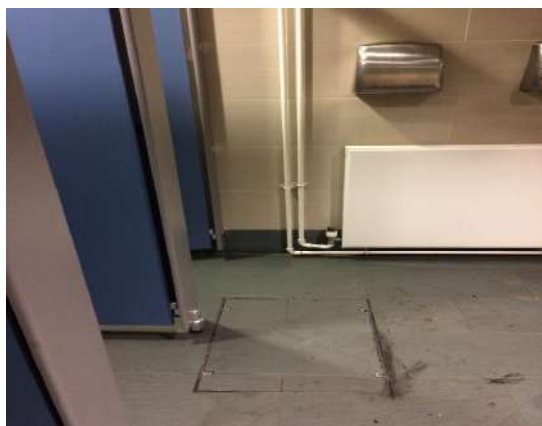
Remarks: Cover over invert, no bolts

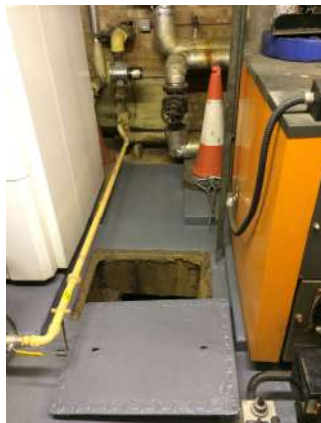
Remarks: Cast iron invert, Has a cast iron lid, nuts and bolts possibly need replacing.  
2 x CI external pipes into chamber.

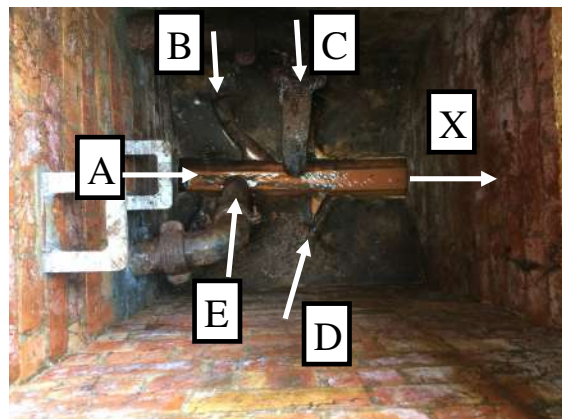
Remarks: 2 External cast iron pipes from the heating system.

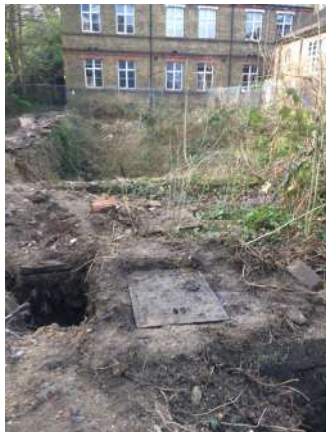
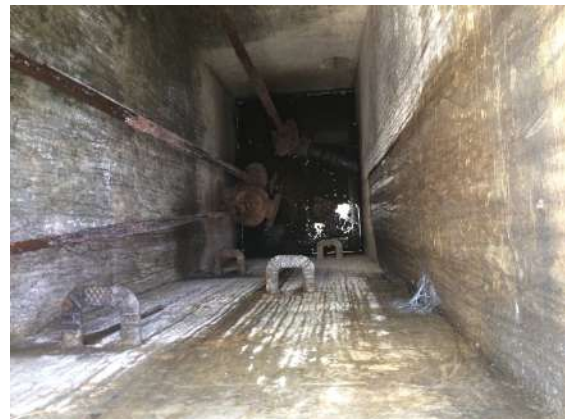
Remarks: X pipe only visible. Overall depth is 3.50m.
