**Descriptive Report with Remarks and Observation Images**

**Site: Mary Neuer Road, Wood Green**

| Client:<br>St William | Location (Street Name):<br>Mary Neuer Road | City/Town/Village<br>Wood Green | Cust Job Ref. | Surveyors Name:<br>Ioan Zbandoc | Date:<br>21/05/2021 |

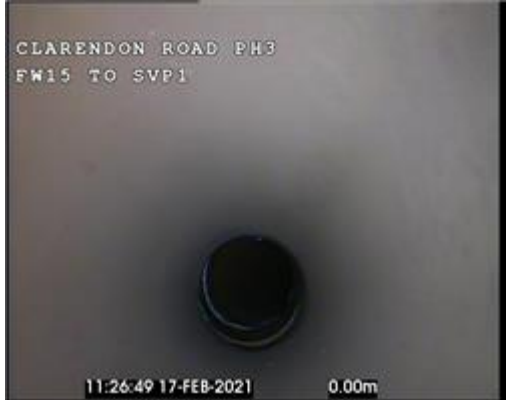
| Pos | Video Ref | Code | Description | Image |
|---|---|---|---|---|
| 00.00m | | MH | Start node type, manhole FW15 | Image Provided - Ref: 42_0<br> |

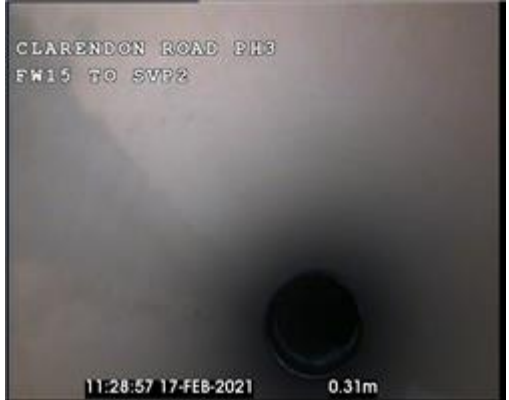
| Pos | Video Ref | Code | Description | Image |
|---|---|---|---|---|
| 00.00m | | MH | Start node type, manhole FW15 | Image Provided - Ref: 43_0<br> |

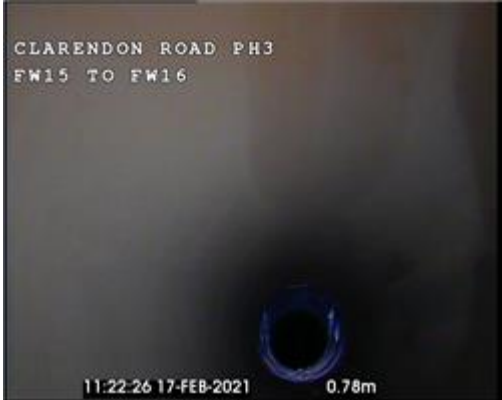
| Pos | Video Ref | Code | Description | Image |
|---|---|---|---|---|
| 00.00m | | MH | Start node type, manhole FW15 | <p>Image Provided - Ref: 44_0</p> |

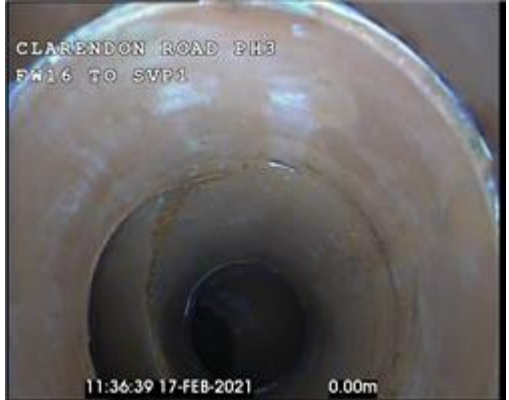
| Pos | Video Ref | Code | Description | Image |
|---|---|---|---|---|
| 00.00m | | MH | Start node type, manhole FW16 | Image Provided - Ref: 45_0<br> |

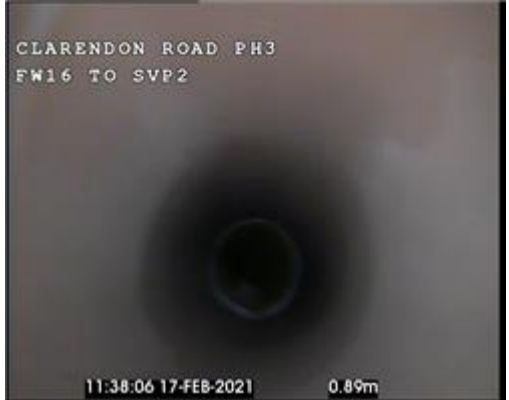
| Pos | Video Ref | Code | Description | Image |
|---|---|---|---|---|
| 00.00m | | MH | Start node type, manhole FW16 | Image Provided - Ref: 46_0<br> |

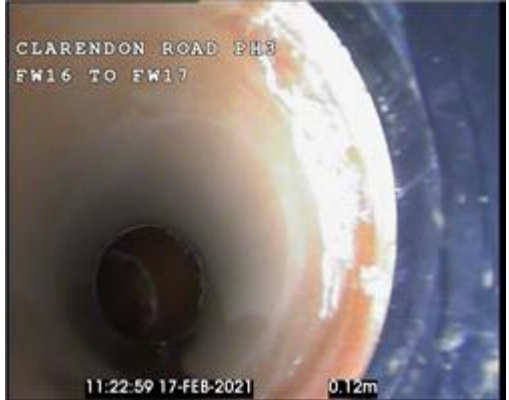
| Pos | Video Ref | Code | Description | Image |
|---|---|---|---|---|
| 00.00m | | MH | Start node type, manhole FW16 | <p>Image Provided - Ref: 47_0</p> |

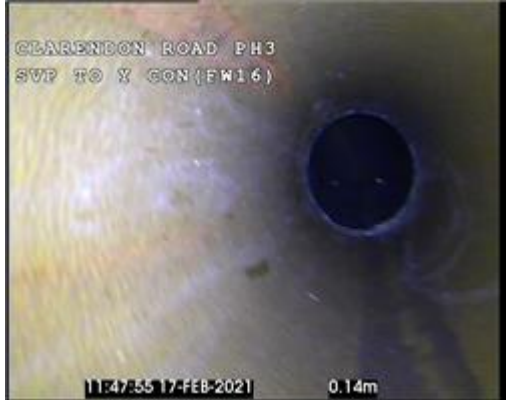
| Pos | Video Ref | Code | Description | Image |
|---|---|---|---|---|
| 00.00m | | OF | Start node type, outfall SVP | Image Provided - Ref: 48_0<br> |

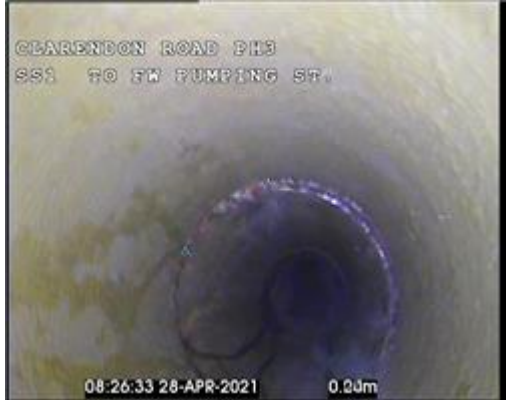
| Pos | Video Ref | Code | Description | Image |
|---|---|---|---|---|
| 00.00m | | OF | Start node type, outfall<br>SS1 | Image Provided - Ref: 49_0<br> |

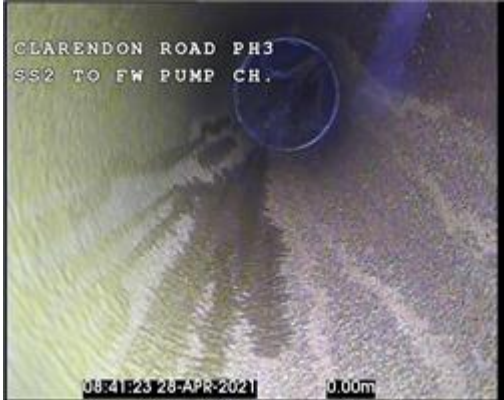
| Pos | Video Ref | Code | Description | Image |
|---|---|---|---|---|
| 00.00m | | MH | Start node type, manhole SS2 | Image Provided - Ref: 50_0<br> |

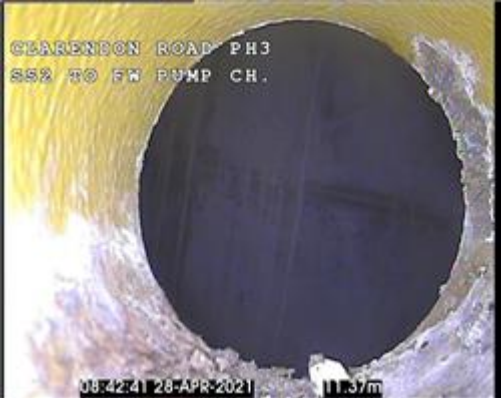
| Pos | Video Ref | Code | Description | Image |
|---|---|---|---|---|
| 11.30m | | OCF | Finish node type, other special chamber<br>FW PUMP ST | <p>Image Provided - Ref: 50_9999</p> |

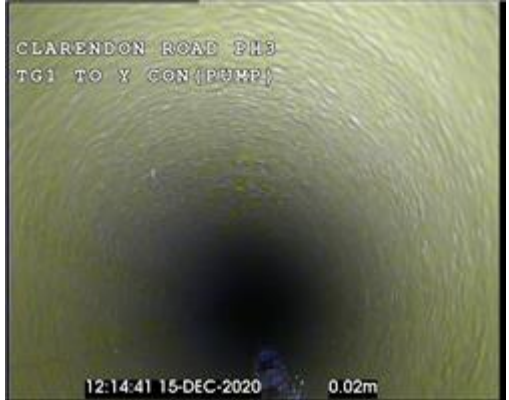
| Pos | Video Ref | Code | Description | Image |
|---|---|---|---|---|
| 00.00m | | GY | Start node type Gully TG1 | Image Provided - Ref: 51_0<br> |

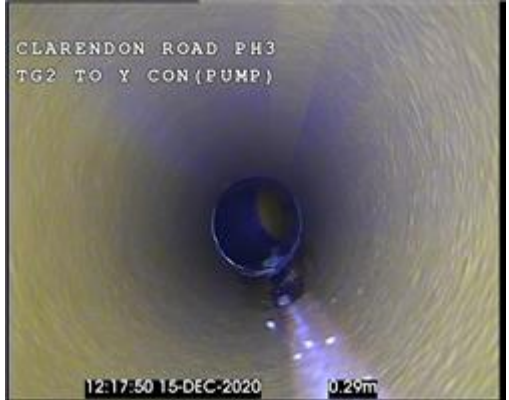
| Pos | Video Ref | Code | Description | Image |
|---|---|---|---|---|
| 00.00m | | GY | Start node type Gully TG2 | Image Provided - Ref: 52_0<br> |

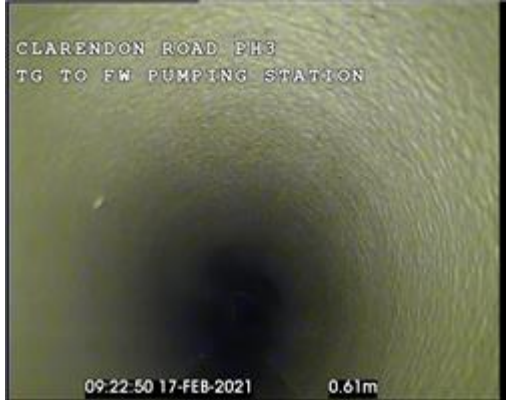
| Pos | Video Ref | Code | Description | Image |
|---|---|---|---|---|
| 00.00m | | GY | Start node type Gully TG | Image Provided - Ref: 53_0<br> |

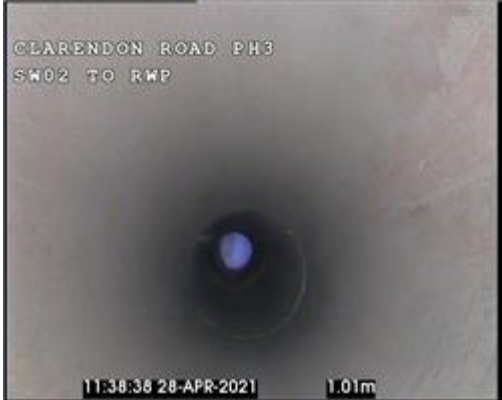
| Pos | Video Ref | Code | Description | Image |
|---|---|---|---|---|
| 00.00m | | MH | Start node type, manhole SW02 | <p>Image Provided - Ref: 55_0</p> |

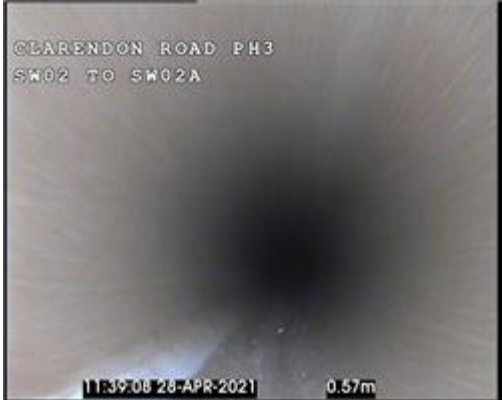
| Pos | Video Ref | Code | Description | Image |
|---|---|---|---|---|
| 00.00m | | MH | Start node type, manhole SW02 | <p>Image Provided - Ref: 56_0</p> |

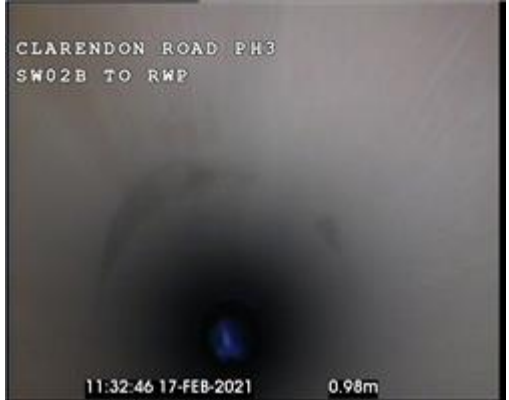
| Pos | Video Ref | Code | Description | Image |
|---|---|---|---|---|
| 00.00m | | MH | Start node type, manhole SW02B | <p>Image Provided - Ref: 57_0</p> |

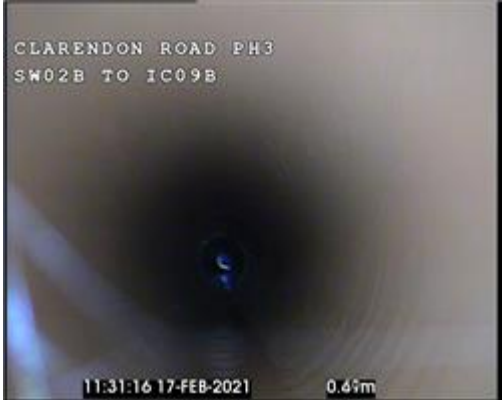
| Pos | Video Ref | Code | Description | Image |
|---|---|---|---|---|
| 00.00m | | MH | Start node type, manhole SW02B | <p>Image Provided - Ref: 58_0</p> |

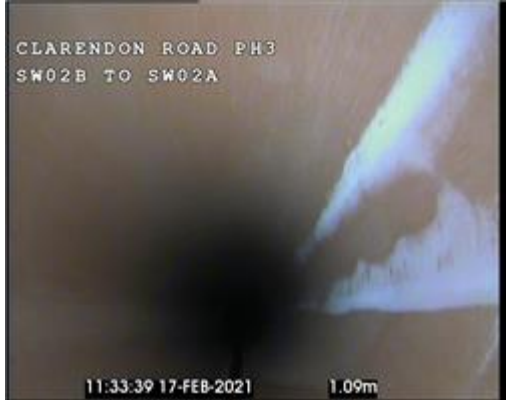
| Pos | Video Ref | Code | Description | Image |
|---|---|---|---|---|
| 00.00m | | MH | Start node type, manhole SW02B | <p>Image Provided - Ref: 59_0</p> |

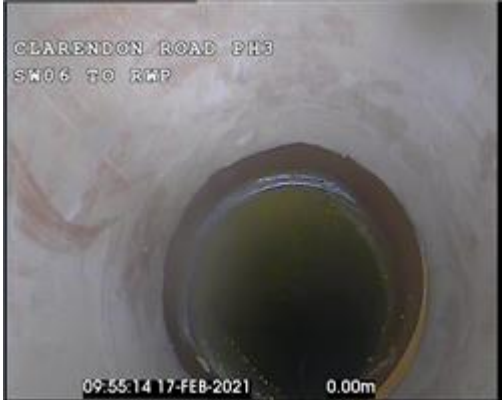
| Pos | Video Ref | Code | Description | Image |
|---|---|---|---|---|
| 00.00m | | MH | Start node type, manhole SW06 | <p>Image Provided - Ref: 60_0</p> |

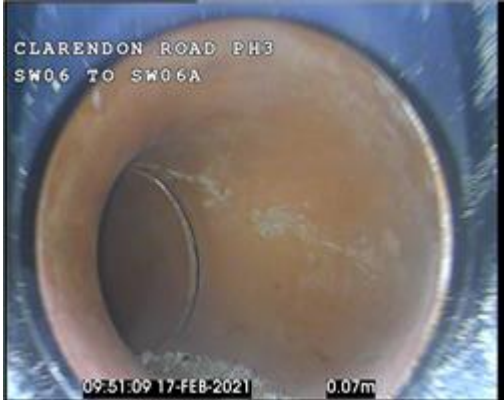
| Pos | Video Ref | Code | Description | Image |
|---|---|---|---|---|
| 00.00m | | MH | Start node type, manhole SW06 | Image Provided - Ref: 61_0<br> |

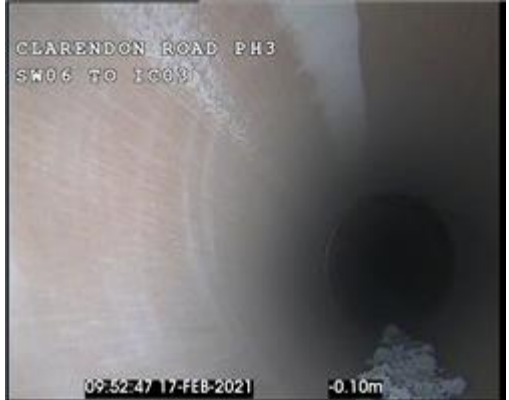
| Pos | Video Ref | Code | Description | Image |
|---|---|---|---|---|
| 00.00m | | MH | Start node type, manhole SW06 | Image Provided - Ref: 62_0<br> |

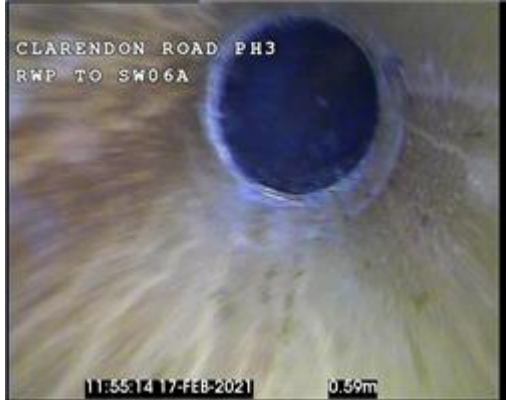
| Pos | Video Ref | Code | Description | Image |
|---|---|---|---|---|
| 00.00m | | OF | Start node type, outfall RWP | Image Provided - Ref: 89_0<br> |

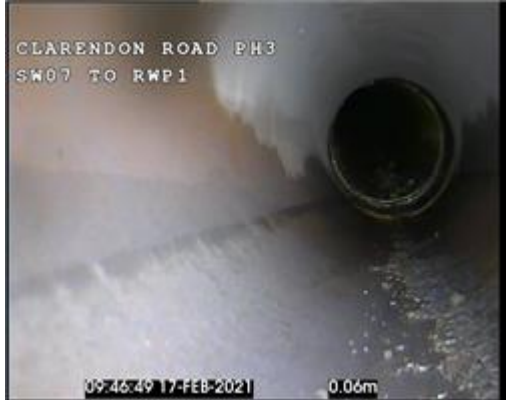
| Pos | Video Ref | Code | Description | Image |
|---|---|---|---|---|
| 00.00m | | MH | Start node type, manhole SW07 | Image Provided - Ref: 63_0<br> A photograph showing the top of a manhole. The text 'CLARENDON ROAD PH3 SW07 TO RWP1' is visible in the upper left. A timestamp '09:46:49 17-FEB-2021' and a distance marker '0.06m' are at the bottom. |

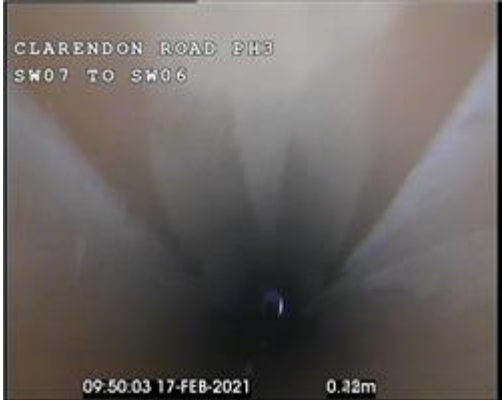
| Pos | Video Ref | Code | Description | Image |
|---|---|---|---|---|
| 00.00m | | MH | Start node type, manhole SW07 | <p>Image Provided - Ref: 65_0</p> |

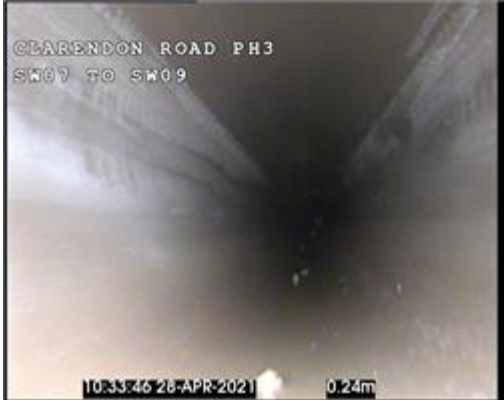
| Pos | Video Ref | Code | Description | Image |
|---|---|---|---|---|
| 00.00m | | MH | Start node type, manhole SW07 | Image Provided - Ref: 66_0<br> |

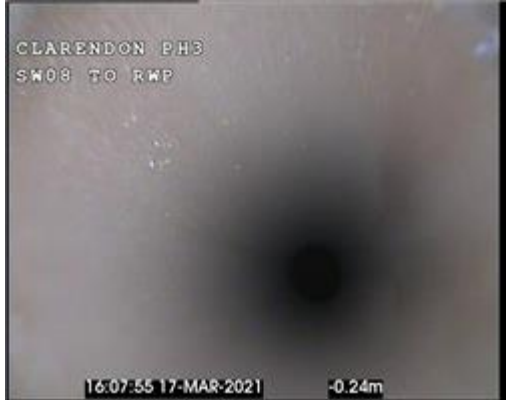
| Pos | Video Ref | Code | Description | Image |
|---|---|---|---|---|
| 00.00m | | MH | Start node type, manhole SW08 | Image Provided - Ref: 67_0<br> |

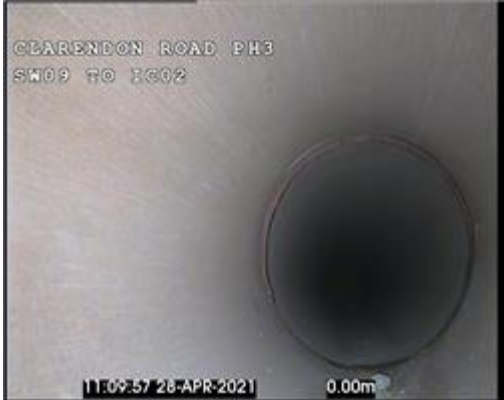
| Pos | Video Ref | Code | Description | Image |
|---|---|---|---|---|
| 00.00m | | MH | Start node type, manhole SW09 | <p>Image Provided - Ref: 69_0</p> |

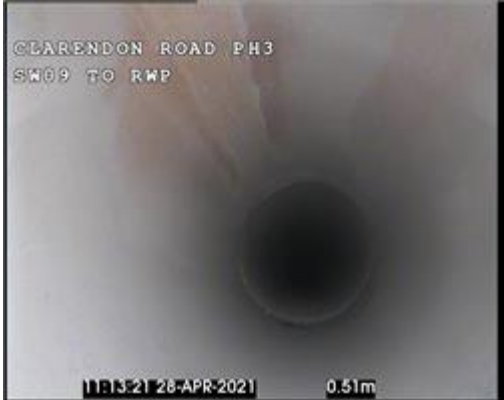
| Pos | Video Ref | Code | Description | Image |
|---|---|---|---|---|
| 00.00m | | MH | Start node type, manhole SW09 | Image Provided - Ref: 70_0<br> |

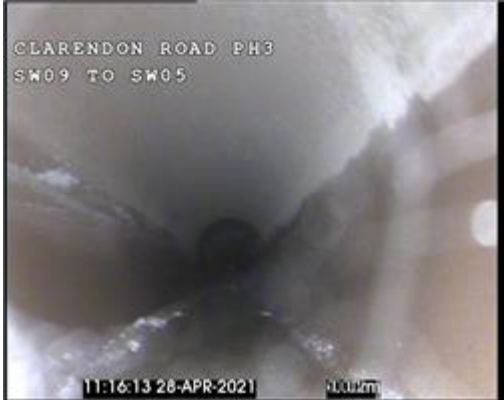
| Pos | Video Ref | Code | Description | Image |
|---|---|---|---|---|
| 00.00m | | MH | Start node type, manhole SW09 | Image Provided - Ref: 71_0<br> |

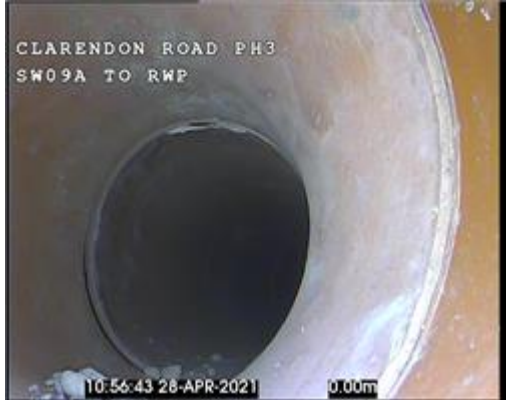
| Pos | Video Ref | Code | Description | Image |
|---|---|---|---|---|
| 00.00m | | MH | Start node type, manhole SW09A | Image Provided - Ref: 72_0<br> |

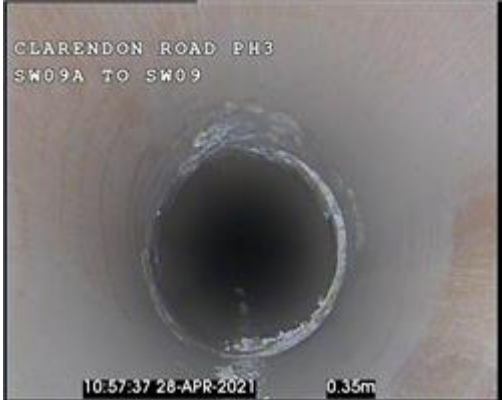
| Pos | Video Ref | Code | Description | Image |
|---|---|---|---|---|
| 00.00m | | MH | Start node type, manhole SW09A | <p>Image Provided - Ref: 73_0</p> |

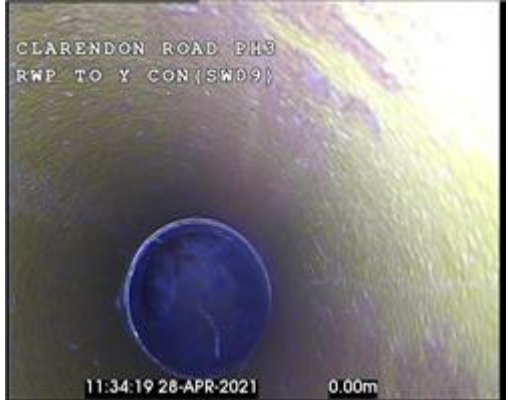
| Pos | Video Ref | Code | Description | Image |
|---|---|---|---|---|
| 00.00m | | OF | Start node type, outfall RWP | Image Provided - Ref: 90_0<br> |

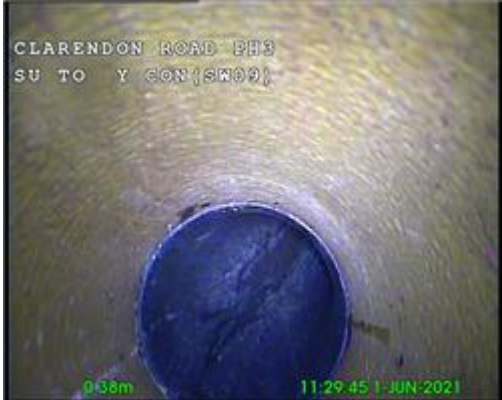
| Pos | Video Ref | Code | Description | Image |
|---|---|---|---|---|
| 00.00m | | GY | Start node type Gully SUMP | <p>Image Provided - Ref: 91_0</p> |

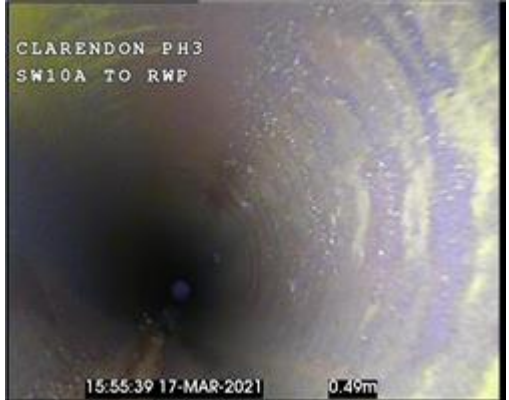
| Pos | Video Ref | Code | Description | Image |
|---|---|---|---|---|
| 00.00m | | MH | Start node type, manhole SW10A | <p>Image Provided - Ref: 76_0</p> |

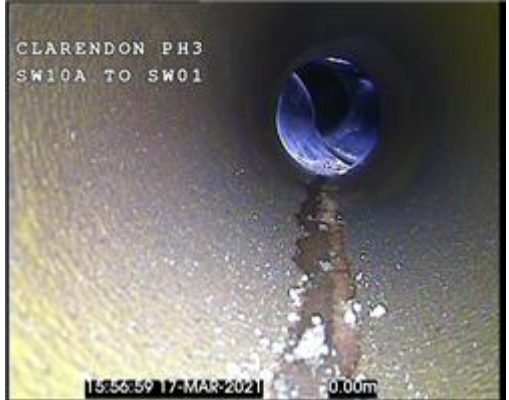
| Pos | Video Ref | Code | Description | Image |
|---|---|---|---|---|
| 00.00m | | MH | Start node type, manhole SW10A | Image Provided - Ref: 77_0<br> |

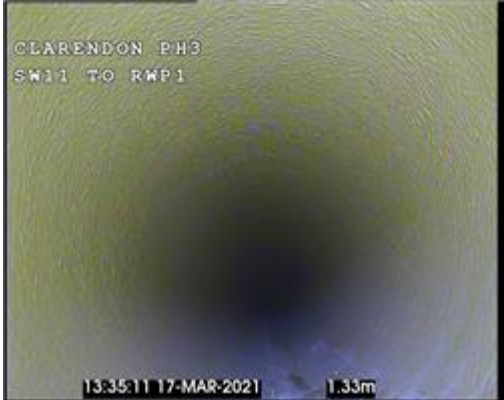
| Pos | Video Ref | Code | Description | Image |
|---|---|---|---|---|
| 00.00m | | MH | Start node type, manhole SW11 | Image Provided - Ref: 78_0<br> |

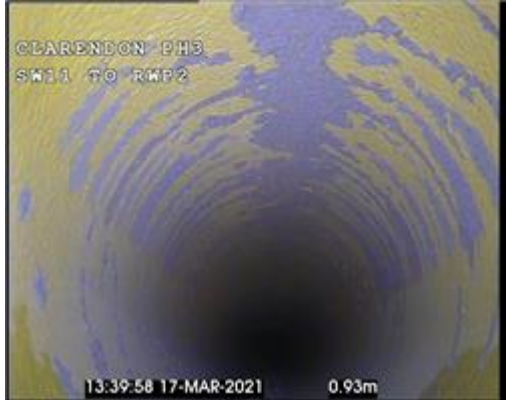
| Pos | Video Ref | Code | Description | Image |
|---|---|---|---|---|
| 00.00m | | MH | Start node type, manhole SW11 | <p>Image Provided - Ref: 79_0</p> |

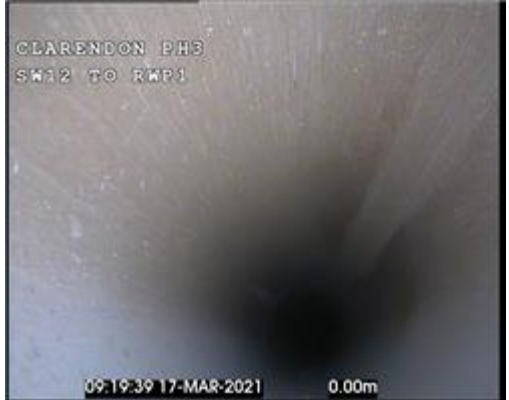
| Pos | Video Ref | Code | Description | Image |
|---|---|---|---|---|
| 00.00m | | MH | Start node type, manhole SW12 | Image Provided - Ref: 80_0<br> |

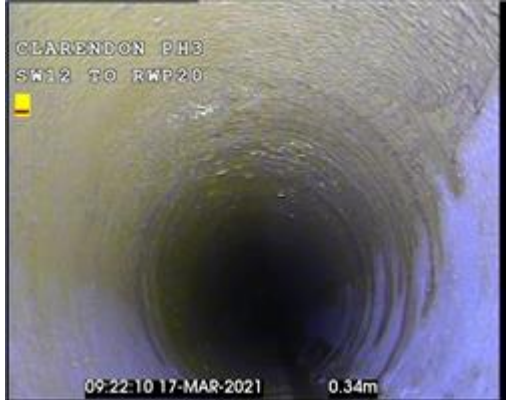
| Pos | Video Ref | Code | Description | Image |
|---|---|---|---|---|
| 00.00m | | MH | Start node type, manhole SW12 | Image Provided - Ref: 81_0<br> |

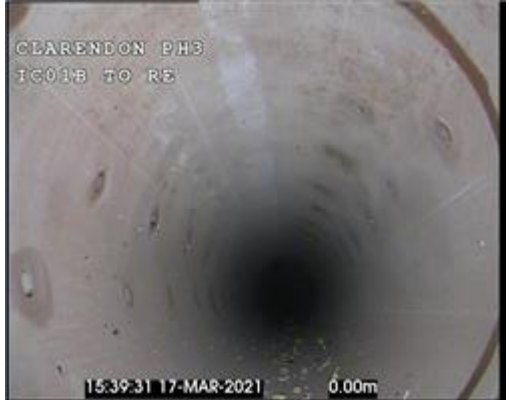
| Pos | Video Ref | Code | Description | Image |
|---|---|---|---|---|
| 00.00m | | MH | Start node type, manhole IC01B | <p>Image Provided - Ref: 82_0</p> |

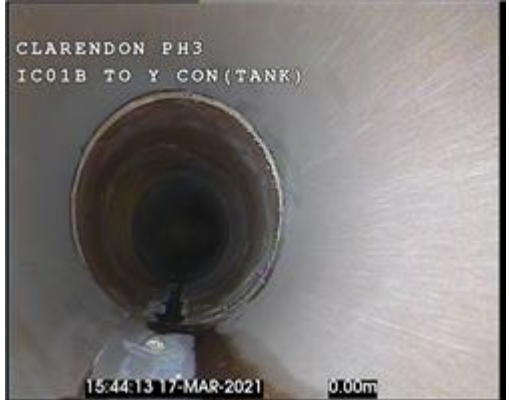
| Pos | Video Ref | Code | Description | Image |
|---|---|---|---|---|
| 00.00m | | MH | Start node type, manhole IC01B | Image Provided - Ref: 83_0<br> |

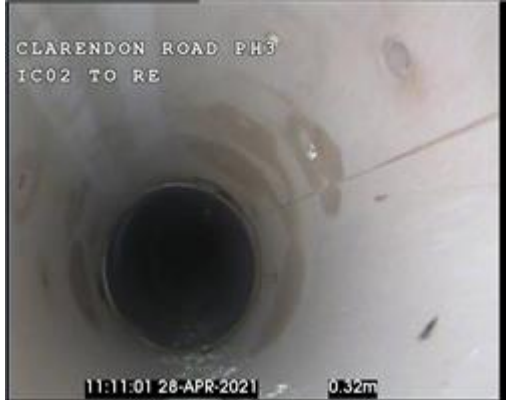
| Pos | Video Ref | Code | Description | Image |
|---|---|---|---|---|
| 00.00m | | MH | Start node type, manhole IC02A | Image Provided - Ref: 84_0<br> |

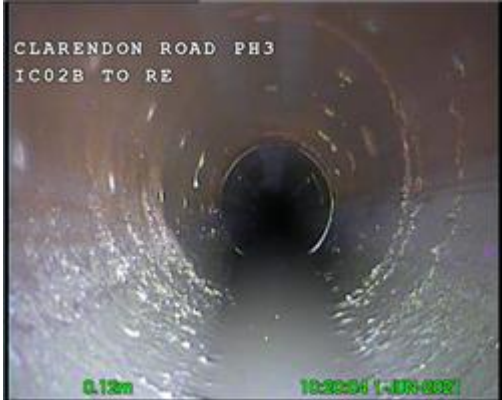
| Pos | Video Ref | Code | Description | Image |
|---|---|---|---|---|
| 00.00m | | MH | Start node type, manhole IC02B | Image Provided - Ref: 85_0<br> |

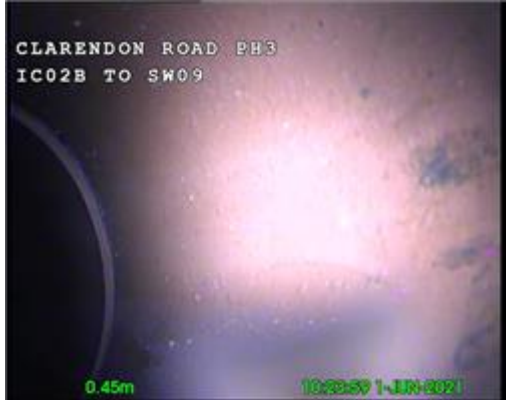
| Pos | Video Ref | Code | Description | Image |
|---|---|---|---|---|
| 00.00m | | MH | Start node type, manhole IC02B | <p>Image Provided - Ref: 86_0</p> |

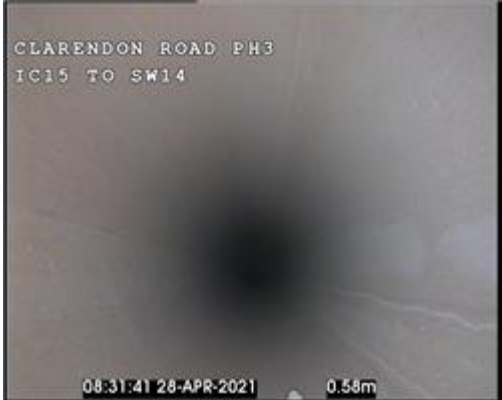
| Pos | Video Ref | Code | Description | Image |
|---|---|---|---|---|
| 00.00m | | MH | Start node type, manhole IC15 | <p>Image Provided - Ref: 87_0</p> |

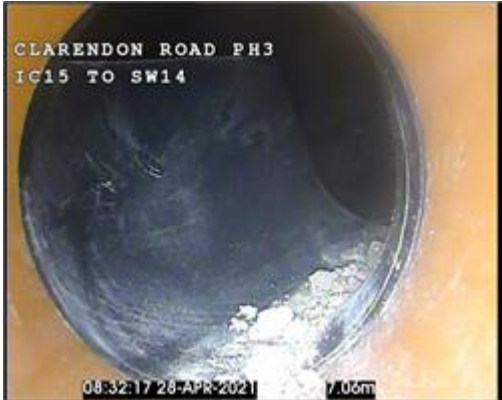
| Pos | Video Ref | Code | Description | Image |
|---|---|---|---|---|
| 07.30m | | MHF | Finish node type, manhole SW14 | <p>Image Provided - Ref: 87_9999</p> |

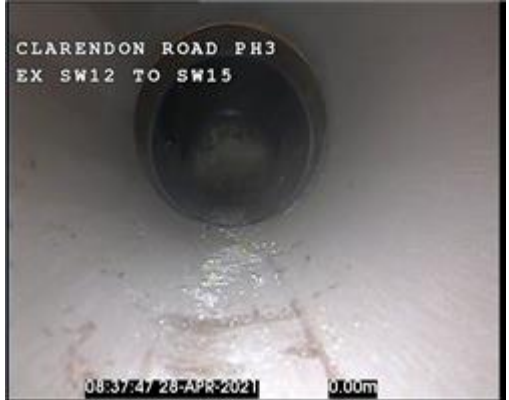
| Pos | Video Ref | Code | Description | Image |
|---|---|---|---|---|
| 00.00m | | MH | Start node type, manhole<br>EX SW12 | Image Provided - Ref: 88_0<br> |
