# Drainage Report

**Clarendon Road**  
**Mary Neuer Road**

**Wood Green**  
**London**  
**N8 0NW**

## Clarendon Road Block D - CCTV Survey Report : 21/05/21

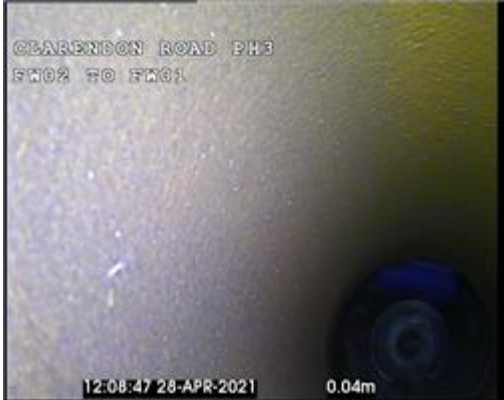
| Pos | Video Ref | Code | Description | Image |
|---|---|---|---|---|
| 00.00m | | MH | Start node type, manhole FW02 | Image Provided - Ref: 0_0<br> |

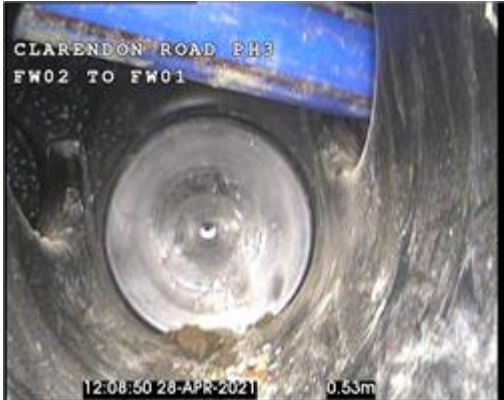
| Pos | Video Ref | Code | Description | Image |
|---|---|---|---|---|
| 00.50m | | MHF | Finish node type, manhole FW01 | Image Provided - Ref: 0_9999<br> |

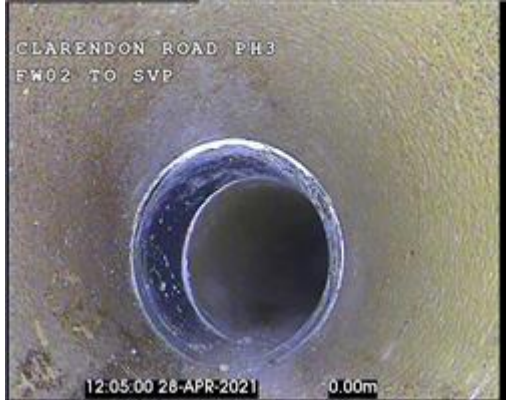
| Pos | Video Ref | Code | Description | Image |
|---|---|---|---|---|
| 00.00m | | MH | Start node type, manhole FW02 | Image Provided - Ref: 1_0<br> |

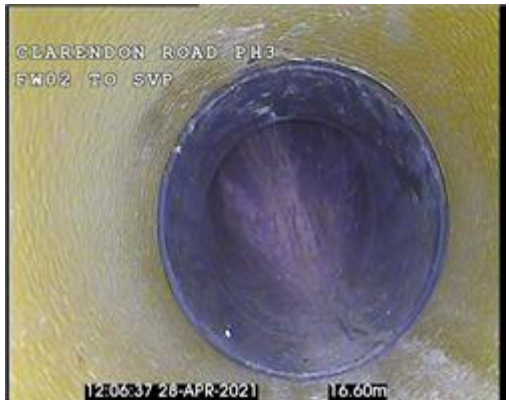
| Pos | Video Ref | Code | Description | Image |
|---|---|---|---|---|
| 17.10m | | OFF | Finish node type, outfall SVP | Image Provided - Ref: 1_9999<br> |

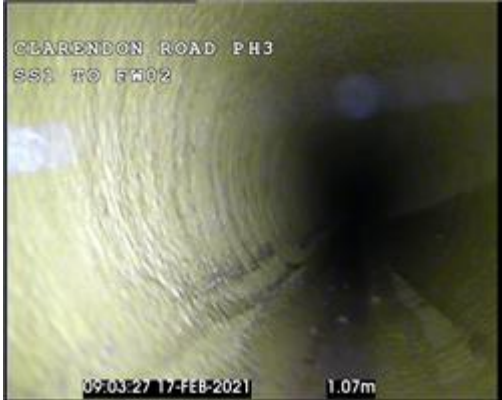
| Pos | Video Ref | Code | Description | Image |
|---|---|---|---|---|
| 00.00m | | OF | Start node type, outfall SS1 | Image Provided - Ref: 2_0<br> |

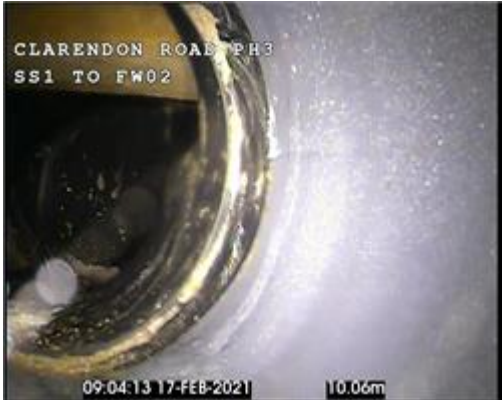
| Pos | Video Ref | Code | Description | Image |
|---|---|---|---|---|
| 10.20m | | MHF | Finish node type, manhole FW02 | Image Provided - Ref: 2_9999<br> |

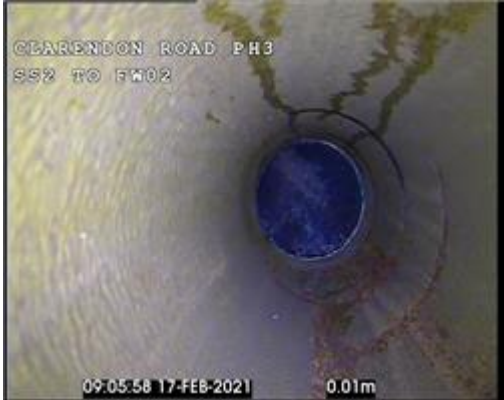
| Pos | Video Ref | Code | Description | Image |
|---|---|---|---|---|
| 00.00m | | OF | Start node type, outfall SS2 | Image Provided - Ref: 11_0<br> |

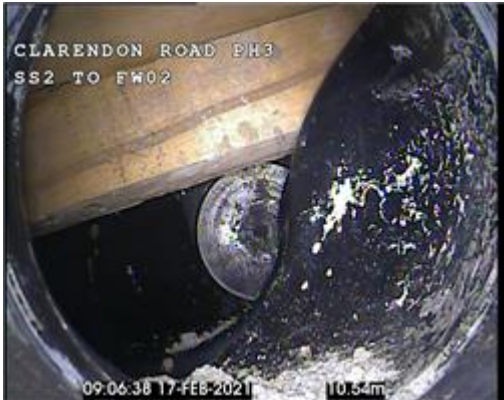
| Pos | Video Ref | Code | Description | Image |
|---|---|---|---|---|
| 10.90m | | MHF | Finish node type, manhole FW02 | Image Provided - Ref: 11_9999<br> |

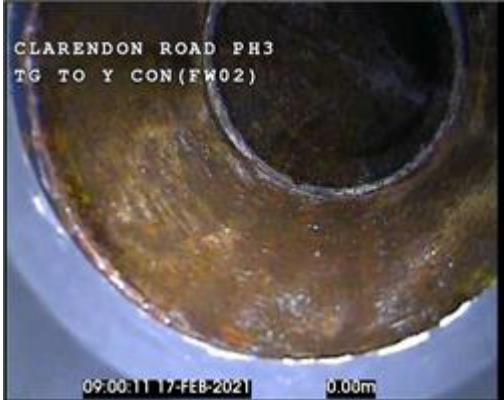
| Pos | Video Ref | Code | Description | Image |
|---|---|---|---|---|
| 00.00m | | GY | Start node type Gully TG | Image Provided - Ref: 5_0<br> |

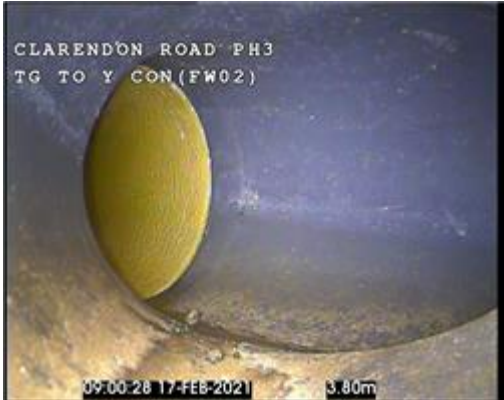
| Pos | Video Ref | Code | Description | Image |
|---|---|---|---|---|
| 04.00m | | WRF | Finish node type, major connection without manhole Y CON(FW02) | Image Provided - Ref: 5_9999<br> |

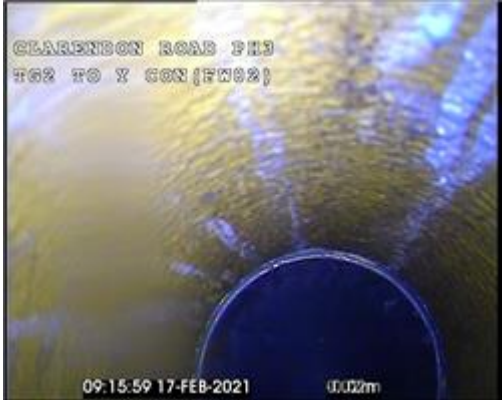
| Pos | Video Ref | Code | Description | Image |
|---|---|---|---|---|
| 00.00m | | GY | Start node type Gully TG2 | <p>Image Provided - Ref: 6_0</p> |

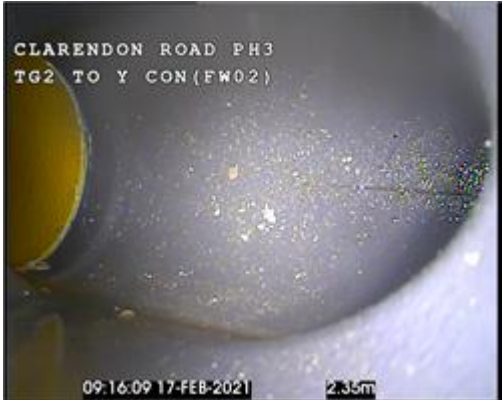
| Pos | Video Ref | Code | Description | Image |
|---|---|---|---|---|
| 02.30m | | WRF | Finish node type, major connection without manhole Y CON(FW02) | <p>Image Provided - Ref: 6_9999</p> |

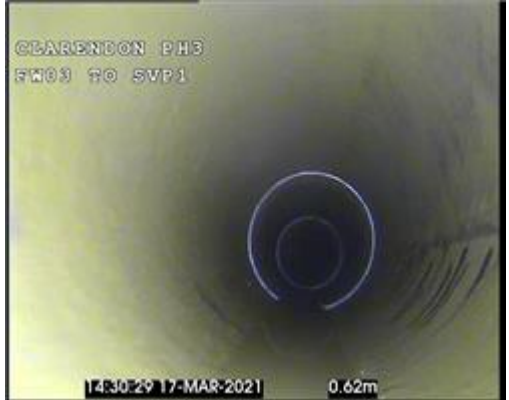
| Pos | Video Ref | Code | Description | Image |
|---|---|---|---|---|
| 00.00m | | MH | Start node type, manhole FW03 | <p>Image Provided - Ref: 3_0</p> |

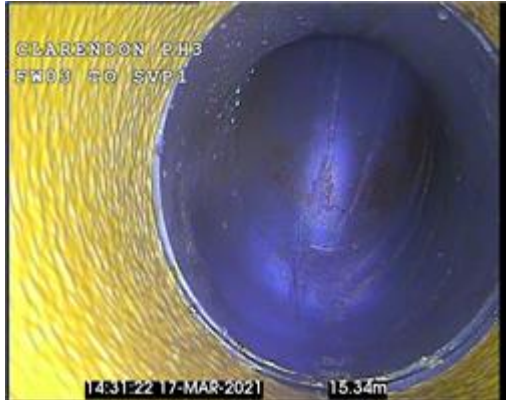
| Pos | Video Ref | Code | Description | Image |
|---|---|---|---|---|
| 15.50m | | OFF | Finish node type, outfall SVP1 | <p>Image Provided - Ref: 3_9999</p> |

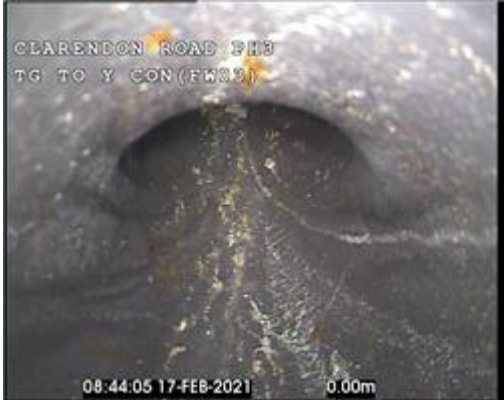
| Pos | Video Ref | Code | Description | Image |
|---|---|---|---|---|
| 00.00m | | GY | Start node type Gully TG | Image Provided - Ref: 4_0<br> |

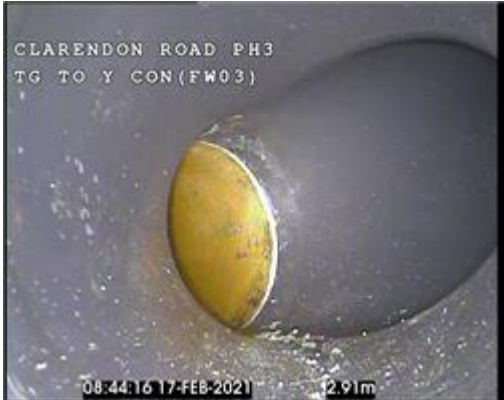
| Pos | Video Ref | Code | Description | Image |
|---|---|---|---|---|
| 02.90m | | WRF | Finish node type, major connection without manhole Y CON(FW06) | Image Provided - Ref: 4_9999<br> |

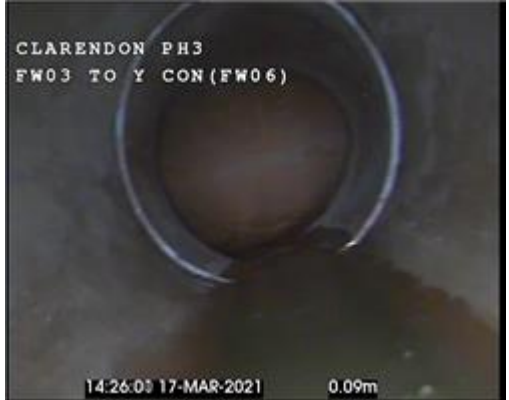
| Pos | Video Ref | Code | Description | Image |
|---|---|---|---|---|
| 00.00m | | MH | Start node type, manhole FW03 | <p>Image Provided - Ref: 7_0</p> |

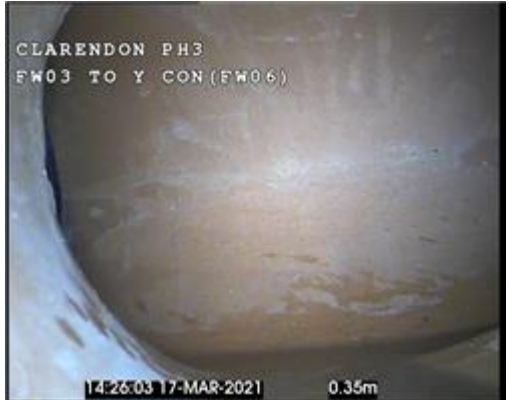
| Pos | Video Ref | Code | Description | Image |
|---|---|---|---|---|
| 00.40m | | WRF | Finish node type, major connection without manhole Y CON(FW06) | <p>Image Provided - Ref: 7_9999</p> |

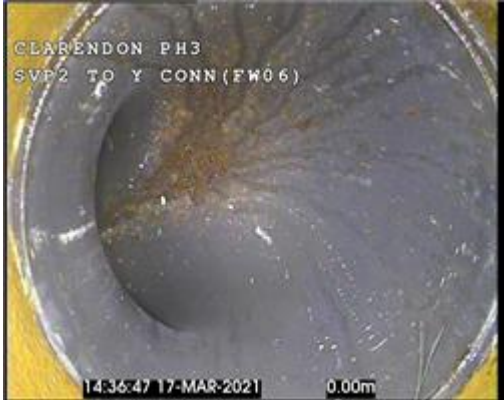
| Pos | Video Ref | Code | Description | Image |
|---|---|---|---|---|
| 00.00m | | OF | Start node type, outfall SVP | Image Provided - Ref: 19_0<br> |

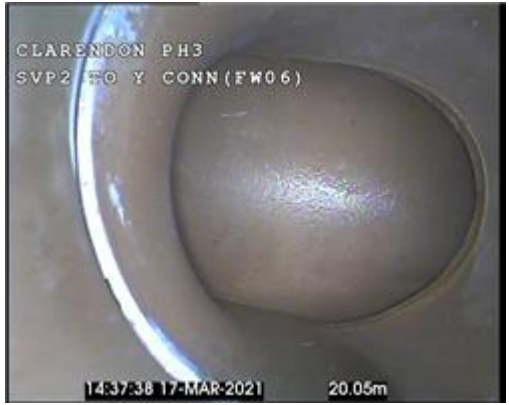
| Pos | Video Ref | Code | Description | Image |
|---|---|---|---|---|
| 20.00m | | WRF | Finish node type, major connection without manhole Y CON(FW06) | <p>Image Provided - Ref: 19_9999</p> |

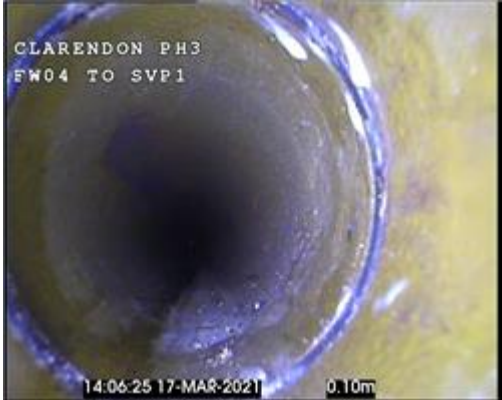
| Pos | Video Ref | Code | Description | Image |
|---|---|---|---|---|
| 00.00m | | MH | Start node type, manhole FW04 | <p>Image Provided - Ref: 8_0</p> |

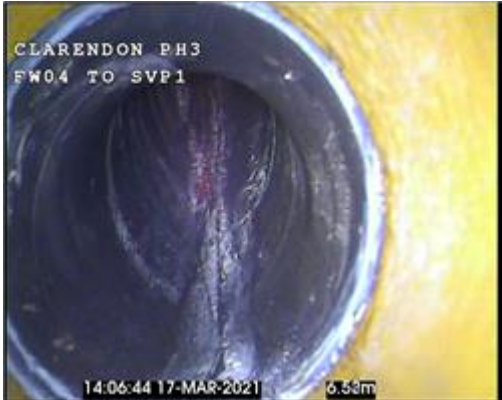
| Pos | Video Ref | Code | Description | Image |
|---|---|---|---|---|
| 06.90m | | OFF | Finish node type, outfall SVP1 | <p>Image Provided - Ref: 8_9999</p> |

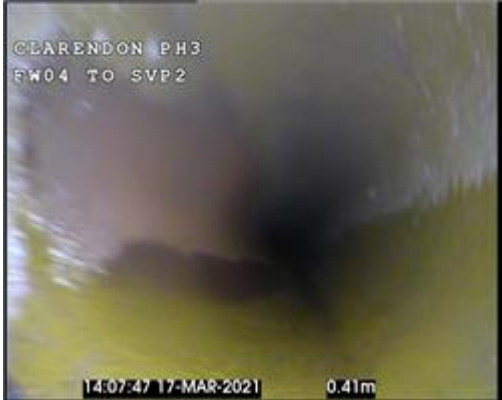
| Pos | Video Ref | Code | Description | Image |
|---|---|---|---|---|
| 00.00m | | MH | Start node type, manhole FW04 | <p>Image Provided - Ref: 9_0</p> |

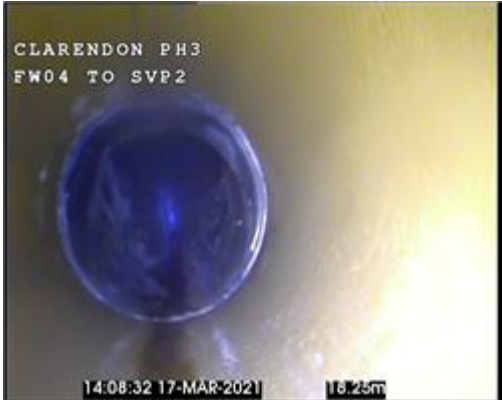
| Pos | Video Ref | Code | Description | Image |
|---|---|---|---|---|
| 16.30m | | OFF | Finish node type, outfall SVP2 | <p>Image Provided - Ref: 9_9999</p> |

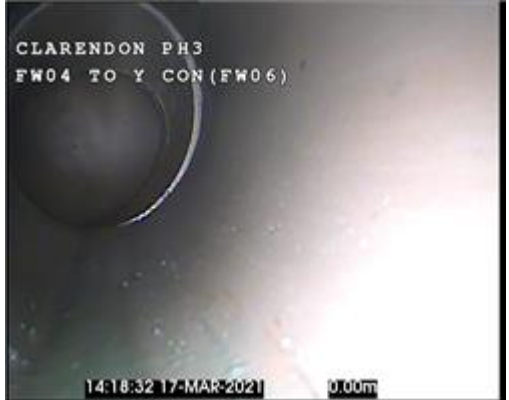
| Pos | Video Ref | Code | Description | Image |
|---|---|---|---|---|
| 00.00m | | MH | Start node type, manhole FW04 | <p>Image Provided - Ref: 10_0</p> |

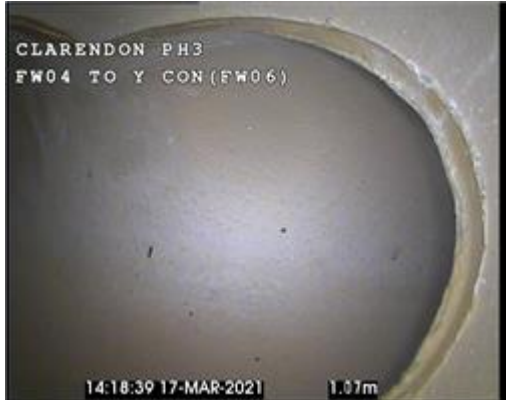
| Pos | Video Ref | Code | Description | Image |
|---|---|---|---|---|
| 01.10m | | WRF | Finish node type, major connection without manhole Y CON(FW06) | <p>Image Provided - Ref: 10_9999</p> |

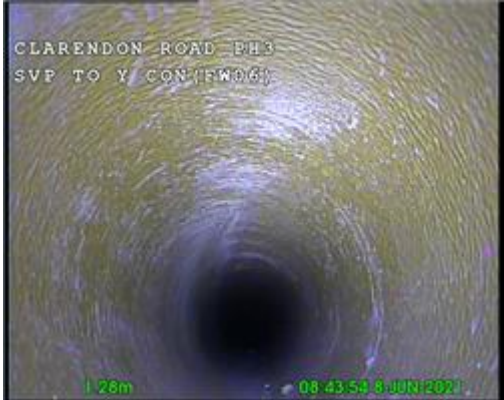
| Pos | Video Ref | Code | Description | Image |
|---|---|---|---|---|
| 00.00m | | OF | Start node type, outfall SVP | Image Provided - Ref: 92_0<br> |

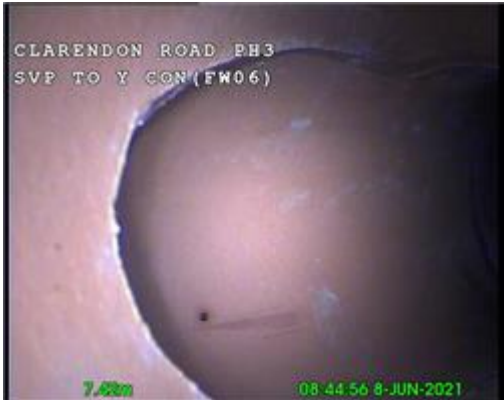
| Pos | Video Ref | Code | Description | Image |
|---|---|---|---|---|
| 07.40m | | WRF | Finish node type, major connection without manhole Y CON(FW06) | Image Provided - Ref: 92_9999<br> |

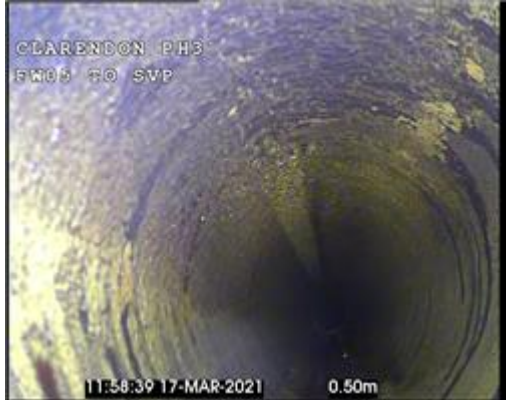
| Pos | Video Ref | Code | Description | Image |
|---|---|---|---|---|
| 00.00m | | MH | Start node type, manhole FW05 | <p>Image Provided - Ref: 12_0</p> |

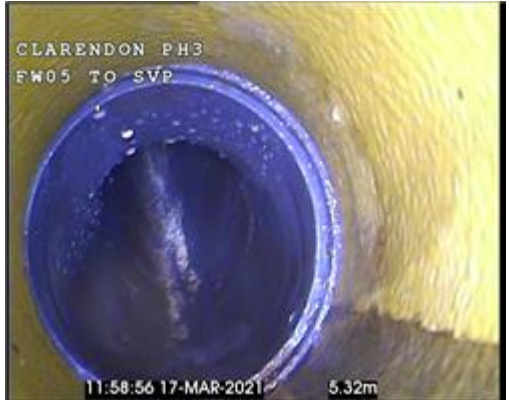
| Pos | Video Ref | Code | Description | Image |
|---|---|---|---|---|
| 05.40m | | OFF | Finish node type, outfall SVP | <p>Image Provided - Ref: 12_9999</p> |

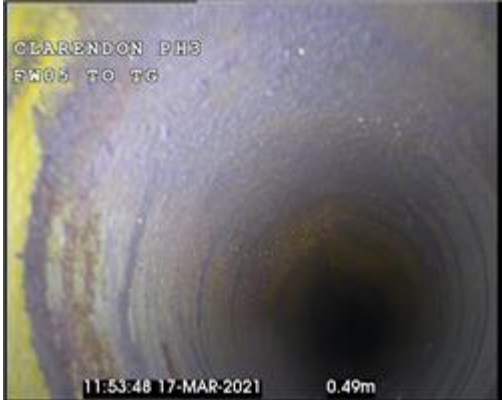
| Pos | Video Ref | Code | Description | Image |
|---|---|---|---|---|
| 00.00m | | MH | Start node type, manhole FW05 | <p>Image Provided - Ref: 13_0</p> |

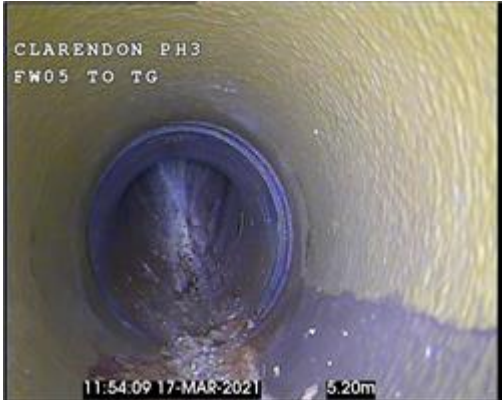
| Pos | Video Ref | Code | Description | Image |
|---|---|---|---|---|
| 05.40m | | GYF | Finish node type Gully TG | <p>Image Provided - Ref: 13_9999</p> |

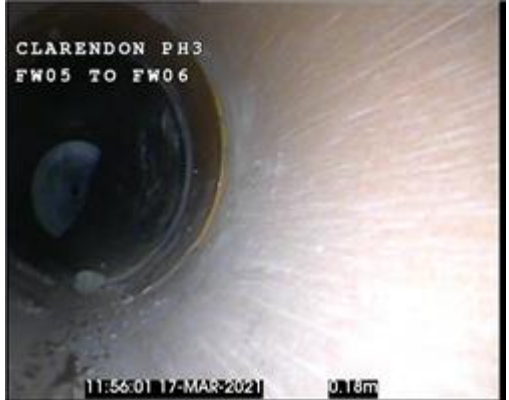
| Pos | Video Ref | Code | Description | Image |
|---|---|---|---|---|
| 00.00m | | MH | Start node type, manhole FW05 | Image Provided - Ref: 14_0<br> |

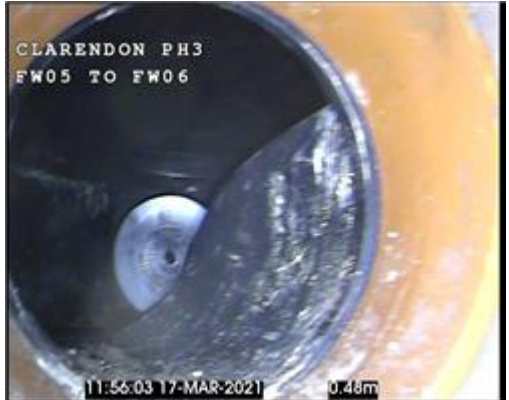
| Pos | Video Ref | Code | Description | Image |
|---|---|---|---|---|
| 01.00m | | MHF | Finish node type, manhole FW06 | Image Provided - Ref: 14_9999<br> |

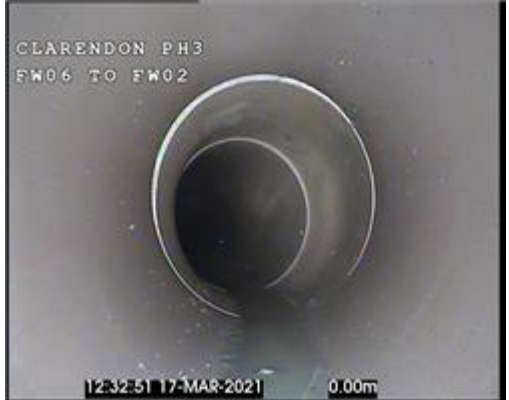
| Pos | Video Ref | Code | Description | Image |
|---|---|---|---|---|
| 00.00m | | MH | Start node type, manhole FW06 | Image Provided - Ref: 15_0<br> |

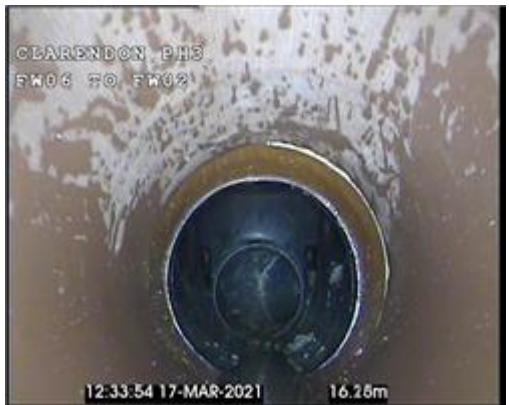
| Pos | Video Ref | Code | Description | Image |
|---|---|---|---|---|
| 16.50m | | MHF | Finish node type, manhole FW02 | <p>Image Provided - Ref: 15_9999</p> |

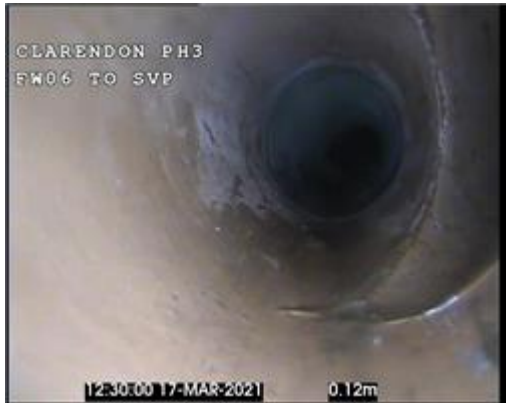
| Pos | Video Ref | Code | Description | Image |
|---|---|---|---|---|
| 00.00m | | MH | Start node type, manhole FW06 | Image Provided - Ref: 16_0<br> |

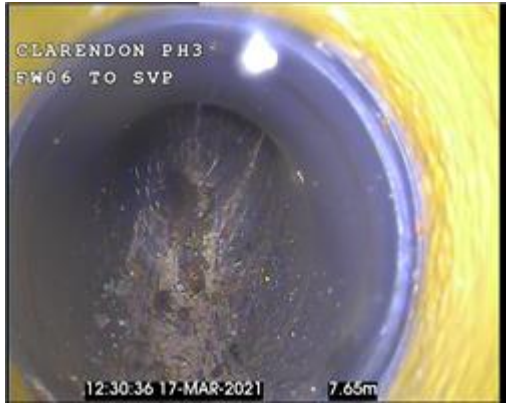
| Pos | Video Ref | Code | Description | Image |
|---|---|---|---|---|
| 07.60m | | OFF | Finish node type, outfall SVP | <p>Image Provided - Ref: 16_9999</p> |

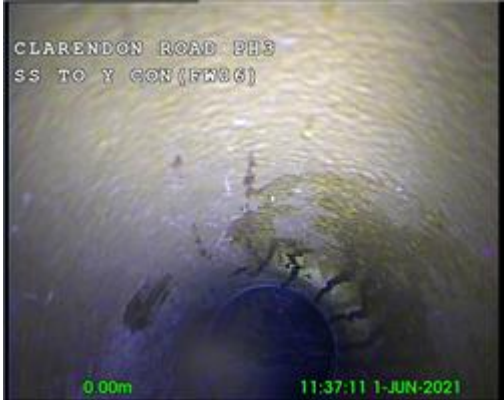
| Pos | Video Ref | Code | Description | Image |
|---|---|---|---|---|
| 00.00m | | OF | Start node type, outfall SS | <p>Image Provided - Ref: 54_0</p> |

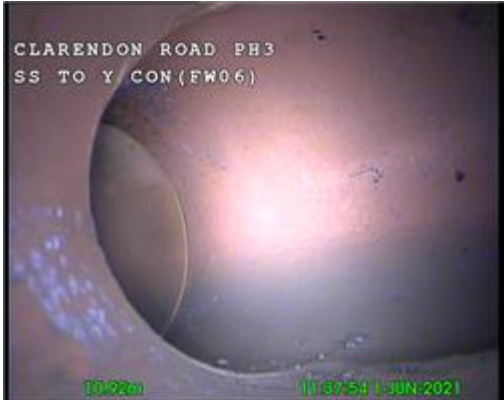
| Pos | Video Ref | Code | Description | Image |
|---|---|---|---|---|
| 10.90m | | WRF | Finish node type, major connection without manhole Y CON(FW06) | <p>Image Provided - Ref: 54_9999</p> |

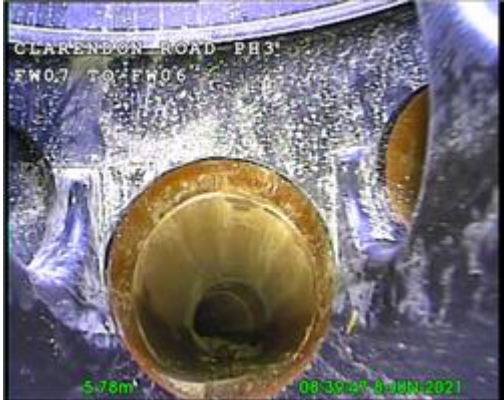
| Pos | Video Ref | Code | Description | Image |
|---|---|---|---|---|
| 00.00m | | MH | Start node type, manhole FW07 | Image Provided - Ref: 93_0<br> |

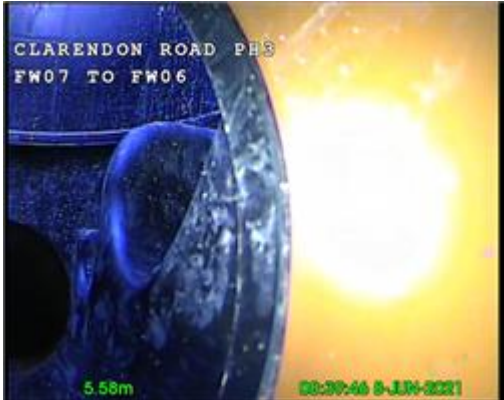
| Pos | Video Ref | Code | Description | Image |
|---|---|---|---|---|
| 05.70m | | MHF | Finish node type, manhole FW06 | Image Provided - Ref: 93_9999<br> |

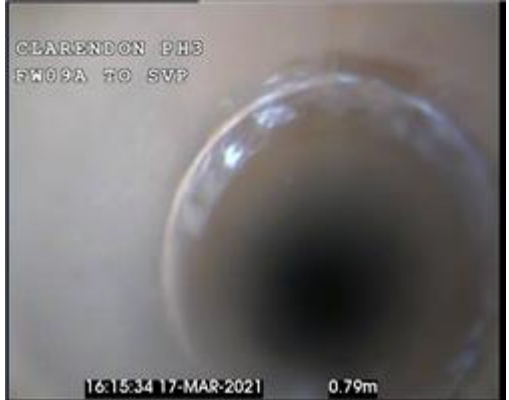
| Pos | Video Ref | Code | Description | Image |
|---|---|---|---|---|
| 00.00m | | MH | Start node type, manhole FW09A | <p>Image Provided - Ref: 17_0</p> |

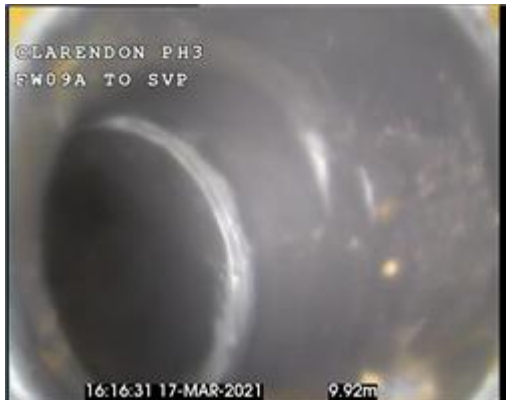
| Pos | Video Ref | Code | Description | Image |
|---|---|---|---|---|
| 10.00m | | OFF | Finish node type, outfall SVP | <p>Image Provided - Ref: 17_9999</p> |

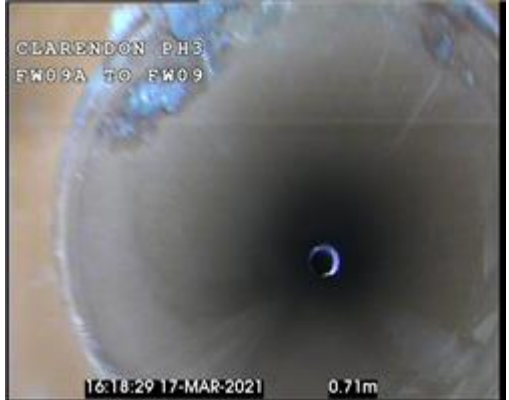
| Pos | Video Ref | Code | Description | Image |
|---|---|---|---|---|
| 00.00m | | MH | Start node type, manhole FW09A | <p>Image Provided - Ref: 18_0</p> |

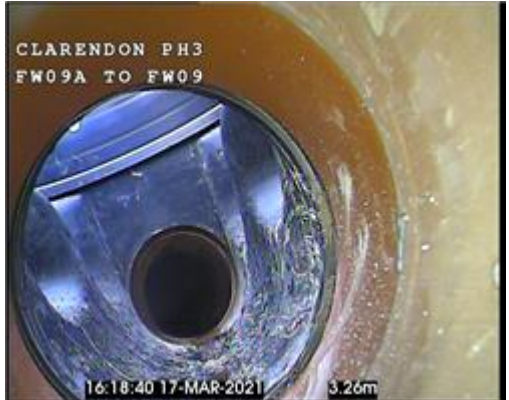
| Pos | Video Ref | Code | Description | Image |
|---|---|---|---|---|
| 03.50m | | MHF | Finish node type, manhole FW09 | <p>Image Provided - Ref: 18_9999</p> |

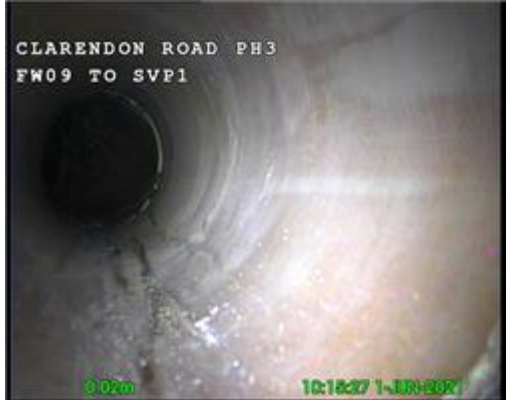
| Pos | Video Ref | Code | Description | Image |
|---|---|---|---|---|
| 00.00m | | MH | Start node type, manhole FW09 | Image Provided - Ref: 20_0<br> |

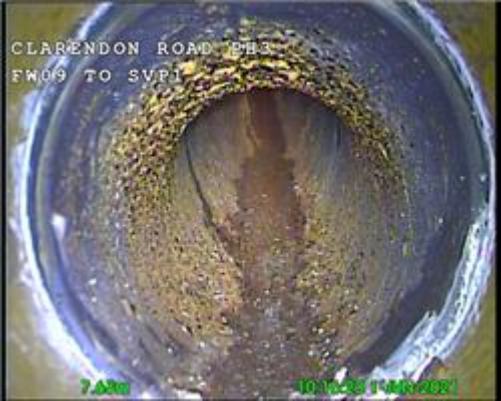
| Pos | Video Ref | Code | Description | Image |
|---|---|---|---|---|
| 07.80m | | OFF | Finish node type, outfall SVP1 | <p>Image Provided - Ref: 20_9999</p> |

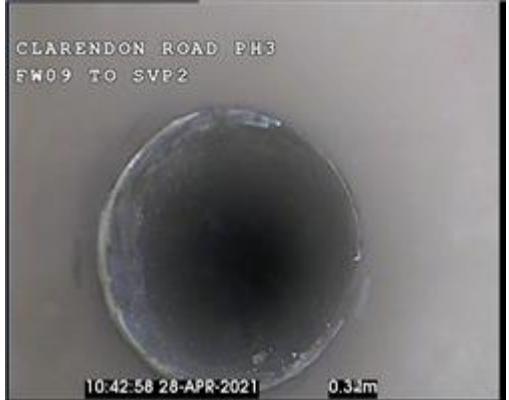
| Pos | Video Ref | Code | Description | Image |
|---|---|---|---|---|
| 00.00m | | MH | Start node type, manhole FW09 | Image Provided - Ref: 21_0<br> |

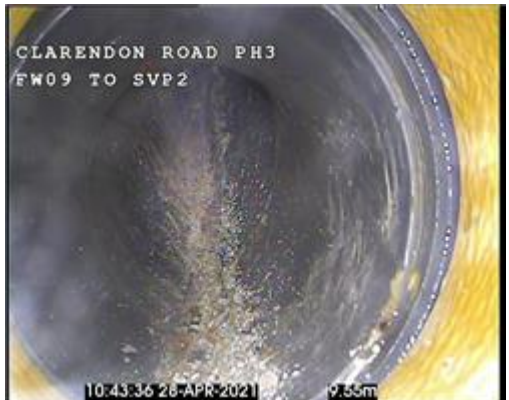
| Pos | Video Ref | Code | Description | Image |
|---|---|---|---|---|
| 09.50m | | OFF | Finish node type, outfall SVP2 | Image Provided - Ref: 21_9999<br> |

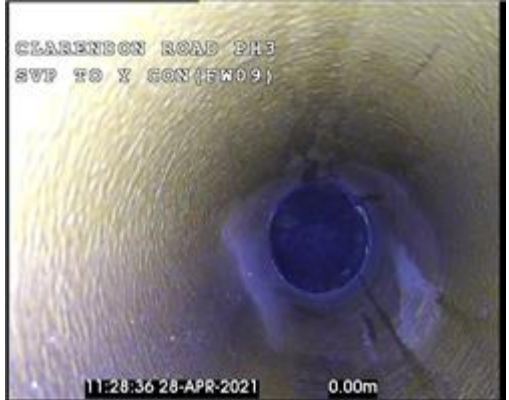
| Pos | Video Ref | Code | Description | Image |
|---|---|---|---|---|
| 00.00m | | OF | Start node type, outfall SVP | Image Provided - Ref: 22_0<br> |

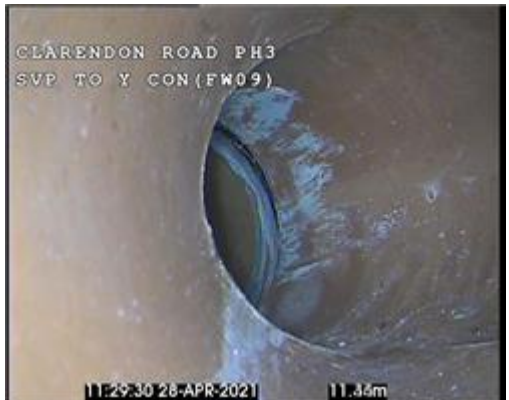
| Pos | Video Ref | Code | Description | Image |
|---|---|---|---|---|
| 11.50m | | WRF | Finish node type, major connection without manhole Y CON (FW09) | Image Provided - Ref: 22_9999<br> |

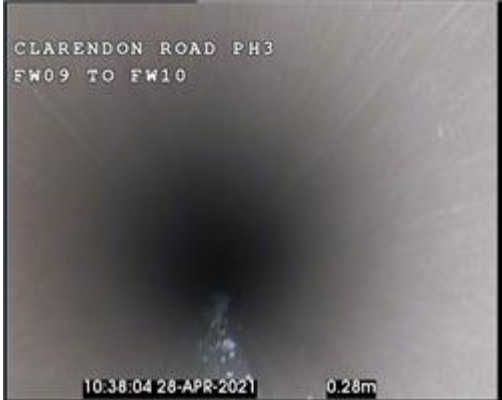
| Pos | Video Ref | Code | Description | Image |
|---|---|---|---|---|
| 00.00m | | MH | Start node type, manhole FW9 | <p>Image Provided - Ref: 25_0</p> |

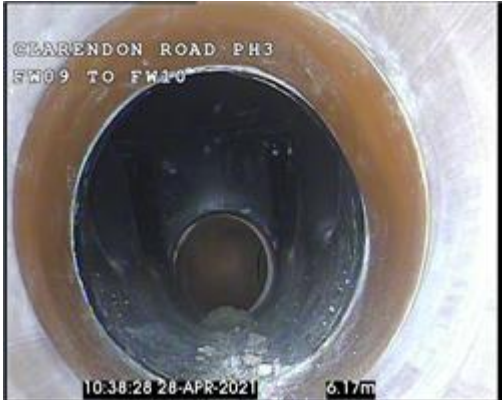
| Pos | Video Ref | Code | Description | Image |
|---|---|---|---|---|
| 06.30m | | MHF | Finish node type, manhole FW10 | <p>Image Provided - Ref: 25_9999</p> |

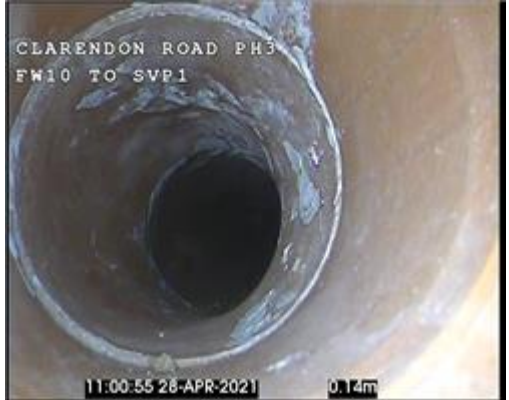
| Pos | Video Ref | Code | Description | Image |
|---|---|---|---|---|
| 00.00m | | MH | Start node type, manhole FW10 | Image Provided - Ref: 23_0<br> |

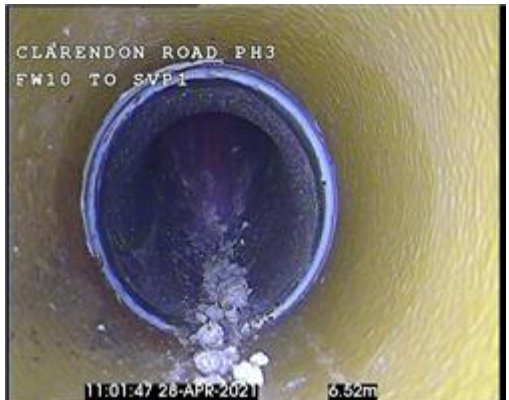
| Pos | Video Ref | Code | Description | Image |
|---|---|---|---|---|
| 06.50m | | OFF | Finish node type, outfall SVP1 | Image Provided - Ref: 23_9999<br> |

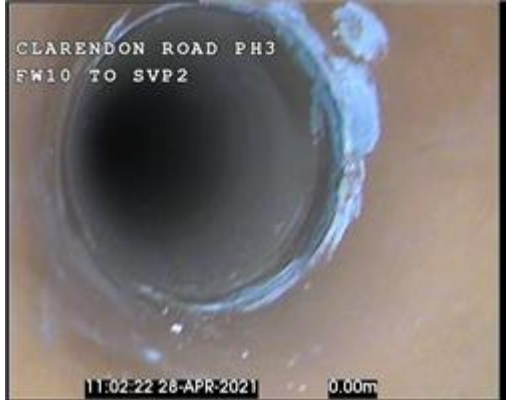
| Pos | Video Ref | Code | Description | Image |
|---|---|---|---|---|
| 00.00m | | MH | Start node type, manhole FW10 | Image Provided - Ref: 24_0<br> |

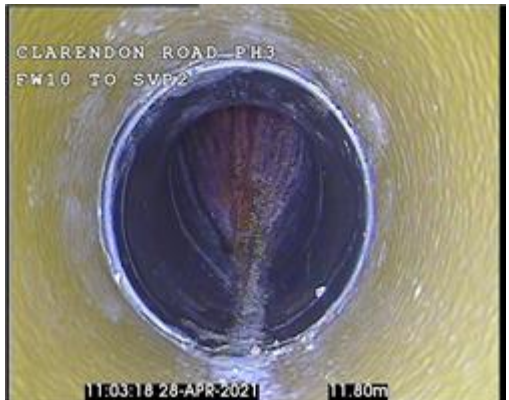
| Pos | Video Ref | Code | Description | Image |
|---|---|---|---|---|
| 11.80m | | OFF | Finish node type, outfall SVP2 | Image Provided - Ref: 24_9999<br> |

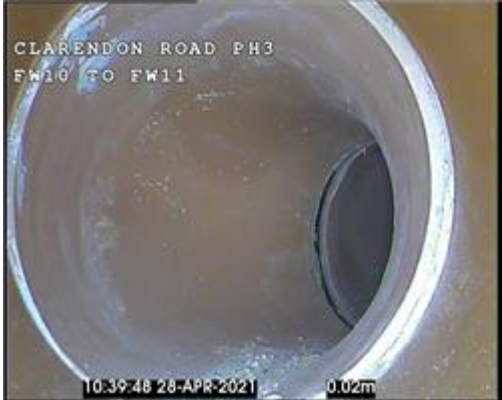
| Pos | Video Ref | Code | Description | Image |
|---|---|---|---|---|
| 00.00m | | MH | Start node type, manhole FW10 | <p>Image Provided - Ref: 26_0</p> |

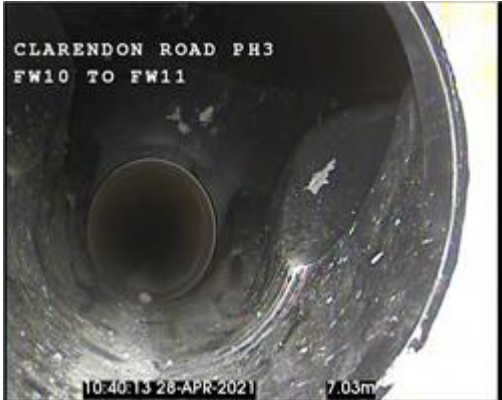
| Pos | Video Ref | Code | Description | Image |
|---|---|---|---|---|
| 07.50m | | MHF | Finish node type, manhole FW11 | <p>Image Provided - Ref: 26_9999</p> |

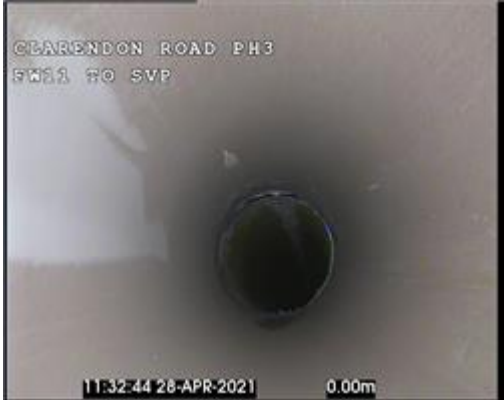
| Pos | Video Ref | Code | Description | Image |
|---|---|---|---|---|
| 00.00m | | MH | Start node type, manhole FW11 | Image Provided - Ref: 27_0<br> |

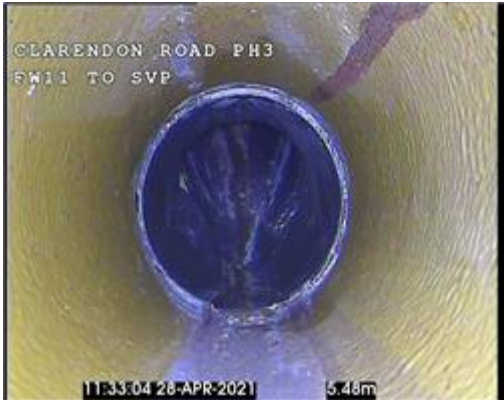
| Pos | Video Ref | Code | Description | Image |
|---|---|---|---|---|
| 05.70m | | OFF | Finish node type, outfall SVP | Image Provided - Ref: 27_9999<br> |

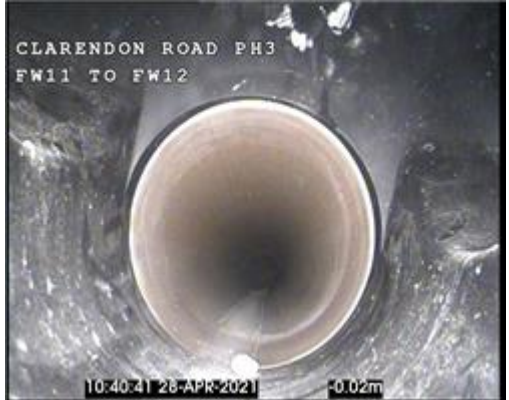
| Pos | Video Ref | Code | Description | Image |
|---|---|---|---|---|
| 00.00m | | MH | Start node type, manhole FW11 | <p>Image Provided - Ref: 28_0</p> |

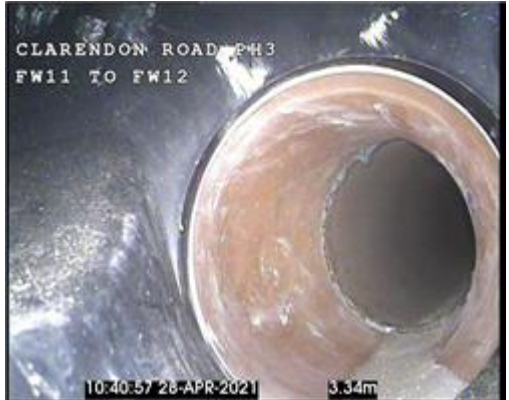
| Pos | Video Ref | Code | Description | Image |
|---|---|---|---|---|
| 03.20m | | MHF | Finish node type, manhole FW12 | <p>Image Provided - Ref: 28_9999</p> |

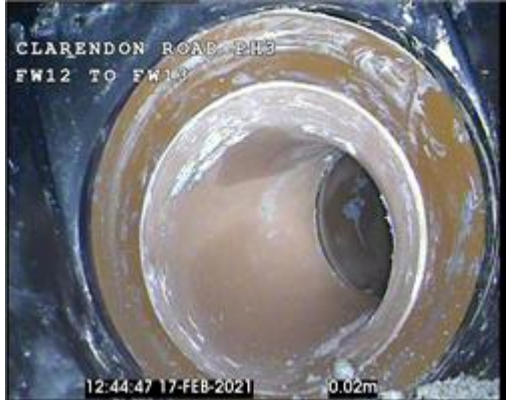
| Pos | Video Ref | Code | Description | Image |
|---|---|---|---|---|
| 00.00m | | MH | Start node type, manhole FW12 | <p>Image Provided - Ref: 29_0</p> |

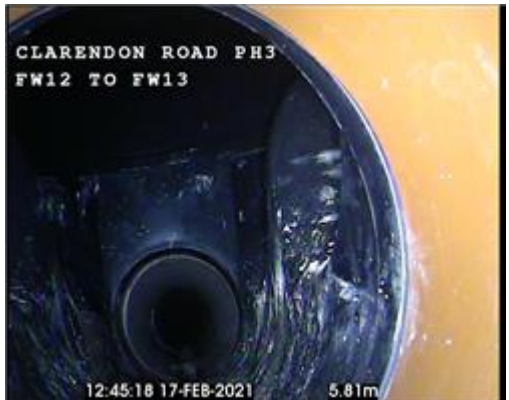
| Pos | Video Ref | Code | Description | Image |
|---|---|---|---|---|
| 06.00m | | MHF | Finish node type, manhole FW13 | <p>Image Provided - Ref: 29_9999</p> |

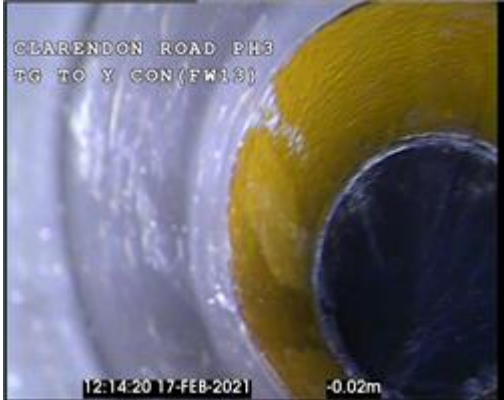
| Pos | Video Ref | Code | Description | Image |
|---|---|---|---|---|
| 00.00m | | GY | Start node type Gully TG | Image Provided - Ref: 30_0<br> |

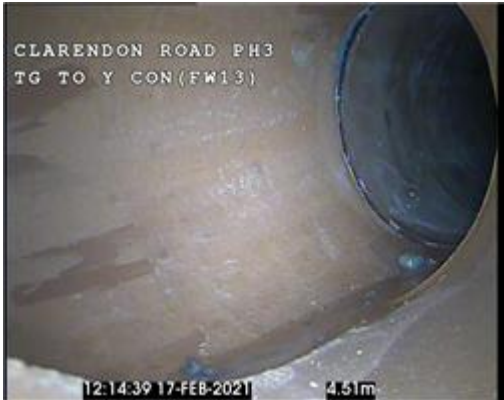
| Pos | Video Ref | Code | Description | Image |
|---|---|---|---|---|
| 04.60m | | WRF | Finish node type, major connection without manhole Y CON(FW13) | Image Provided - Ref: 30_9999<br> |

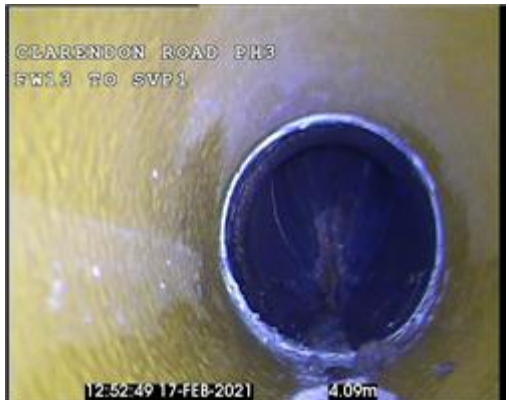
| Pos | Video Ref | Code | Description | Image |
|---|---|---|---|---|
| 04.30m | | OFF | Finish node type, outfall SVP1 | Image Provided - Ref: 31_9999<br> |

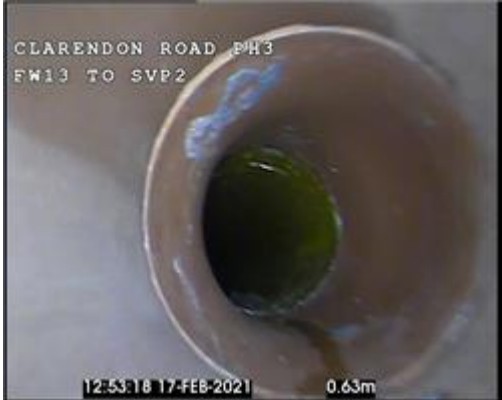
| Pos | Video Ref | Code | Description | Image |
|---|---|---|---|---|
| 00.00m | | MH | Start node type, manhole FW13 | <p>Image Provided - Ref: 32_0</p> |

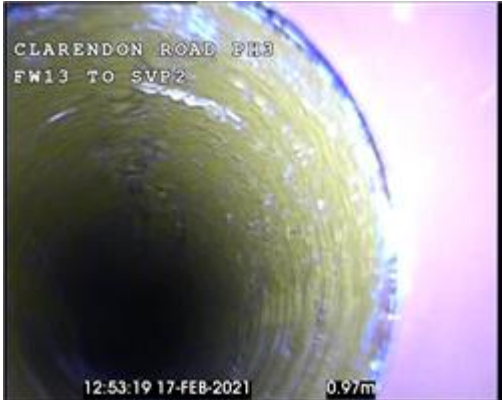
| Pos | Video Ref | Code | Description | Image |
|---|---|---|---|---|
| 01.10m | 0:00:03 | MCCI | Material of pipe changes to Cast Iron | <p>Image Provided - Ref: 32_2</p> |

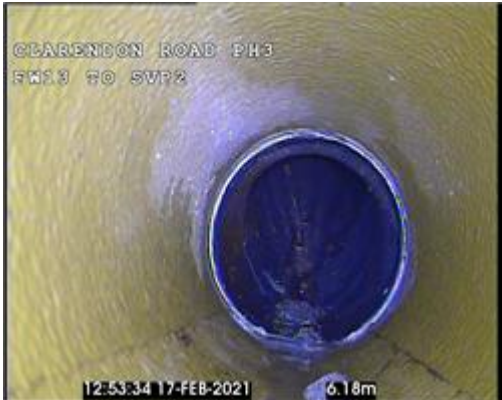
| Pos | Video Ref | Code | Description | Image |
|---|---|---|---|---|
| 06.50m | | OFF | Finish node type, outfall SVP2 | <p>Image Provided - Ref: 32_9999</p> |

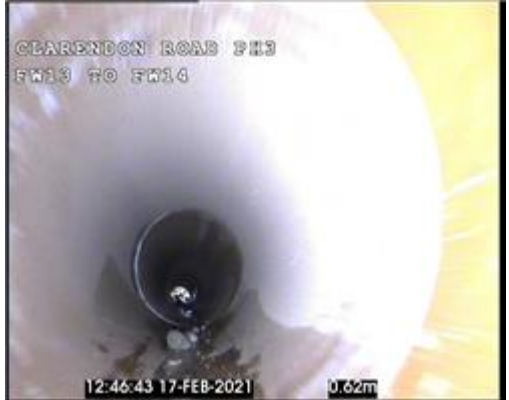
| Pos | Video Ref | Code | Description | Image |
|---|---|---|---|---|
| 00.00m | | MH | Start node type, manhole FW13 | <p>Image Provided - Ref: 33_0</p> |

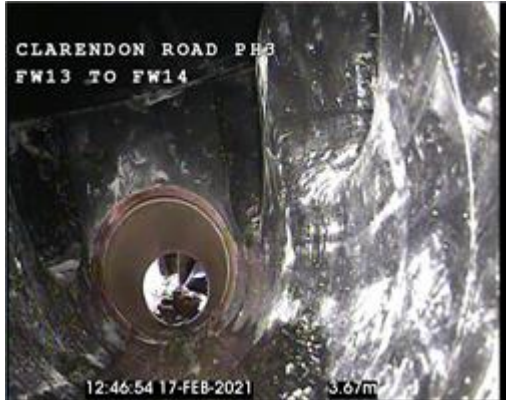
| Pos | Video Ref | Code | Description | Image |
|---|---|---|---|---|
| 03.70m | | MHF | Finish node type, manhole FW14 | <p>Image Provided - Ref: 33_9999</p> |

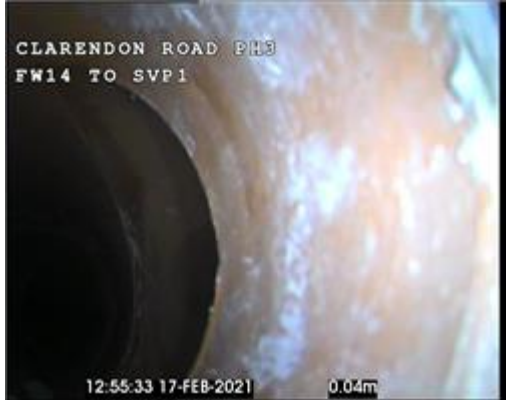
| Pos | Video Ref | Code | Description | Image |
|---|---|---|---|---|
| 00.00m | | MH | Start node type, manhole FW14 | Image Provided - Ref: 34_0<br> |

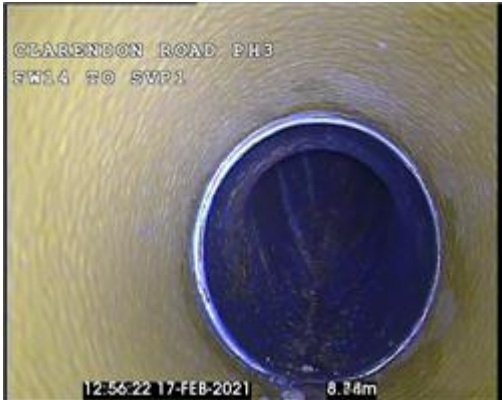
| Pos | Video Ref | Code | Description | Image |
|---|---|---|---|---|
| 08.90m | | OFF | Finish node type, outfall SVP1 | <p>Image Provided - Ref: 34_9999</p> |

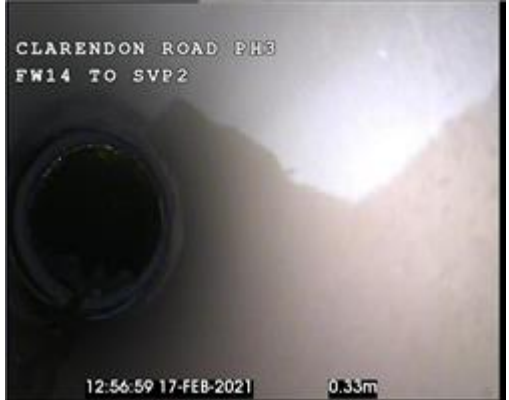
| Pos | Video Ref | Code | Description | Image |
|---|---|---|---|---|
| 00.00m | | MH | Start node type, manhole FW14 | Image Provided - Ref: 35_0<br> |

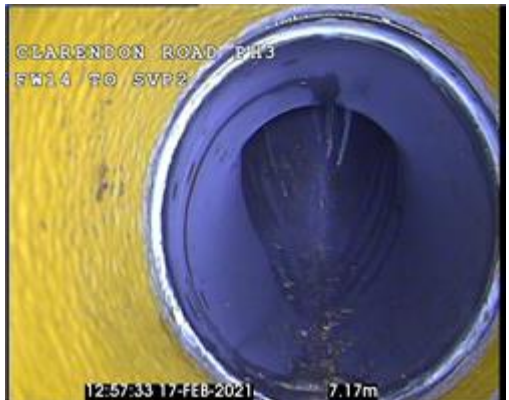
| Pos | Video Ref | Code | Description | Image |
|---|---|---|---|---|
| 07.50m | | OFF | Finish node type, outfall SVP2 | Image Provided - Ref: 35_9999<br> |

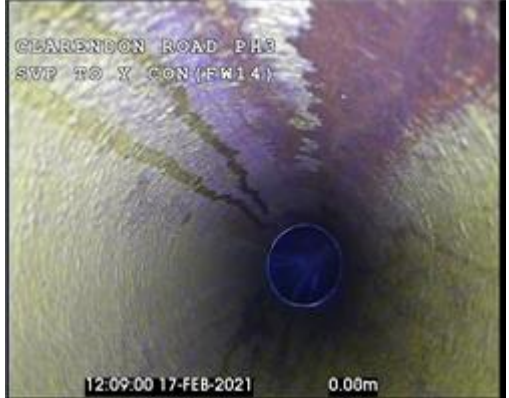
| Pos | Video Ref | Code | Description | Image |
|---|---|---|---|---|
| 00.00m | | OF | Start node type, outfall SVP | <p>Image Provided - Ref: 36_0</p> |

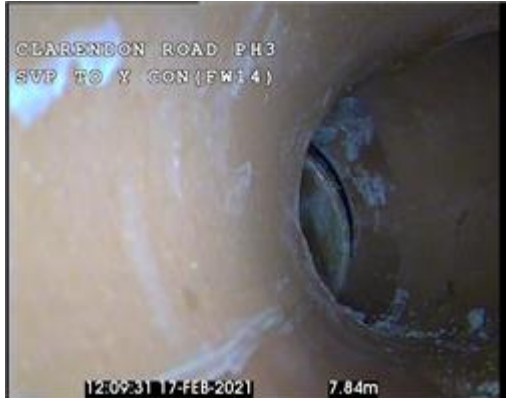
| Pos | Video Ref | Code | Description | Image |
|---|---|---|---|---|
| 07.80m | | WRF | Finish node type, major connection without manhole Y CON(FW14) | <p>Image Provided - Ref: 36_9999</p> |

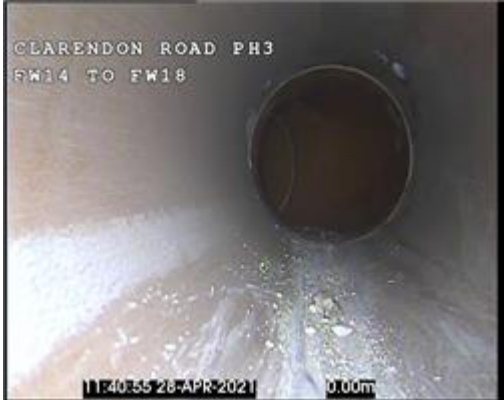
| Pos | Video Ref | Code | Description | Image |
|---|---|---|---|---|
| 00.00m | | MH | Start node type, manhole FW14 | <p>Image Provided - Ref: 37_0</p> |

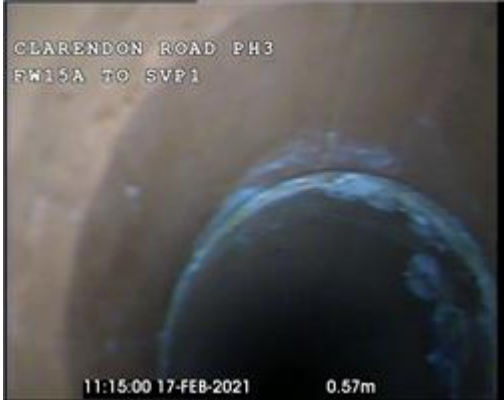
| Pos | Video Ref | Code | Description | Image |
|---|---|---|---|---|
| 00.00m | | MH | Start node type, manhole FW15A | Image Provided - Ref: 38_0<br> |

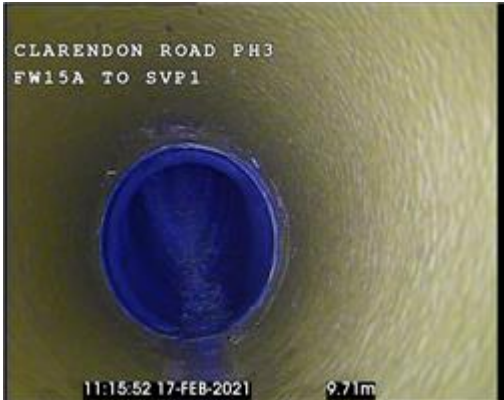
| Pos | Video Ref | Code | Description | Image |
|---|---|---|---|---|
| 10.00m | | OFF | Finish node type, outfall SVP1 | Image Provided - Ref: 38_9999<br> |

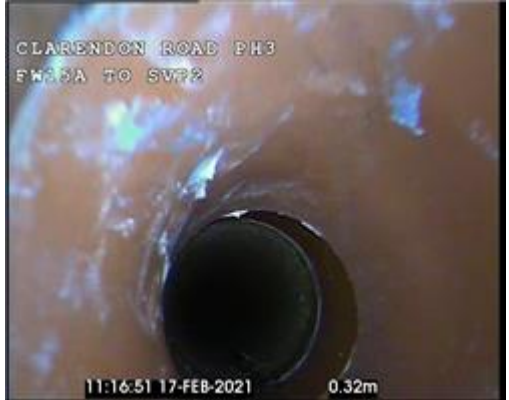
| Pos | Video Ref | Code | Description | Image |
|---|---|---|---|---|
| 00.00m | | MH | Start node type, manhole FW15A | Image Provided - Ref: 39_0<br> |

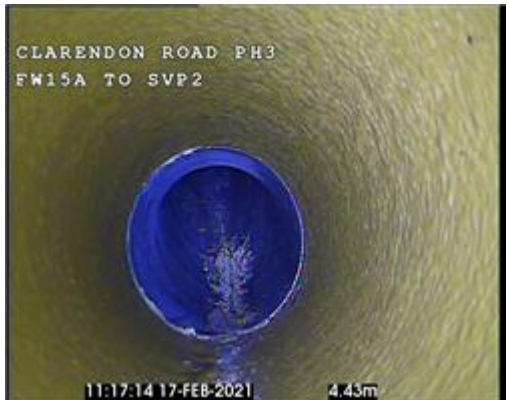
| Pos | Video Ref | Code | Description | Image |
|---|---|---|---|---|
| 04.90m | | OFF | Finish node type, outfall SVP2 | Image Provided - Ref: 39_9999<br> |

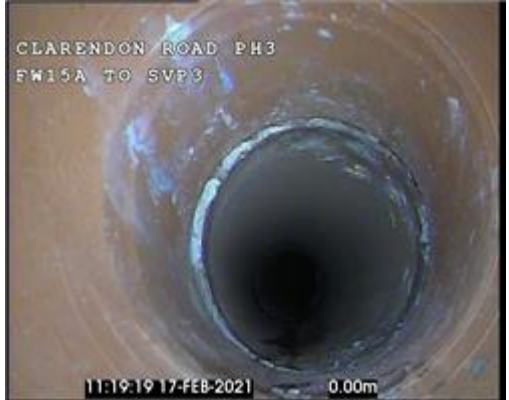
| Pos | Video Ref | Code | Description | Image |
|---|---|---|---|---|
| 00.00m | | MH | Start node type, manhole FW15A | Image Provided - Ref: 40_0<br> |

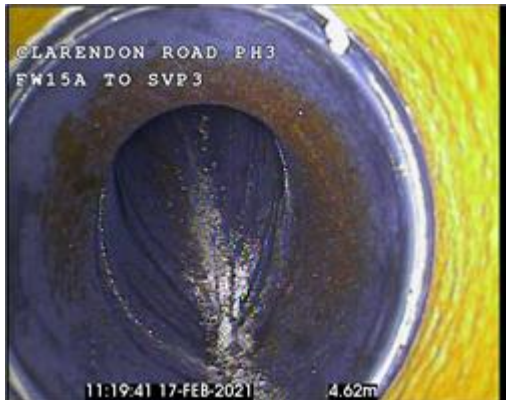
| Pos | Video Ref | Code | Description | Image |
|---|---|---|---|---|
| 04.50m | | OFF | Finish node type, outfall SVP3 | Image Provided - Ref: 40_9999<br> |

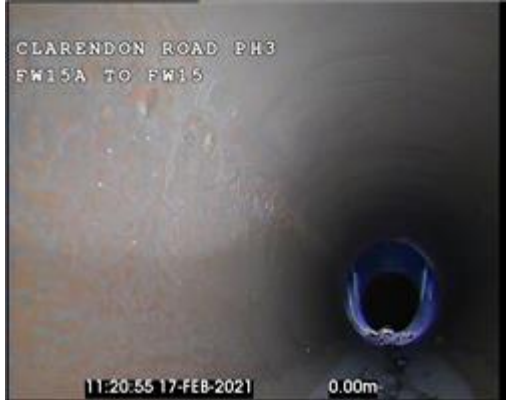
| Pos | Video Ref | Code | Description | Image |
|---|---|---|---|---|
| 00.00m | | MH | Start node type, manhole FW15A | <p>Image Provided - Ref: 41_0</p> |

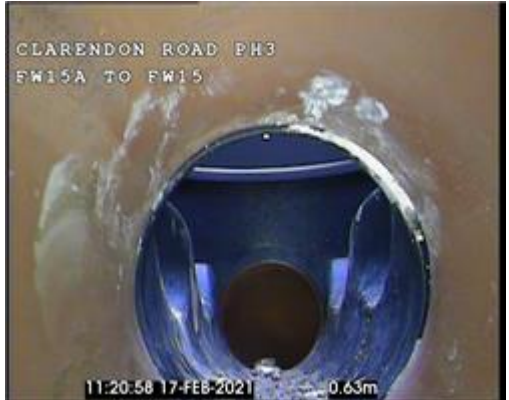
| Pos | Video Ref | Code | Description | Image |
|---|---|---|---|---|
| 01.00m | | MHF | Finish node type, manhole FW15 | <p>Image Provided - Ref: 41_9999</p> |
