# GEOSHIELD Verification Report

007

GCL - Clarendon Road PHASE 3

AREA SURVEYED: Block D1 Slab - Pour 1 (third visit for this area)

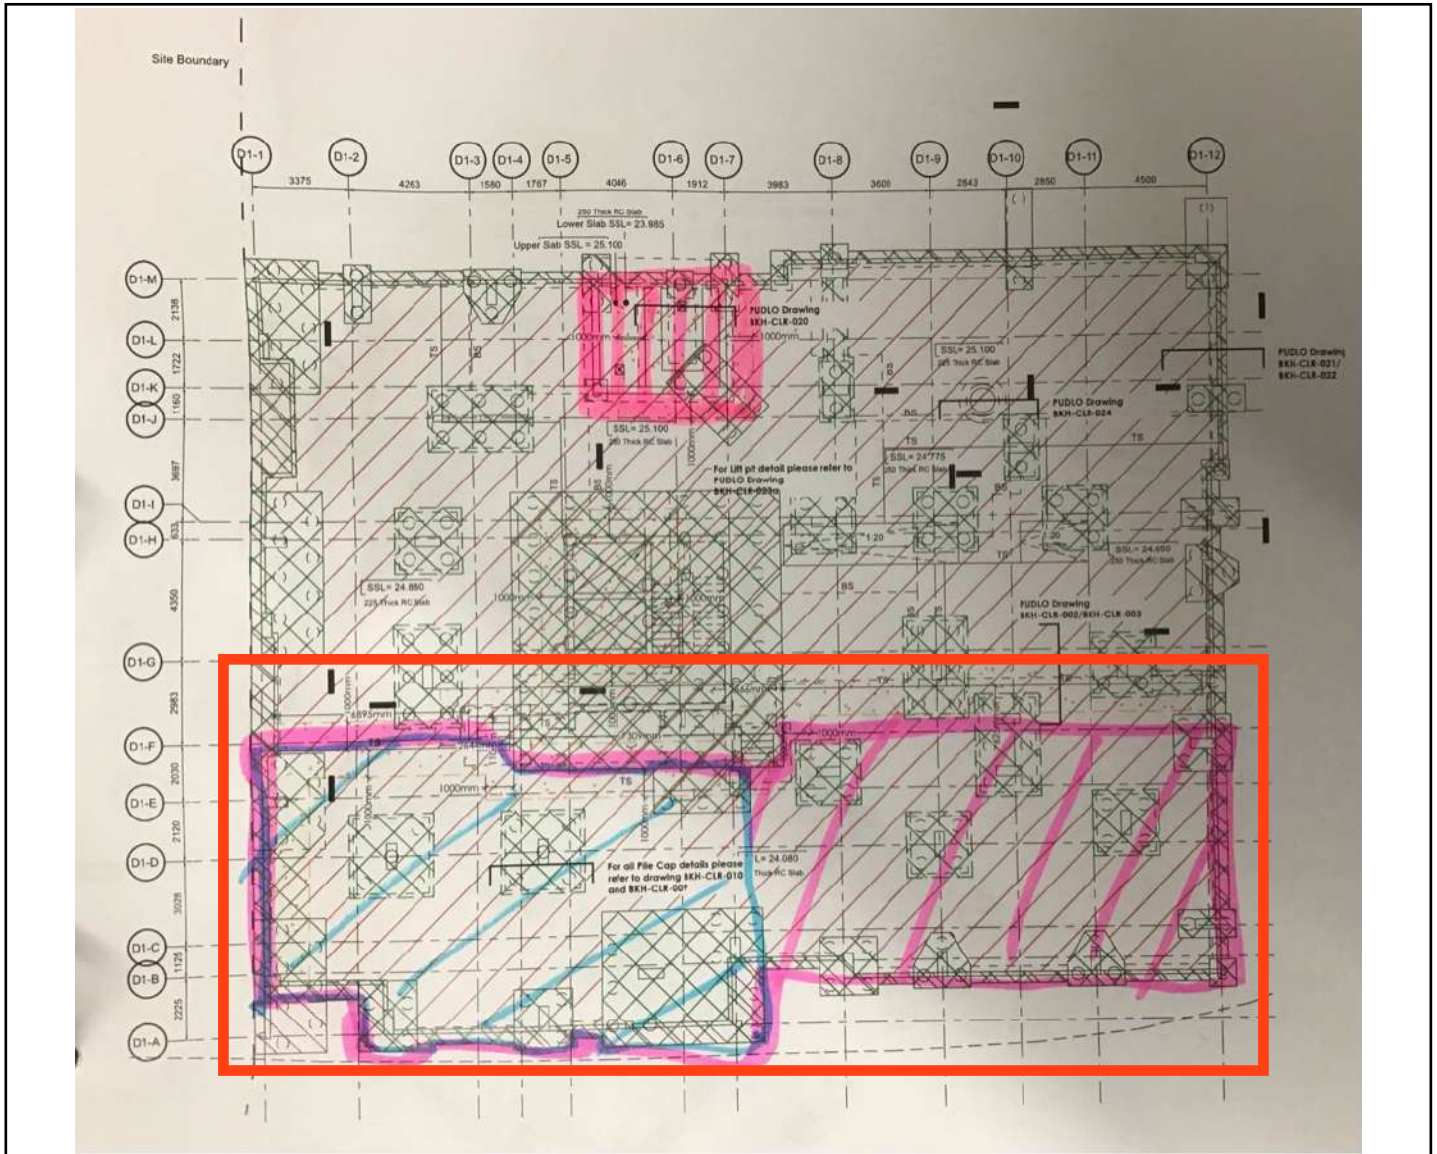
## VERIFICATION LAYOUT

The area within the red box above shows Block D1 Slab which was 100% complete

and ready for verification on this visit. The small pink area above shows D1
