JOB TITLE:  
**BRUCE GROVE  
YOUTH SPACE**

DRAWING TITLE:  
**NO. 10 BRUCE GROVE - CONDITION  
FABRIC REPAIRS**

| JOB CODE:<br><b>001550</b> | DRAWING NUMBER:<br><b>ADP-00-ZZ-DR- A-1220</b> | REVISION:<br><b>4</b> |

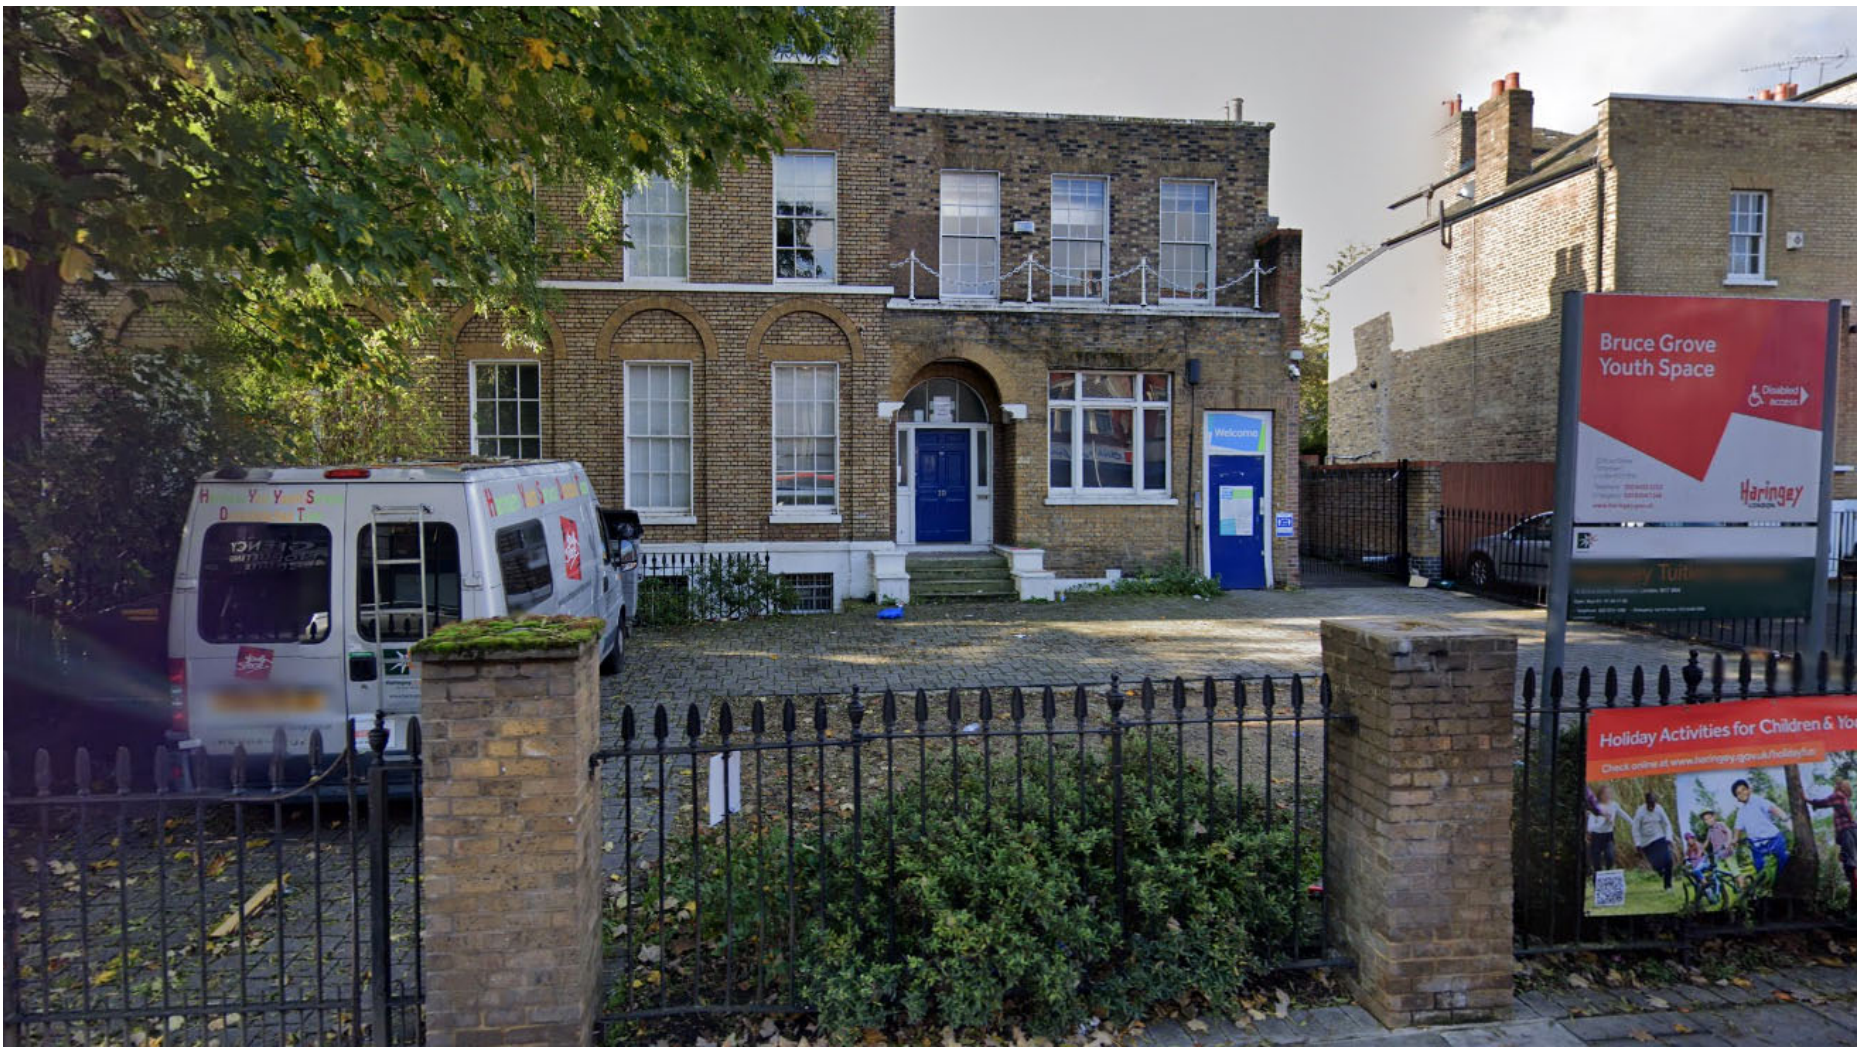
1 NO. 10 BRUCE GROVE FRONT ELEVATION  
1 : 50

| Condition Notes | | | |
|---|---|---|---|
| C1 | Pollution and algae on brickwork and mortar | Conservation clean front and rear elevations using Stonehealth 'Doff' system. Sample area to rear to be agreed with CA prior to clean of whole building | Aesthetic / Environmental |
| C2 | Decaying paintowrk to stone/recon stone capitals | Clean paint from stone/ recon stone capitals to either side of front door | Aesthetic |
| C3 | Poor conditon of steps | Clean steps to entrance | Aesthetic |
| D1 | Post and railing not in line with proposal | Remove posts and chain link rail to flat roof | Aesthetic |
| D2 | Trailing cables | Remove trailing cables from front elevations | Aesthetic |
| D3 | Light fitting not inline with proposal | Remove light fittings to either side of door and replace | Aesthetic |
| D4 | Poor quality side door | Remove side door and frame from external side passage. Replace with new gate to allow visibility through | Aesthetic |
| R1 | Window frames in generally poor condition | Prepare and redecorate windows generally colour to match existing, improve visibility, and approach to Youth Space in consideration of Secure by Design | Aesthetic |
| R3 | Door in poor condition | Prepare and redecorate front door. Colour TBC | Aesthetic |
| R4 | Front door fan lights and sidelight frames in poor condition | Prepare and redecorate side lights and fanlight to front door | Aesthetic |
| R5 | Poor quality glazing to door side lights and fan lights | Replace Georgian wired glass to side lights and fanlight with clear toughened glass | Aesthetic |
| R6 | Blocked drainage on flat roof and vegetation growth | Clear and repair roof covering to flat roof. Clear outlet and add leaf guard. | Water ingress |
| R7 | Water damaged soffit above front door | Prepare and redecorate soffit above front door where water damaged from blocked outlet to flat roof | Water ingress |
| R8 | Unknown condition of RWP within side passage | Repair RWP within side passage as necessary | Drainage |
| R10 | Cracked walls to side of entrance steps | Prepare and redecorate low walls to side of entrance steps | Aesthetic |
| R11 | Letterbox in poor condition | Replace with new brass letterbox | Aesthetic |
