REF: 9659386

## SITE RECORD DETAILS

ADDRESS: 81 Hillfield Avenue, LONDON, N8 7DS

DATE 26 October 2022

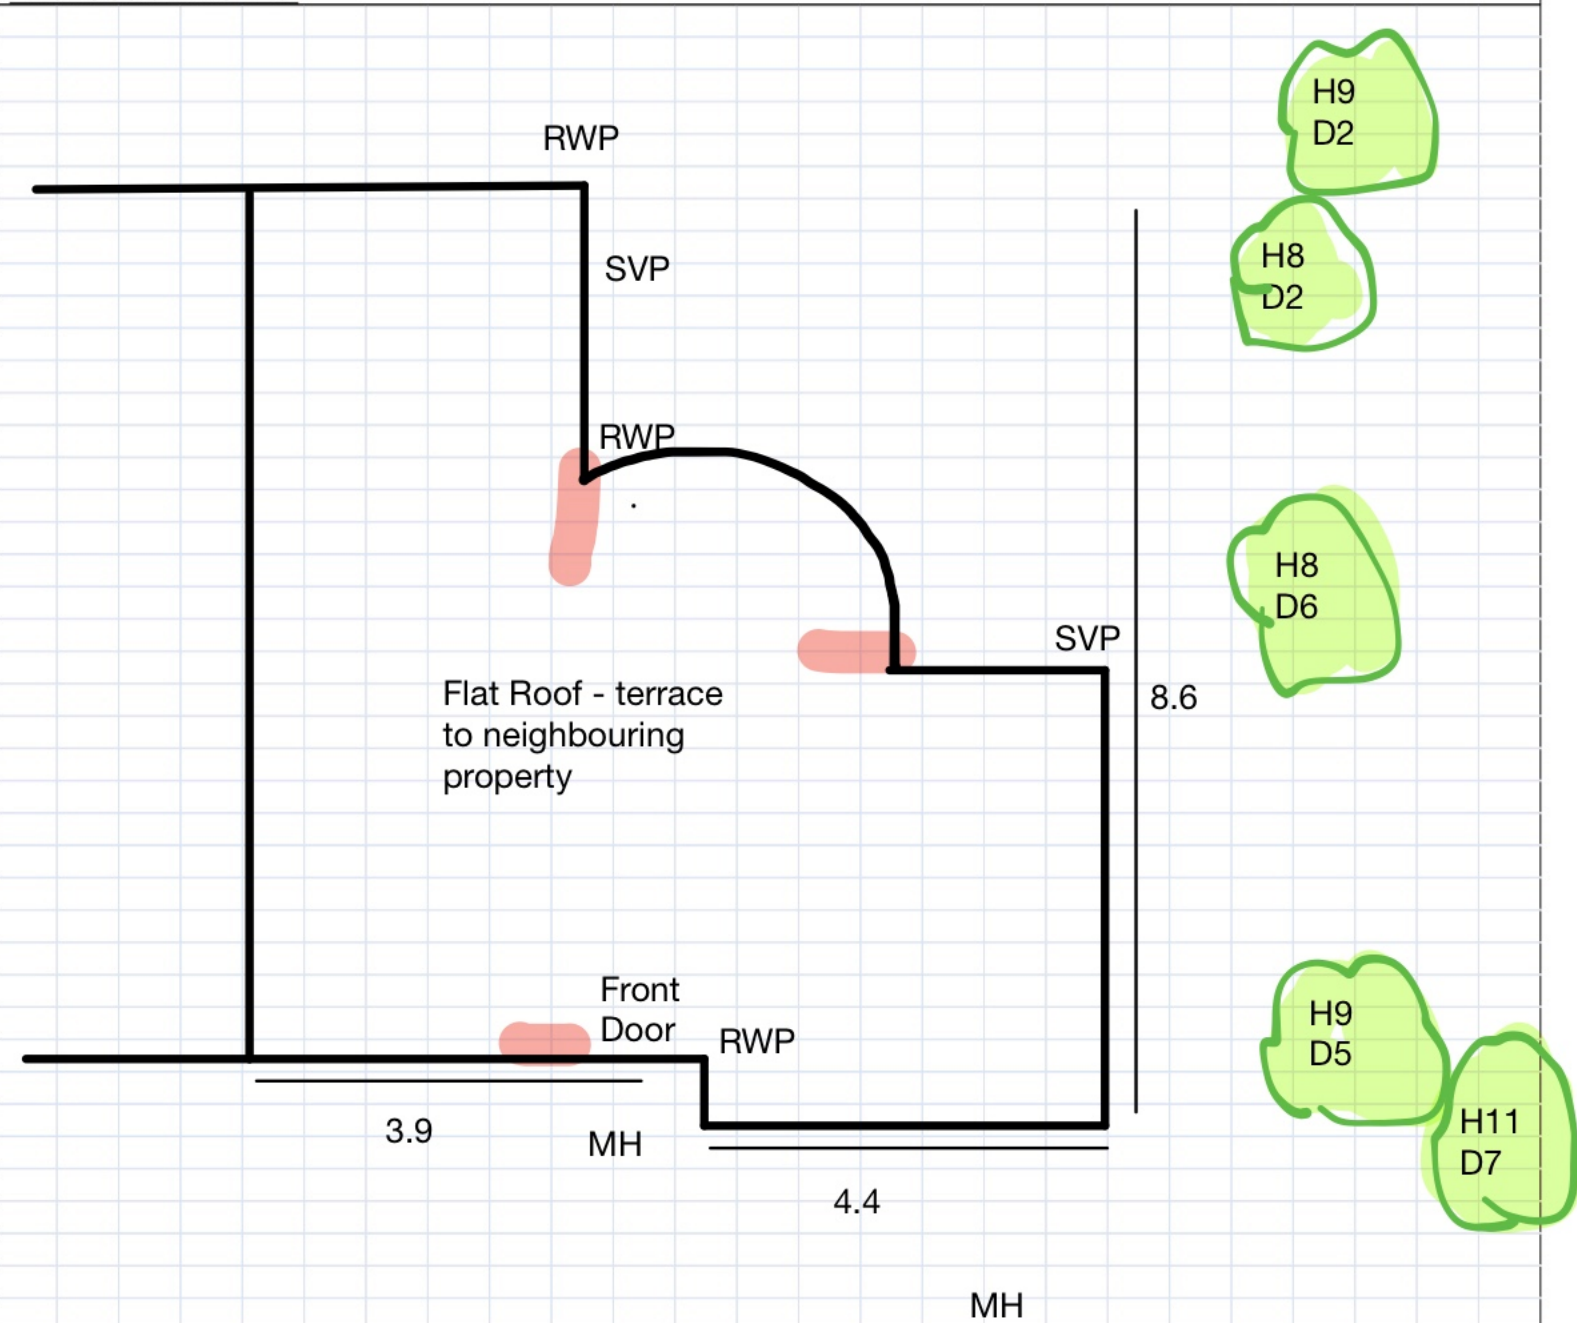
NOTES: Property comprises a circa 1900s semi detached house converted into 2 houses and a flat.

The damage is located to the front elevation of No.80 with internal cracks to the entrance hallway, lounge, landing, front bedroom and first floor corridor.

The BGS map suggests the area is clay. A drain run is located to the front elevation. Multiple PTP owned trees sits to the right elevation of the property. Full site investigation is required to confirm cause of damage with appropriate mitigation.
