# Arboricultural Appraisal Report

## Subsidence Damage Investigation at:

Cufos Building  
Alexandra Palace  
London  
N22 7AY

| MWA REF: | SUB221206-11595 |

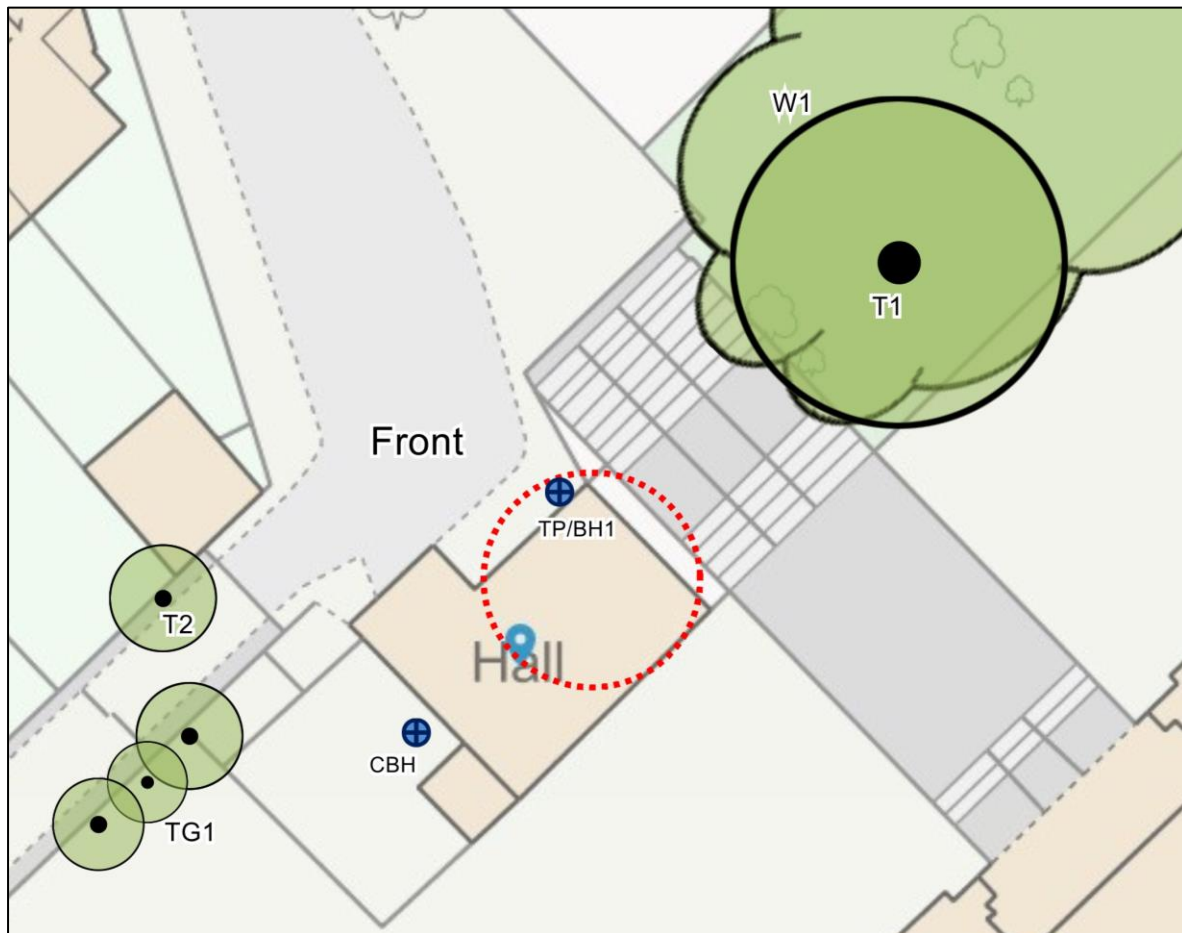
## Site Plan

Approximate areas of damage

If an arboricultural solution is to be implemented to mitigate the influence of the implicated trees/vegetation we recommend that T1 Poplar is removed. Other vegetation recorded presents a potential future risk to building stability and management is therefore recommended. Recommended tree works may however be subject to change upon receipt of additional information.
