# Arboricultural Consultancy for Lloyds Bank

| Insured | Ms Sally Eichner | Address | 36 Grasmere Road, London, N10 2DJ | | |

**36 Grasmere Road, London, N10 2DJ**

Client: Subsidence Management Services  
Client Contact: Ian Domigan  
Client Ref: IFS-LBG-SUB-22-0102137  
Policy Holder: Ms Sally Eichner  
Report Date: 28 October 2022  
Our Ref: C65817G29864

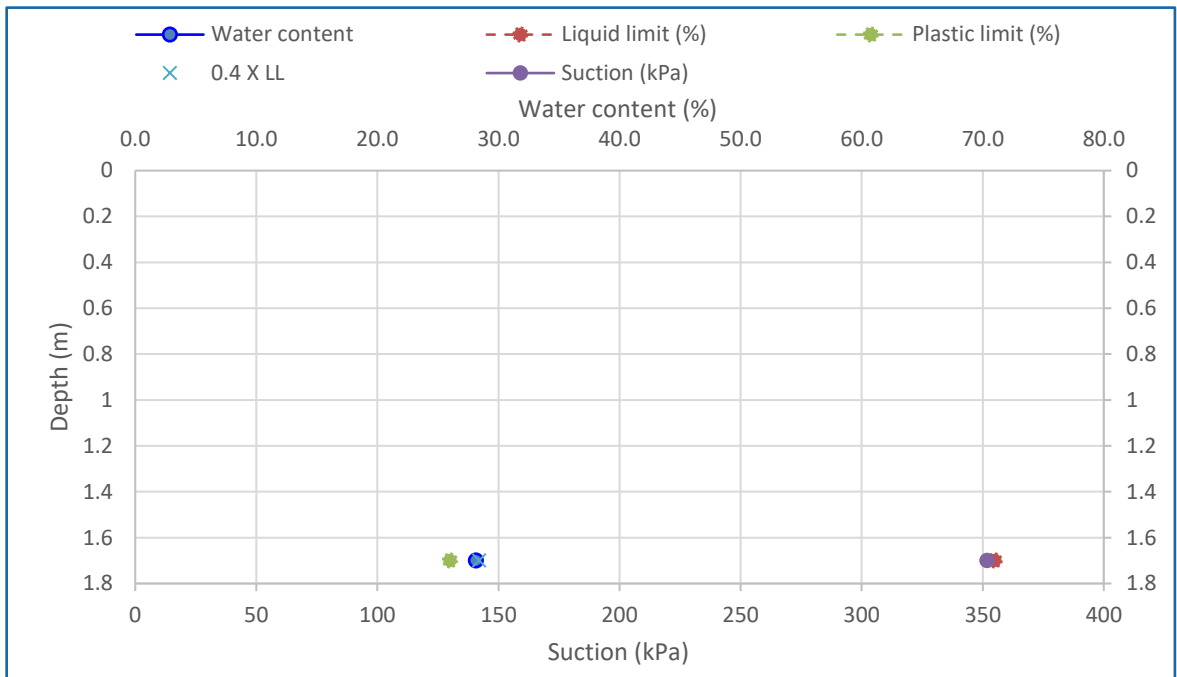
| Lab Ref | Depth (m) | WC (%) | LL (%) | PL (%) | PI (%) | .425 mm(%) | mod. PI (%) | Av. Suc. (kPa) | Description |
|---|---|---|---|---|---|---|---|---|---|
| 1 | 1.7 | 28.1 | 71 | 26 | 45 | 96 | 43 | 352 | Firm brown slightly gravelly CLAY . Gravel is fine and medium. |
