Existing Building

Key Internal Spaces - Lobby

External Fabric Condition

Summary of Facade Condition

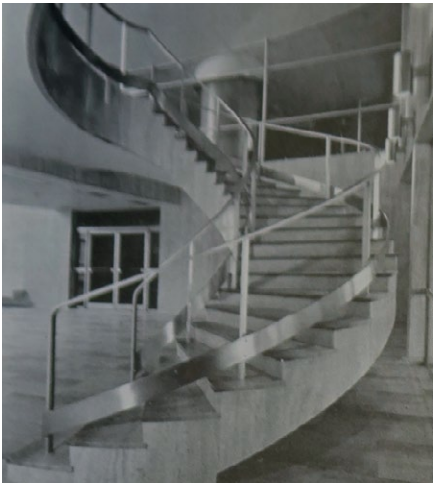
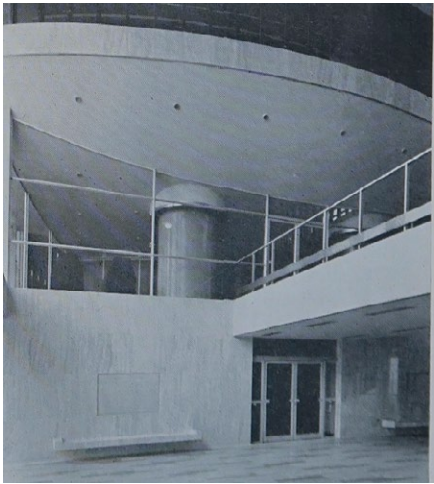
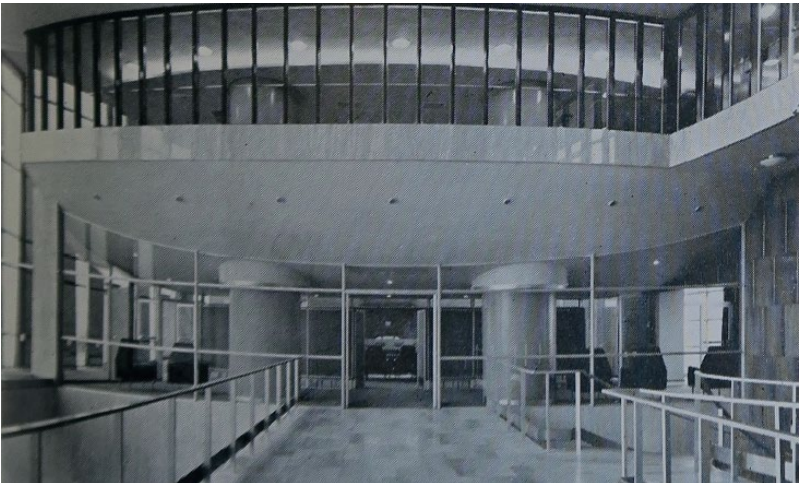
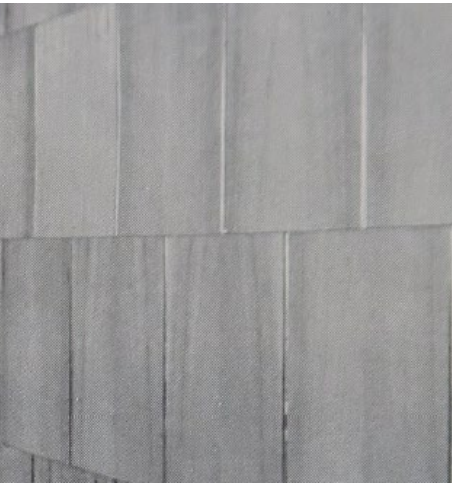
Entrance Lobby

- Pre-Enabling Works Condition**
- Extensive cracking/chipping in stone tiled flooring
  - Brass inlays tarnished
  - Spotlights and recessed strip-lights in bridge require upgrading

- Post-Enabling Works Condition**
- Ceiling below bridge removed
  - Carpet Removed & Blinds Removed

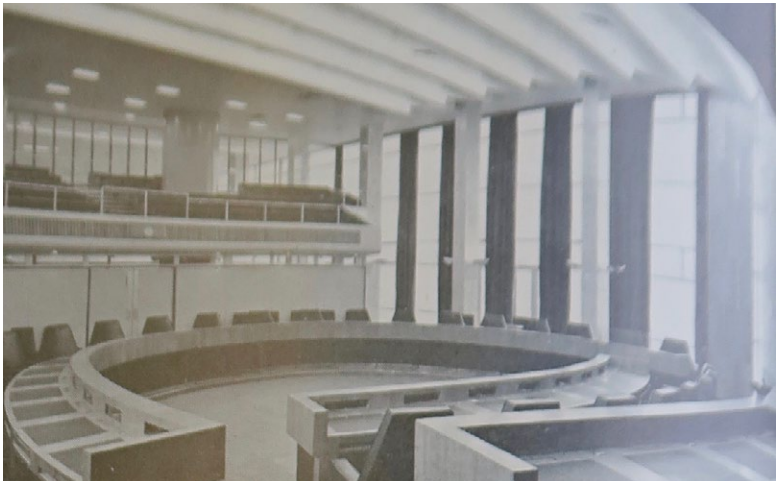
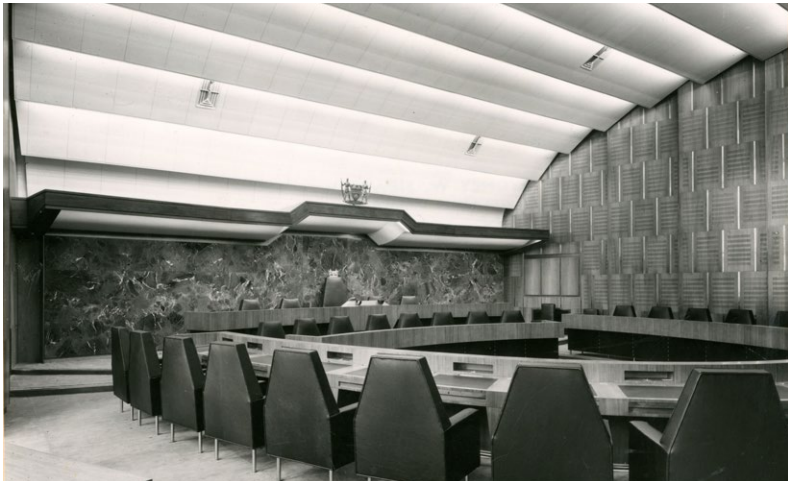
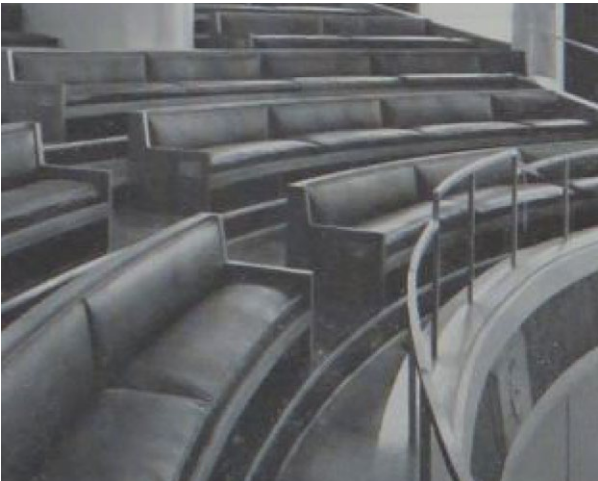
Council Chamber

- Asbestos ceiling
- Timber panelling with brass inlays - brass tarnished
- Non-Original carpet
- Vertical Blinds
- Original brass clock removed

- Asbestos ceiling removed
- Carpet Removed & Blinds Removed (Curtain track retained)

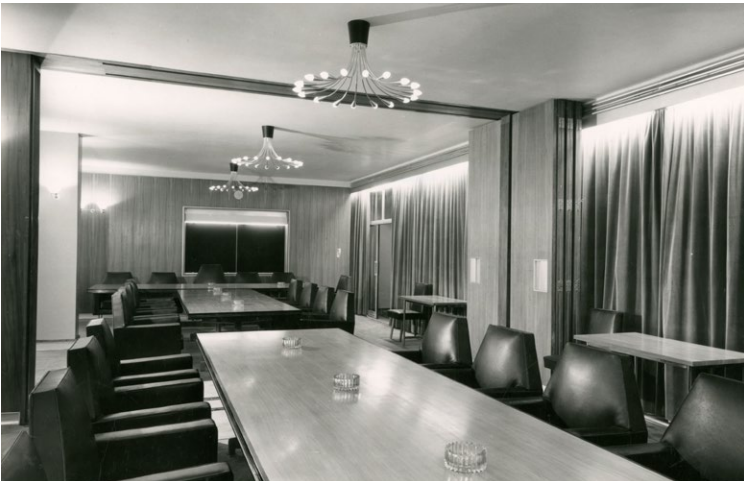
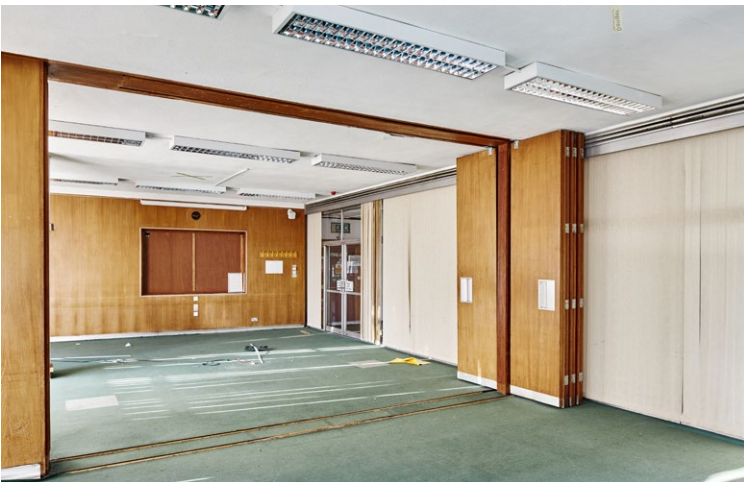
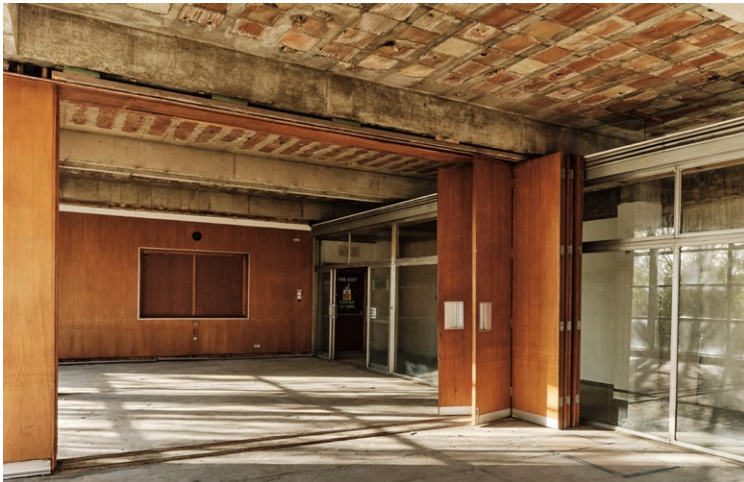
Large Committee Room

Glazing
- Pre-Enabling Works Condition
- Asbestos ceiling

Timber panelling with brass inlays - brass tarnished

Non-Original carpet

Vertical Blinds

Original brass clock removed
- Post-Enabling Works Condition
- Asbestos ceiling removed

Carpet Removed & Blinds Removed (Curtain track retained)

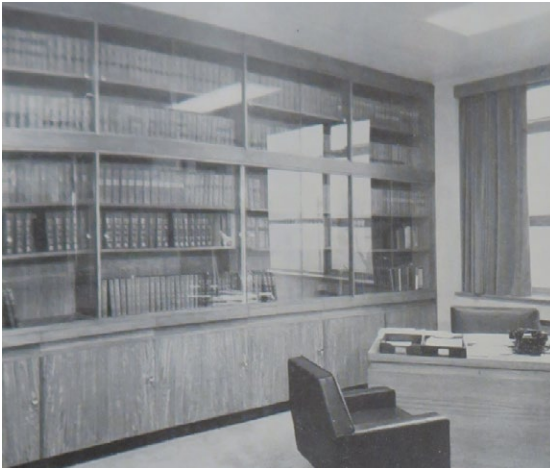
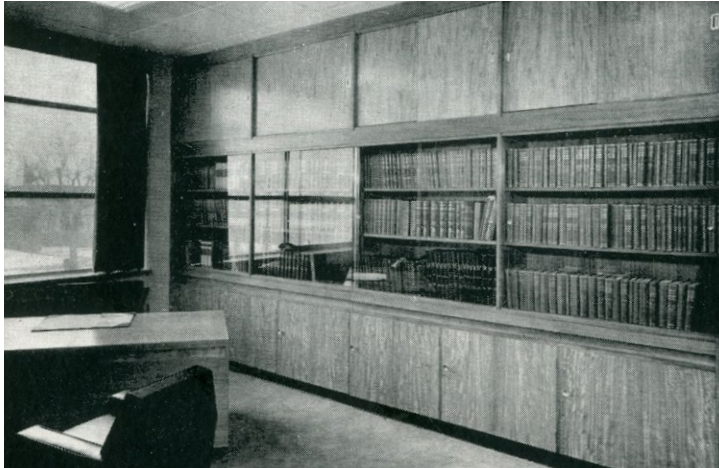
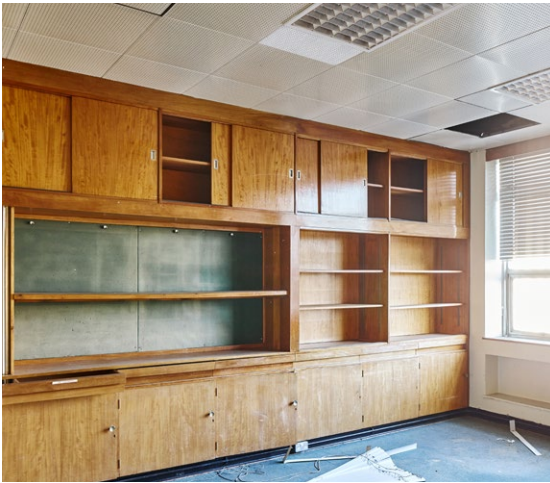
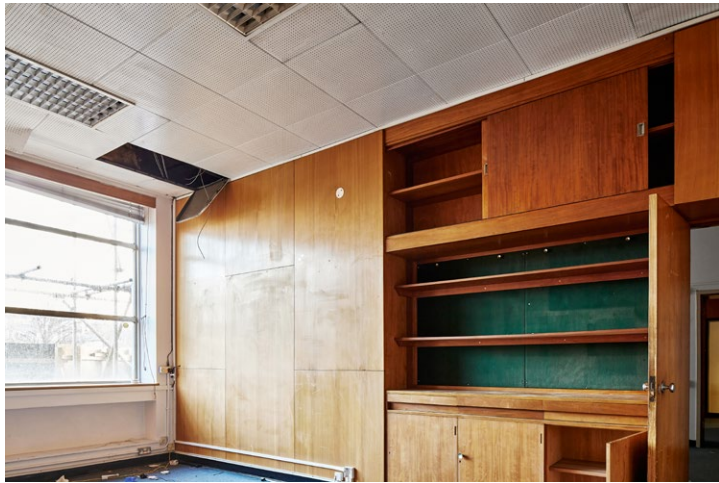
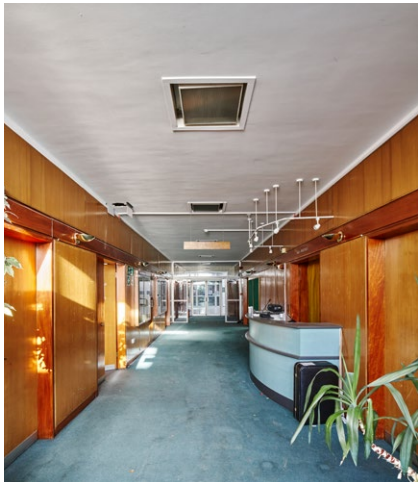
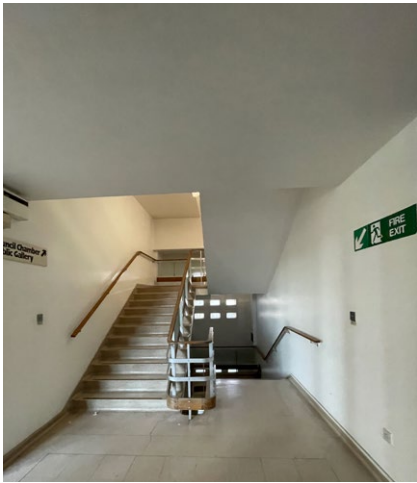
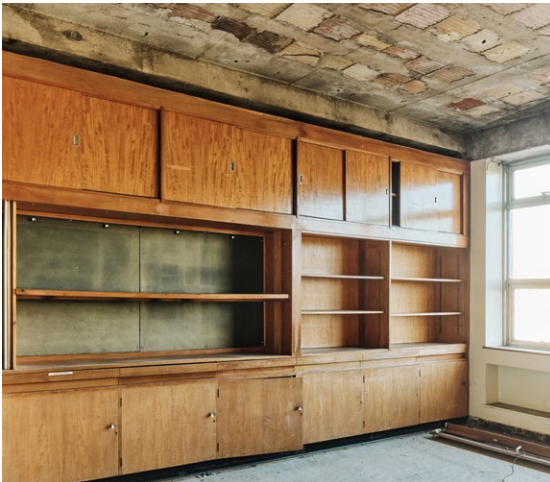
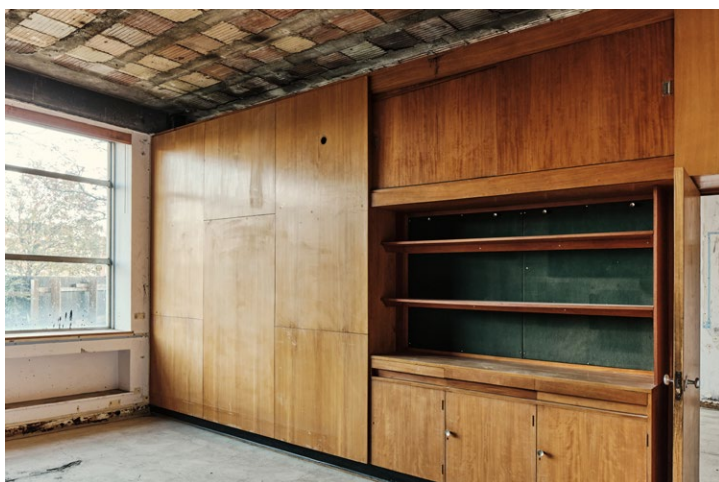
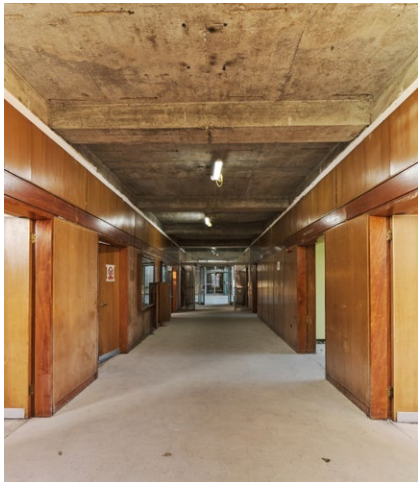
North Wing Meeting Room

Timber panelling & cupboards
- Pre-Enabling Works Condition
- Asbestos above ceilings

Non-Original carpet

Vertical Blinds

Original brass clocks removed

Scratched joinery
- Post-Enabling Works Condition
- Asbestos ceiling removed

Carpet Removed & Blinds Removed (Curtain track retained)

Metal balustrade with timber handrail
- Pre-Enabling Works Condition
- Vinyl flooring on landings
- Post-Enabling Works Condition
- Flooring & ceilings removed

Scratched joinery
- Post-Enabling Works Condition
- Asbestos removed

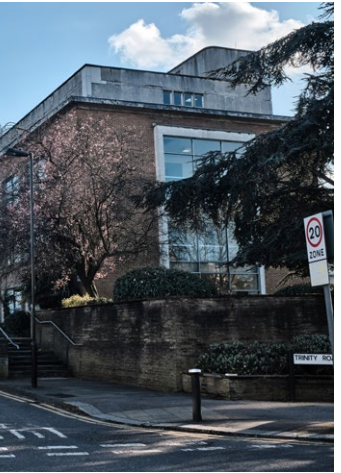
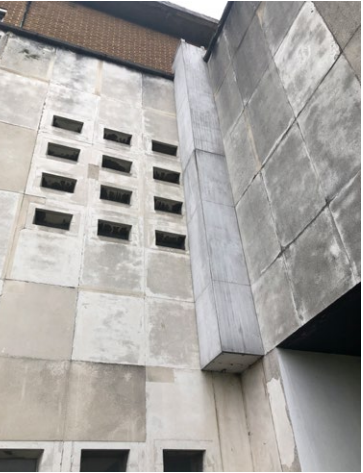
East Facade (Front)

The pre-cast cladding at levels 0 to 2 are generally in poor condition. The cladding at level 3 is in a more advanced state of disrepair.

A small band of travertine stone cladding to the East elevation fascia and canopy appears in fair condition: some cracked tiles require replacement and a general cleaning is recommended as well as possible re-fixing of the larger cladding stones at the canopy columns which appear dislodged.

The reinforced concrete cornice at level 3 is in need of urgent concrete treatment including removal of stone cladding, removal of detached and loose portions of concrete, making good of the exposed reinforcement with anti corrosion treatment, refacing with thixotropic mortar products.
