**Haringey Council**

**Schedule of Condition**

**Hornsey Library, Haringey Park, London, N8 9JA**

9 May 2023

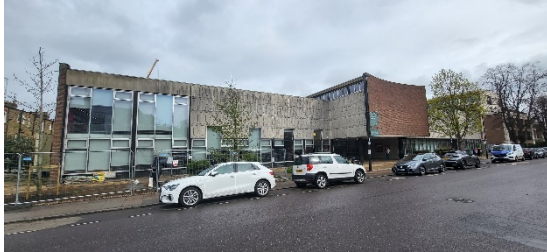
| Item | Description | Condition | Photograph |
|---|---|---|---|
| 1 | Library Building. | General view of front elevation. | |
