**47 NORTH ROAD, LONDON N6 4BE**  
**SUPPLEMENTARY DESIGN AND ACCESS STATEMENT IN CONNECTION WITH**  
**LISTED BUILDING CONSENT APPLICATION HGY 2022/4382**

This statement was prepared by Jon Bolter BA Arch AA Dip Cons AABC following a site inspection on 11 May 2023. The weather was bright at the time of the inspection.

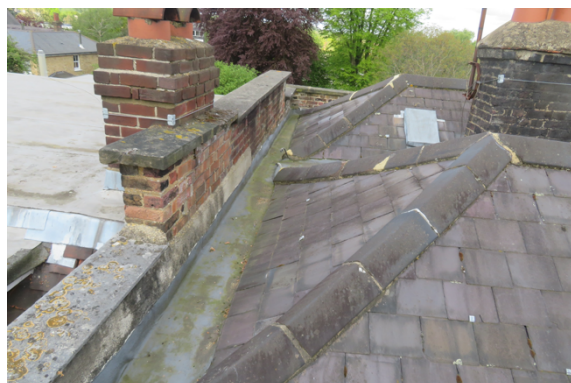
The hipped ends of the front and rear roofs, looking west.

The clay hip and ridge tiles are in fair condition but there are a number of areas where missing or damaged parts have been made up in mortar and the junction of the hips with the ridge is poorly formed.

The clay hip and ridge tiles should be removed and reset. It is likely that some will require replacement which should be done with matching tiles.

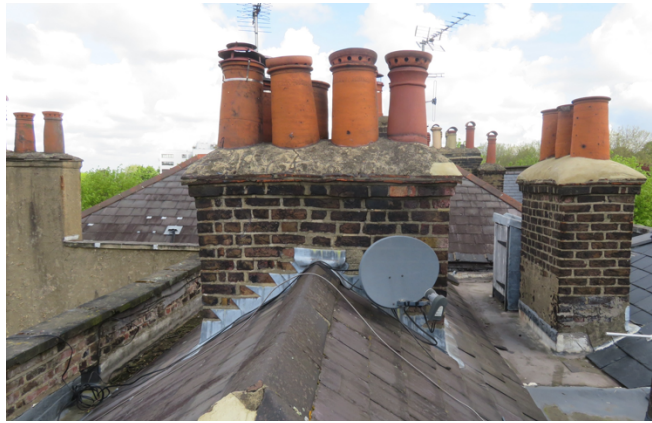
The large chimney stack to the rear roof.

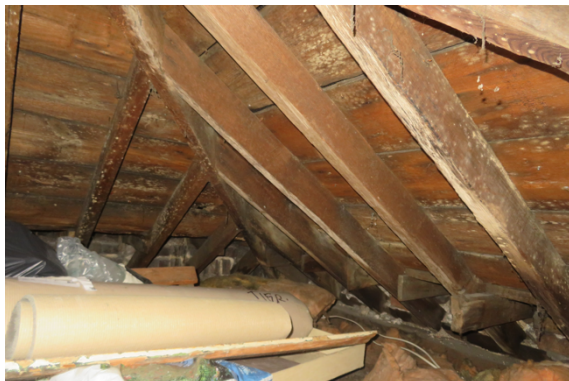
Interior of the front roof looking to the south east.

Some of the roof timbers appear to be of oak.

On the limited inspection possible, the roof structure appears sound but does show some signs of mould, likely to be related to condensation within the roof void, exacerbated by high humidity levels because of water penetration through the gutter linings. The condensation results from the lack of ventilation and the use of a vapour resistant underslating membrane. The underside of the sarking boards appears otherwise fair. It was not possible to view the lay boards below the gutters but these are likely to have suffered some damage and are also likely to have to be adjusted to suit the asphalt coverings. At least some parts of the roof structure and boarding appear to be in oak.
