# Site Investigation Report

138280.1.USI

| <b>Brief</b> | Auger were commissioned by Crawford & Co to undertake a site investigation and CCTV inspection of the underground drainage within the area of concern (AOC) at the property. |

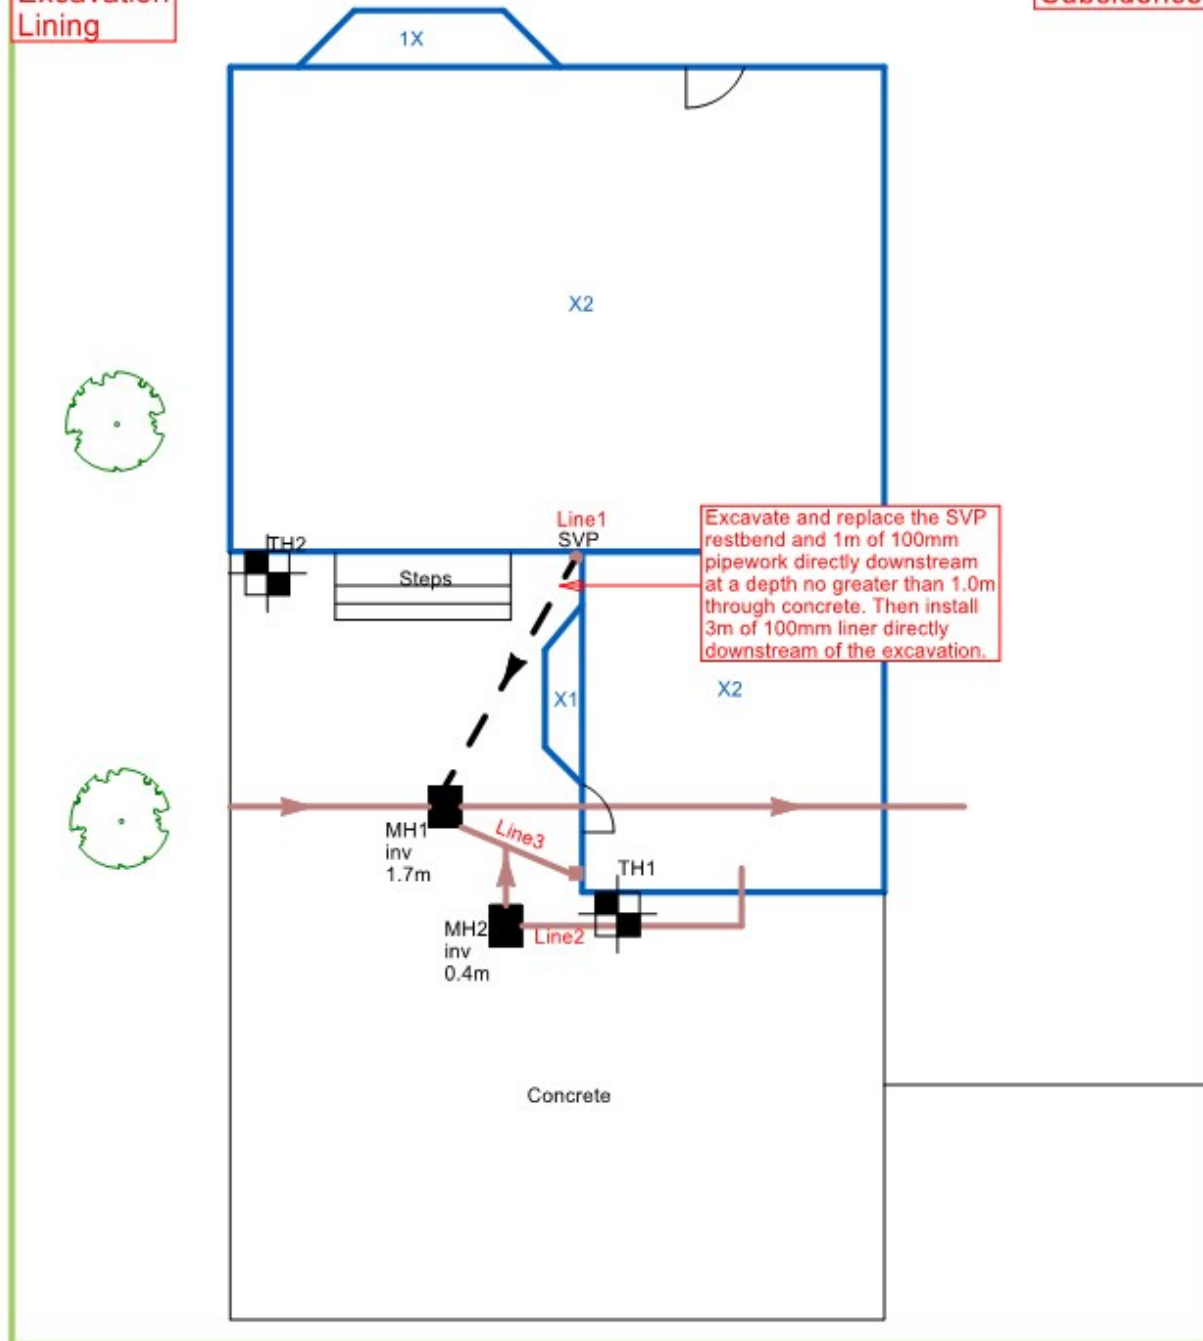
## FRONT OF PROPERTY

| <b>Visual Inspection</b> | A visual inspection of the site revealed MH1, which was noted to be constructed out of brick, has a defective drainage channel. This was a large diameter LWA main. The visible defects identified are affecting the function of the system. |
| <b>Drain Survey</b> | <p>We carried out a CCTV survey of the below ground drainage system, our findings of which are as follows:</p> <p><b>Line 1 - From SVP downstream to MH1</b><br/>Our survey of line 1 revealed joint displacements (see fig 3.1)</p> <p><b>Line 2 - From MH2 upstream to the head of the line (disused)</b><br/>Our survey of line 2 revealed no significant defects to the pipework on this line which could be allowing an escape of water.</p> <p><b>Line 3 - From MH1 upstream to WG</b><br/>Our survey of line 3 revealed no significant defects to the pipework on this line which could be allowing an escape of water.</p> <p>The above mentioned defects to the below ground drainage system have been caused by ground movement.</p> |

| <b>Refer Back to Client</b> | <p>It is recommended that the following repairs are carried out to prevent an escape of water from the system:</p> <p><b>Line 1</b><br/>Excavate and replace the SVP restbend and 1m of 100mm pipework directly downstream at a depth no greater than 1.0m through concrete. Then install 3m of 100mm liner directly downstream of the excavation.</p> <p>Our investigations revealed potential defects within drainage lines that we understand to be LWA assets. These defects could be leading to an escape of water into the surrounding ground. If the Loss Adjuster/Engineer is of the opinion that these defects are an influence in the cause of subsidence to the building structures, we recommend you inform the LWA of the problem and request that they (the LWA) inspect and repair their asset. We cannot undertake any further inspection or repair of LWA assets without the express approval of the LWA.</p> <p>We will now refer the claim back to the client in order to progress the claim.</p> |

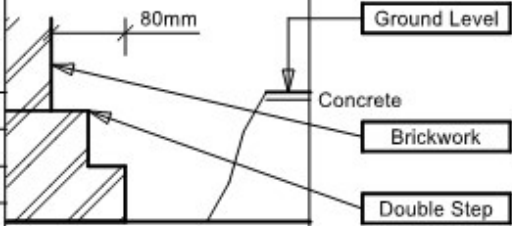
## Trial Hole Log No.1

Location: Rear right corner of rear projection

| Depth<br>(m) | Symbolic Log | Strata Description | Insitu Tests | | Soil<br>Sample | Root<br>Sample |
|---|---|---|---|--|---|---|
| 2.0 | | Brown fine to medium gravelly silty CLAY | 86kpa | | Soil<br>@ 1.85m | |
| 3.0 | | TRIAL HOLE TERMINATED | 64kpa<br>64kpa | | Soil<br>@ 2.85m | |

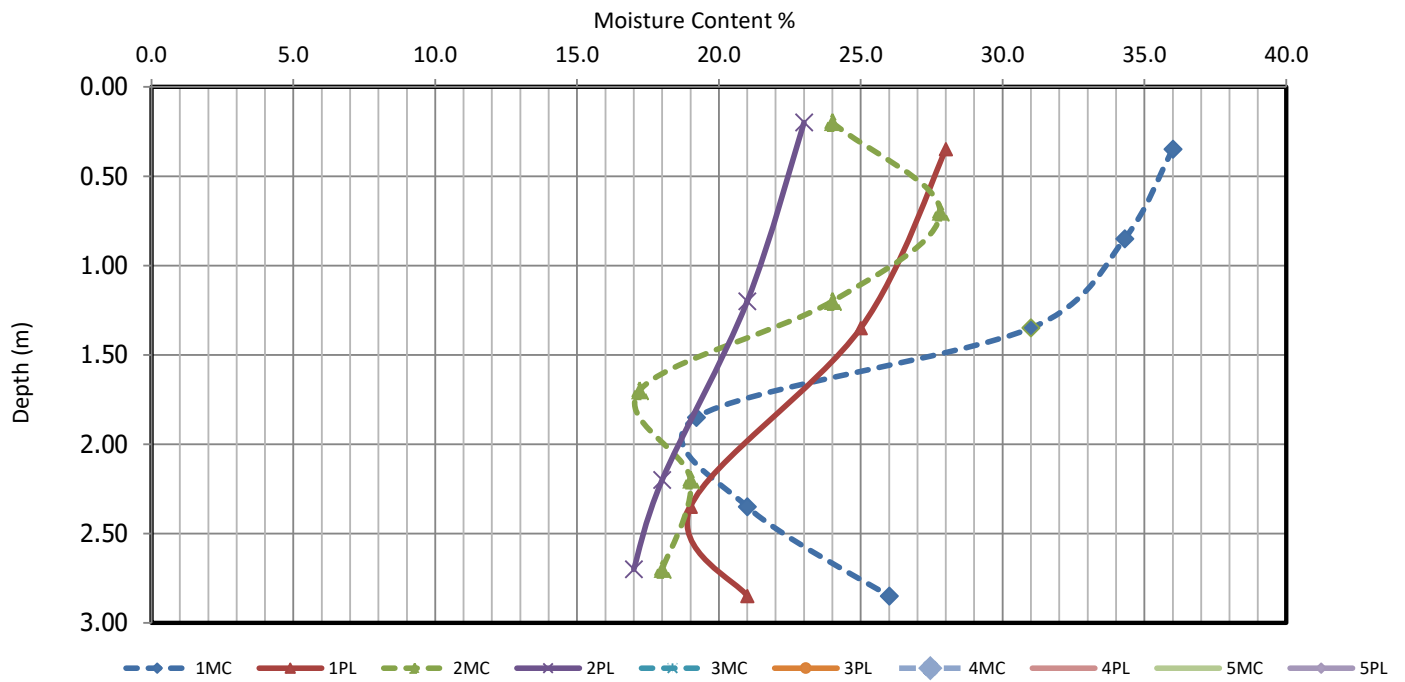
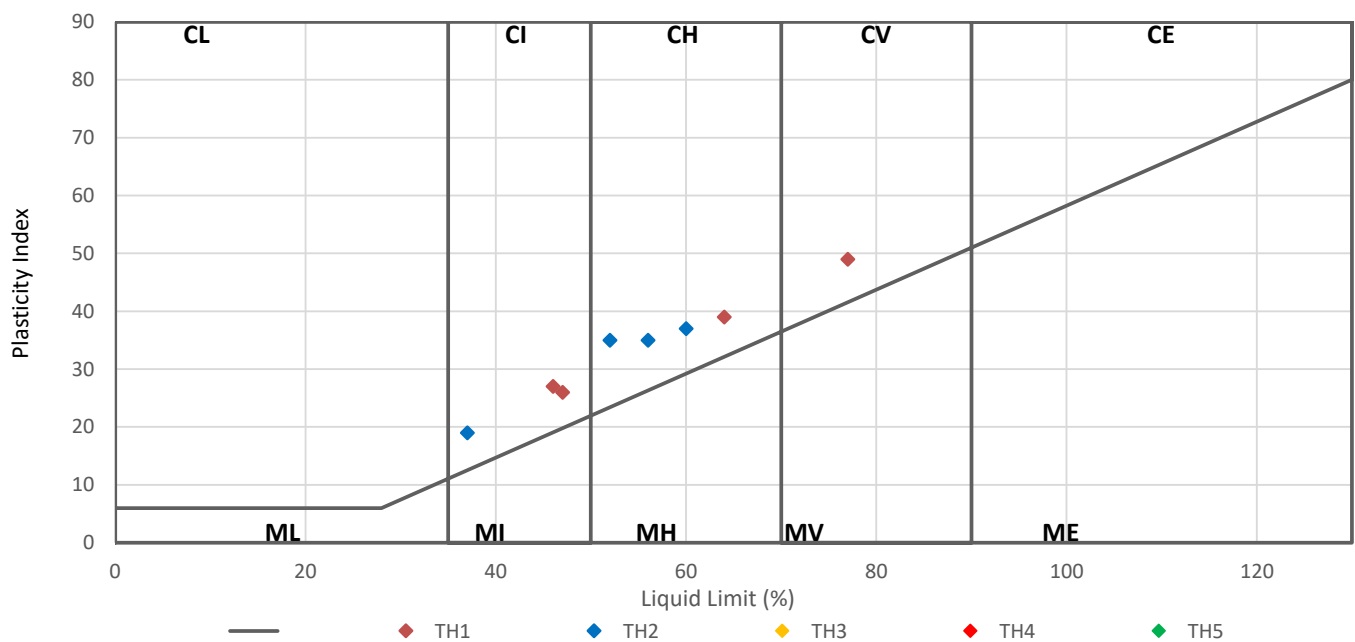
PLASTICITY CHART FOR CASAGRANDE CLASSIFICATION  
BS 5930:1999+A2:2010

Modified Plasticity Index (PI) <10 : Non Classified  
 Modified PI = 10 to <20 : Low volume change potential (LOW VCP)  
 Modified PI = 20 to <40 : Medium volume change potential (Med VCP)  
 Modified PI = 40 or greater : High volume change potential (HIGH VCP)
