# Arboricultural Appraisal Report

## Subsidence Damage Investigation at:

2 Lansdowne Road  
London  
N17 9XE

| MWA REF: | SUB221221-11808 |

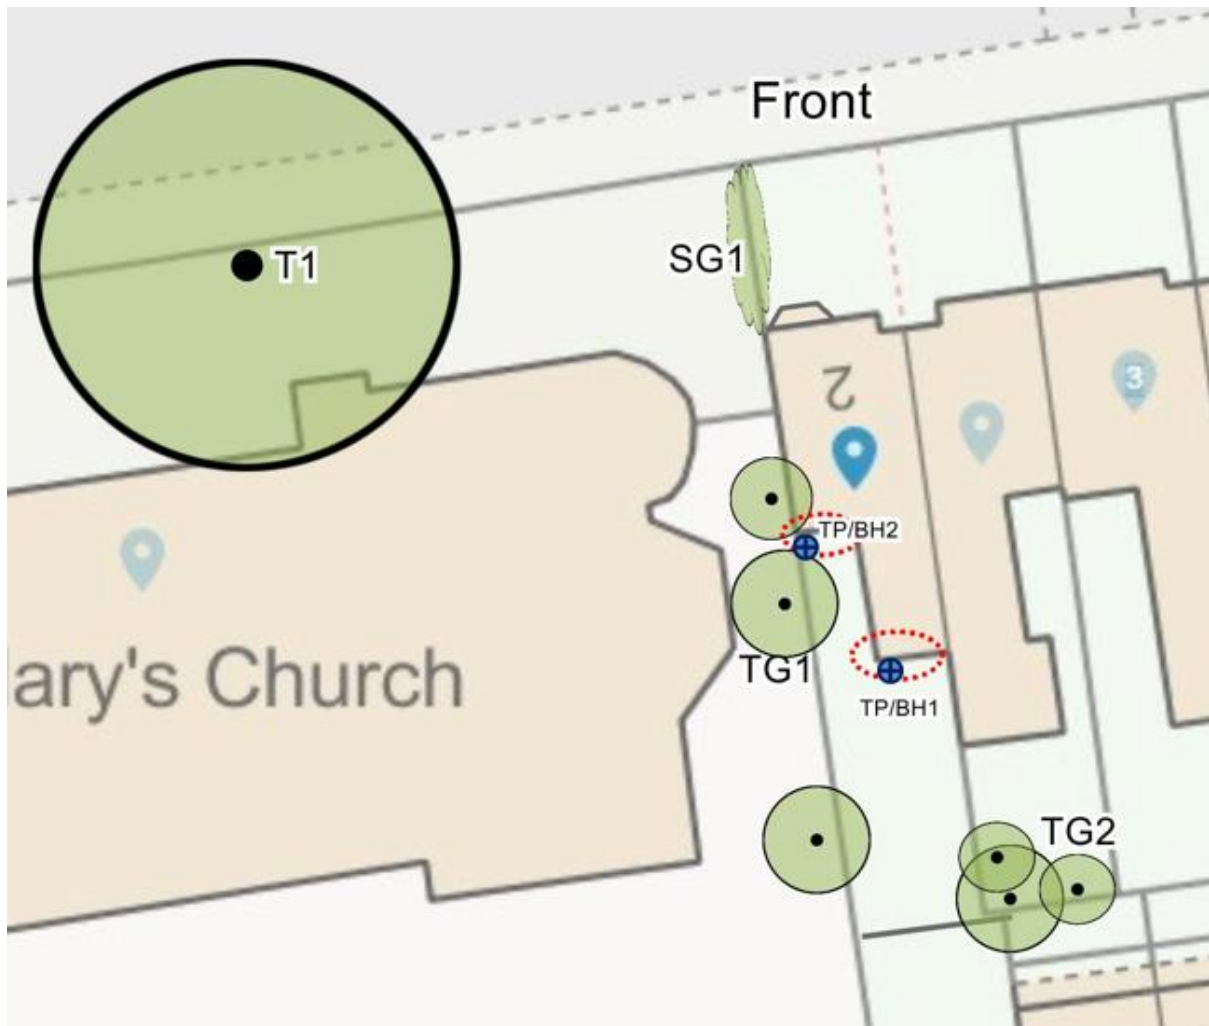
## Site Plan

Roots were observed to a depth of 1.2m bgl in TP/BH2, and recovered samples have been positively identified (using anatomical analysis) as *Acer* spp.; the origin of which will be the nearby Sycamore stems of TG1 group.

| Tree No. | Species | Ht (m) | Dia (mm) | Crown Spread (m) | Dist. to building (m) | Age Classification | Ownership |
|---|---|---|---|---|---|---|---|
| Recommendation | | Remove (fell) all to near ground level and treat stumps to inhibit regrowth. | | | | | |
