# Arboricultural Consultancy for Aviva

| Insured | Mr and Mrs Richard and Maria Corrigan | Address | 2 Elms Avenue, Muswell Hill, London, N10 2JP | | |
| Report Date | 23/08/2021 <b>Revised:</b> 13/07/2022 | | | | |

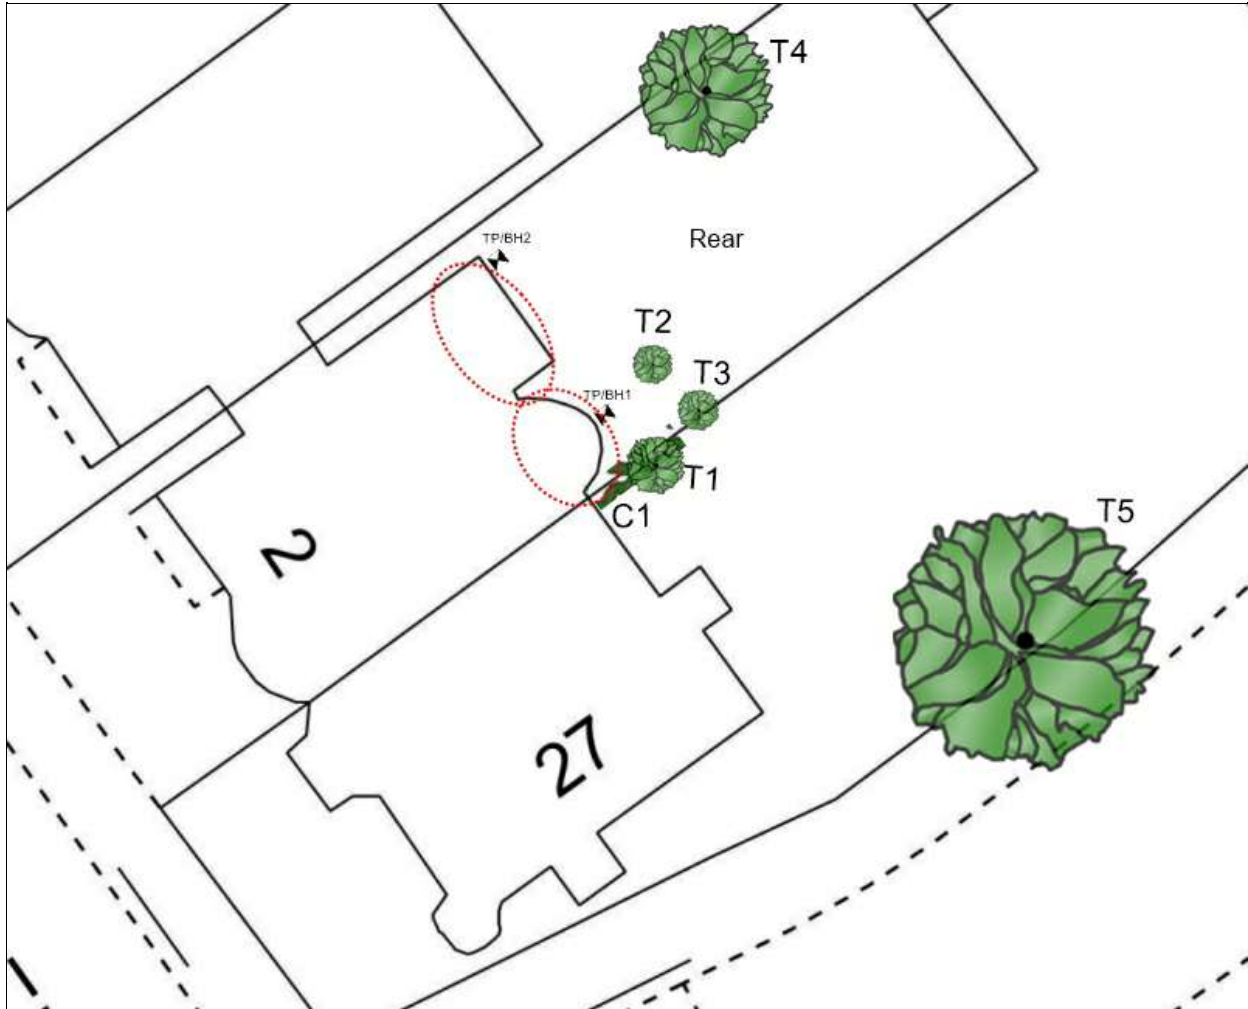
7. Site Plan

Our survey of the site identified the London Plane (T5), given its position relative to the damage it is our opinion that the roots identified will emanate from this vegetation and accordingly we have identified it as the principal cause of the subsidence damage.

However, whilst not positively implicated by root analysis, the Wisteria (C1) cannot be discounted as contributing to the overall level of soil drying proximate to the area of damage and is therefore also considered to retain a contributory influence, albeit in a localised capacity to the rear bay window only.

Given the above and considering the advised mechanism of movement, in order to mitigate the current damage thereby allowing soils beneath the property to recover to a position such that an effective engineering repair solution can be implemented, we recommend a program of vegetation management as detailed by this report.
