# Site Investigation Report

145370.1.USI

Auger were commissioned by Crawford & Co to undertake a site investigation and CCTV inspection of the underground drainage within the area of concern (AOC) at the property.

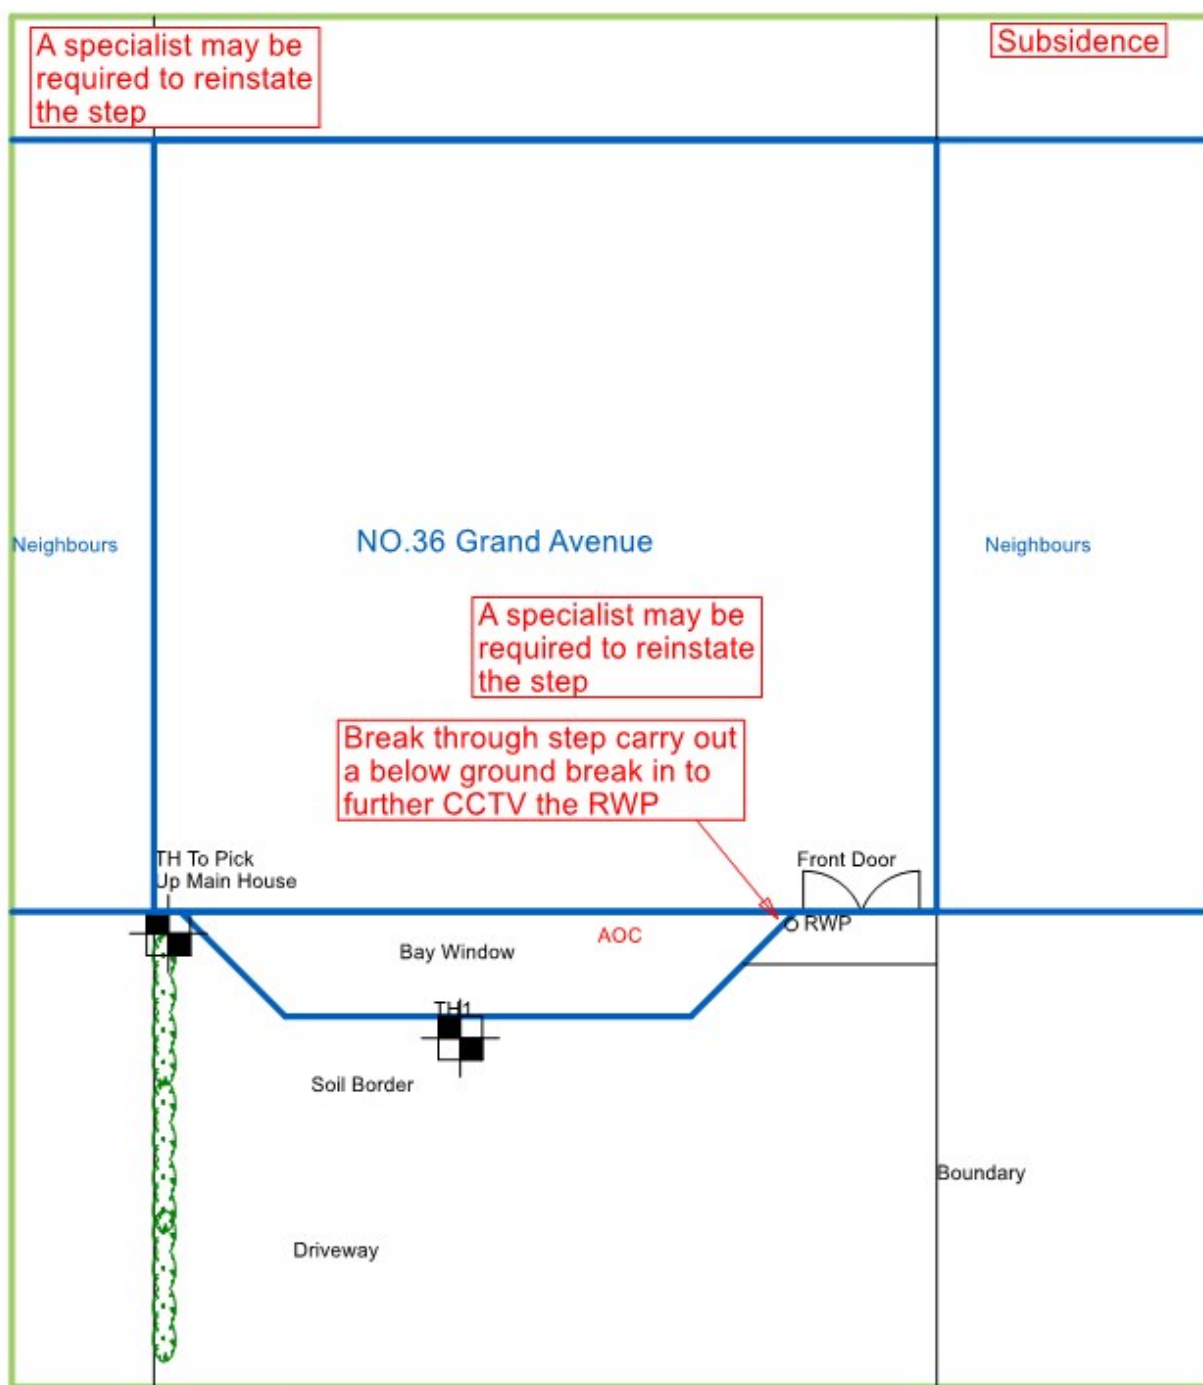
## Further investigation Layout

No CCTV survey of the underground drainage was undertaken whilst on site due to the RWP at the front of the property being the only drainage within the area of concern. This requires a break in through the porch step.

### FRONT OF PROPERTY

Break through step carry out a below ground break in to further CCTV the RWP, Auger will attempt to reinstate the step however is the customer is not happy with the reinstatement. A specialist may be required to reinstate.
