# Site Investigation Report

143197.1.USI

Auger were commissioned by Crawford & Co to undertake a site investigation and CCTV inspection of the underground drainage within the area of concern (AOC) at the property.

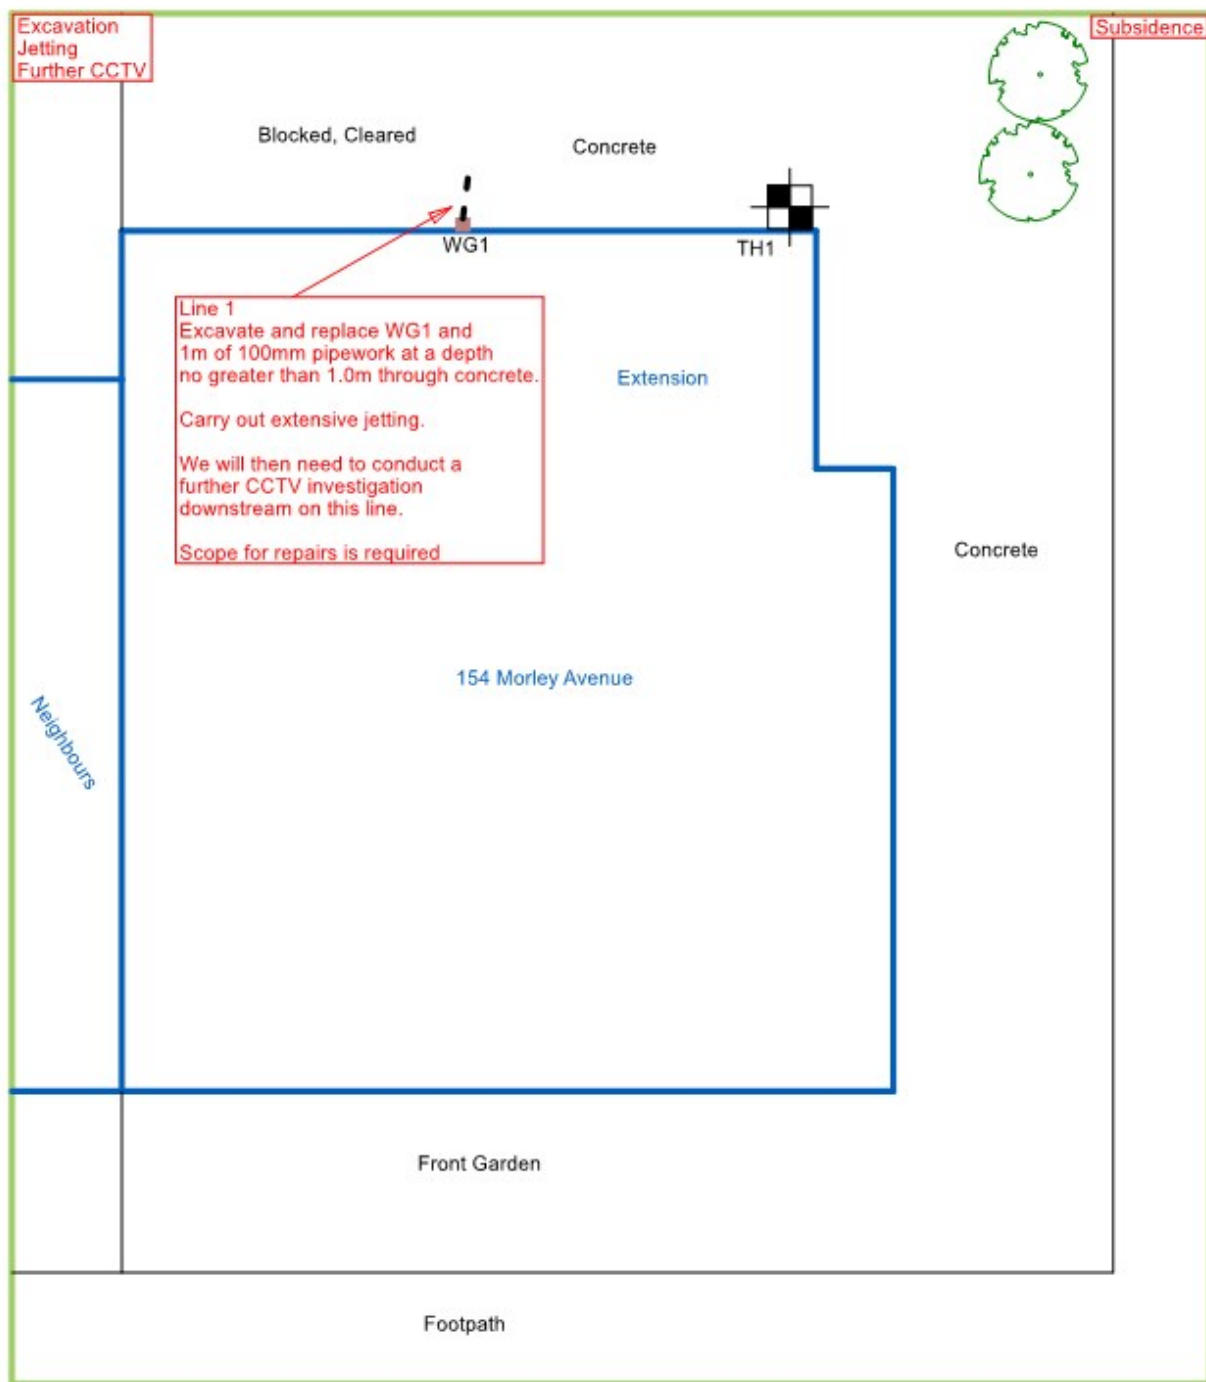
## FRONT OF PROPERTY

The gully pot is cracked which will be allowing an escape of water to the surrounding area.

Excavate and replace WG1 and 1m of 100mm pipework at a depth no greater than 1.0m through concrete.
