## Room: G.57 Assembly Hall [plate 95, 95A]

## First Floor

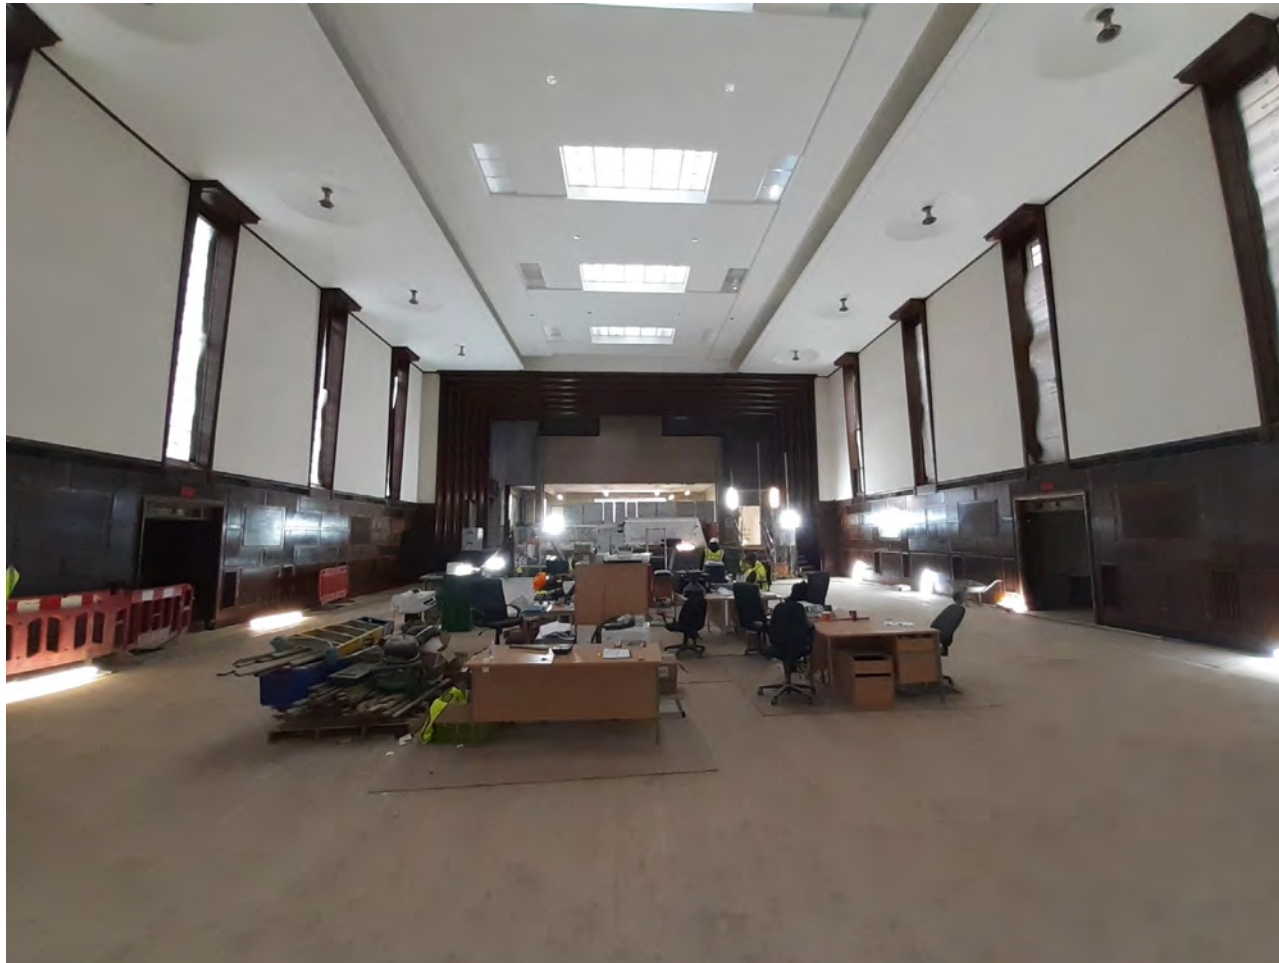
**95** G.57 Assembly Hall looking to east (stage)

**Ceiling:** The ceiling is deeply coffered (containing the radiator panels) and has small disc pendants. The return face of the gallery has been clad in acoustic tiles (probably 1960s) [Plate 95F and 95]. The ceiling has been repaired and redecorated in flat white.

**Walls:** The walls here are panelled with veneered walnut, set out in geometric pattern. The vents for the heating system are framed by timber architraves with timber louvers. The walls have been repaired and redecorated in flat white.

**Floor:** The floor is sprung teak, with sections of linoleum (later), although this was covered during the site visit Dec 2022).

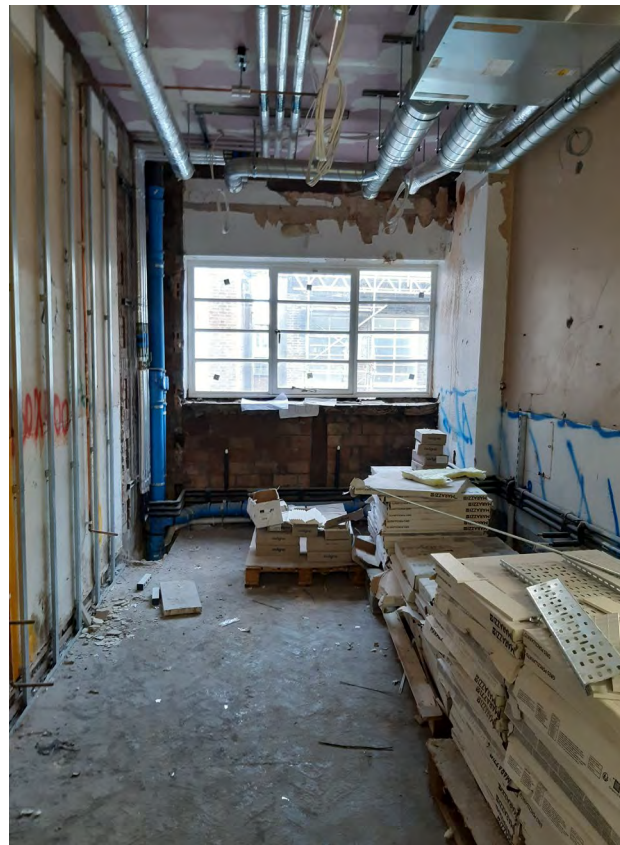
**100** *F.1 Ladies Lavatories*

**General Description:** Ladies Lavatories, currently under refurbishment with all fixtures and fittings removed.

**Floor:** None (previously parquet, removed during site visit, Dec 2022)

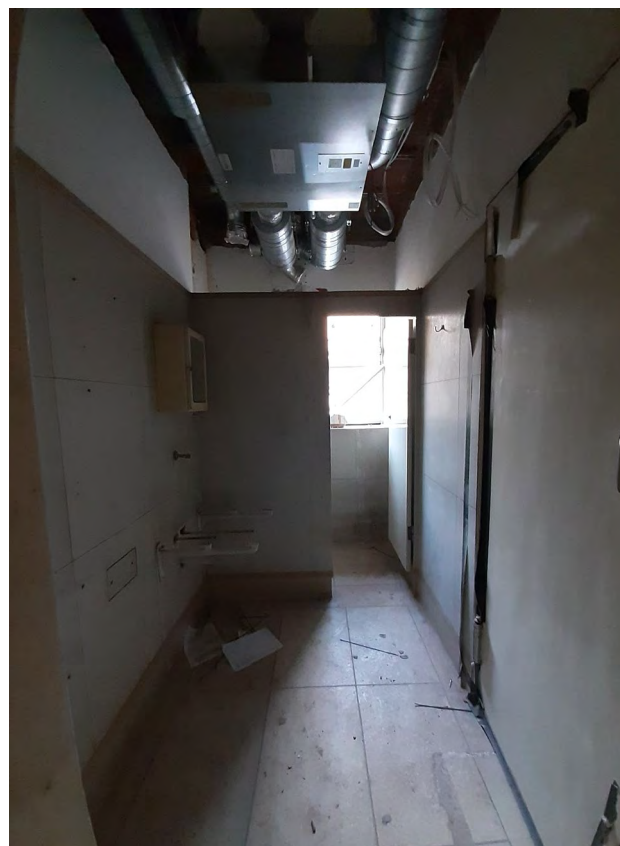
**101** *F.2 Mayor's Lavatory*

**General Description:** Mayor's WC with access from F.3 Mayor's Parlour only, now with most of fixtures and fitting removed.

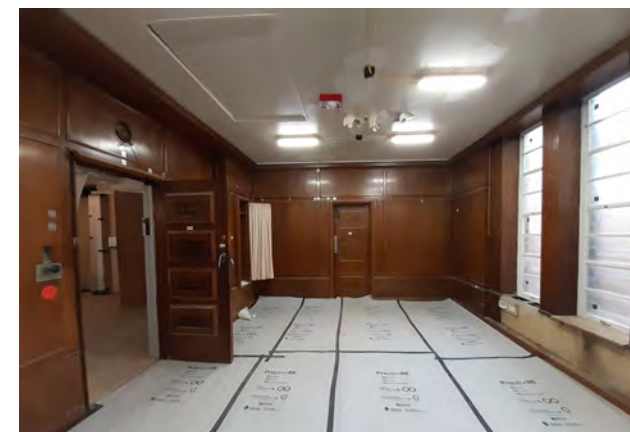
102 F.3 Mayor's Parlour looking north

**Fittings:** None during site visit but 2017 inspection noted marble and stone radiant heater. There is a 1930s vanity with keyhole-shaped mirror (from elsewhere). The nickel-plated chandelier is in storage. Original curtains lost.

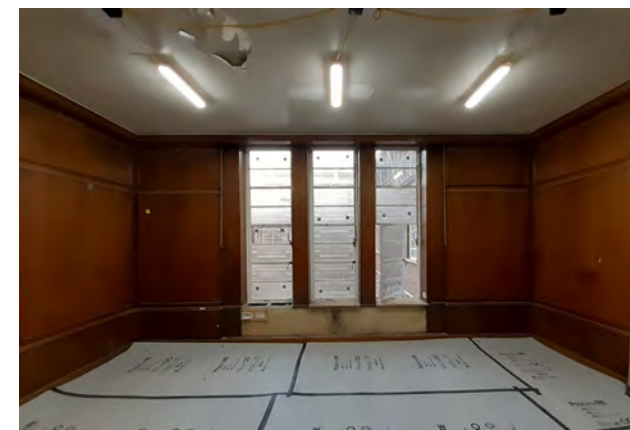
102A F.3 Mayor's Parlour looking east

**Windows:** Three tall bronze-framed casements with etched glass in the east wall, set in walnut reveals [plates 102A and 102C].

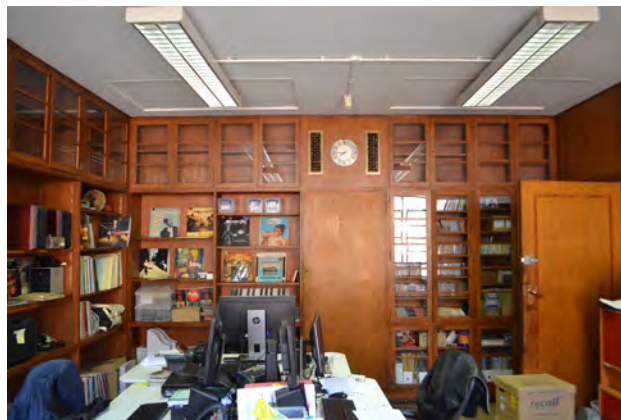
**105A** First Floor, former Town Clerk's Room, F.9 (2017)

**General Description:** Ensuite hotel room accessed from F.30 Corridor, previously fitted with full height panelled cupboards [plate 105A].

**Fittings:** Some original cupboards to be re-fitted.

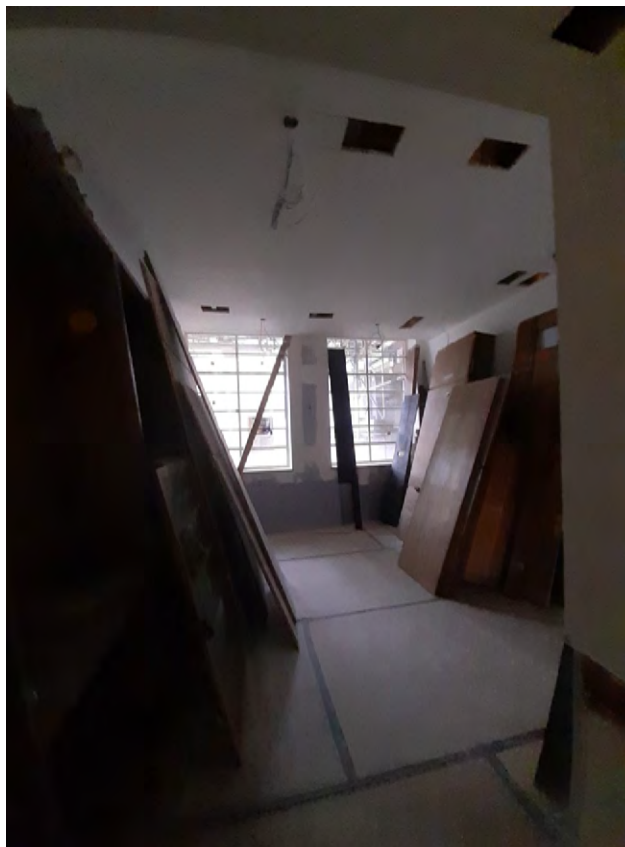
**109B** *F.21 Hotel Room (Former Medical Officer's Room)*

**Fittings:** Some original cupboards to be re-fitted in F.21 Former Medical Officer's Room (previously this room was panelled full height with built in cupboards).

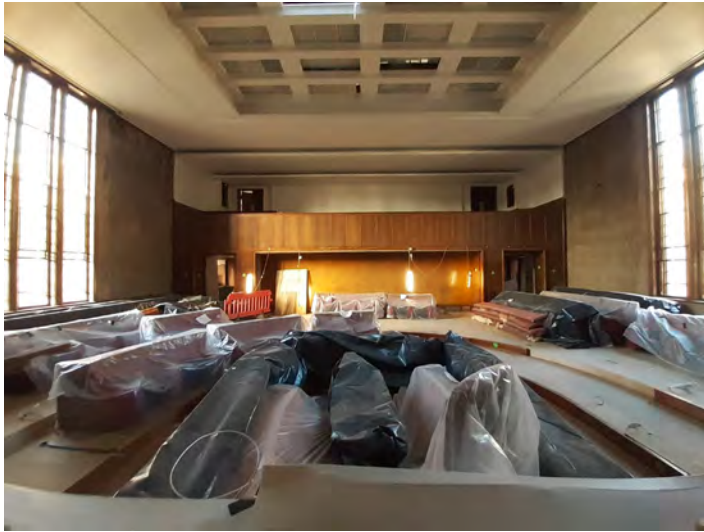
**112** *F.33 Council Chamber looking north to Public Gallery*

**Fittings:** Much of the seating has been moved out of place and covered, but originally the seating is arranged in tiers, with integrated writing desks with drawers. The bench seats are Australian walnut and teak and upholstered with leather (which is in a very poor state). The mayoral and council member chairs behind the rostrum are stored elsewhere in the building. Semi-circular-ended table in the centre of the horseshoe is free-standing. See plate 112 C.

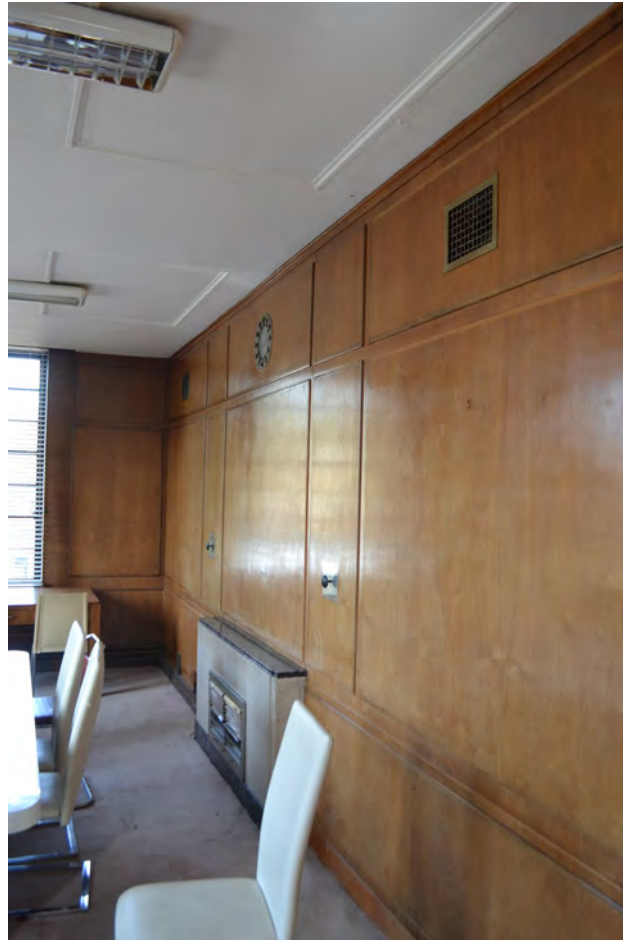
**115B** First Floor, former Member's Room, F.37 (2017)

**Ceiling:** Plastered ceiling - there is an odd cut back junction by the windows [Plate 115B].

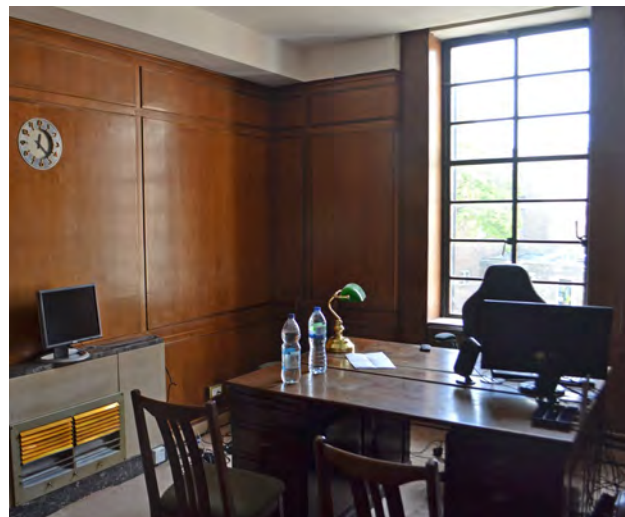
**117A** First Floor, former Lady Member's Room, F.39 (2017)

**Fittings:** None during site visit, although the 2017 inspection noted a marble and stone radiant heater and clock [plate 117A].

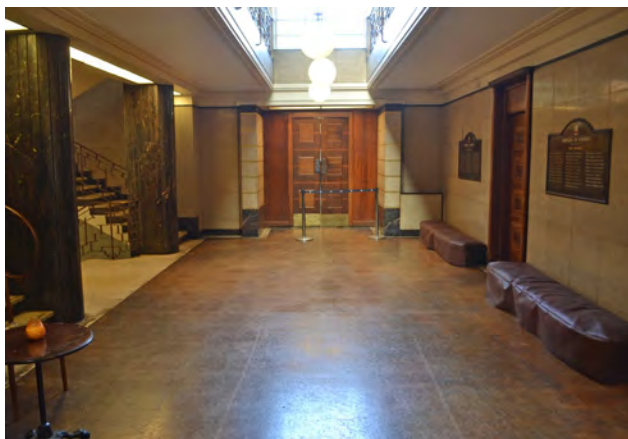
**119D** First Floor, landing, F.44 (2017)

**Fittings:** There is a range of original light fittings and switch plates [plate 119C], including flush lighting panels beneath the stair and over doorways and squat domed ceiling lights. Two bronze plaques flank the door to the Mayor's Parlour; containing lists of past mayors [plate 119D]. There is a Second World War memorial at the centre of the south wall, from Hornsey County School (installed in the 1980s, covered during site visit). The lift is fronted by walnut doors and retains its lift car. There is a range of original furniture in this space, including the reception desk from the Entrance Hall, leather-covered benches and velvet-covered bucket seats, all of which were not inspected (covered during site visit).

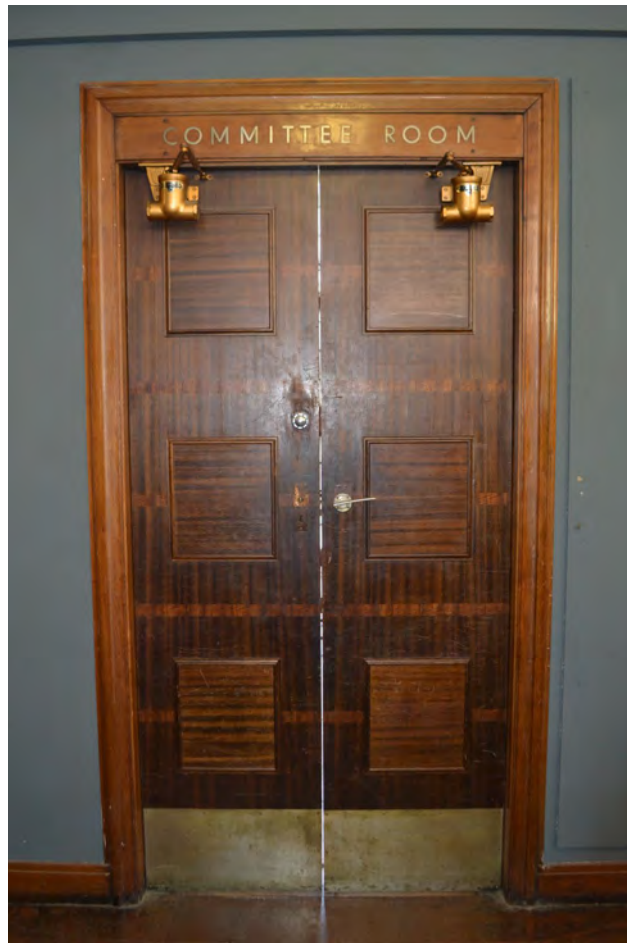
**121B** First Floor, Committee Room doors, F.49 (2017)

**Doors:** The two sets of double doors into the Committee Room are panelled walnut, with lettering: 'COMMITTEE ROOM', in the frieze of the architraves and original brass-coloured Britten door closers [see historic images, plates 121A and 121B].

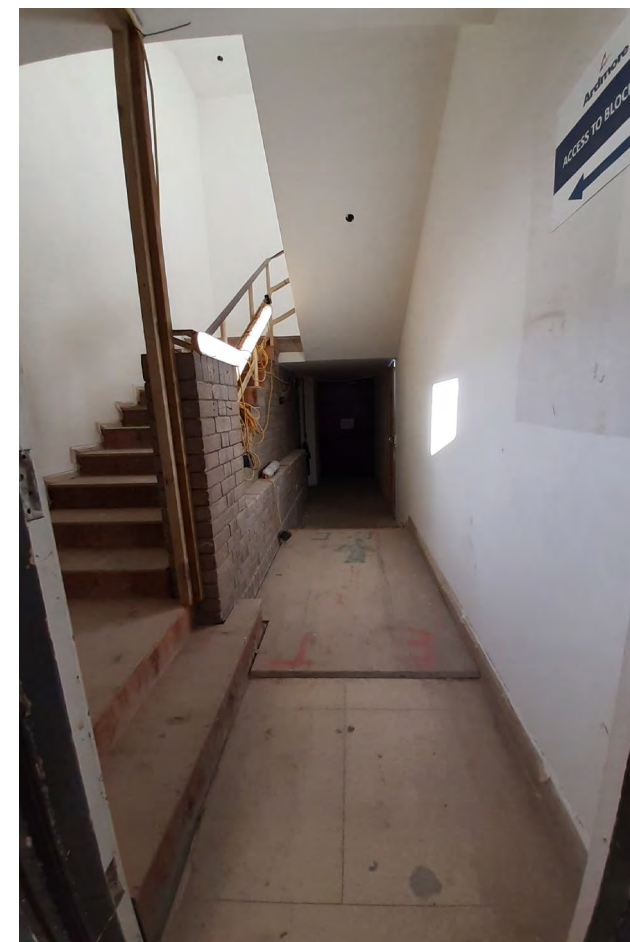
152 ST.04 ground floor looking to G.43 vestibule

**Floor:** Covered during site visit, but previously noted as granolithic covering and skirting between basement and first, terrazzo tile up to second floor.

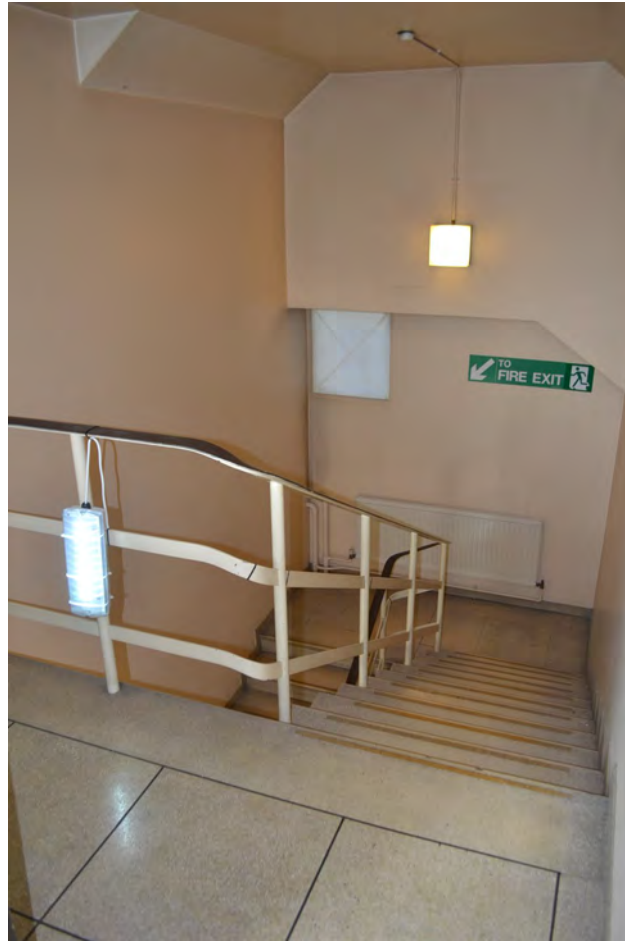
**152B** Second Floor, ST.04 (2017)

**Handrail & balusters:** Tubular steel handrail and balusters linked by flat rails between ground and second floor [plate 152B].

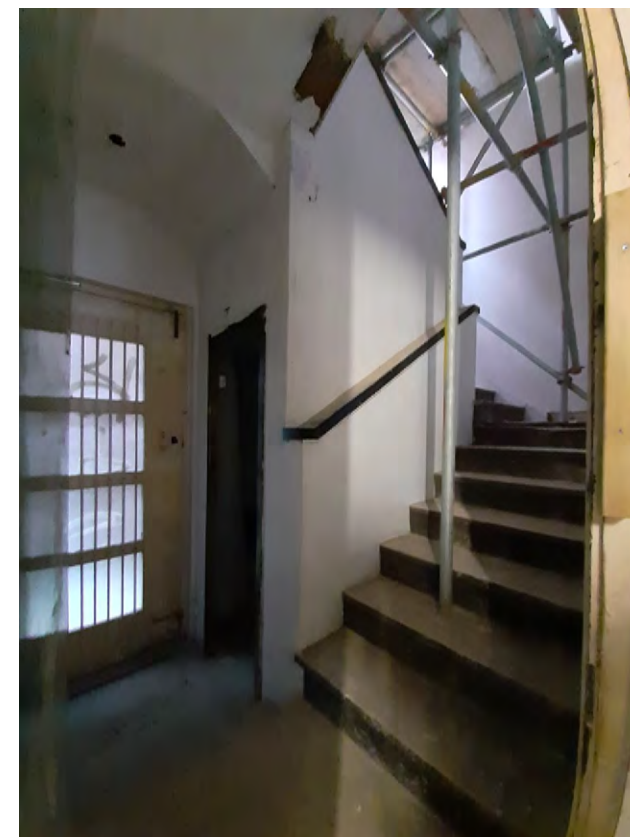
**153** ST.05 first floor

**Floor:** Covered during site visit, but previously noted as covered with modern linoleum with metal anti-slip treads.

**Handrail & balusters:** Previously noted that balustrades have been over-boarded.

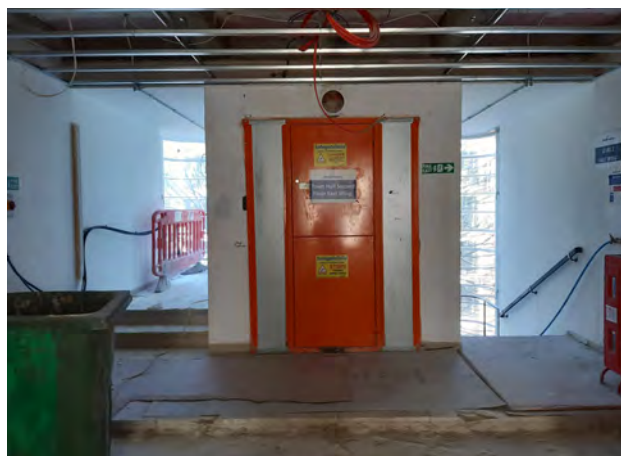
154 ST.06 second floor

**Handrail & balusters:** Painted steel handrails are supported on brass wall brackets.

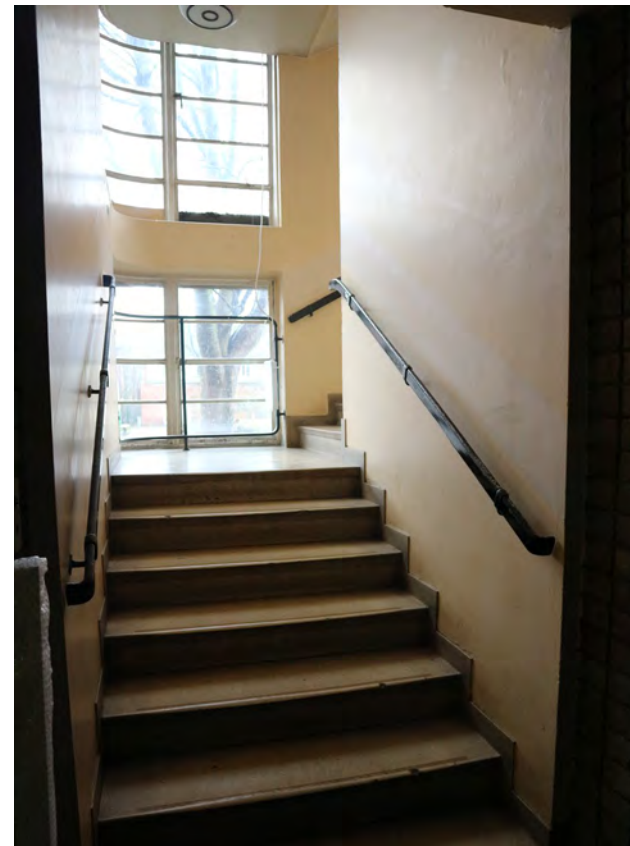
**154C** Basement, ST-06 (2017)

**General Description:** This is the main stair in east office wing, which served the offices. It wraps around Lift No.1. Steel railings also front the original curved windows, which are the most striking element of the stairwell [plate 154C].

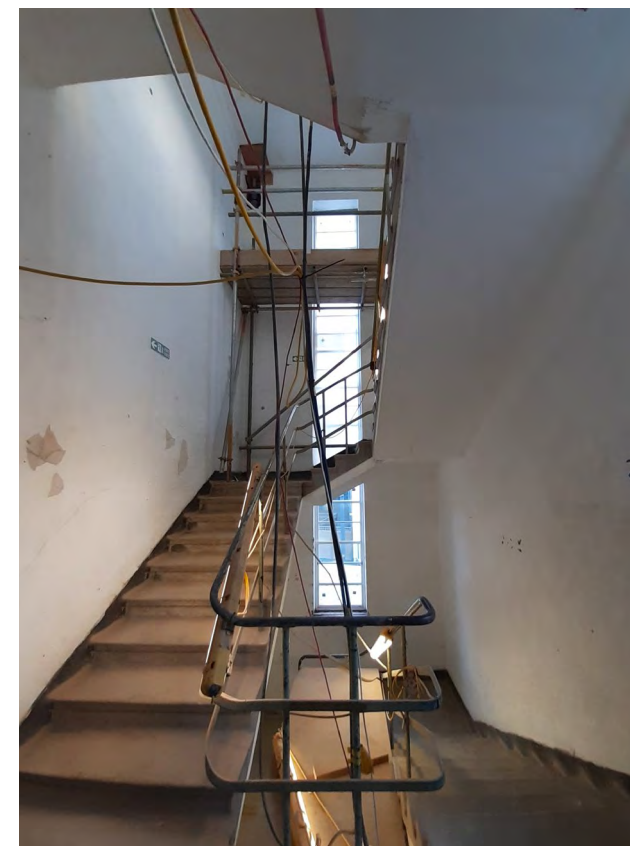
155 ST.07

**Handrail & balusters:** Fine tubular steel handrail and balusters linked by flat rails, painted pale green.

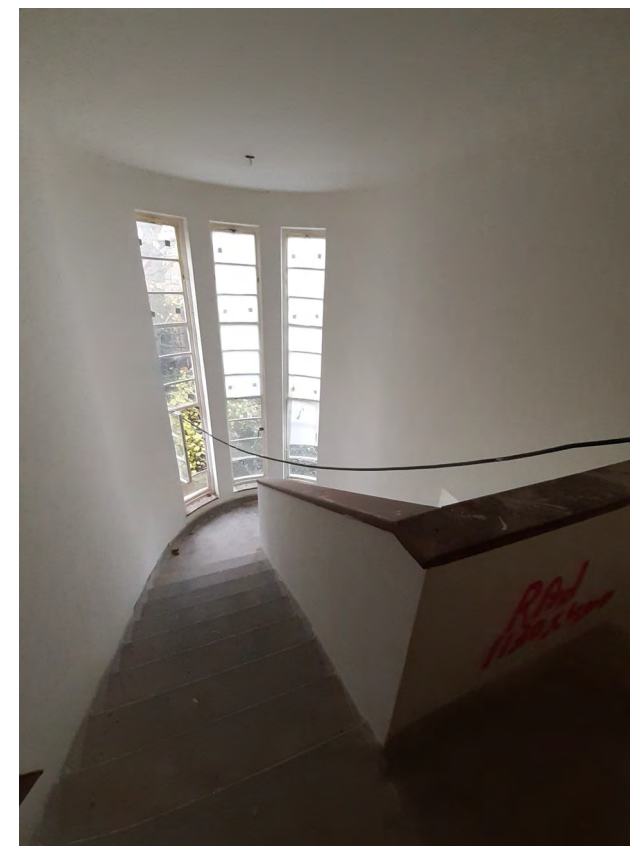
156 ST.09

**General Description:** This is the cantilever curved bay stair to the north of the Assembly Hall Block. It runs between ground and first floors. It is utilitarian, with a solid balustrade but has grand proportions and is well lit by a tall north window.

**Handrail & balusters:** Solid balustrade with timber cap.

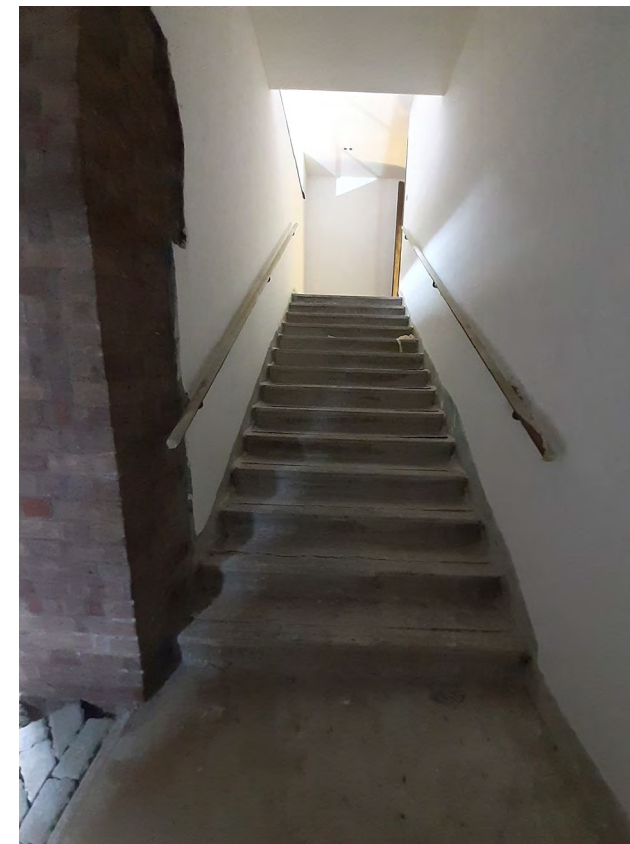
**157** ST.10 basement to ground

**Handrail & balusters:** Handrail only, covered during site visit (Dec 2022).
