## 6.0 Gazetteer

### 6.1 Exterior

## 6.2 Interior

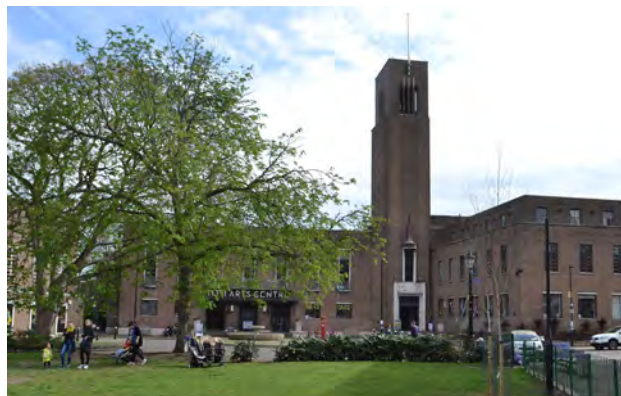
30 Main elevations of Hornsey Town Hall (2017)

The Assembly Hall Block is seven bays wide. Its base is Portland stone and its ground floor contains squat bronze-framed windows with Portland stone lintels and sills. There are three large entrances framed by curved and rusticated brick piers, accessed via stone steps with slim metal railings. These openings are fronted by ziggurat openwork shutters. Between are semi-hexagonal wall-mounted lights and above a curved-profile canopy (later, yet suitable additions). The modern lettering: 'HTH ARTS CENTRE' previously above the north Assembly Hall block has been removed [plate 30, 31].

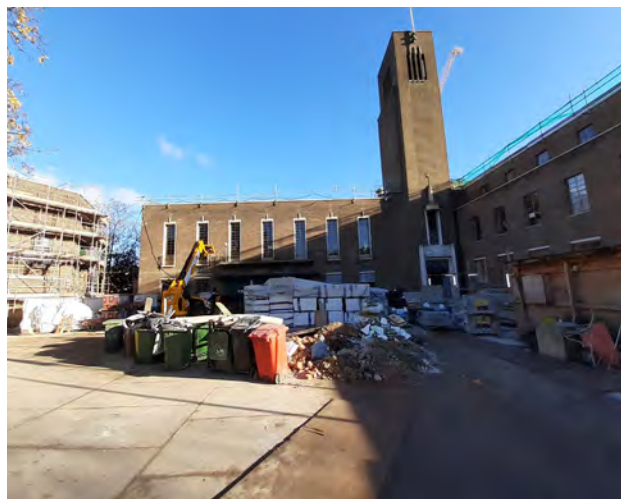
31 Front West elevation

At first floor are seven double-height bronze-framed windows, surrounded by Portland stone with slit keystone details. Fronting the three central windows is a bronze openwork balcony, and the remaining windows have individual openwork balconies; now all with modern plastic safety screens.

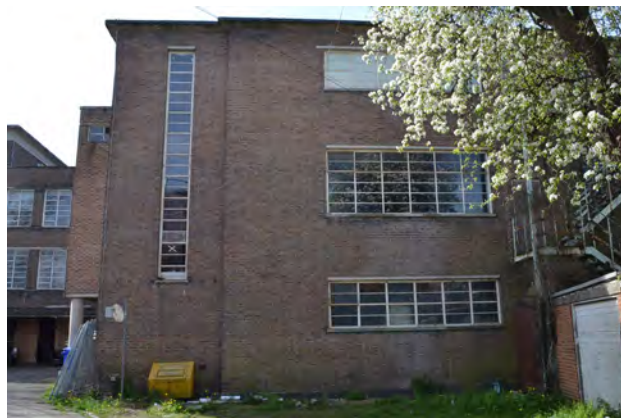
**35** Rear (east) elevation of Assembly Hall Block (2017)

The rear of the Assembly Hall Block is three storeys, two bays wide and is arranged asymmetrically. The left hand bay contains a tall steel-framed strip window which illuminates the stair core. The right hand bay contains wide steel-framed windows with concrete lintels and sills on each of its levels **[plate 35]**.

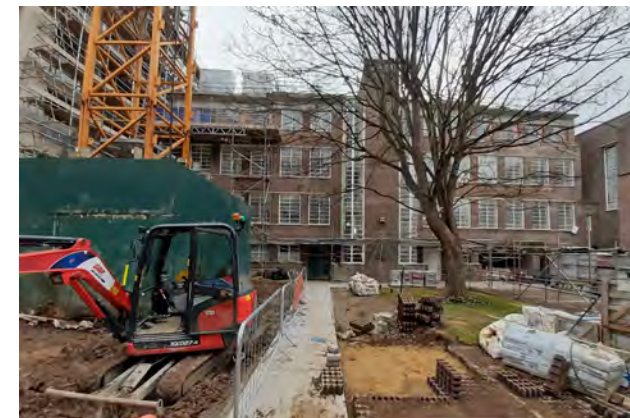
**36** Rear (east) elevation of the east office wing, second floor extended to length of east office wing

The rear elevation of the east office wing is largely symmetrical. It is four storeys as it accommodates the lower ground floor. It is thirteen bays wide with its central stair and lift core flanked by the secondary entrances. The stair and lift core is the main feature of this elevation – it is oblong and features curved wrap-around windows. The remainder of the windows are steel-framed casements (like the stair, all painted white) with continuous concrete sill and lintel bands. At lower ground floor, there are entrances either side of the stair, with a large curved canopy over (half of which has been altered). To the north, the remainder of the lower ground floor contains the former car entrance to the Service Court, this has been blocked off with sheets of ply. The second floor is arranged as two bays wide either side of the stair core, again with large steel-framed windows. There is a deep stone parapet above and the core rises to accommodate the lift overrun, the second floor has been extended either side of the stair core to the full length of the building **[plate 36]**. There is a new residential block to the east of the Town Hall across what was the previous service court **[plate 37]**.

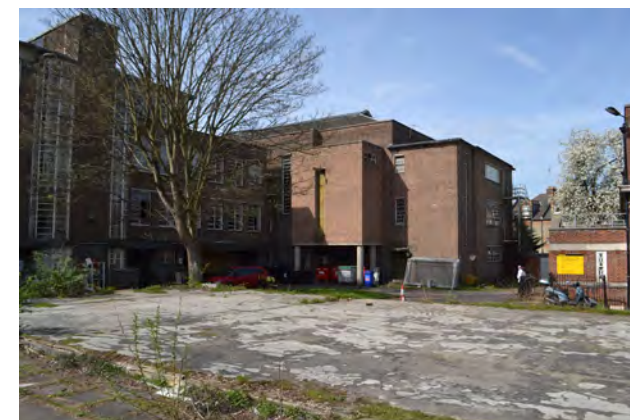
**38** South elevation of Assembly Hall Block (2017)

The south elevation of the Assembly Hall faces the Service Court and is largely obscured by the east office wing. Between the two blocks runs a narrow fire exit passage; the Assembly Hall has five tall steel-framed windows facing onto this. Where it faces the rear of the site, one of these narrow windows is visible. The projecting two-storey stage wing is a later addition; it is in a very similar brick. The remainder of this block contains the stair core, accessed via the stage door, which has curved steps and a corresponding canopy. At ground and first floor there are steel-framed windows **[plate 38]**.

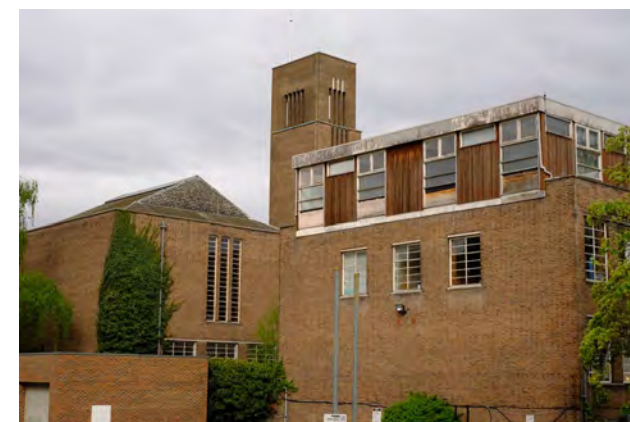
The east office wing and Council Chamber block are set around the 'Garden Court', and its elevations are fairly utilitarian. The south elevations of the projecting wings (east wing and Council Chamber blocks) are largely blind, with the exception of three steel-framed windows at first floor level to the east wing **[plate 39]**.

**39** South Elevations (2017). Note that timber extension to right now replaced with a new storey providing hotel accommodation to the second.

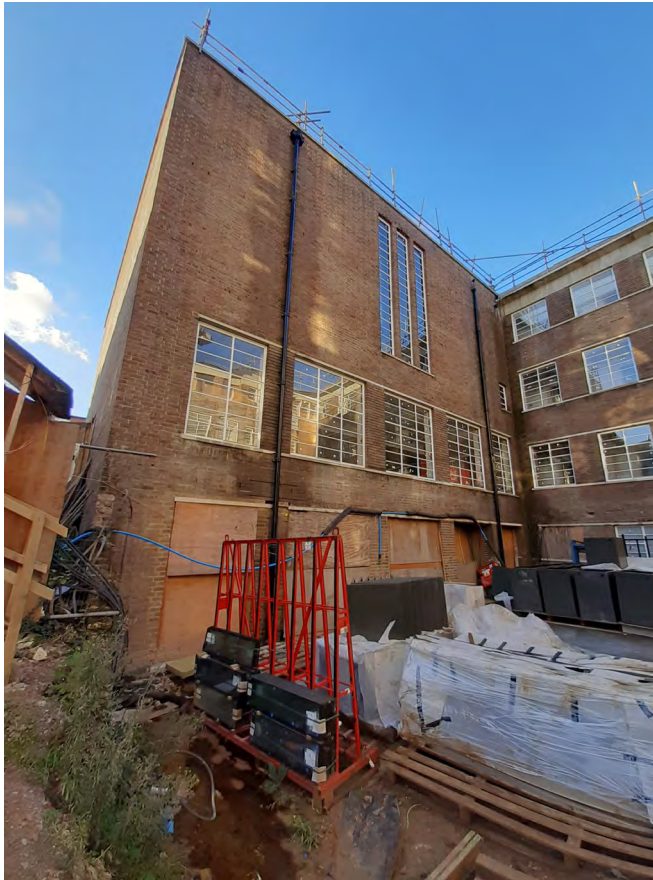
**40** Council Chamber block around the 'Garden Court'

Facing the Garden Court, the south elevation of the Link Block is four-storeys, six bays wide and contains large steel-framed windows at each level, linked by continuous concrete lintel and sill bands. The return elevation of the east wing is four storeys and ten bays wide, with steel-framed windows at each level. The Council Chamber Block is four storeys; at lower ground level, the former Caretaker's room (now hotel rooms) will have large steel casements. Five large steel casements illuminate the former General Clerk's offices (now providing co-working space) and the Council Chamber above is lit by three narrow double-height steel-framed windows **[plate 40, 41]**.

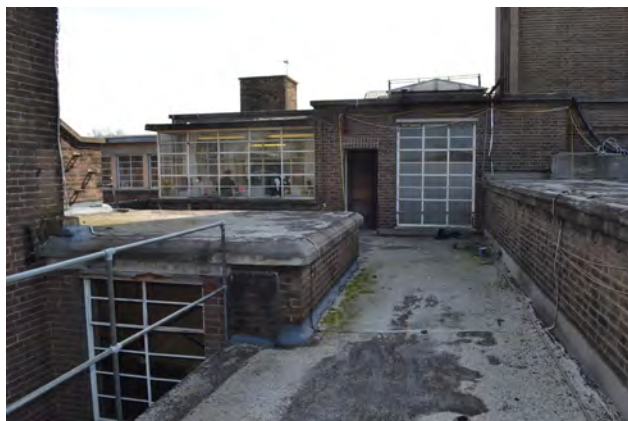
44 Flat asphalted roof over Assembly Hall Block (2017)

The roofs over the Assembly Hall and Council Chamber are pitched and slated. The remaining flat sections of roof are asphalted [plate 44].

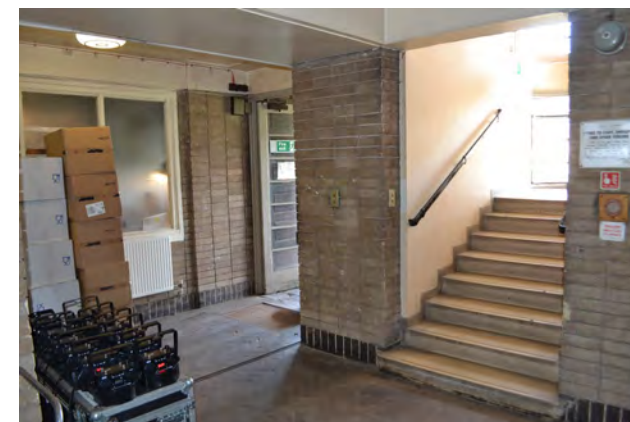
**50** Basement, lobby and stair, LG.03 and ST.06 (2017)

**General Description:** Entrance Hall, with access to stair No.6 and lift No.2. Construction works underway.

**Doors:** No timber framed doors or concertina security gate visible (opening boarded during site visit Dec 2022)

**Fittings:** Lift call buttons not present during site visit.

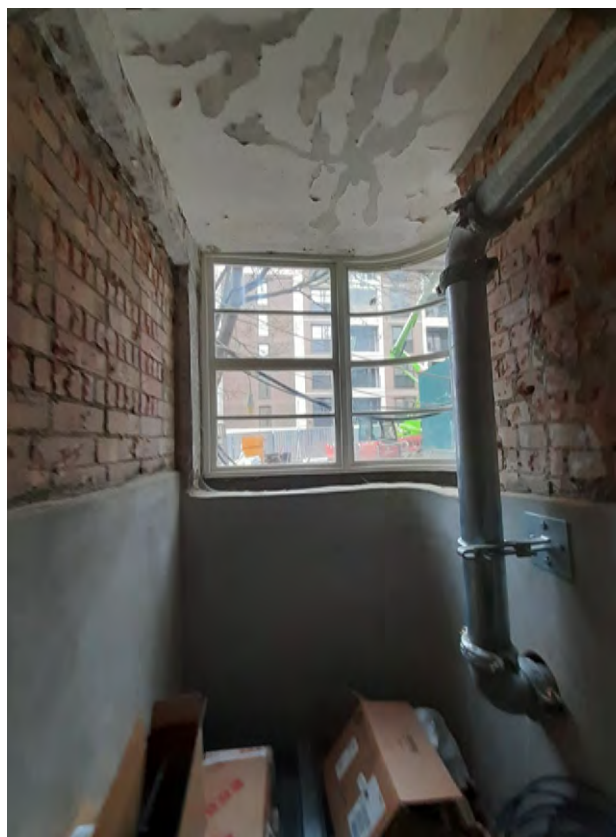
51 LG.4 Store

**General Description:** This is a Storeroom (but formerly Telephone Exchange), adjacent to Stair No.6. Access now from Lobby LG.7 and not connected to stair/lift lobby. The room is now a storeroom with modern finishes, with the original curved window remaining.

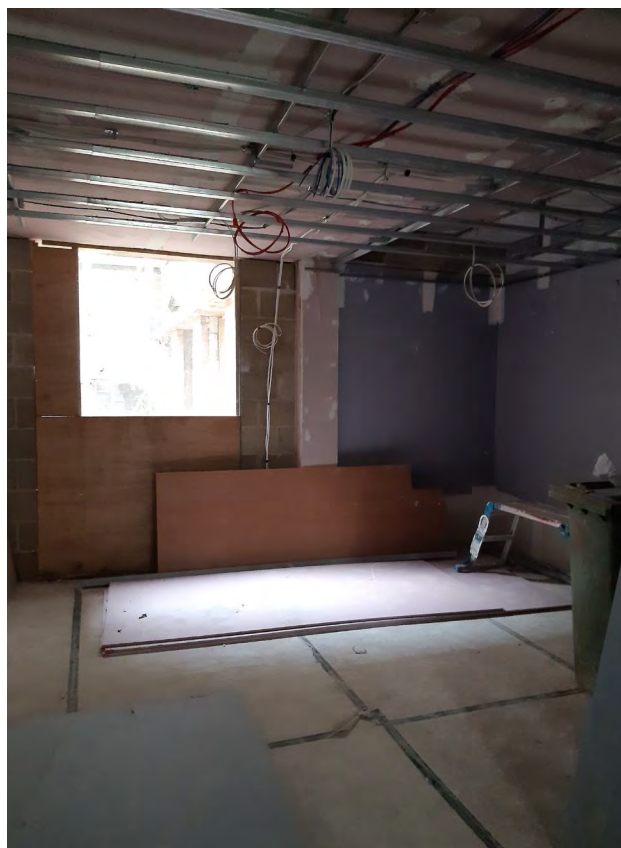
56 LG.22 Hotel Room

**General Description:** En-suite hotel rooms (formerly Garages off Service Court).

**Windows:** No windows during site visit (construction ongoing).

**Floor:** Not inspected (covered during construction works).

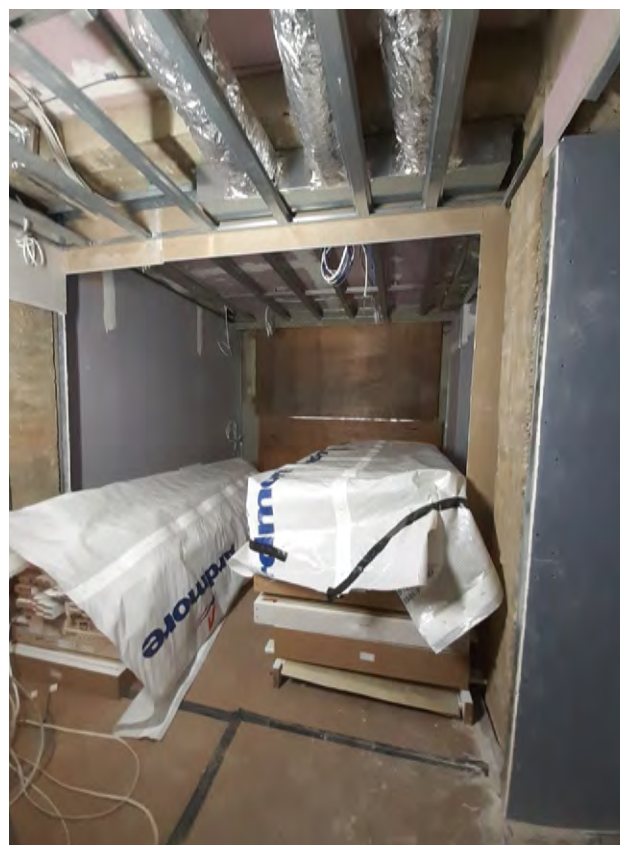
57 LG.23 Hotel Room

**Windows:** New doors to existing window openings and new openings with doors to rooms LG.23 and LG.23b.

**Floor:** Covered during site visit (Dec 2022).

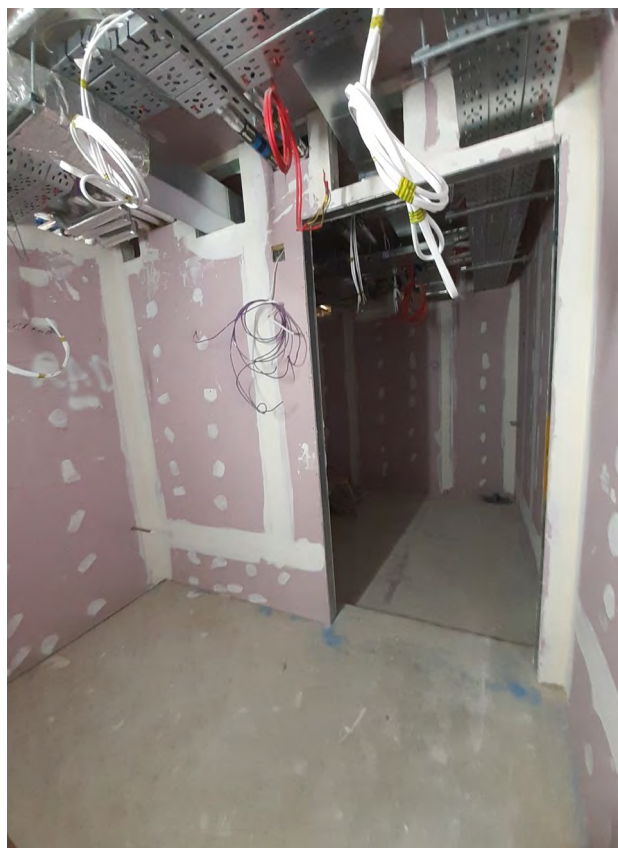
58 LG.24 Staff Facilities Room

**General Description:** Staff Facilities/ Room including washing and toilet facilities, with new partitions and finishes [generic plate 58]

**Doors:** John Tann 'Reliance' steel door off LG.26.  
Reused

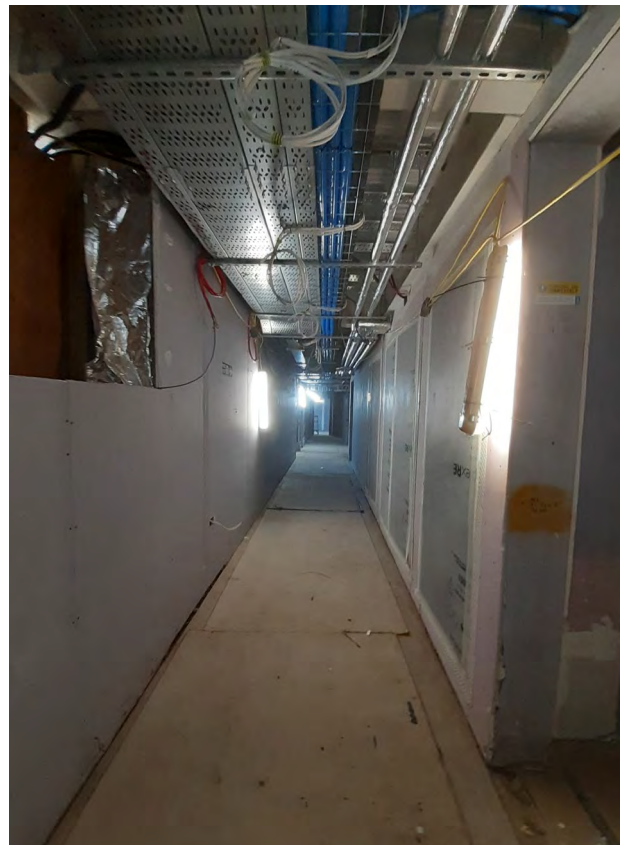
**59** LG.28a Corridor

**Doors:** None present during site visit (Dec 2022).

**Fittings:** Lift LF-01 call buttons etc. not present

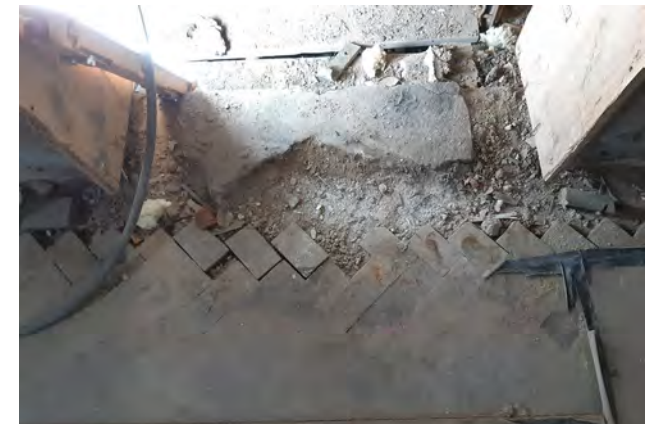
**Floor:** Covered during site visit (Dec 2022) but likely to be original parquet [plate 59B].

**59B** LG.28b Corridor floor showing original parquet floor blocks

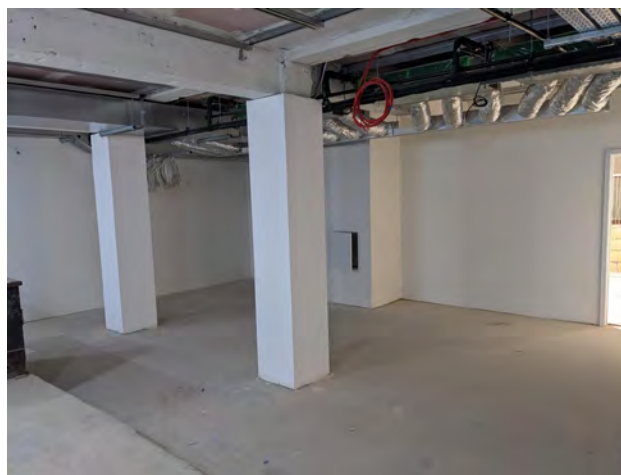
**60** LG.31 Restaurant Main Kitchen and BOH

**General Description:** Servicing to new area to form main kitchen and BOH.

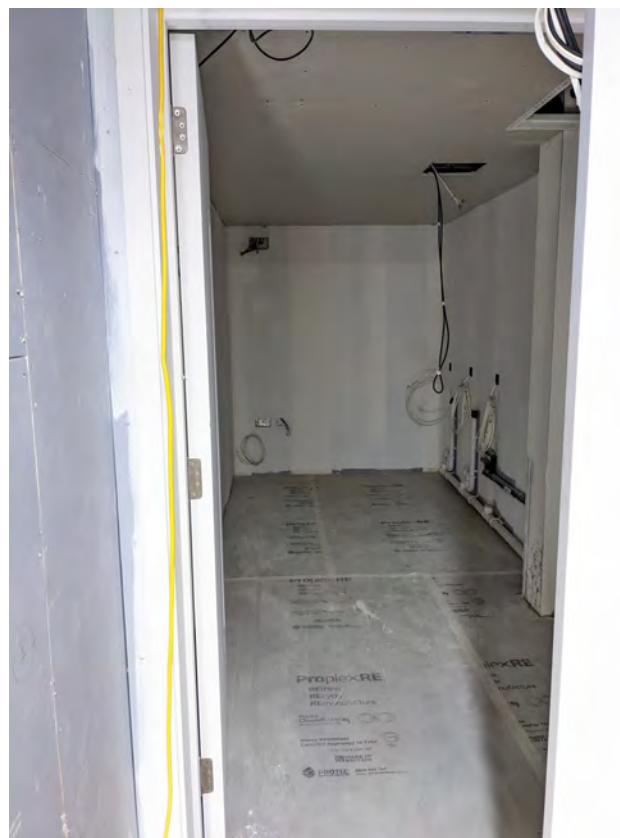
**60A** LG.31a Laundry

**General Description:** Hotel Laundry (no access)

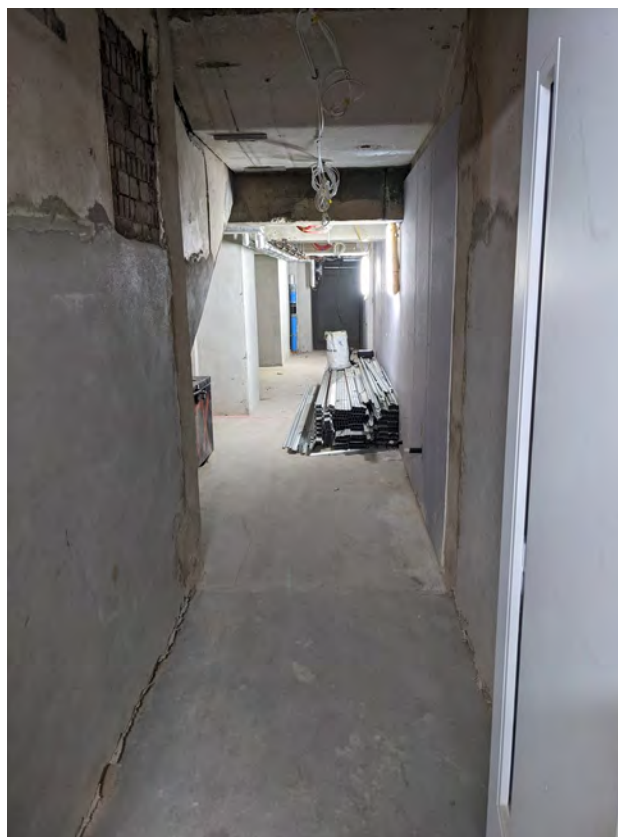
**60B** LG.31b Corridor

**General Description:** New corridor formed behind lift.

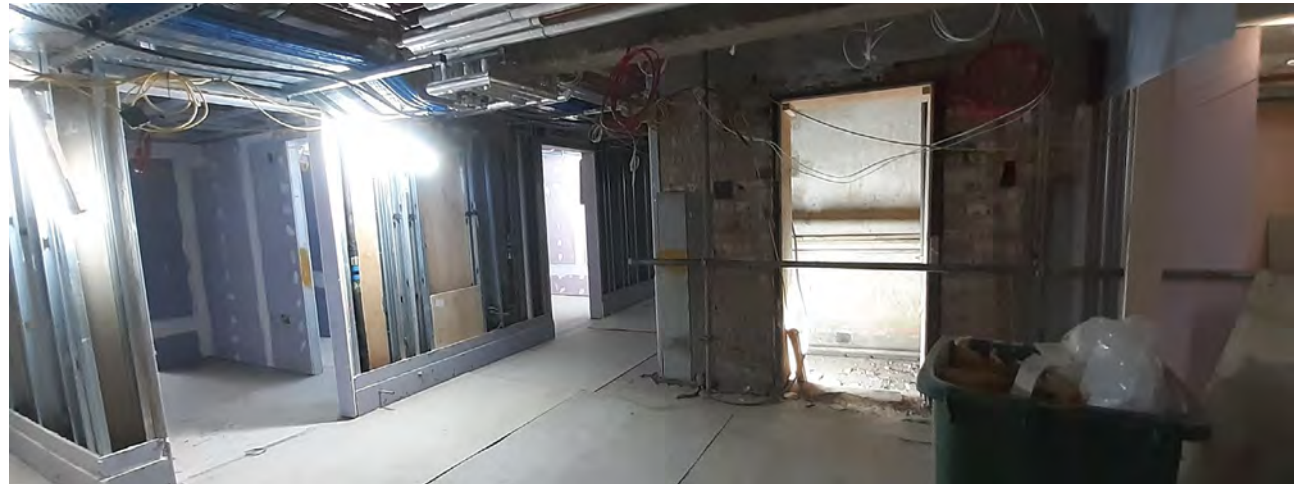
61 LG.32 Hotel Gym

**Room: LG.32 Hotel/ Gym [plate 61]****General Description:** Hotel Gym**Significance:** Neutral.**Use:** Hotel ancillary guest services (Leisure).**Ceiling:** Modern plaster.**Walls:** Modern plaster.**Windows:** None.**Doors:** None during site visit (Dec 2022).**Floor:** Covered during site visit (Dec 2022) but likely to be original parquet.**Fittings:** None during site visit (Dec 2022).

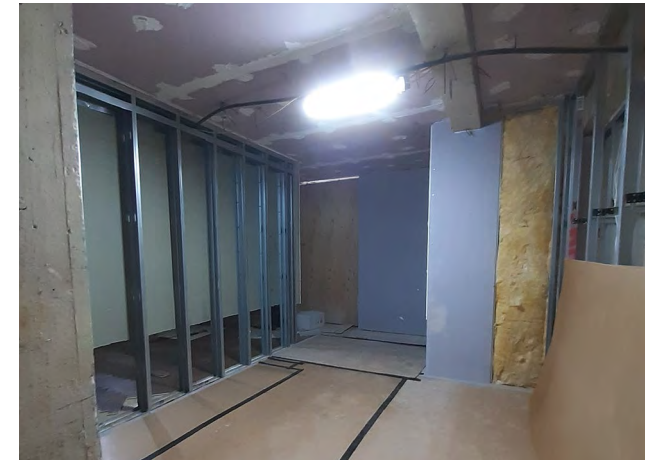
**62** LG.34 Hotel Room

**Floor:** Not inspected (covered during  
construction works).

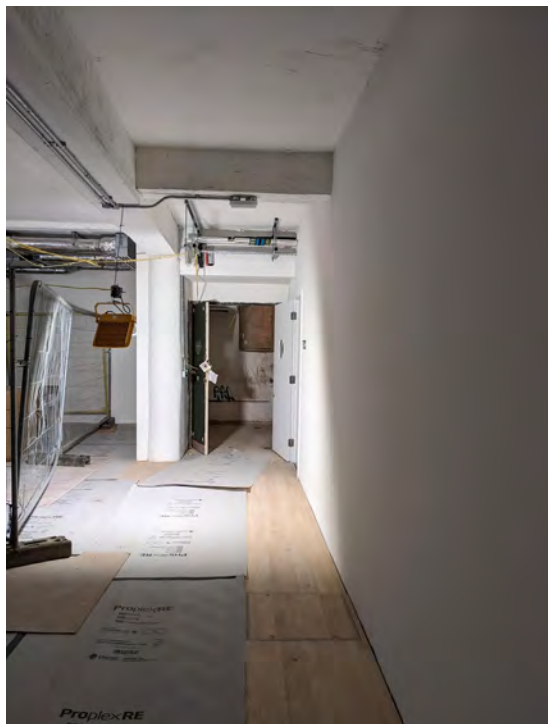
63 LG.40 Supper Room - 1

**Floor:** Covered during site visit, likely to be narrow timber floorboards,

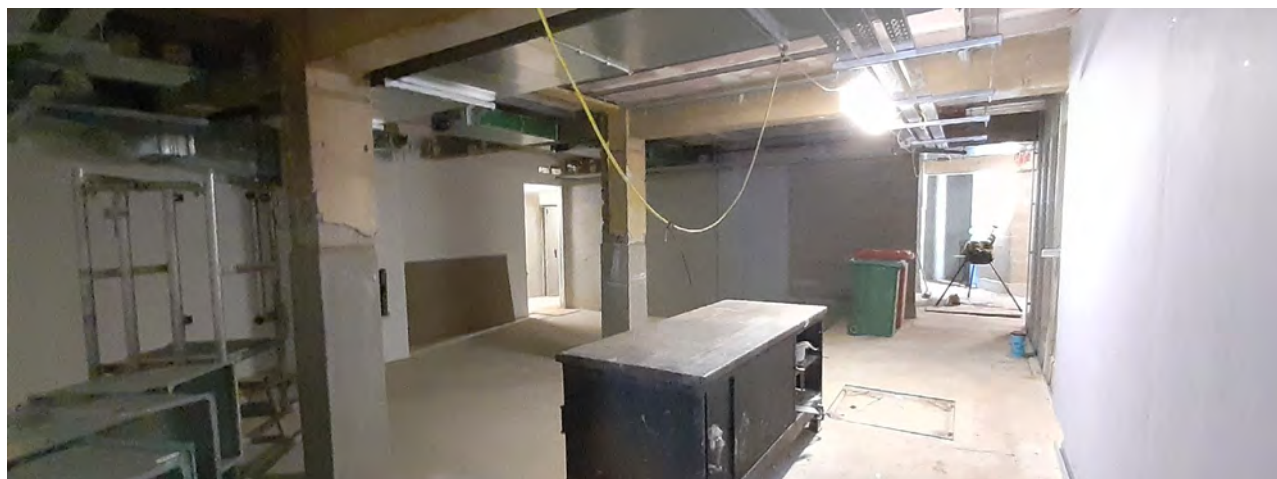
64 LG.42 Kitchen and Bar

**General Description:** Kitchen and Bar adjacent to the Supper Room. There is a level difference with some items of furniture remaining.

**Floor:** Bare concrete during site visit.

**Fittings:** Double dumbwaiter (original) previously noted.

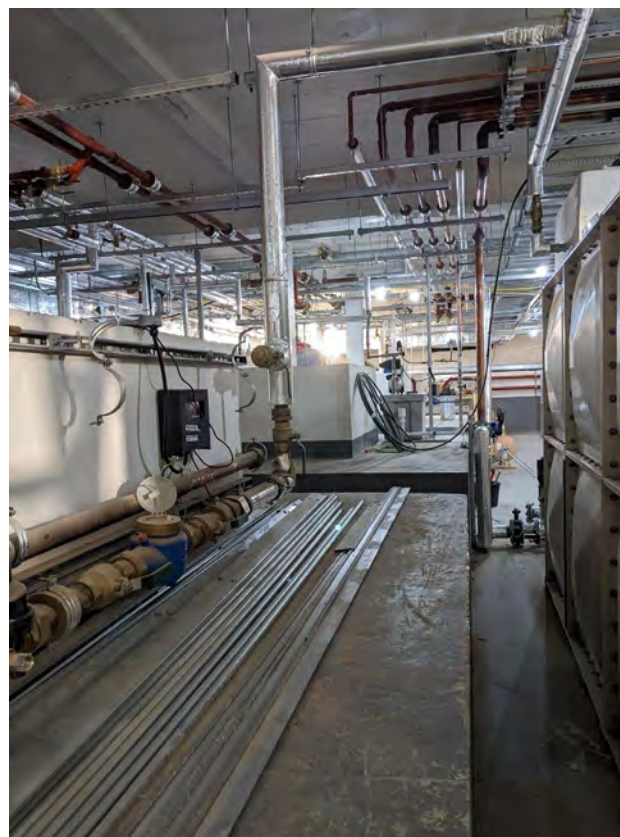
**65** LG.43 Plant Room beneath Assembly Hall 1

**Room: LG.43a Plant [plate 65 and 65A]**

**General Description:** Plant Room, set beneath Assembly Hall Block.

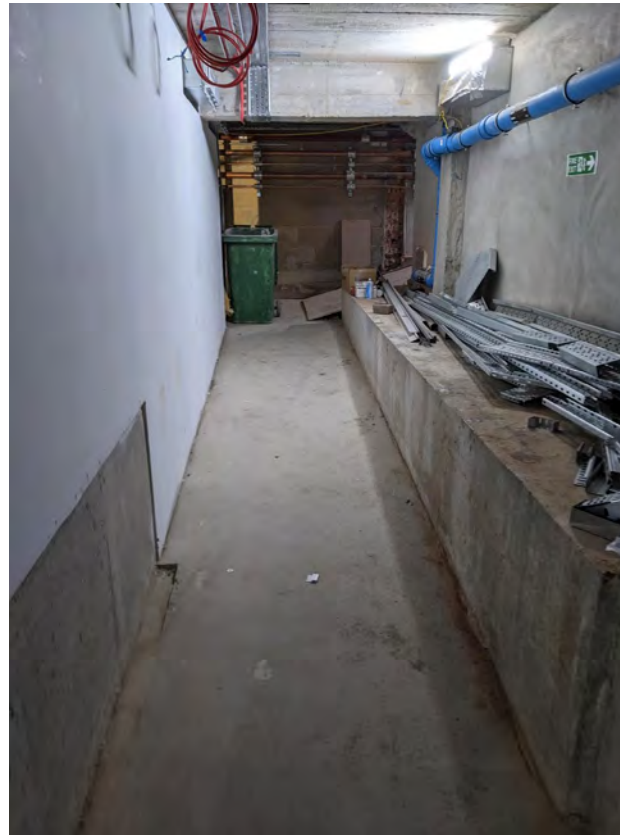
**65B** LG.44 Corridor

**General Description:** Access and service corridors of modern finish.

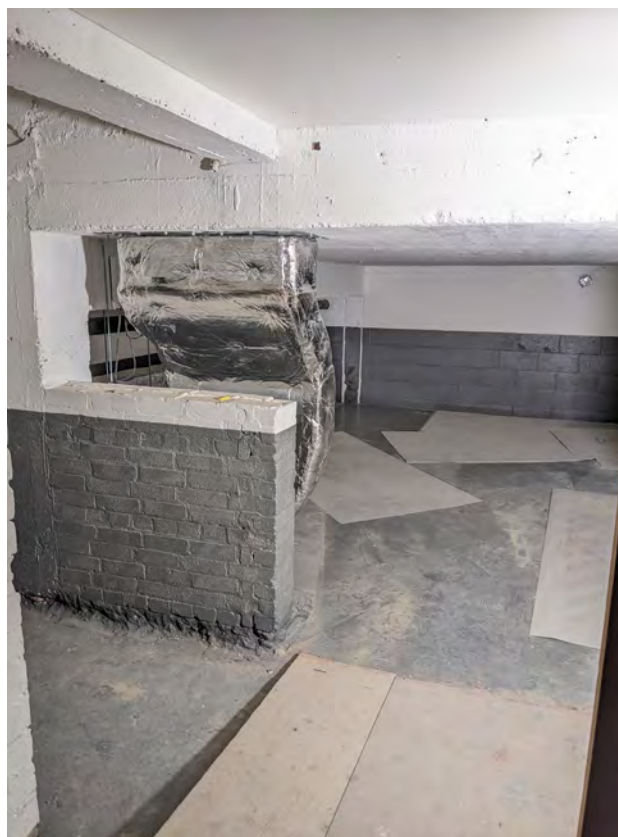
**65C** LG.45a Refuse store

**General Description:** Town Hall Refuse housed in previous Cycle Store LG.45

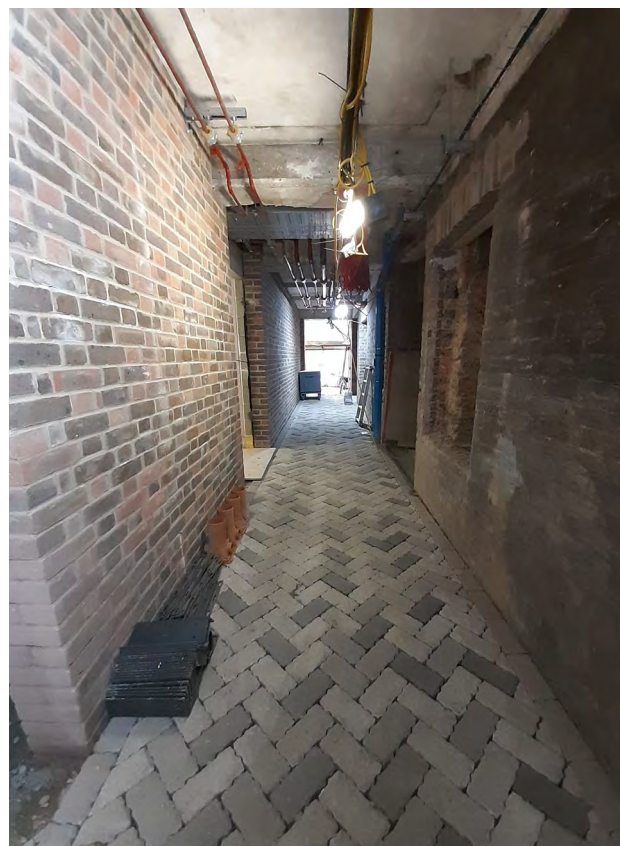
**66** LG.45f New covered corridor near Plant and Refuse Store

**General Description:** New covered (outdoor) access corridor built in former Service Court.

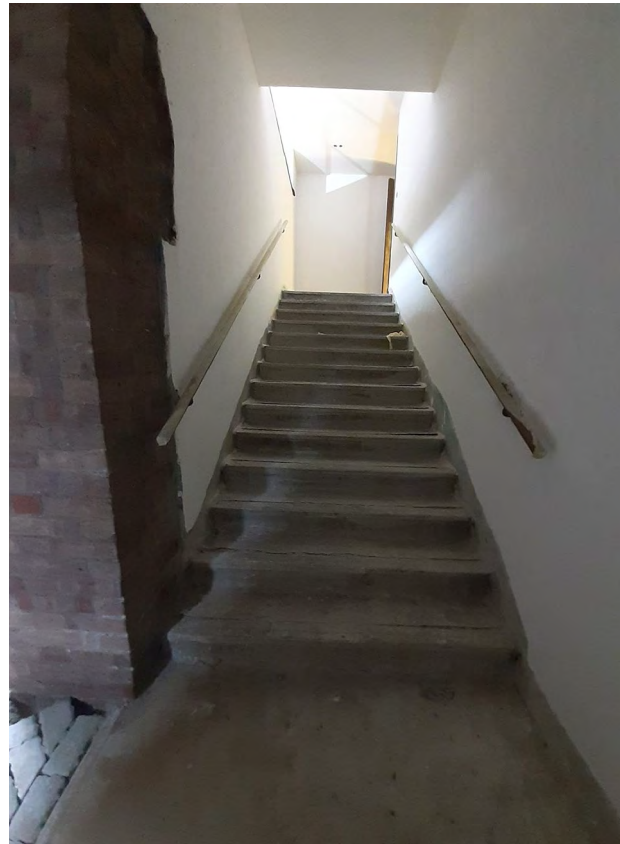
67 LG.46 Stair

**Floor:** Granolithic stairs with handrails.

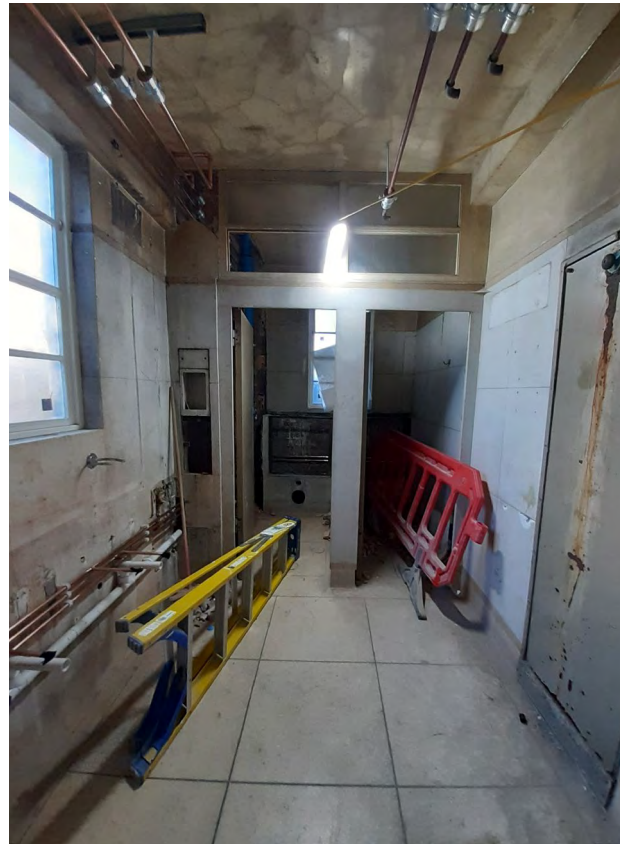
**69A** LG.52 Men's Lavatory

**Floor:** LG.50: Covered during site visit (construction underway, Dec 2022.). Parquet floor with perimeter detail originally. LG.52: Precast terrazzo tiles with bitumen joints.

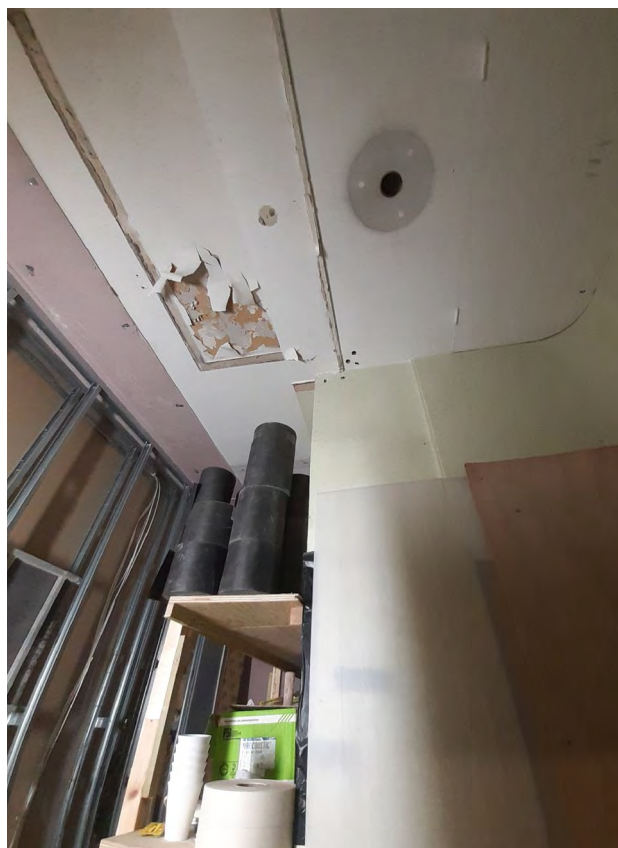
**General Description:** Concierge (being used as storage during site visit, difficult to inspect).

70 G.2 Concierge interior showing curved wall and painted ceiling

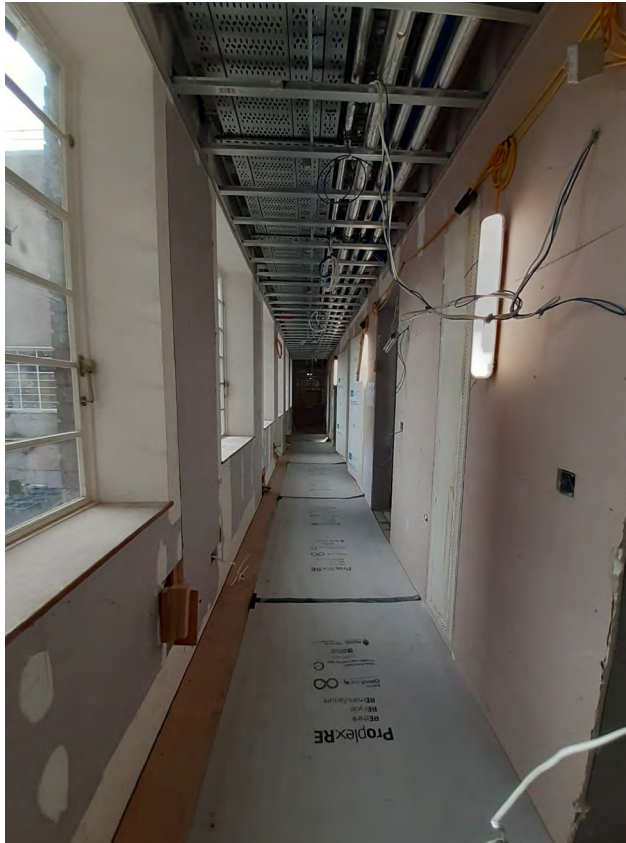
**Floor:** Covered during site visit (2017 inspection noted that this section is carpeted but the cork floor remains beneath [Plate 72B, 2017].

**72** G.4 Corridor looking west to entrance hall (courtyard on left)

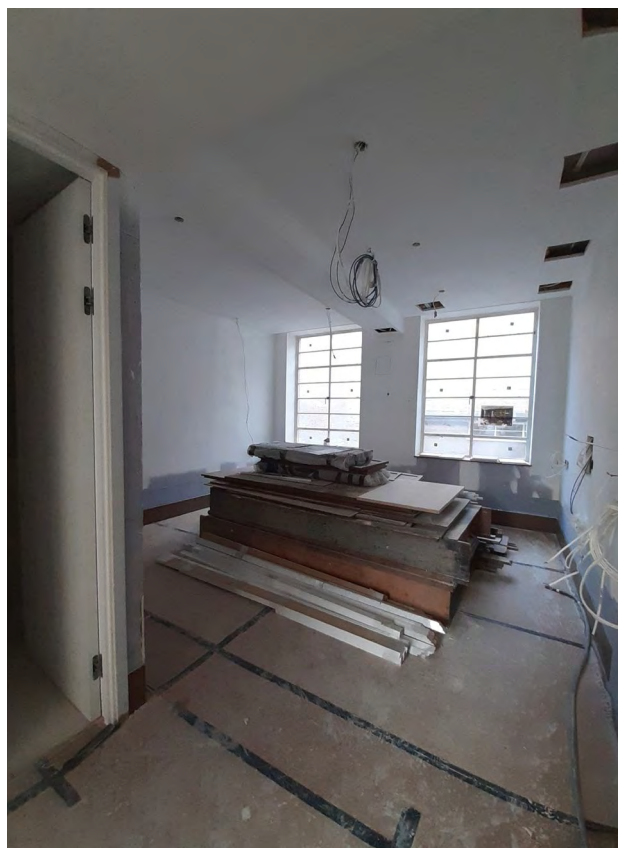
**Walls:** Painted plaster and modern drylined walls – construction underway. (The 2017 inspection noted that this room had full-height panelled walls with Indian silver greywood and teak; set out with cross-banding and glazed built-in cupboards of the same.)

**73** G.8 Hotel Room Former Borough Treasurer Room (furniture for reassembly)

**Fittings:** Original cupboards are to be refitted to rooms.

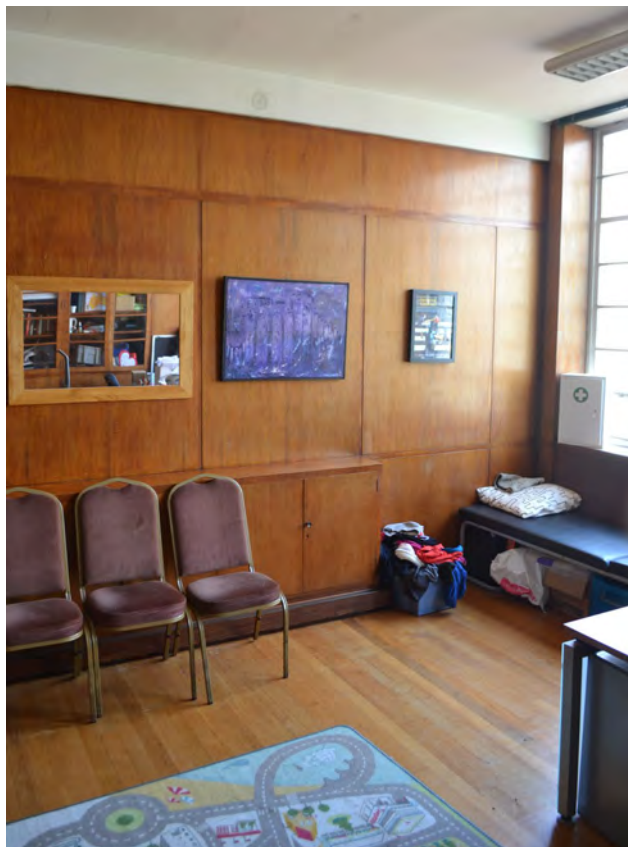
2017 inspection noted that this room (Former Borough Engineer's Office) had full-height panelled walls with Indian silver greywood and teak; set out with cross-banding and glazed and solid panel doors to built-in cupboards. **[Plate 76A]**.

**76A** Ground Floor, Former Borough Engineer's Office, G.15 (2017)

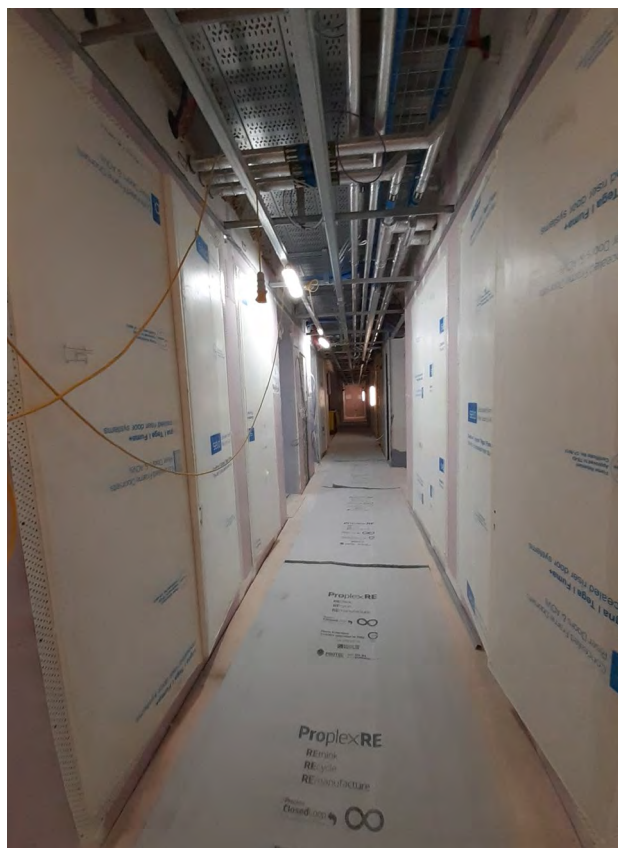
77 G.16 Corridor (north end)

**General Description:** Corridor. This is the cross corridor (running north – south) providing access from Stair ST-06 and Lift LF-02. The 2017 inspection noted that there is a timber-framed glazed screen, which borrows light from the lobby (G.17). Further light is borrowed from G.21.

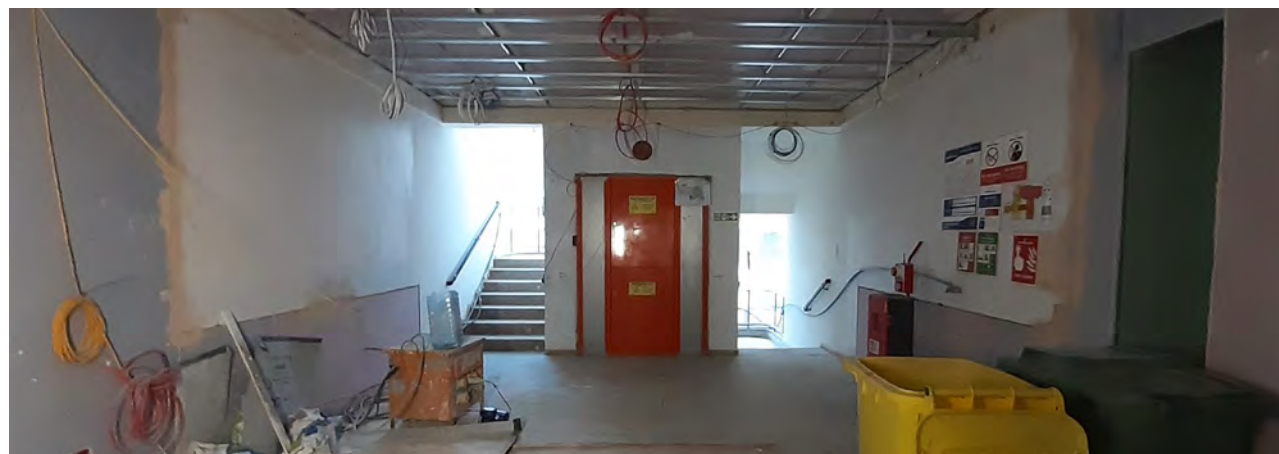
78 G.17 Ground Floor Landing

**Windows:** Original curved steel casement windows to stairwell and landings.

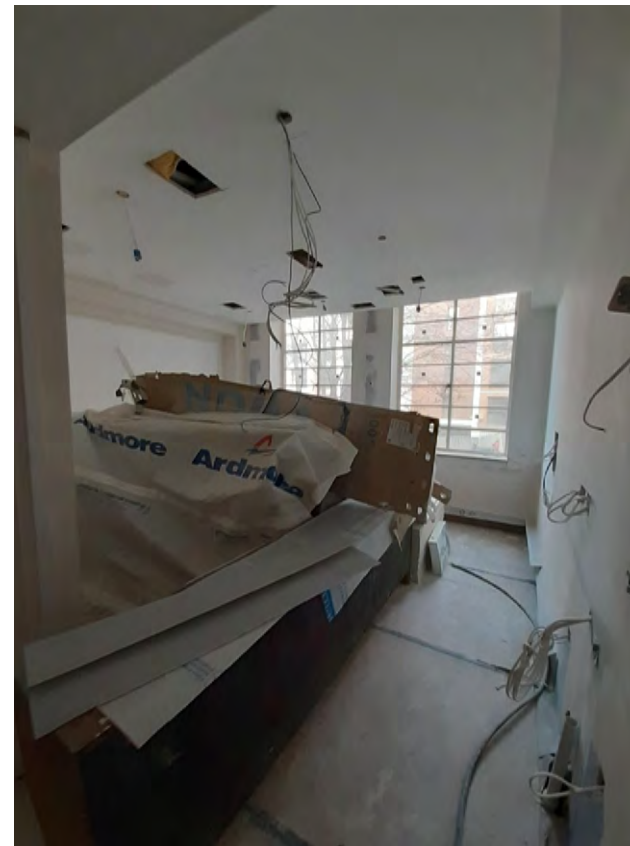
**79B** G.19b Hotel Room (original furniture for reassembly in room)

**Fittings:** LG19b and G21a to have original cupboards remade in rooms.

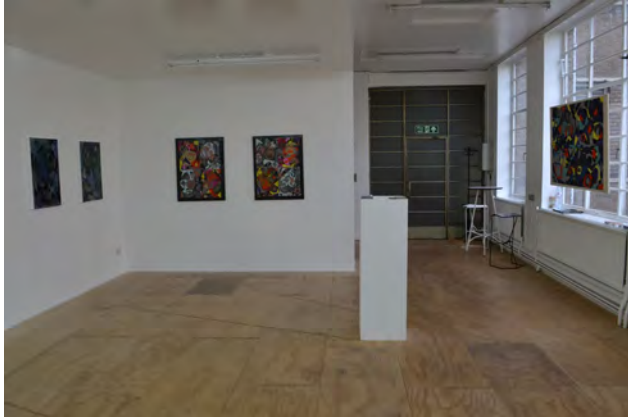
**General Description:** Co-working space; this single larger space previously housed several Clerks offices, book room and a public access space for dealing with the rates office. The 2017 inspection notes: This is the former General Clerk's Office, which was used as a rates collection office. The space is currently occupied as a gallery. There are large screens with nickel-plated frames and a single leaf door onto the main office corridor (G.4), the glazing replaced with Georgian wired glass. There have been earlier changes to the layout of these areas, with new partitions. [plate 80D]

**80D** G.27 Ground Floor, Former General Clerk's Offices, G.29 (2017)

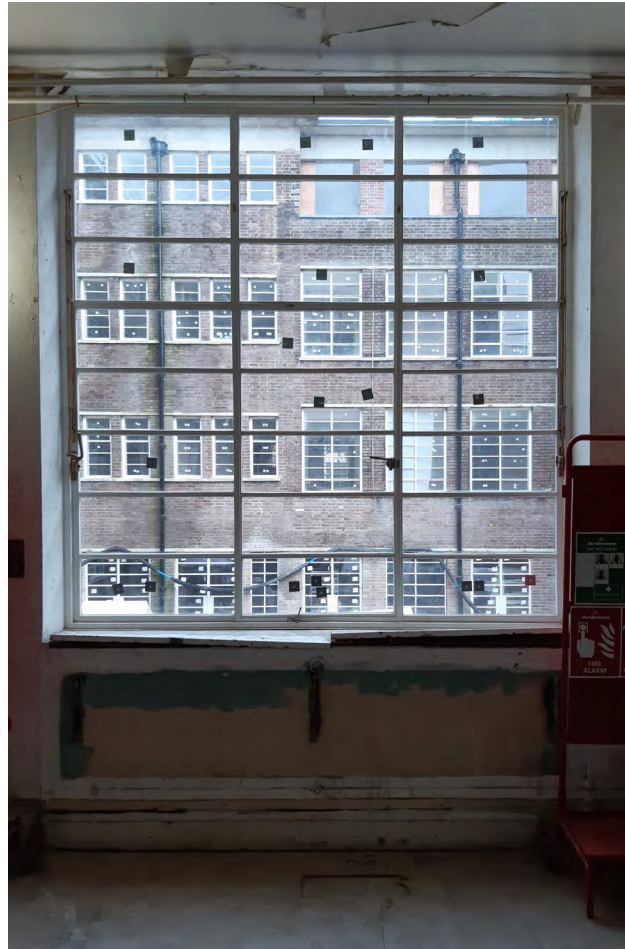
**80C** G.27 original windows to co-working space (shown here with metal cills)

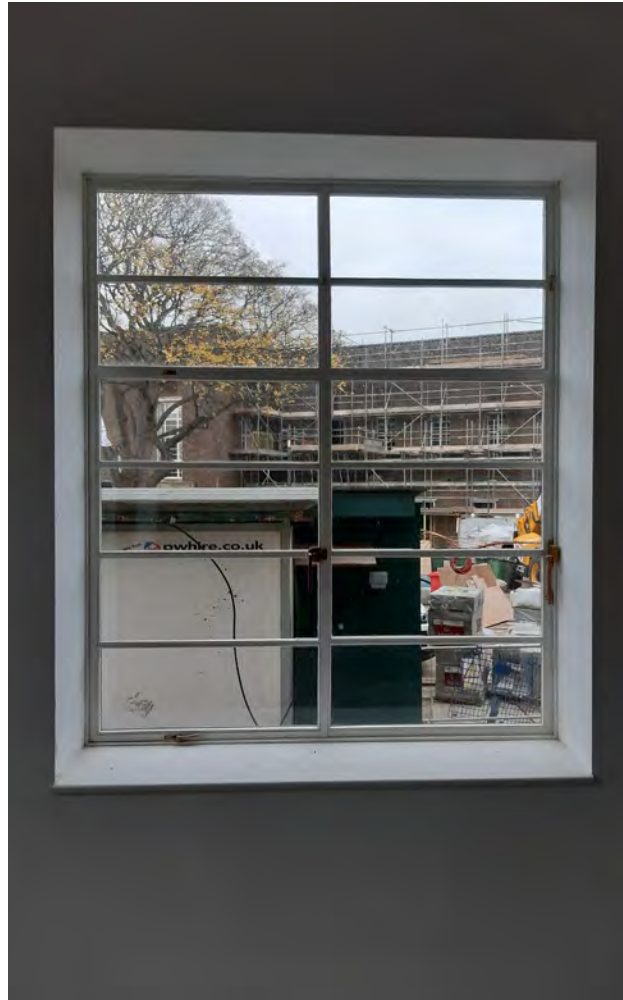
**Windows:** Original Bronze-framed casements [plate 81C]

**81C** G.38 F&B Restaurant windows (original)

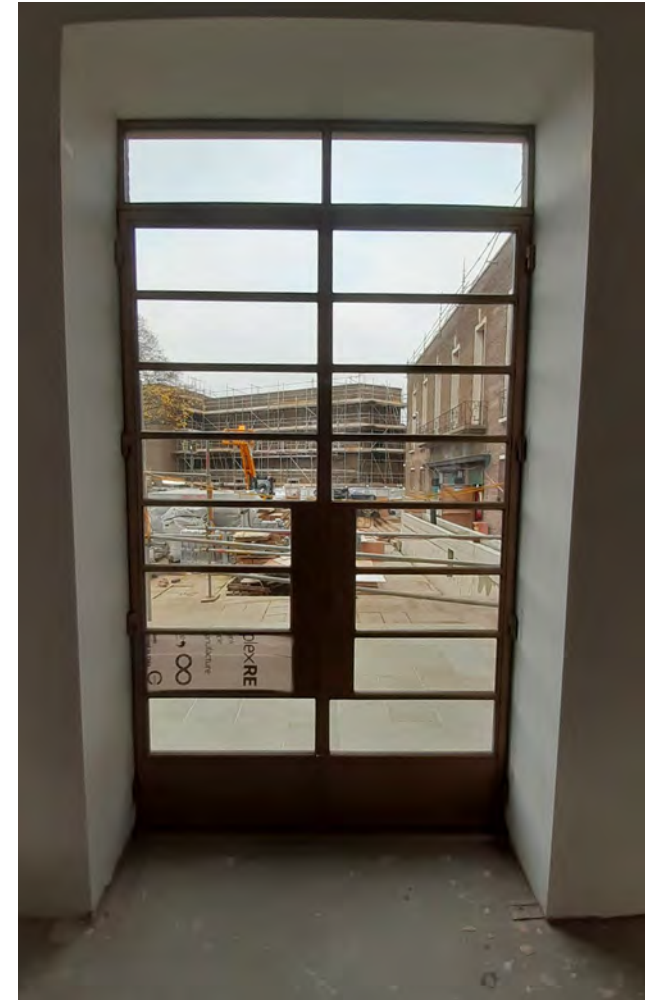
**Doors:** New double-glazed bronze casement doors [plate 81D. Door to G.38 is original but has been shifted, the door and borrowed lights to G.38a are non-original.

**81D** G.38 F&B Restaurant doors (new double glazed)

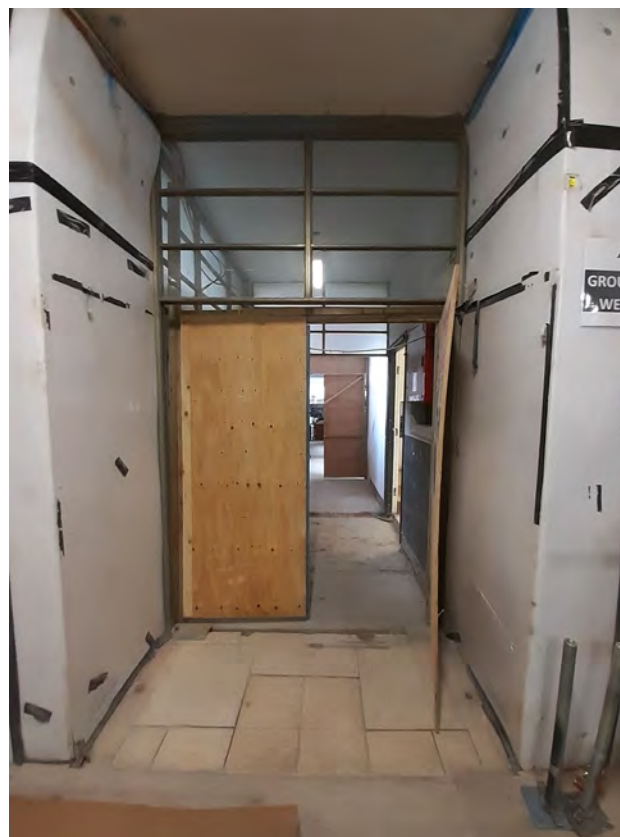
82 G.38b Corridor

**Floor:** Part of corridor floor has cream terrazzo floor as G.41 Entrance Hall, with the rest being bare concrete (previously carpeted).

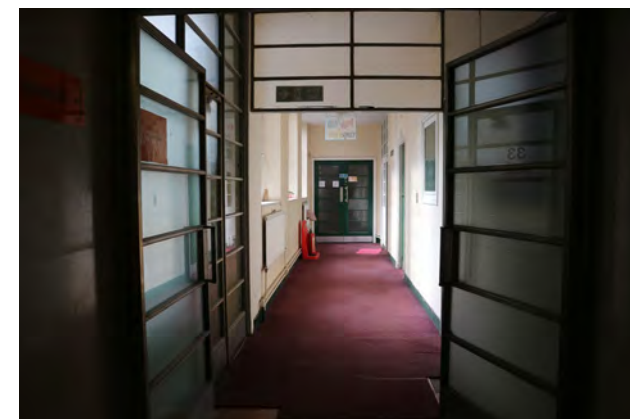
82A Ground Floor, G.4 from the Entrance Hall (2017)

**Doors:** Temporary doors in place during site visit (Dec 2022). Original doors were part of the glazed screens [see plate 82A]

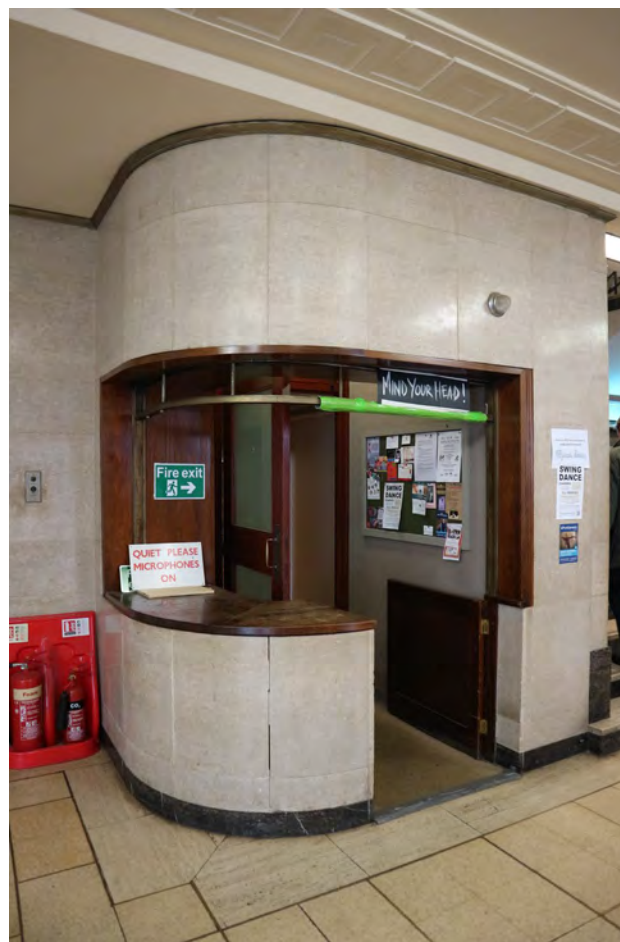
**General Description:** Barista, formerly Hall Porter's kiosk, balancing the form and function of the enquiry desk opposite (now G.2 Concierge). This space was boarded up during the site visit, but a previous image is shown from 2017 **[plate 84A]**.

**84A** Ground Floor, Main Entrance Hall (2017), G.41 looking to Hall Porter's kiosk.JPG (2017)

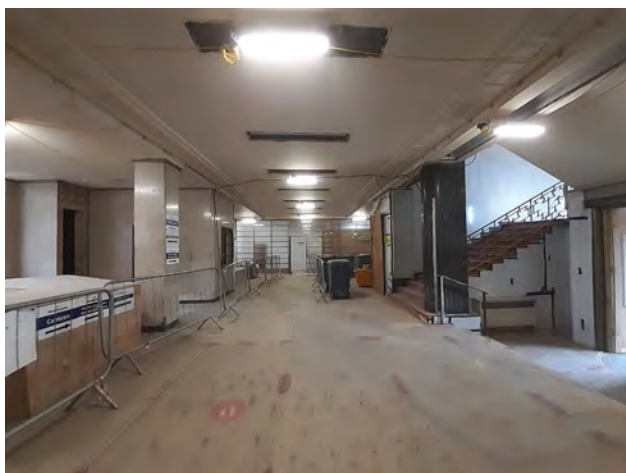
**85A** G.41 Entrance Hall looking south, with the main entrance on the right
