## 6.0 Gazetteer

### 6.1 Exterior

## 6.2 Interior

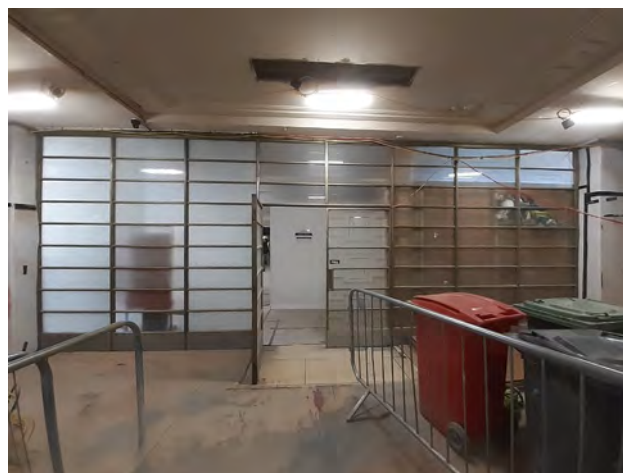
**85D** G.41 Entrance Hall screen at south end

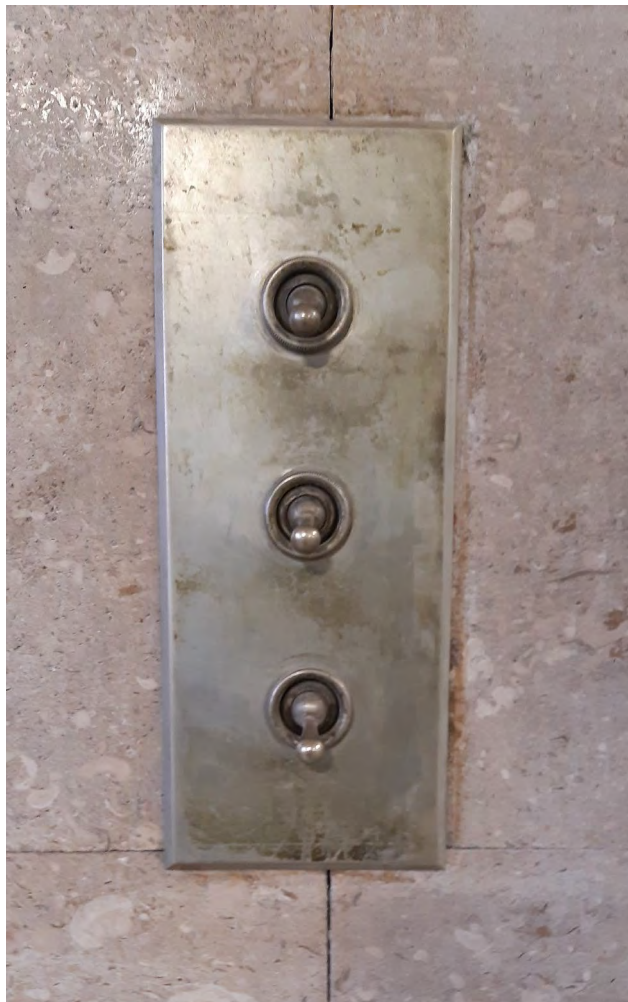
**85E** G.41 Entrance Hall light switches

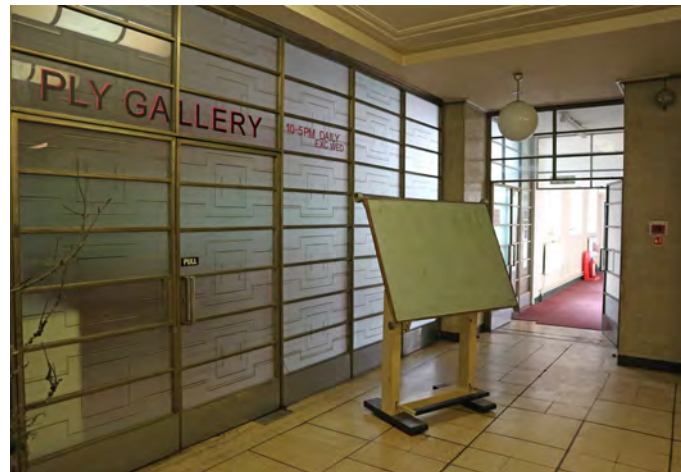
Full-height screens (nickel-plated) divide the Entrance Hall from the former Rates Office, the Assembly Hall Foyer and the former General Clerk's Room, the glass is etched and has the geometric pattern, found elsewhere in the building. There are further matching doors with overlights dividing the office corridor from the Hall. Some of the glass to the Rate's Office screen and those to the office corridors been replaced by Georgian wired glass [Plate 85G].

**85G** Ground Floor, Main Entrance Hall, G.41 (2017)

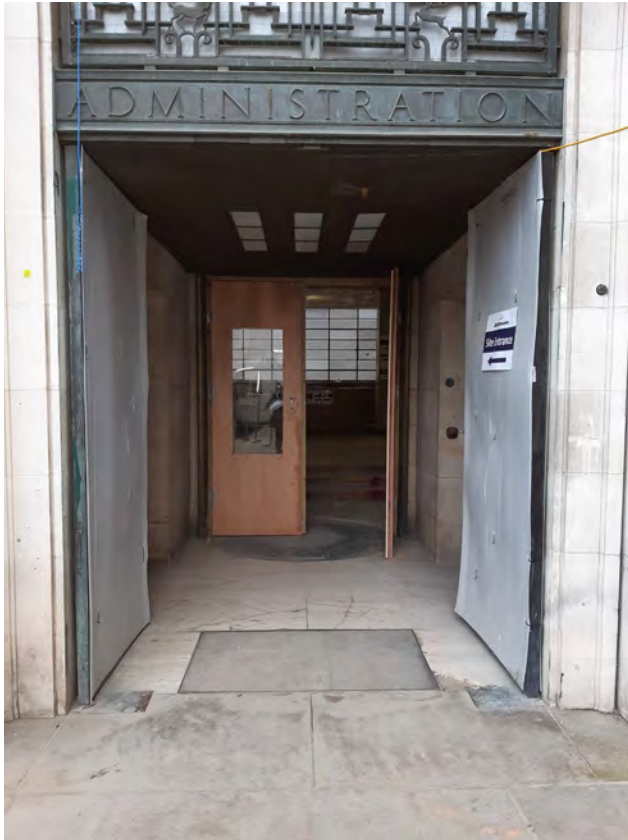
**Walls:** Vestibule walls lined with Perrycot stone.

**Floor:** Vestibule floor lined with Perrycot stone.

**86A** G.43 Vestibule

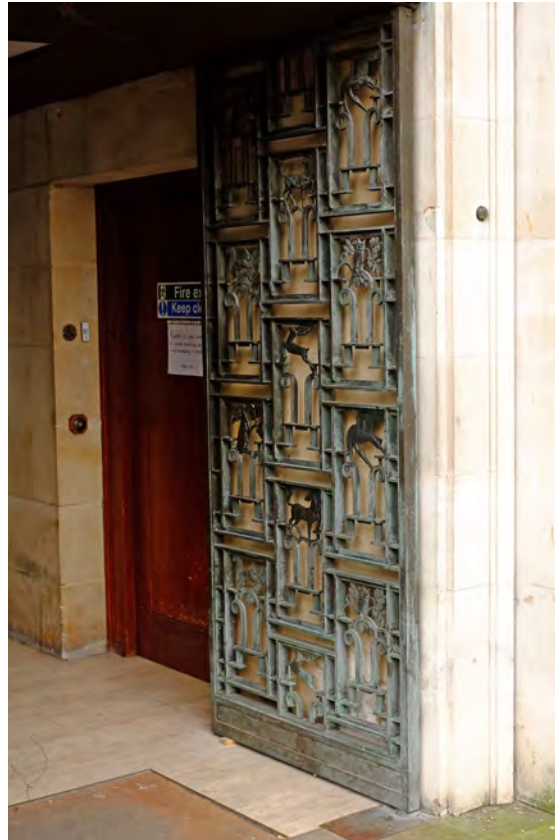
**Doors:** It has decorative bronze gates which were presumably closed at night; they feature stylised animals including horses, squirrels, owls and storks [plate 86B]. There is a matching bronze grille fitted externally over the overlight. There are two panelled timber doors off the vestibule, leading to ST.08 and G.39. G.42 is set beneath the main staircase. Temporary inner doors to Vestibule during the construction works.

**86B** Bronze gate to the administrative entrance (2017)

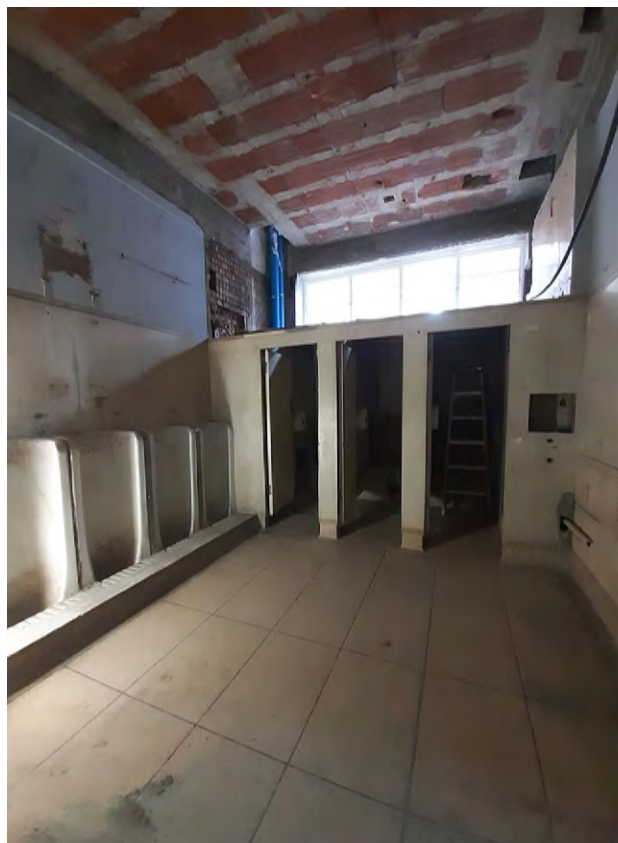
**Fittings:** Terrazzo cubicles. Urinals retained. Sinks, taps and other fixtures and fittings removed.

87 G.45 Men's Lavatory looking east

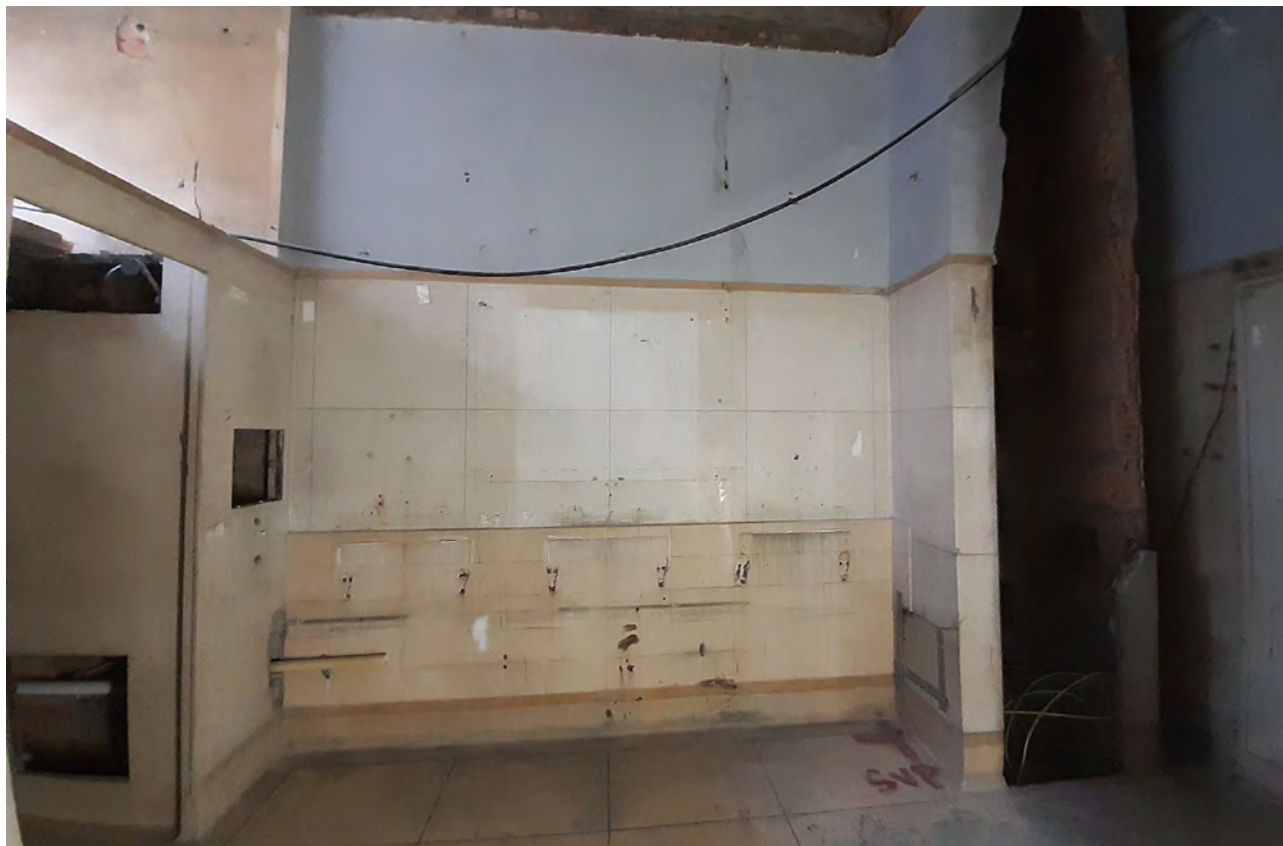
**87A** G.45 Men's Lavatory looking south

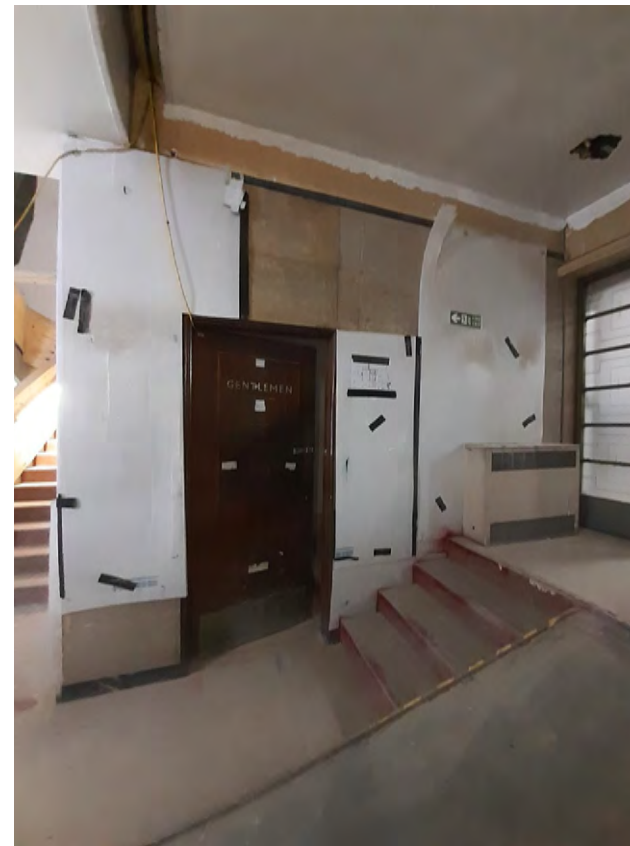
**Doors:** Door with some original ironmongery, including panelled door to G.45 [plate 87B].

**87B** G.45 entrance door

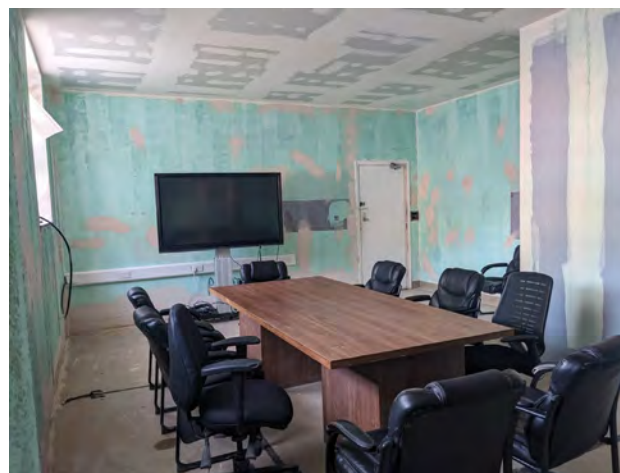
88 G.48 Cafe

**Fittings:** Surface-mounted services, modern counter and modern pendant lights.

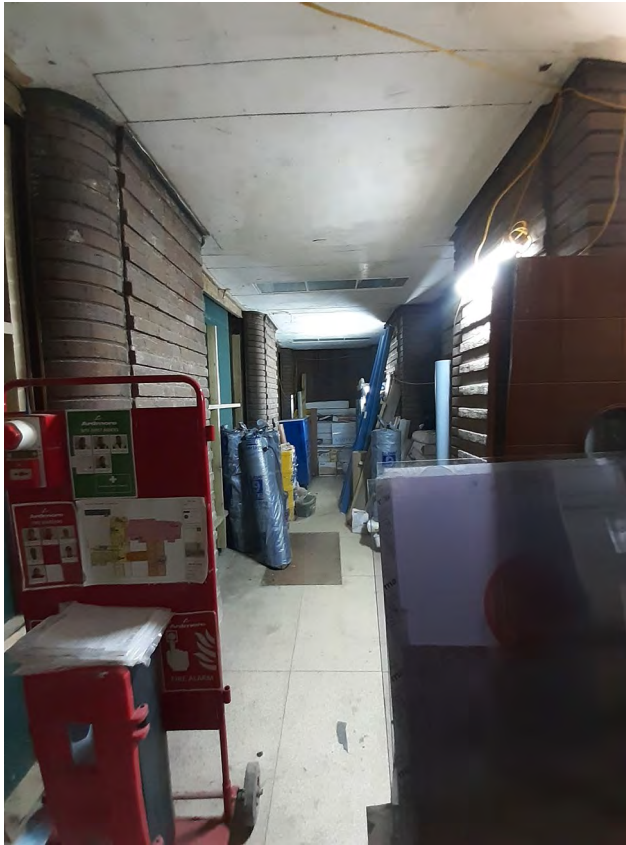
**89** G.49 Vestibule looking north

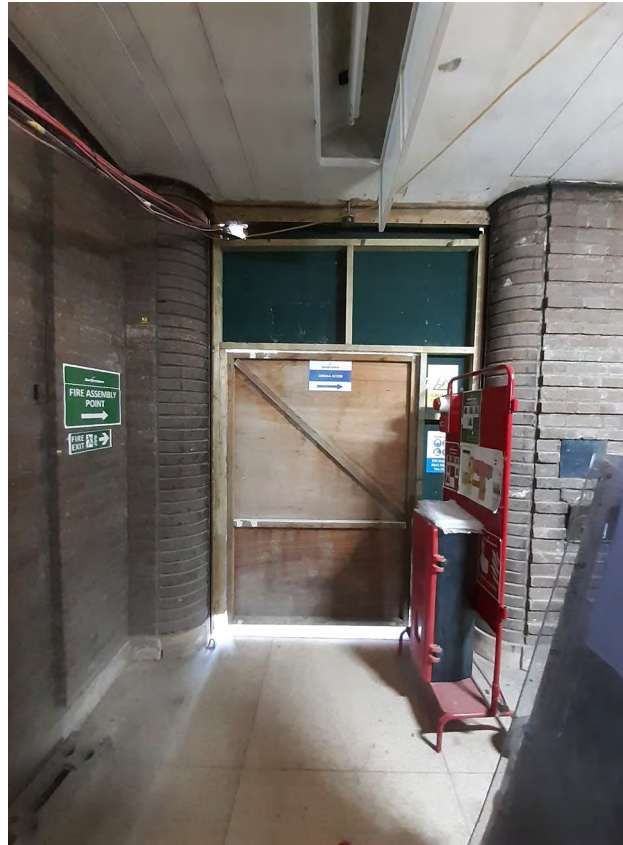
**General Description:** Vestibule to Assembly Hall Foyer. The inner reveals of the three main entrance doors are clad in Ashburton-marble (to G.55 Foyer). Two of the outer entrances have been temporarily closed with a temporary door in the outer door in the remaining outer entrance.

**89A** G.49 Vestibule, entrance door opening

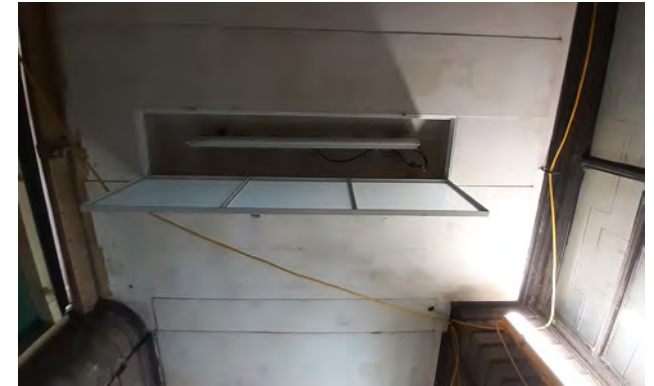
**89B** G.49 Vestibule ceiling radiator lights

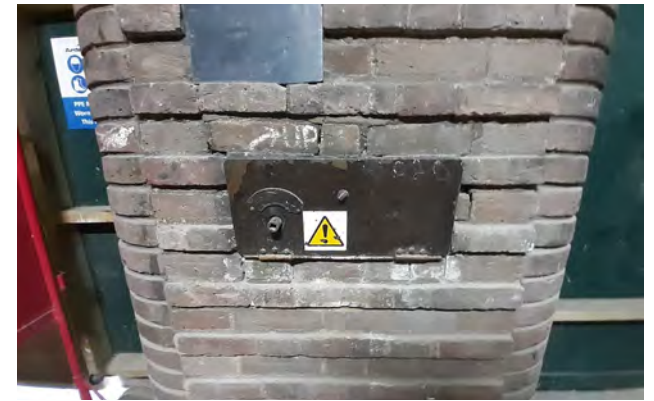
**89D** G.49 Vestibule switchplates and fittings set into decorative brickwork

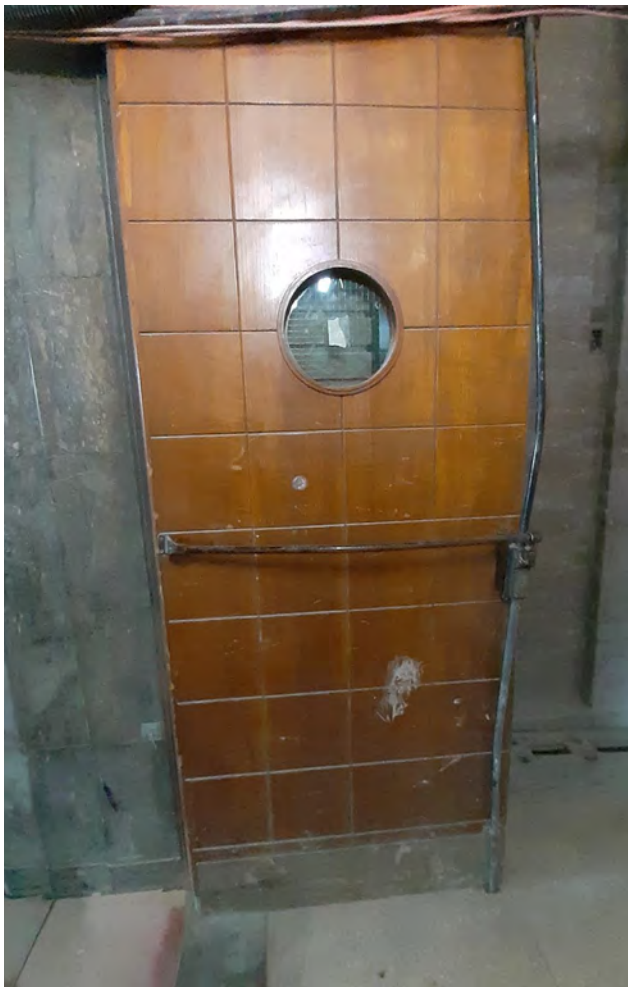
**Doors:** Inner doors are solid timber with channelled detail and portholes (modern), over which are large original overlights with sandblasted and etched glass [plate 90C]. Outer doors have been removed and openings boarded, but shutters appear to be intact.

**89C** G.49 Vestibule inner entrance door

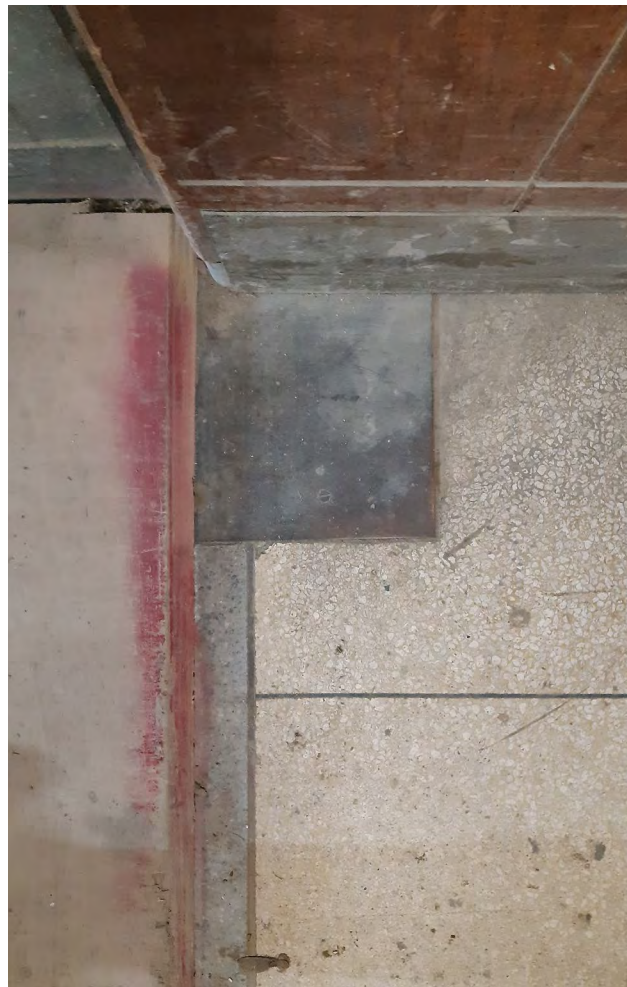
**Floor:** Cream terrazzo, with a pale blue threshold [plate 90E].

**89E** G.49 Vestibule floor finish details including for floor mounted hinge plates

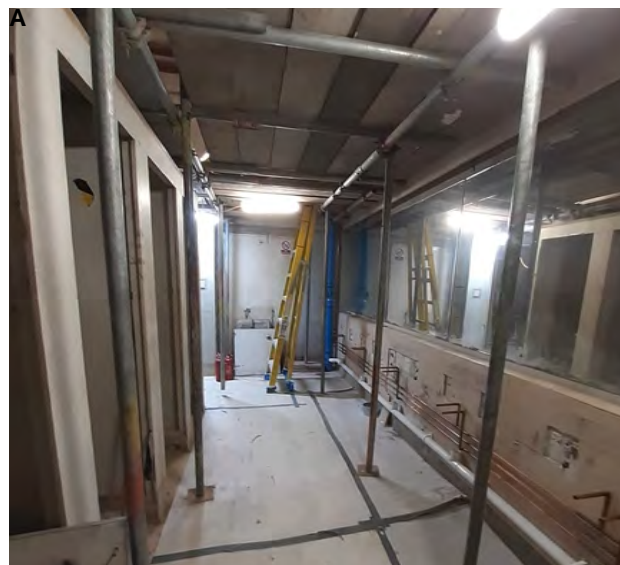
**Fittings:** Terrazzo cubicles. Sinks, taps and other fixtures and fittings removed.

92 G.54 Ladies Lavatory looking back to entrance door

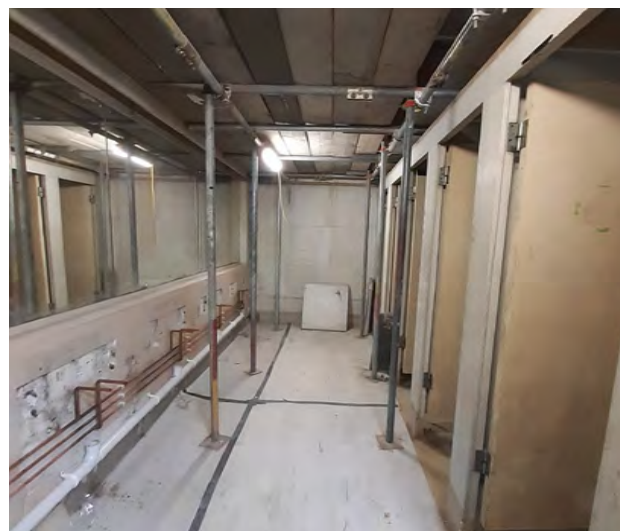
92A G.54 Ladies Lavatory looking east

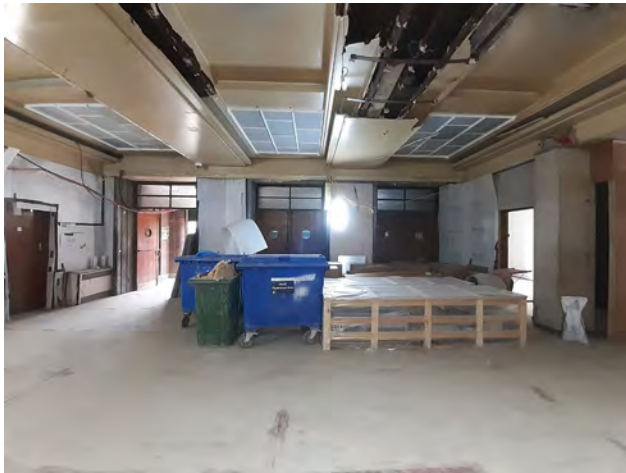
**93** G.55 Foyer looking towards Assembly Hall

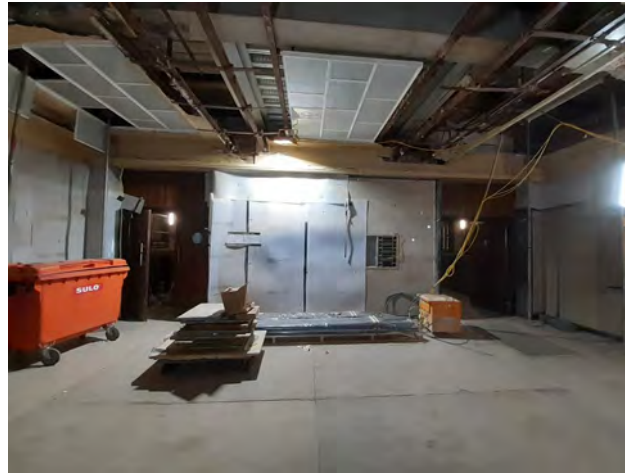
**93B** G.55 Foyer looking towards Assembly Hall

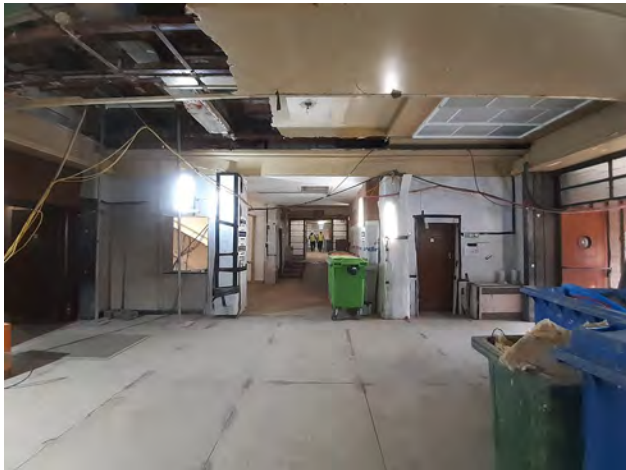
**93A** G.55 Foyer looking towards G.41 Entrance Hall

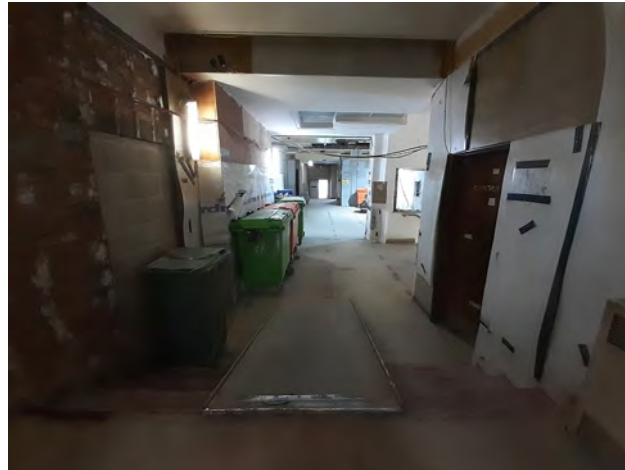
**93D** G.46 Corridor looking towards G.55 Foyer

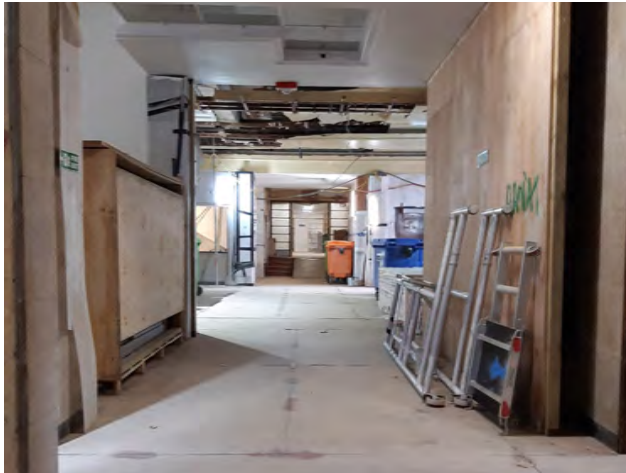
**93C** G.52 Corridor looking towards G.55 Foyer

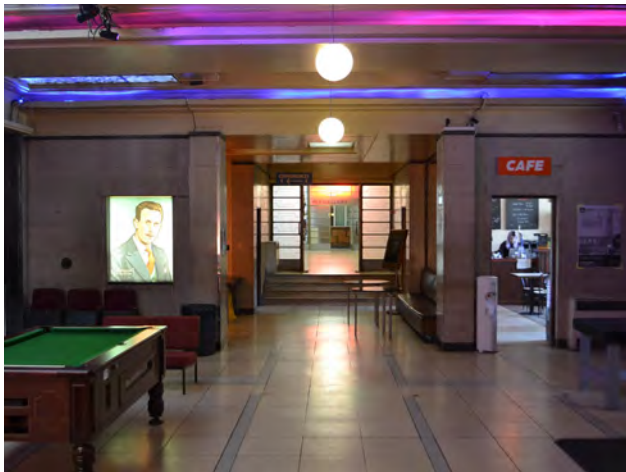
There are male and female cloakrooms and WCs arranged off the Foyer via the corridors G.46 and G.52. These spaces have veneered doors and retain original ironmongery, although there has been some change to the internal layout and finishes of these spaces. There are terrazzo lined steps and etched glass screens with double doors through to the Entrance Hall [plate 93F].

There were a number of appealing additional features and fittings in this area mentioned in the 2017 inspection, including the ceiling-hung 'WAY OUT' signs and cigarette butt plates. There is modern illuminated artwork (depicting the architect - Uren) and signage attached to the walls [plate 93F].

**93F** Ground Floor, Assembly Hall Foyer, G.55 (2017)

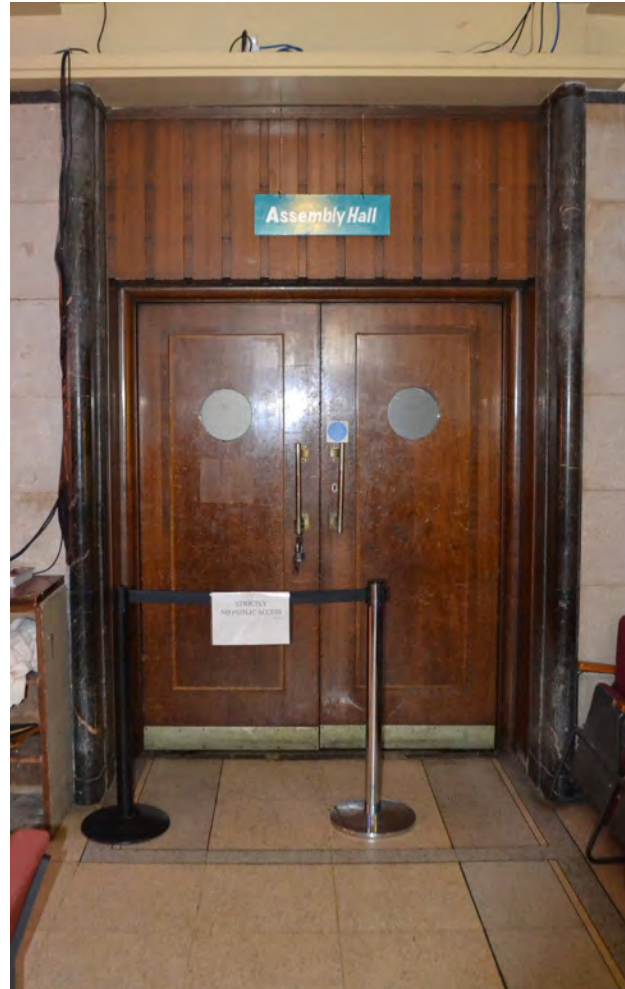
**General Description:** This is the Foyer to Assembly Hall, another of the building's prominent public spaces, though it is less elaborate than the Entrance Hall. There are two sets of double doors to the Assembly Hall, these are veneered with portholes (with later wired glass) brass pull handles, with fluted timber friezes over and are framed by Ashburton marble jambs and reveals [plate 93E]. Between these doors the former Ticket Office is set into the wall, which is fronted by silver openwork screens.

**93E** Ground Floor, entrance doors to the Assembly Hall from the foyer G.55 (2017)

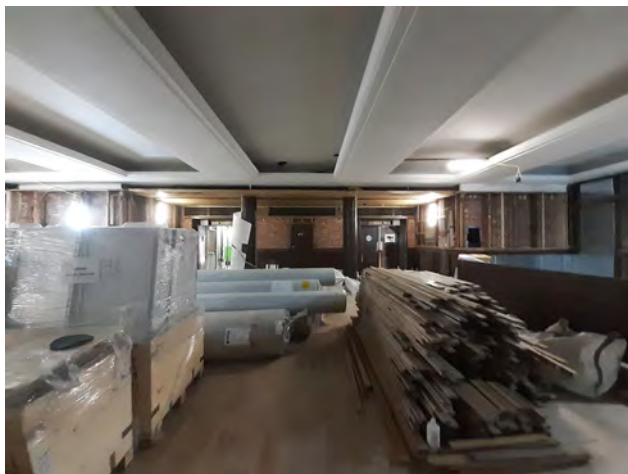
**94** G.55a Function Room looking towards G.55 Foyer

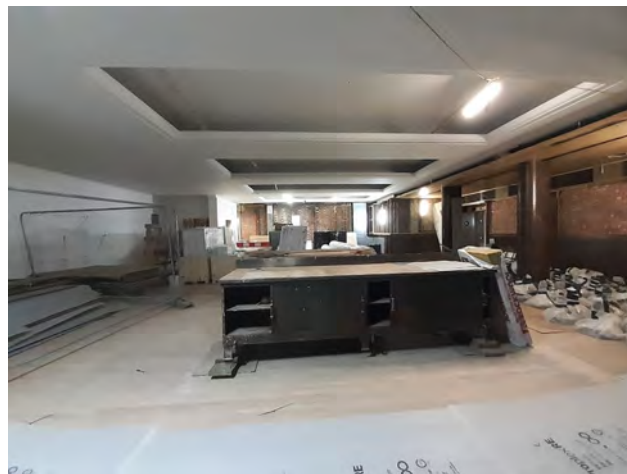
**94A** G.55a Function Room looking south; image shows some retained furniture and lighting fixtures being stored for re-use

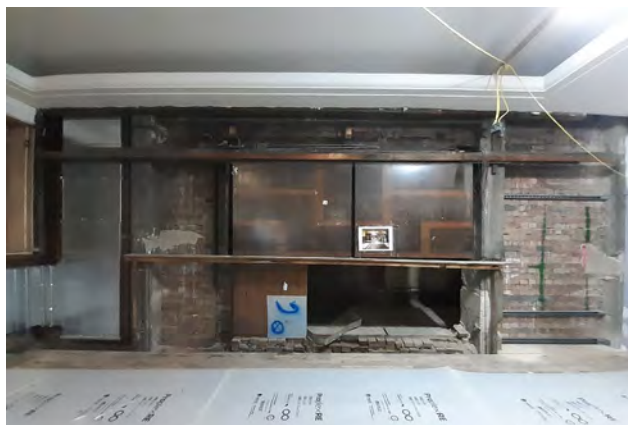
**94B** G.55a Function Room, looking towards G66 Servery Pantry, image shows panelled wall to this north side of the room

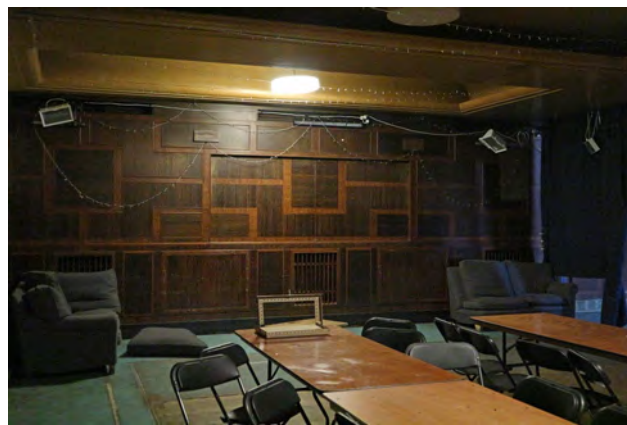
**94C** Former Ground Floor, Assembly Hall, this section now to be used as G.55a Function Room next to Servery Pantry (2017)
